CONSTRUCTION MONITORING REPORT

Eversource Transmission Lines:
F107

**Madbury, Durham,
Newington, Portsmouth, NH**

TYPE OF INSPECTION: Weekly Storm Event Incident Corrective Action

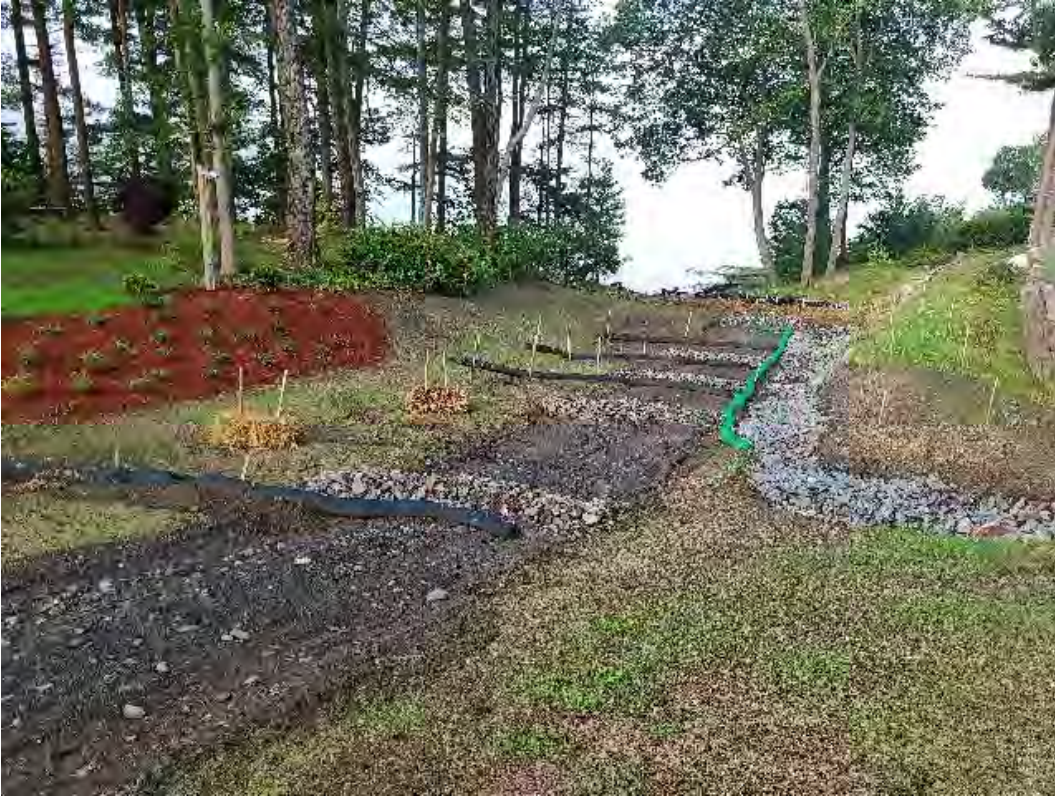
Fig 1: Temporary BMPs on slope above manhole at Gundalow Landing/east side of the bay. Viewing southwest. (07-09-20).

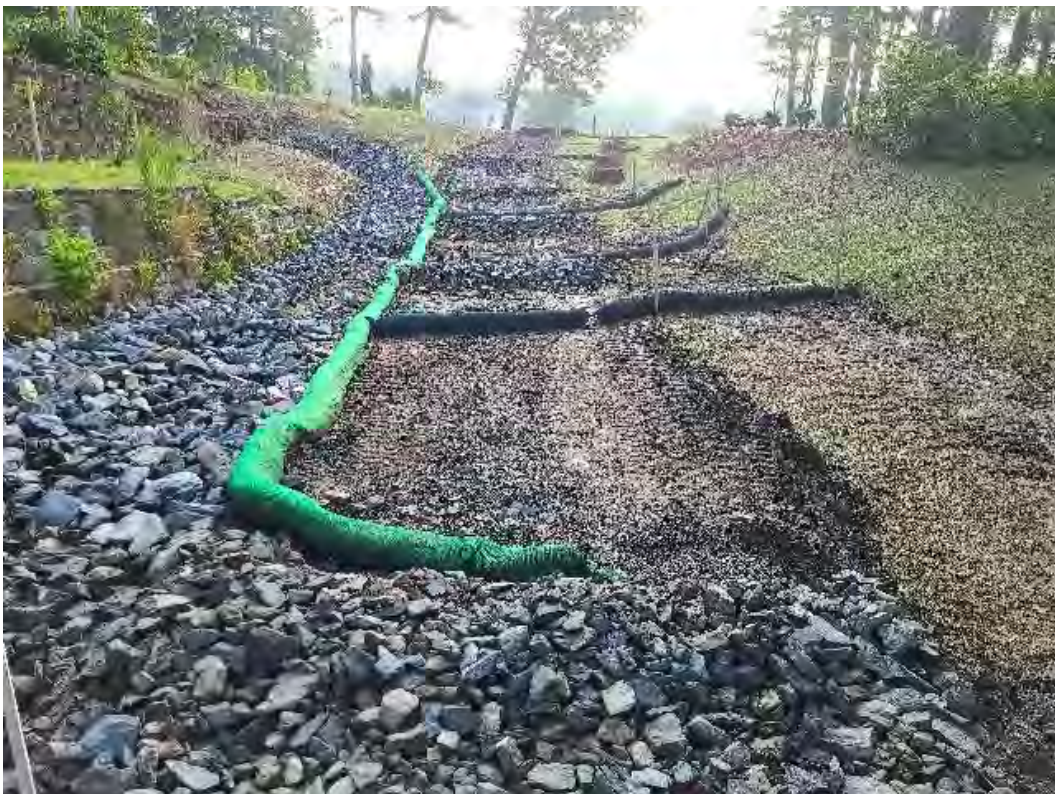
Fig 2: Temporary BMPs installed on slope above manhole at Gundalow Landing/east side of the Bay. Viewing west. (07-09-20).

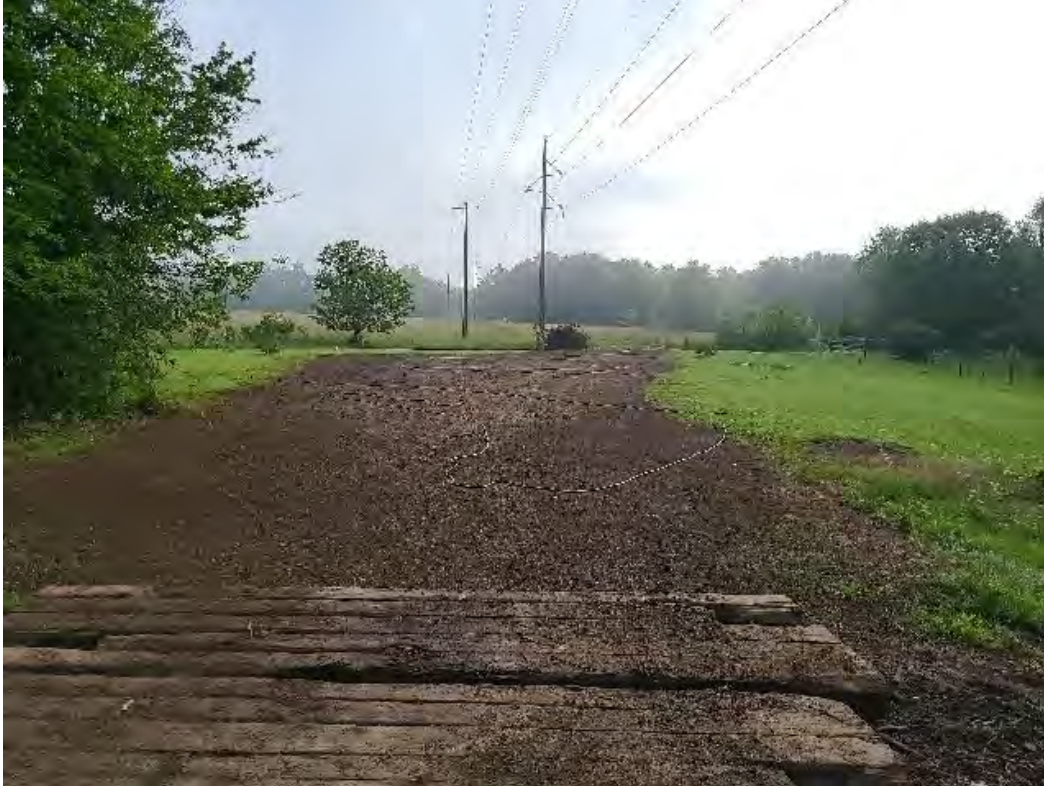
Fig 3: Restored access road between Strs. 109 and 110. Viewing northeast. (07-09-20).

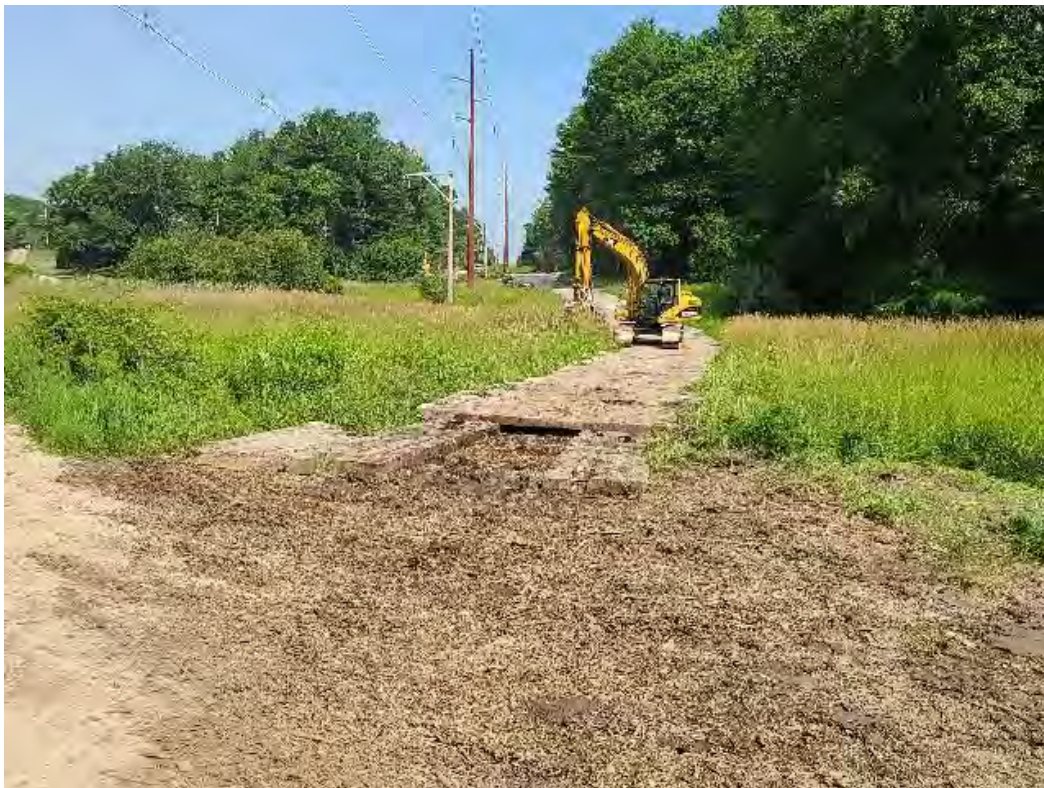
Fig 4: Removing timber matted access road in wetland DW6, between Strs. 95 and 96. Viewing northwest. (07-09-20).

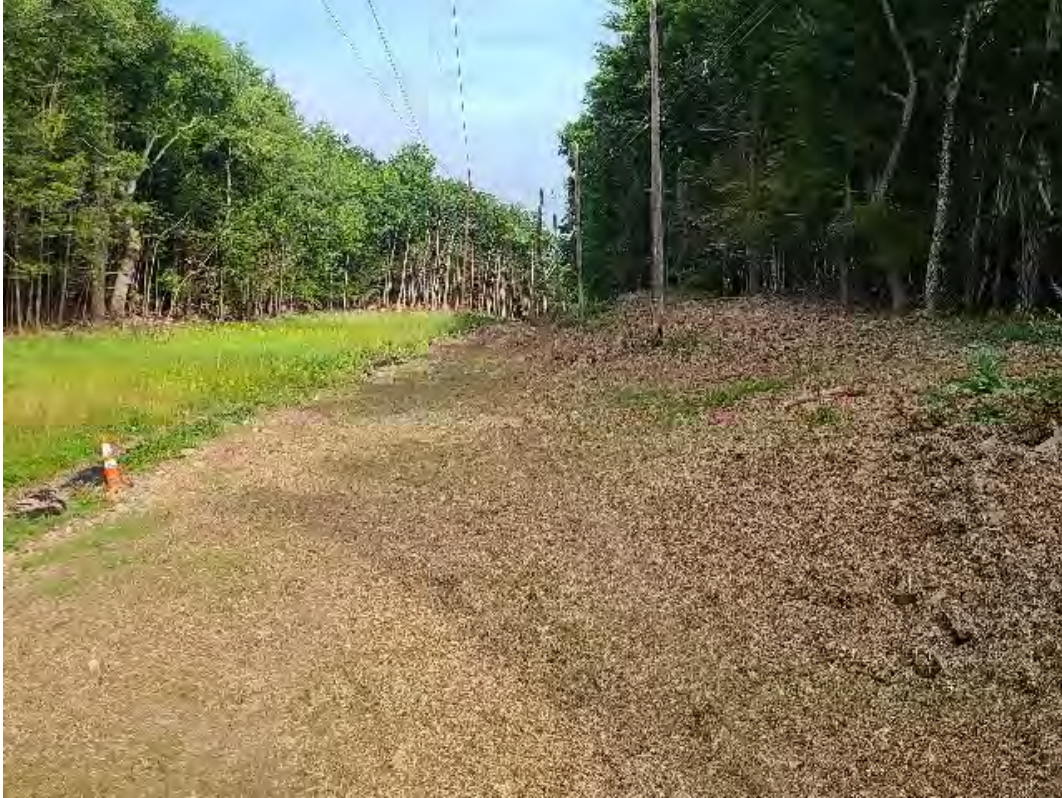
Fig 5: Slight germination on access road between Strs. 97 and 98, post restoration. Viewing west. (07-10-20).

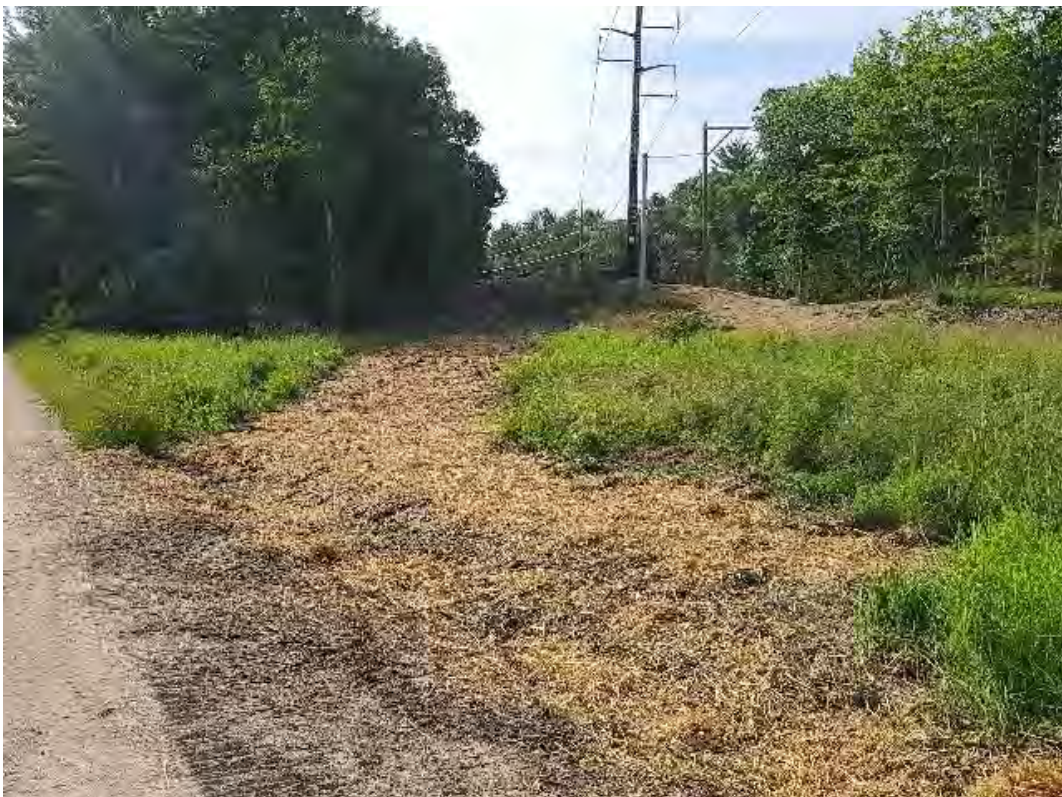
Fig 6: Access road through wetland DW4, between Strs. 95 and 96 restored. Viewing southeast. (07-10-20).

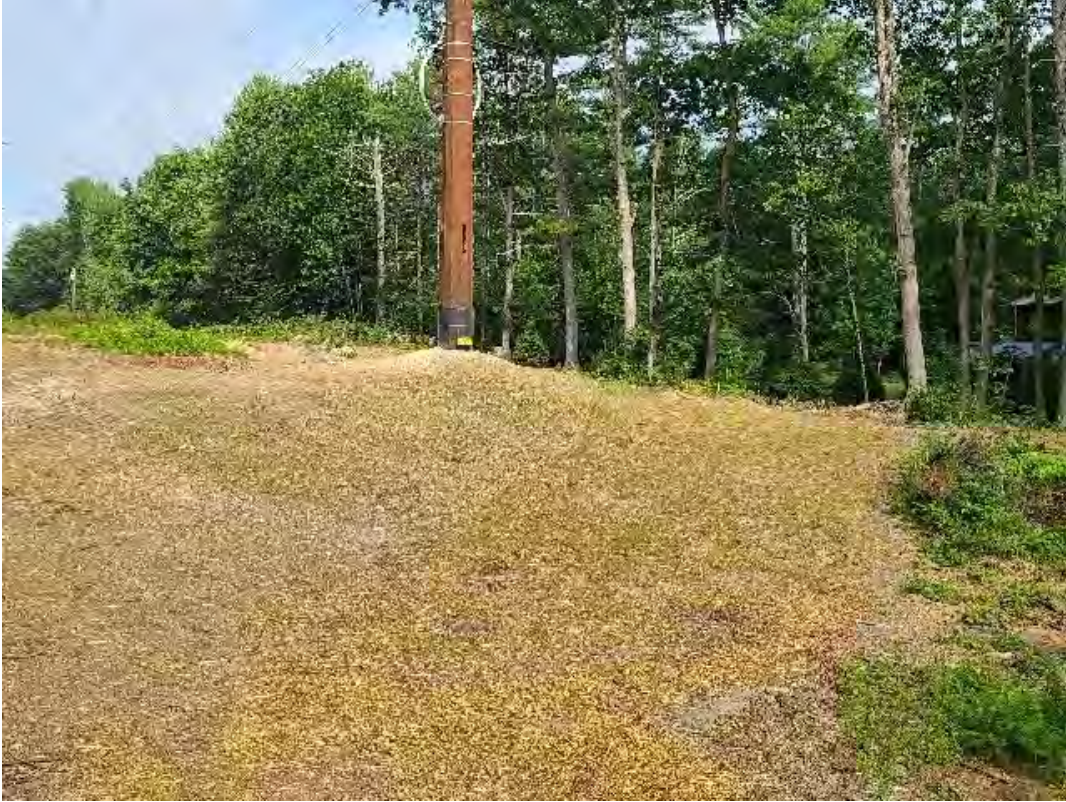
Fig 7: Slight germination at Str. 66. Viewing west. (07-10-20).

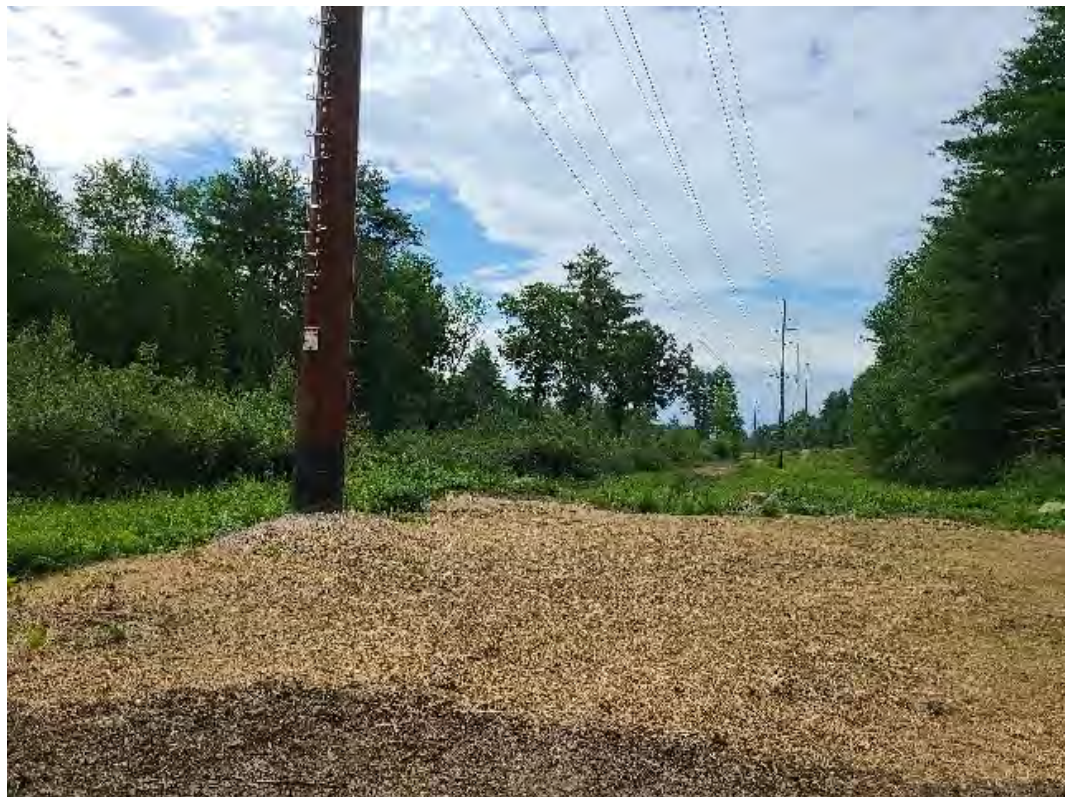
Fig 8: Str. 39 area restored. Viewing south. (07-13-20).

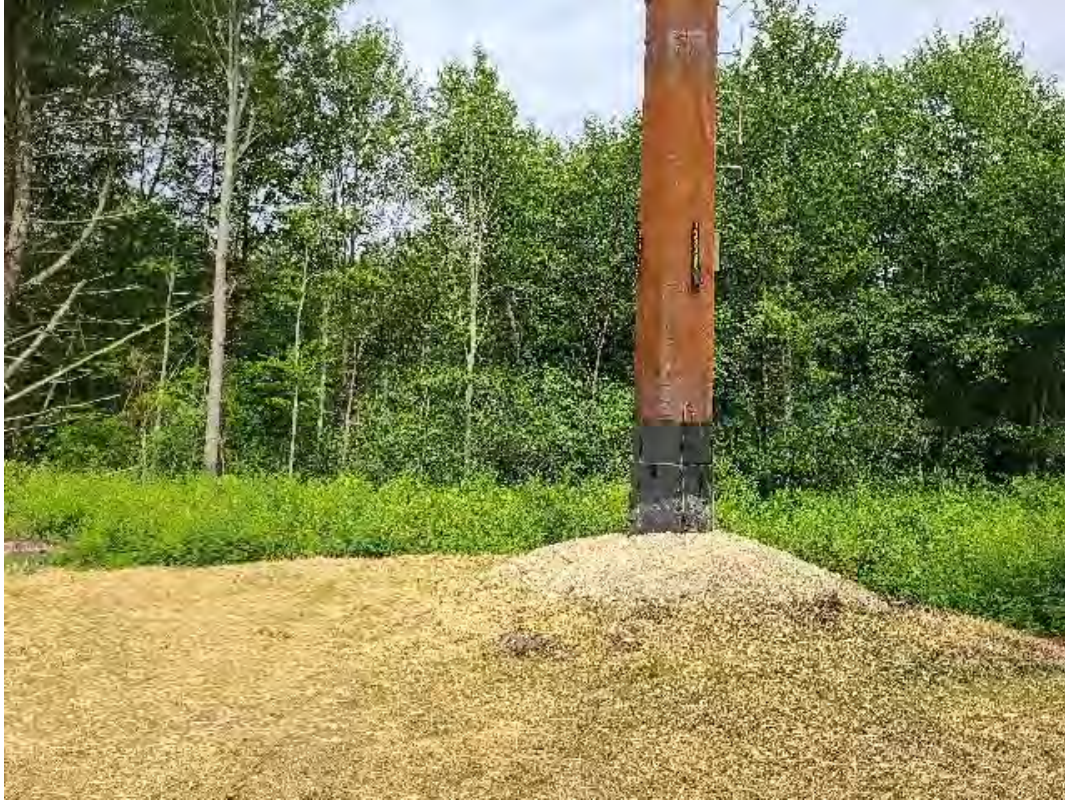
Fig 9: Str. 40 area restored. Viewing west. (07-13-20).

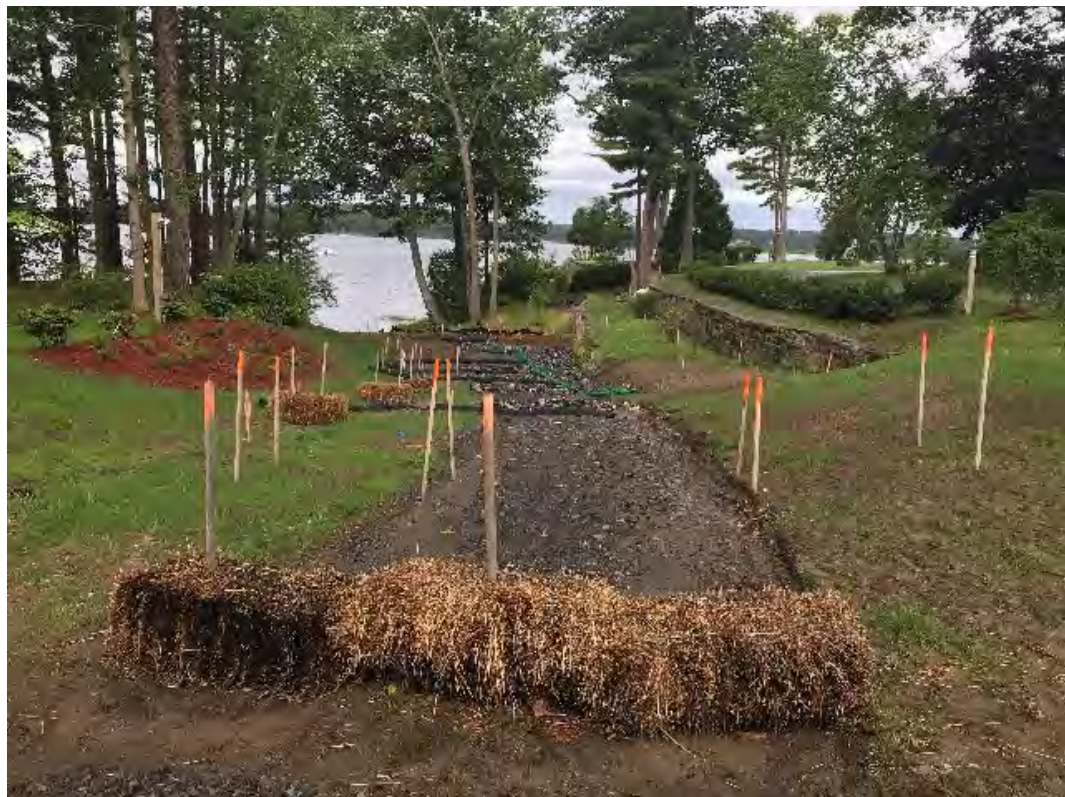
Fig 10: Slight sediment build up on BMPs on slope above manhole at Gundalow Landing/east side of the bay. Viewing west. (07-14-20).

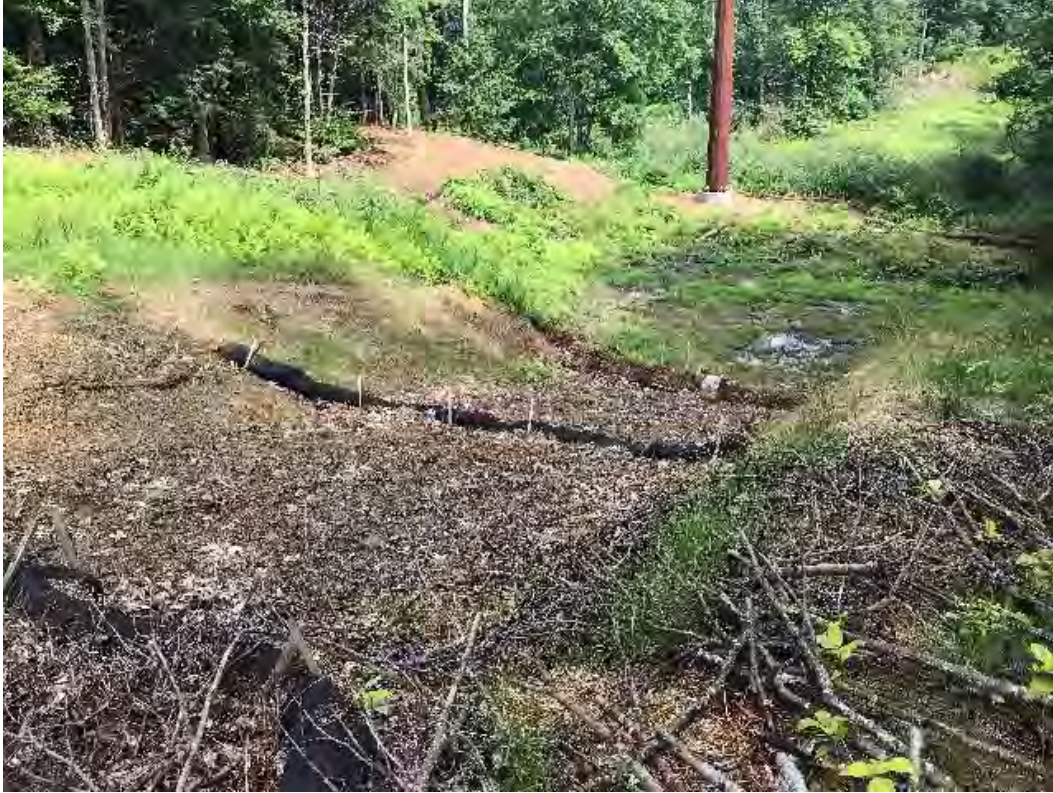
Fig 11: Original access route to Str. 28. Viewing north. (07-14-20).

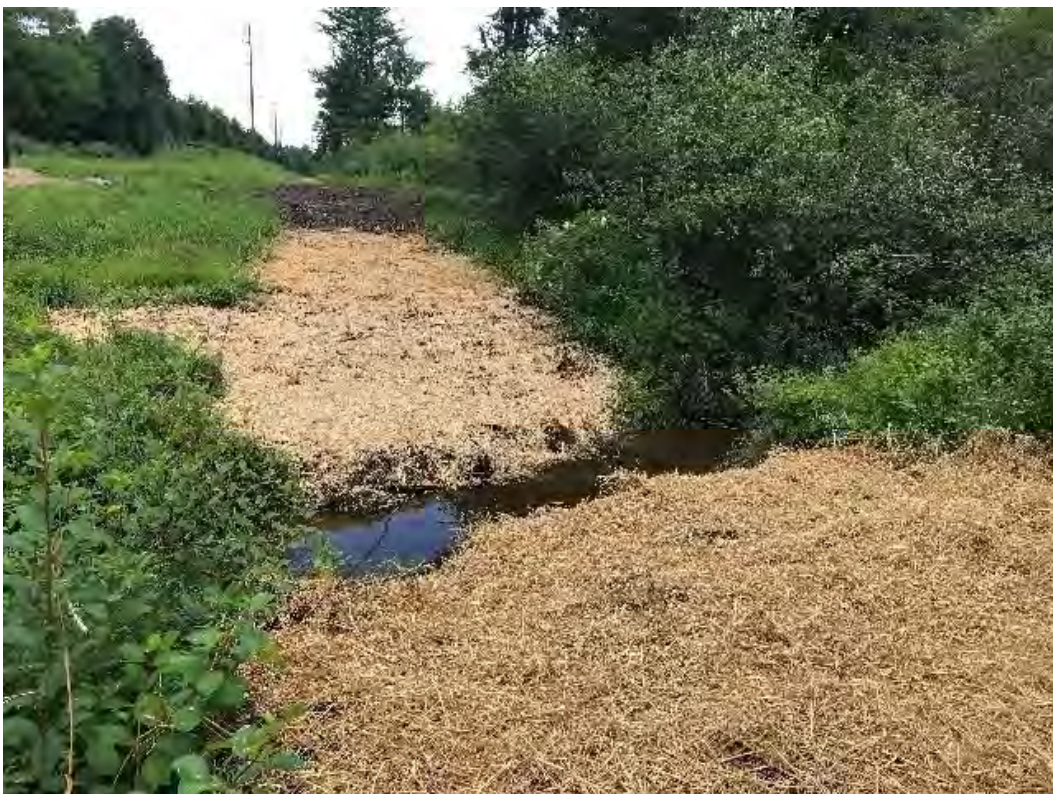
Fig 12: Restored access road and stream banks of stream DS60 between Strs. 44 and 45. Viewing north. (07-14-20).

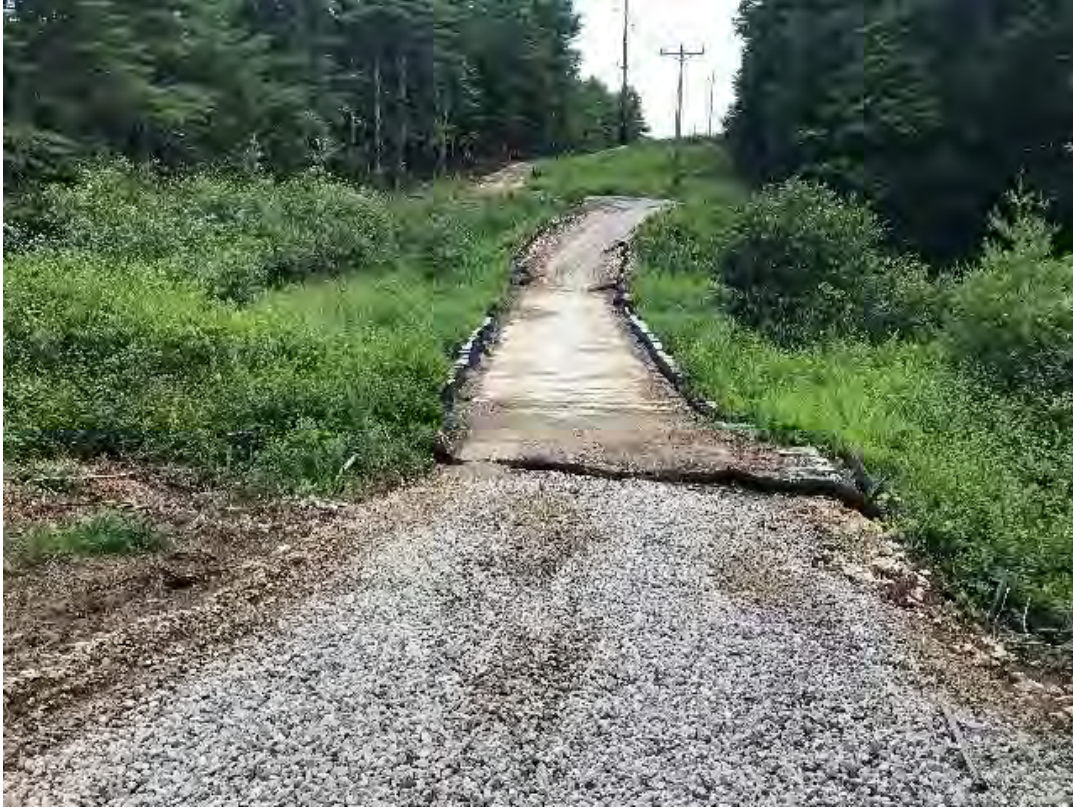
Fig 13: Access road through wetland DW48, over stream DS46, between Strs. 51 and 52. Viewing northeast. (07-14-20).

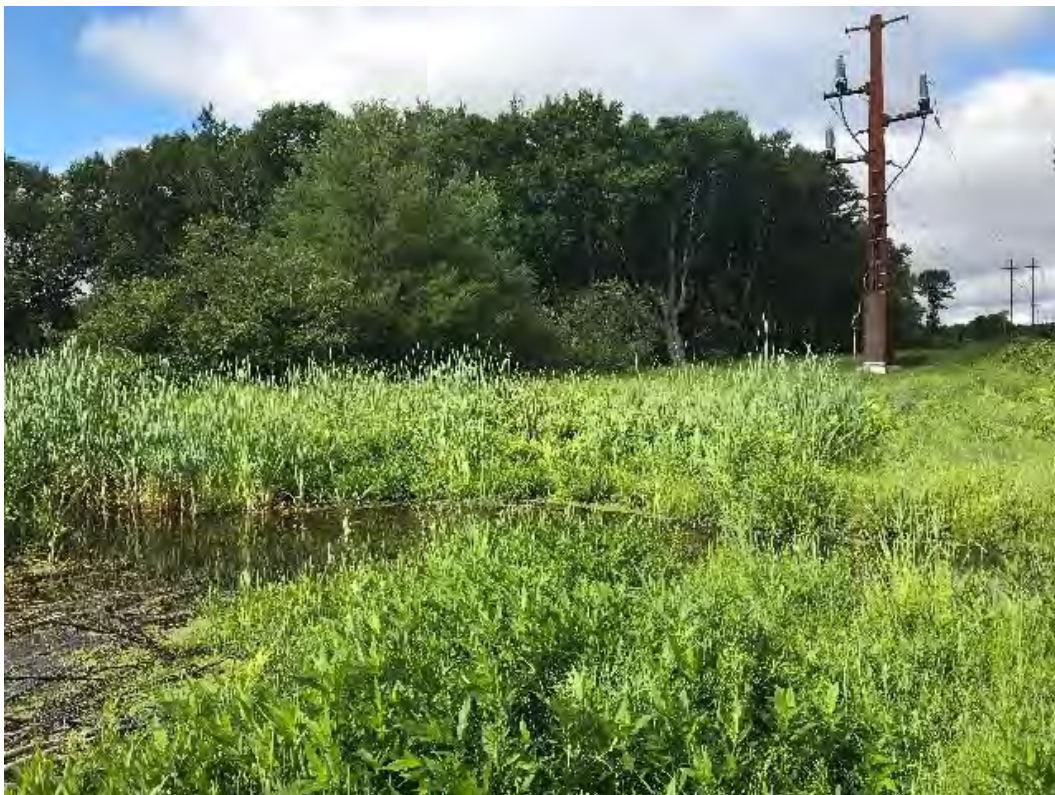
Fig 14: Stream NS107 through wetland NW16 at Frink Farm, between Strs. 106 and 107 Viewing southwest. (07-15-20).

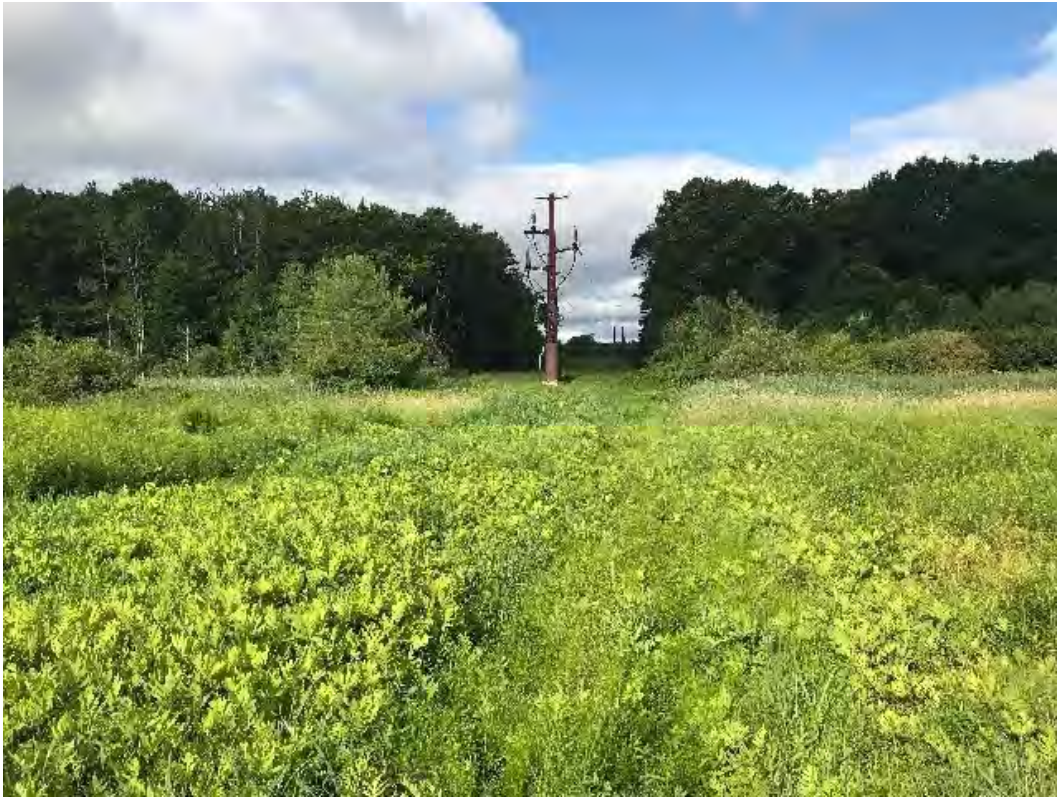
Fig 15: Re-vegetation of previously timber matted route across wetland NW 16, over stream NS107. Viewing west. (07-15-20).

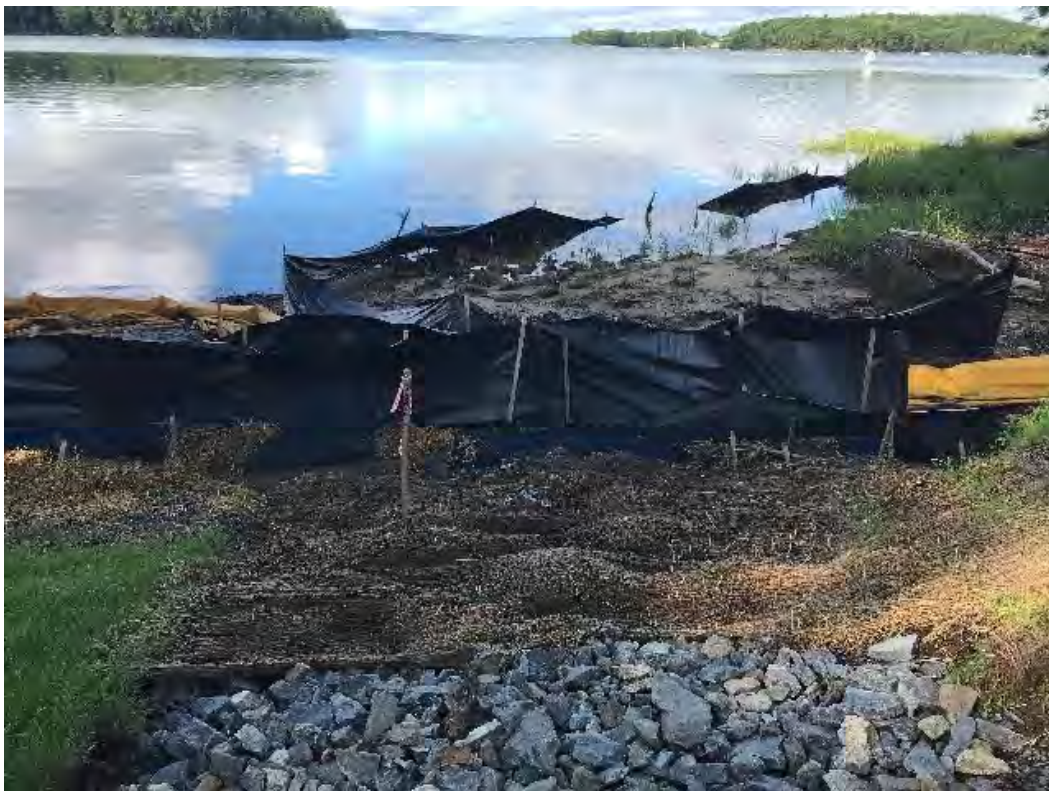
Fig 16: Temporary BMPs at toe of slope/intertidal zone at Gundalow Landing/east side of the bay. Viewing southwest. (07-15-20).

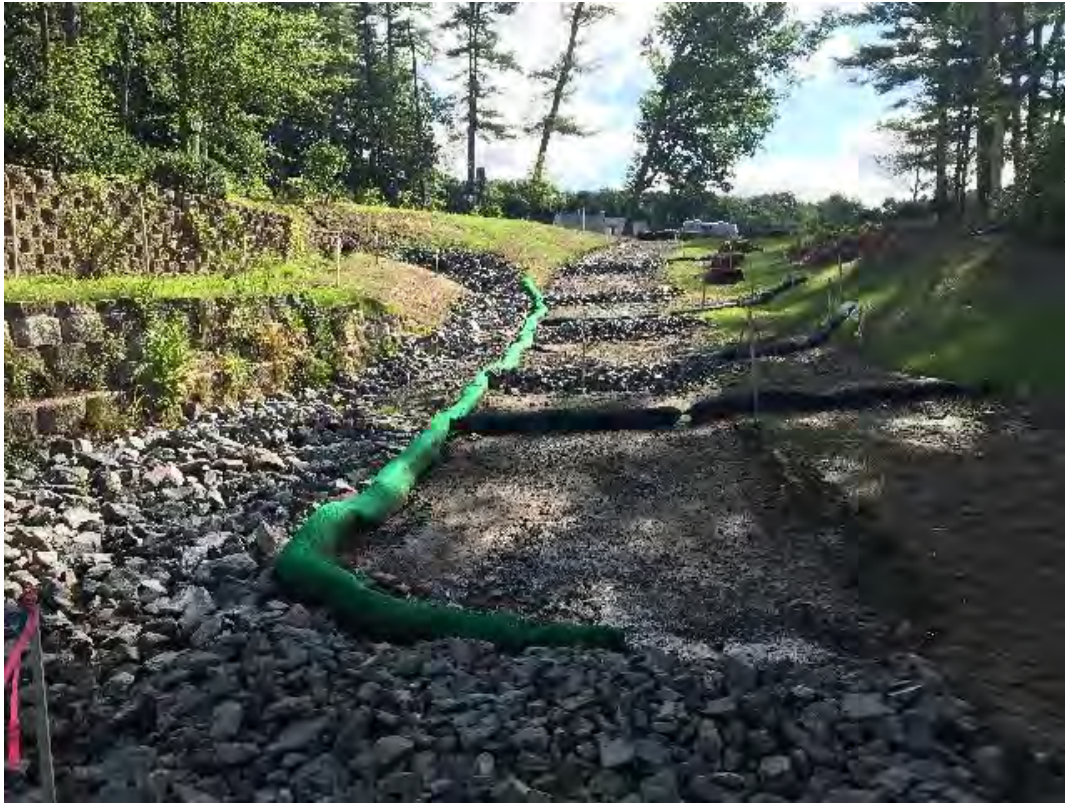
Fig 17: Temporary BMPs on slope above manhole at Gundalow Landing/east side of the bay. Viewing northeast. (07-15-20).

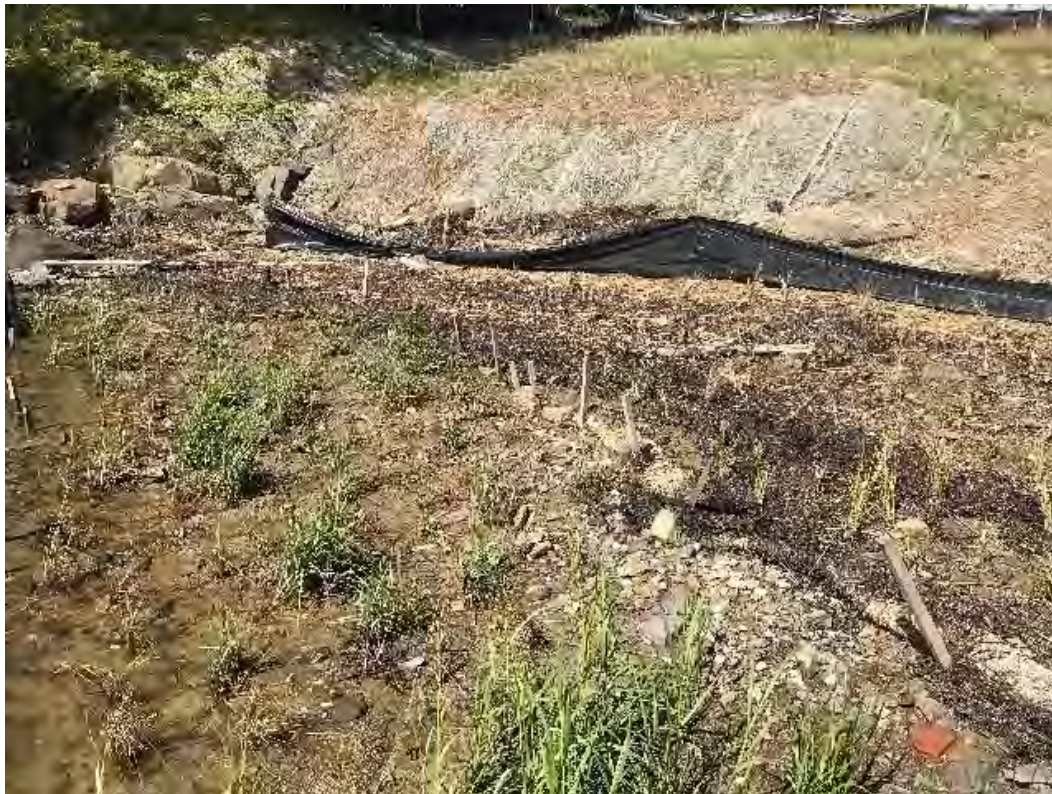
Fig 18: Salt marsh restoration at Getchell property/west side of the bay. Viewing west. (07-15-20).

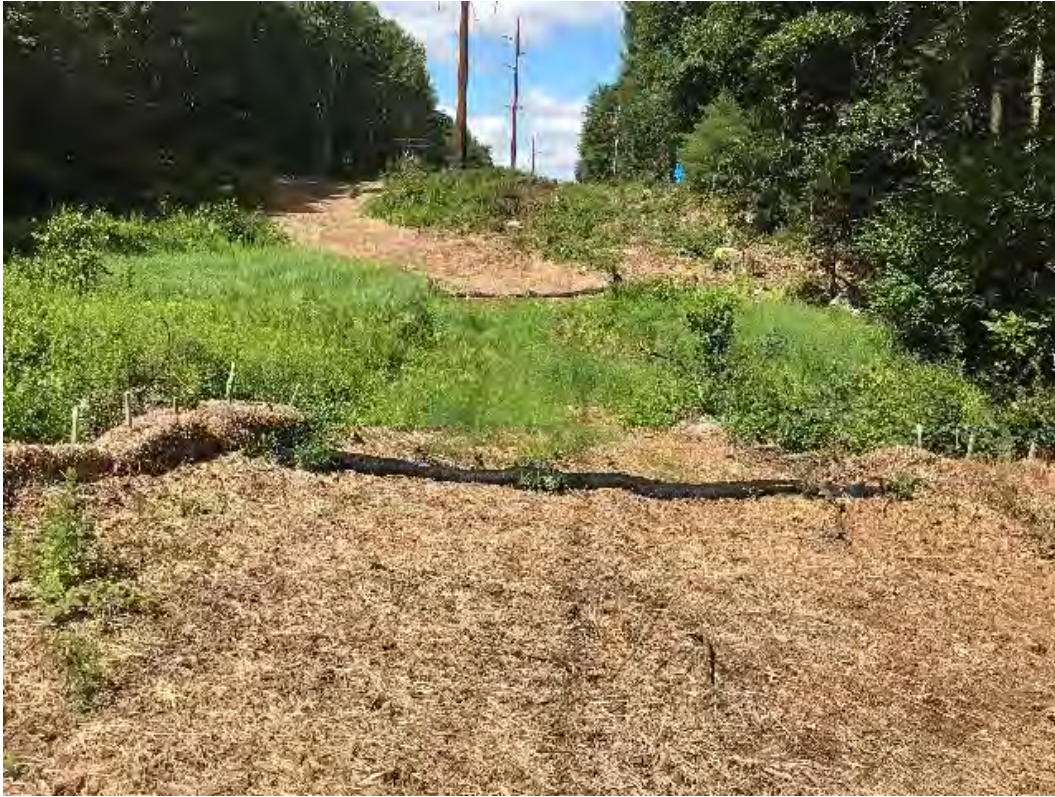
Fig 19: Re-vegetation of wetland DW9 between Strs. 65 and 66. Viewing west. (07-15-20).
