DRAINAGE MONITORING REPORT

F107 - Seacoast Reliability Project

Newington, New Hampshire

04.0190967.00

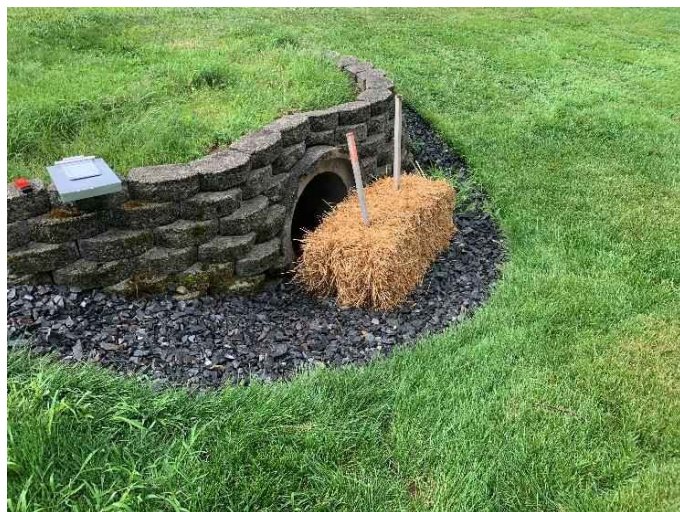
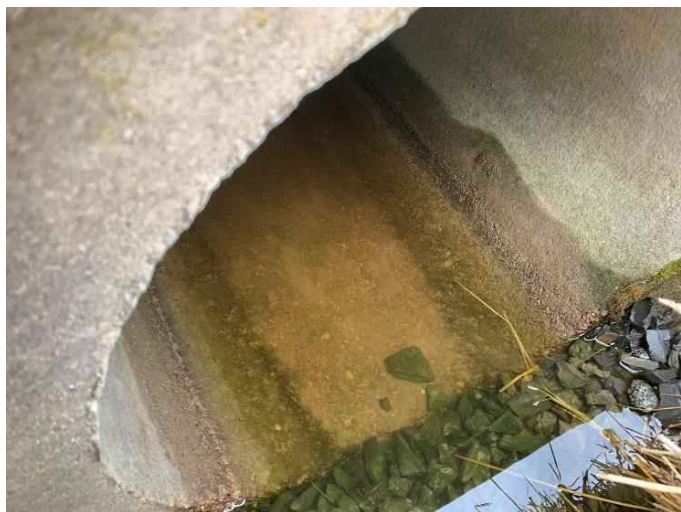
29 Gundalow -1 (Drainage Area)

pH: **Not Monitored – Could not access due to construction/drainage improvement work**

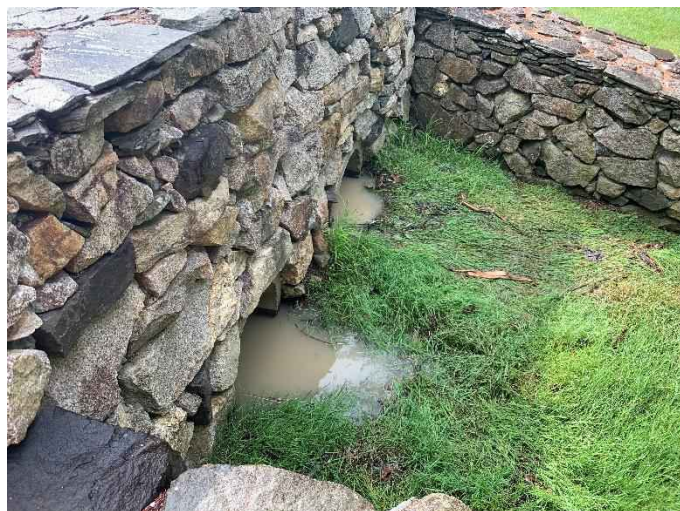
4 Brickyard Circle – 1 (Drainage Course)

pH: **7.0**

Observations/Notes: ~ 8" of standing water extending ~ 18" beyond culvert outlet in grassed raceway. Drainage course improvements at 64 Gundalow were ongoing on 7/13/20 when rain event occurred. Turbid stormwater resulting from the 7/13/20 rain event and the construction at 64 Gundalow was observed standing at the 4 Brickyard – 1 monitoring location. The stormwater was removed by the construction crews for off-site disposal after the time of this monitoring.

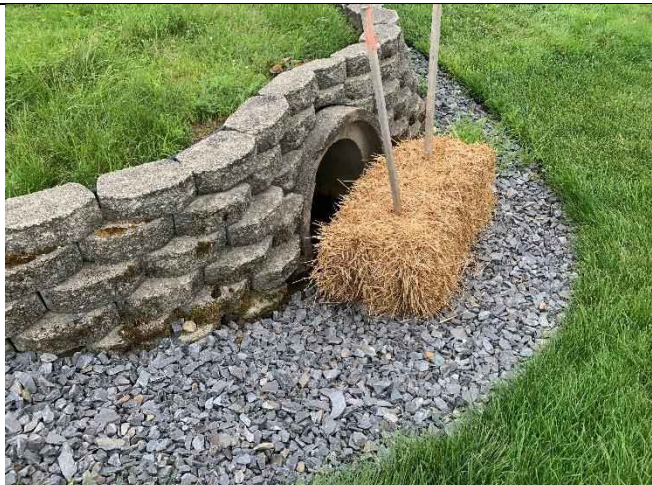
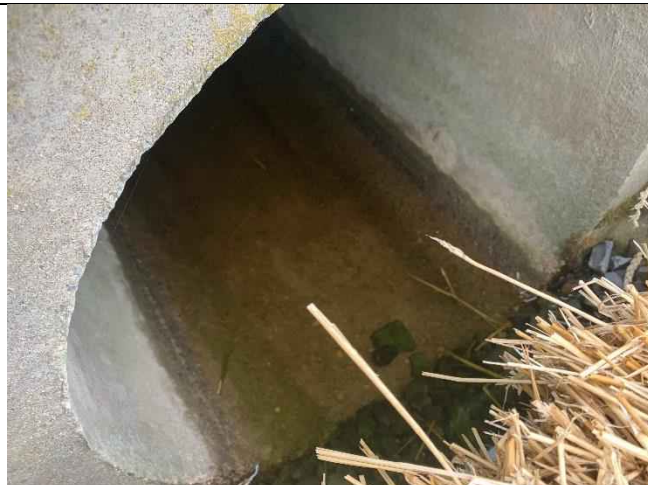
29 Gundalow - 1 (Drainage Area)

pH: **Not Monitored – Could not access due to construction/drainage improvement work**

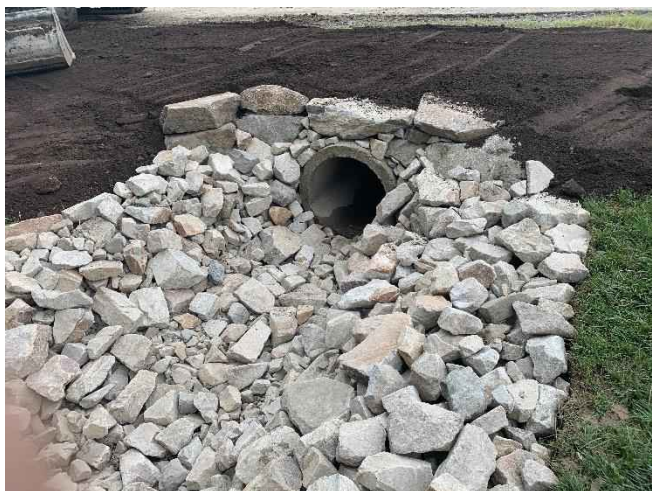
64 Gundalow - 1 (Drainage Course)

- Major construction/drainage improvements in the drainage course at 64 Gundalow Landing completed 7/16. Work on 7/17 included grading areas adjacent to stone ditch and laying sod/seeding.

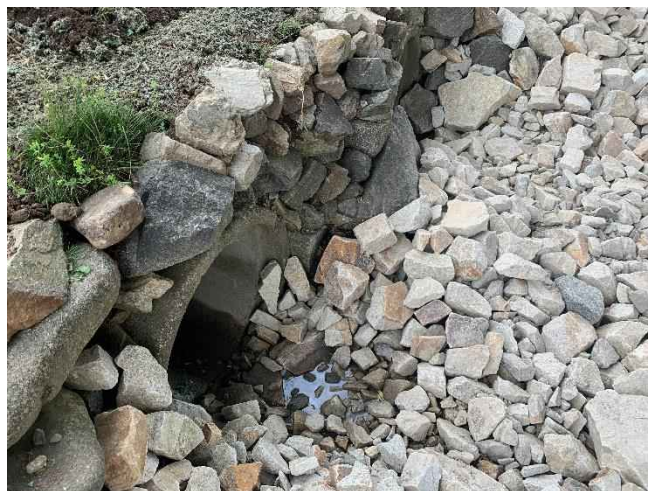
64 Gundalow - 2 (Drainage Course)

pH: **7.2**

Observations/Notes: Small area of standing water adjacent to culvert inlet, approx. 1" deep

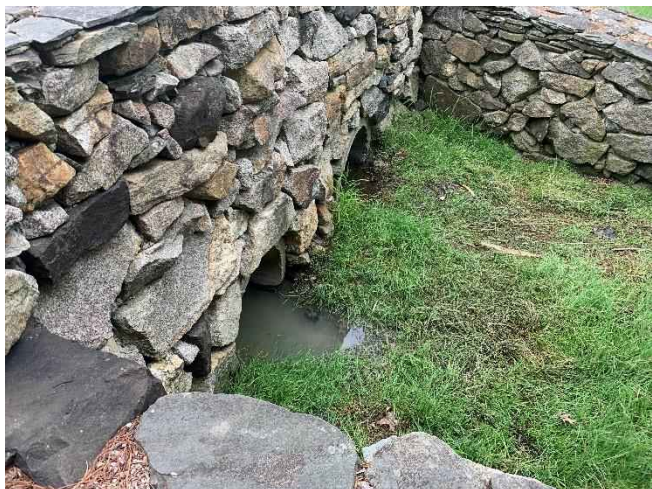
4 Brickyard Circle - 1 (Drainage Course)

pH: **7.1**

Observations/Notes: ~ 8" of standing water extending ~ 18" beyond culvert outlet in grassed raceway
