CONSTRUCTION MONITORING REPORT

Eversource Transmission Lines:
F107

**Madbury, Durham,
Newington, Portsmouth, NH**

TYPE OF INSPECTION: Weekly Storm Event Incident Corrective Action

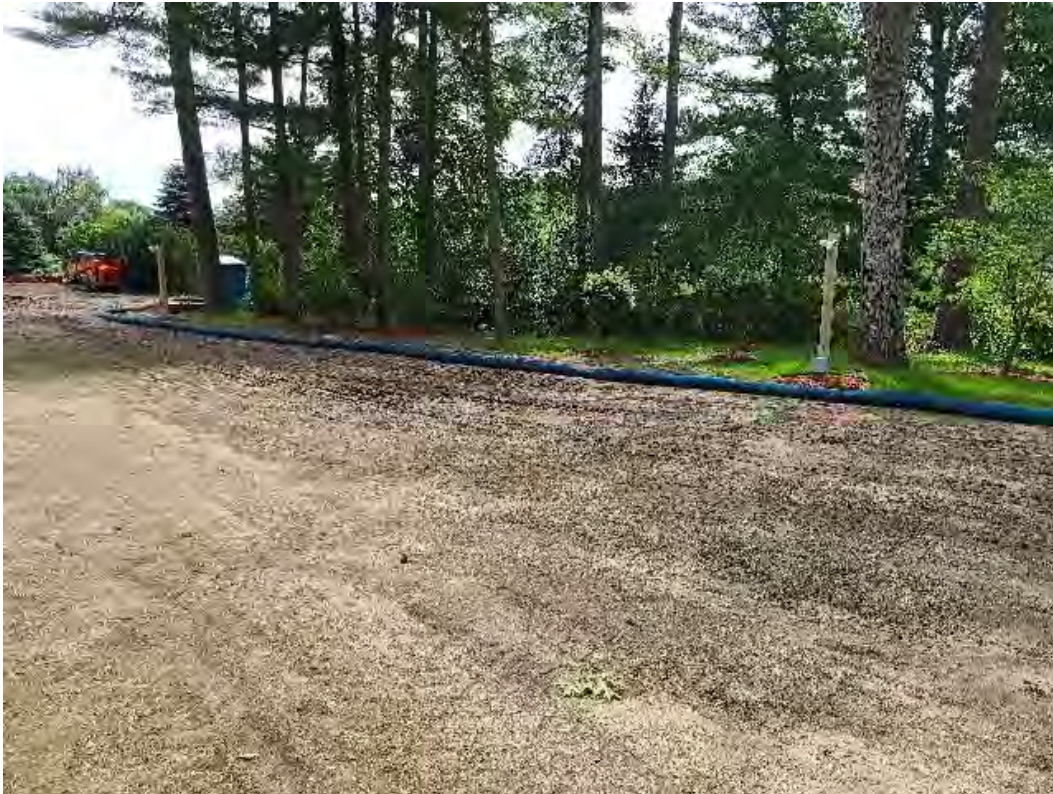
Fig 1: Filter sock at Gundalow Landing/east side of bay to prevent potential sediment-laden water from exiting the site. Viewing southeast. (07-16-20).

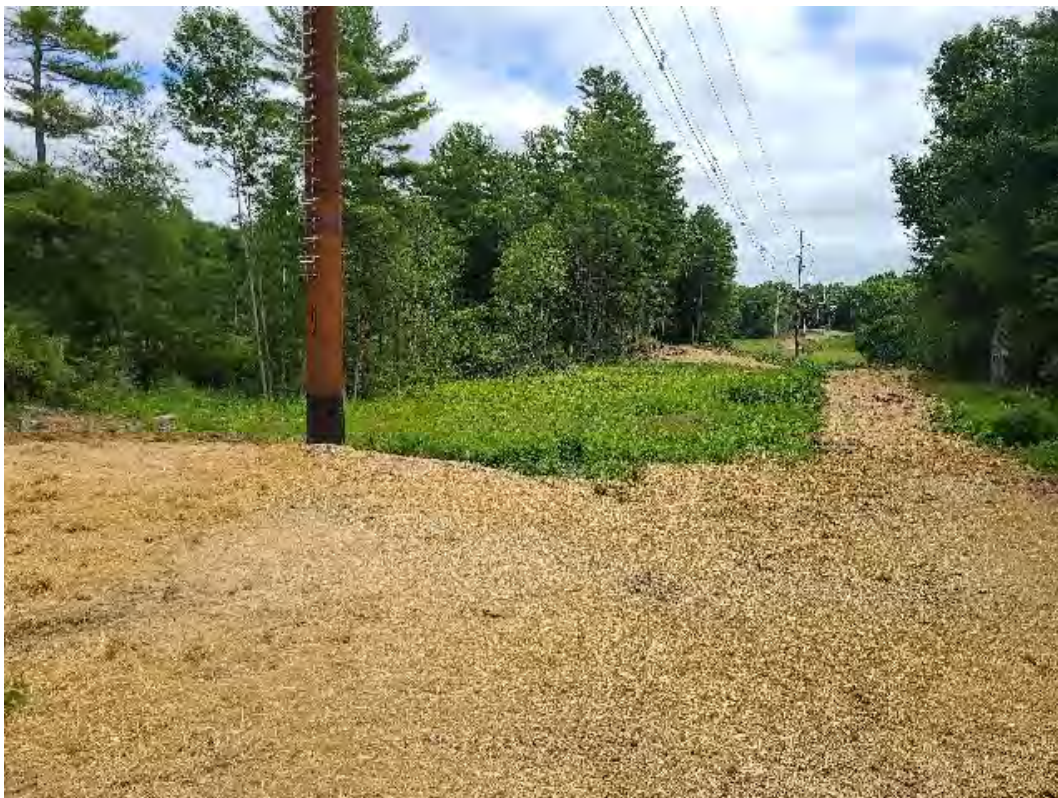
Fig 2: Str. 94 work area restored. Viewing northeast. (07-16-20).

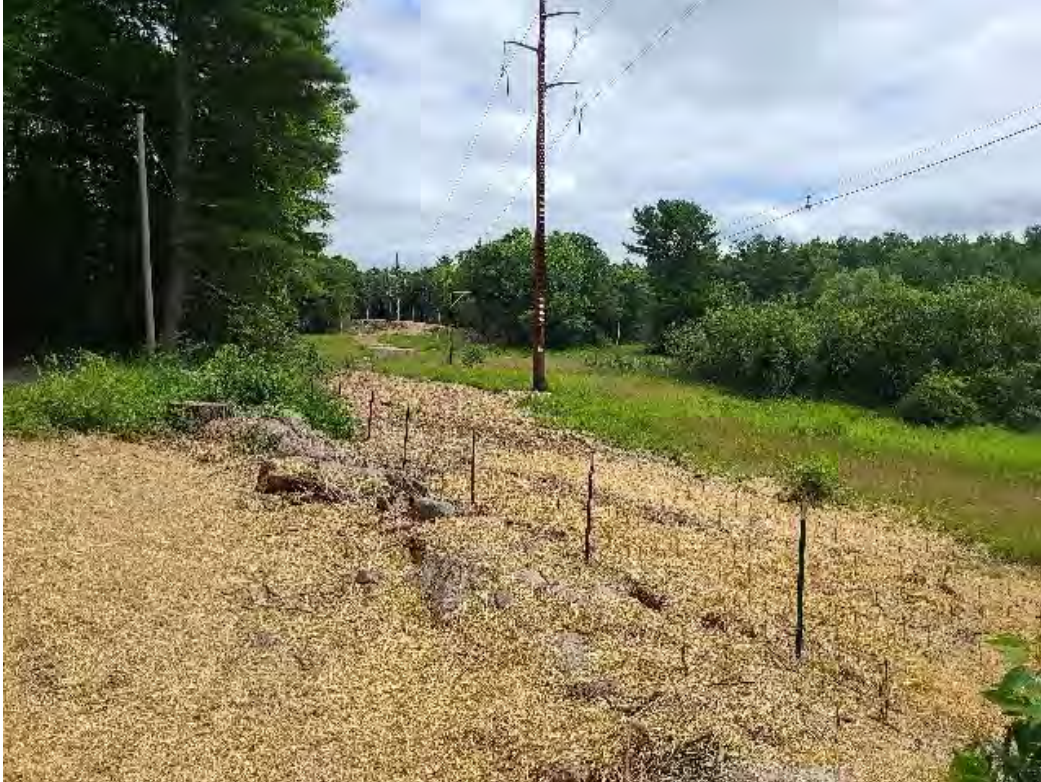
Fig 3: Access route between Strs. 94 and 95 restored. Note replacement fence. Viewing southeast. (07-16-20).

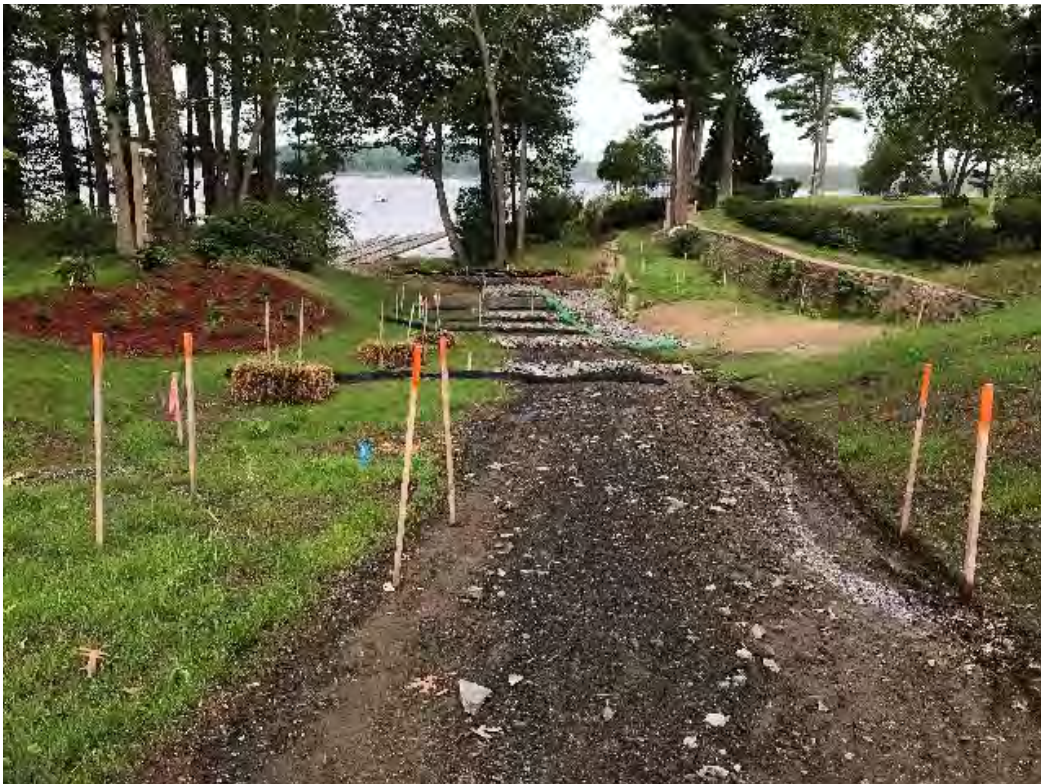
Fig 4: Temporary BMPs on slope above manhole at Gundalow Landing/east side of the bay. View southwest. (07-20-20).

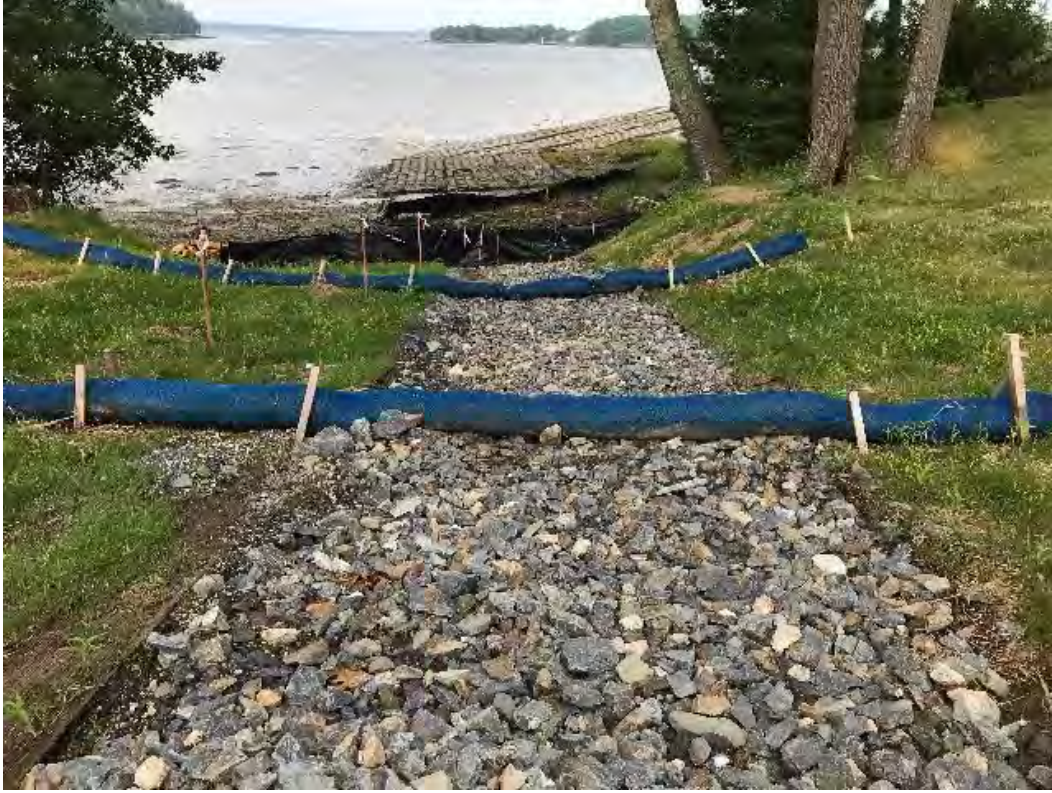
Fig 5: Temporary BMPs on slope below manhole at Gundalow Landing/east side of the bay. Viewing southwest. (07-20-20).

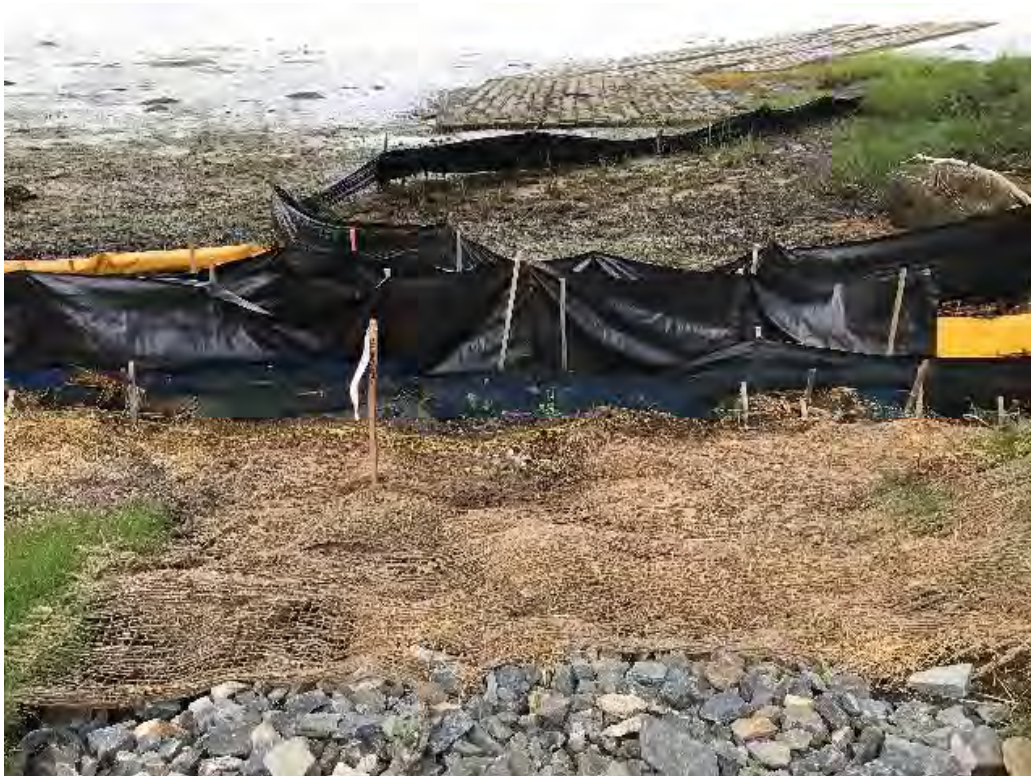
Fig 6: Temporary BMPs on toe of slope below manhole at Gundalow Landing/east side of the bay. Viewing southwest. (07-20-20).

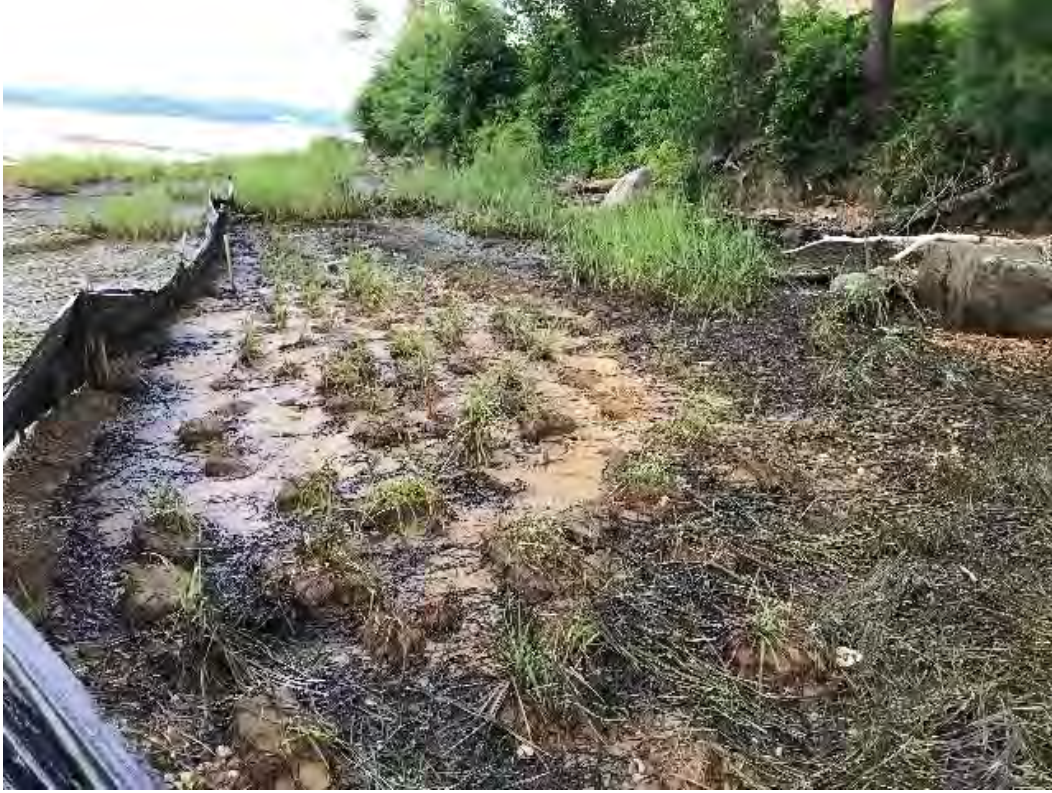
Fig 7: Salt marsh restoration at Gundalow Landing/east side of the bay. Viewing northwest. (07-20-20).

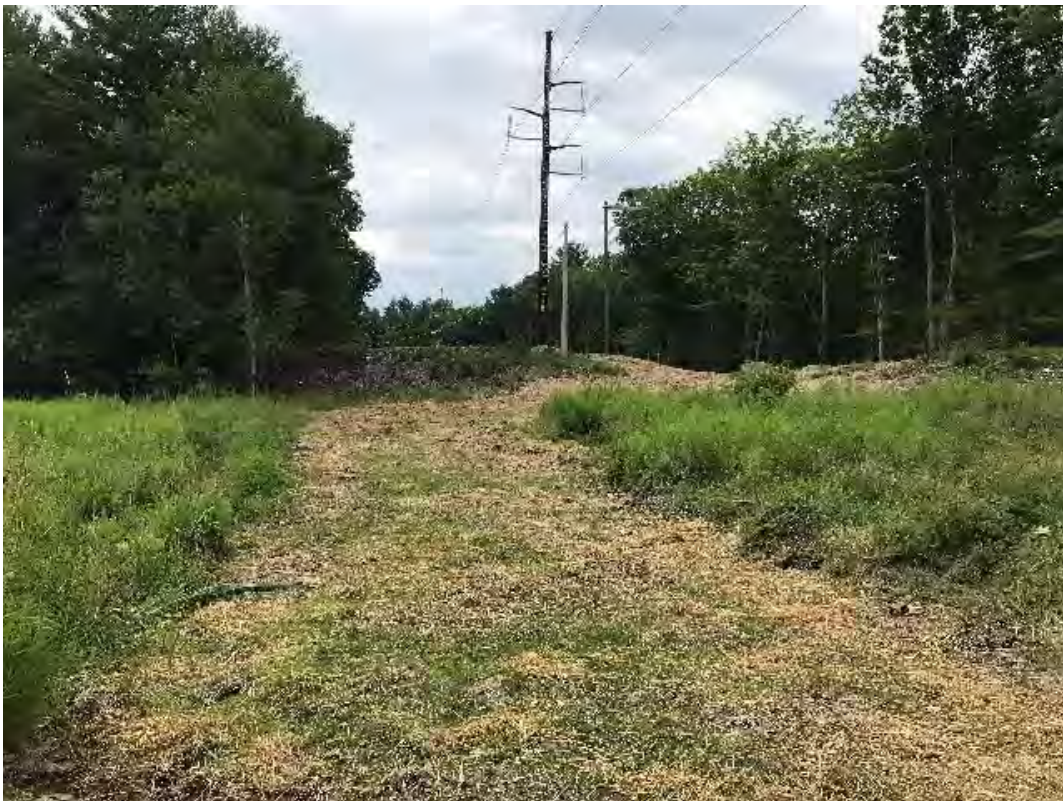
Fig 8: Initial germination on restored access between Strs. 96 and 95. Viewing southeast. (07-20-20).

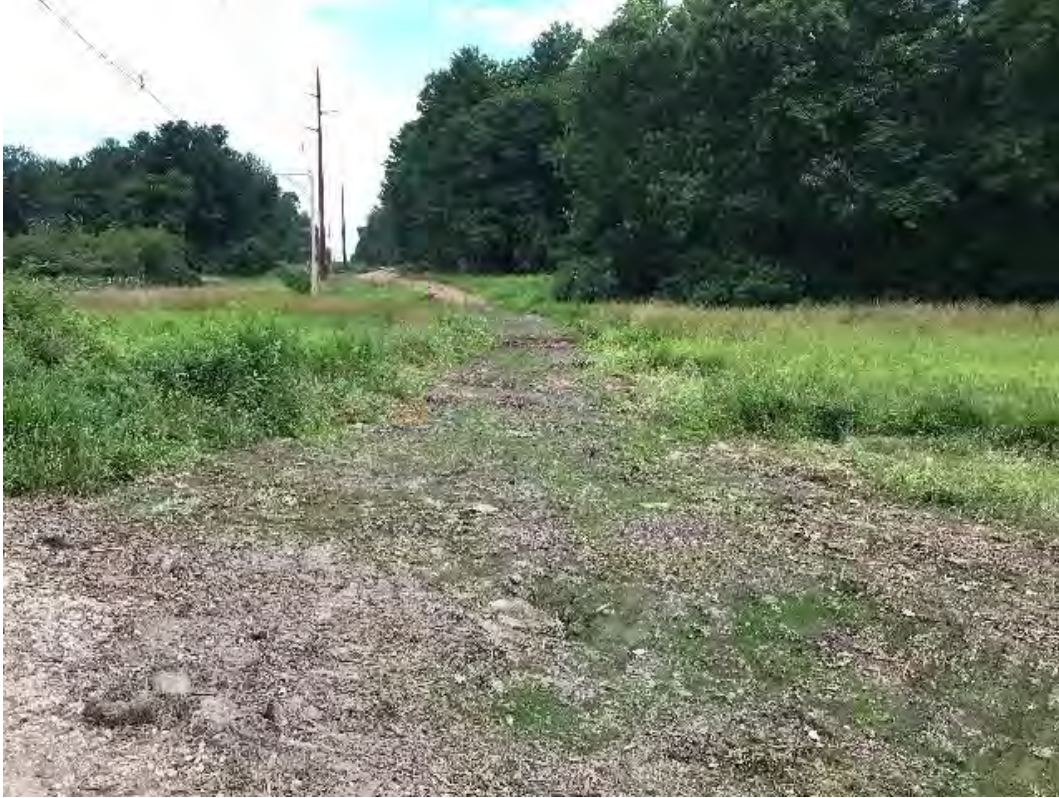
Fig 9: Initial germination on restored access between Strs. 96 and 95. Viewing northwest. (07-20-20).

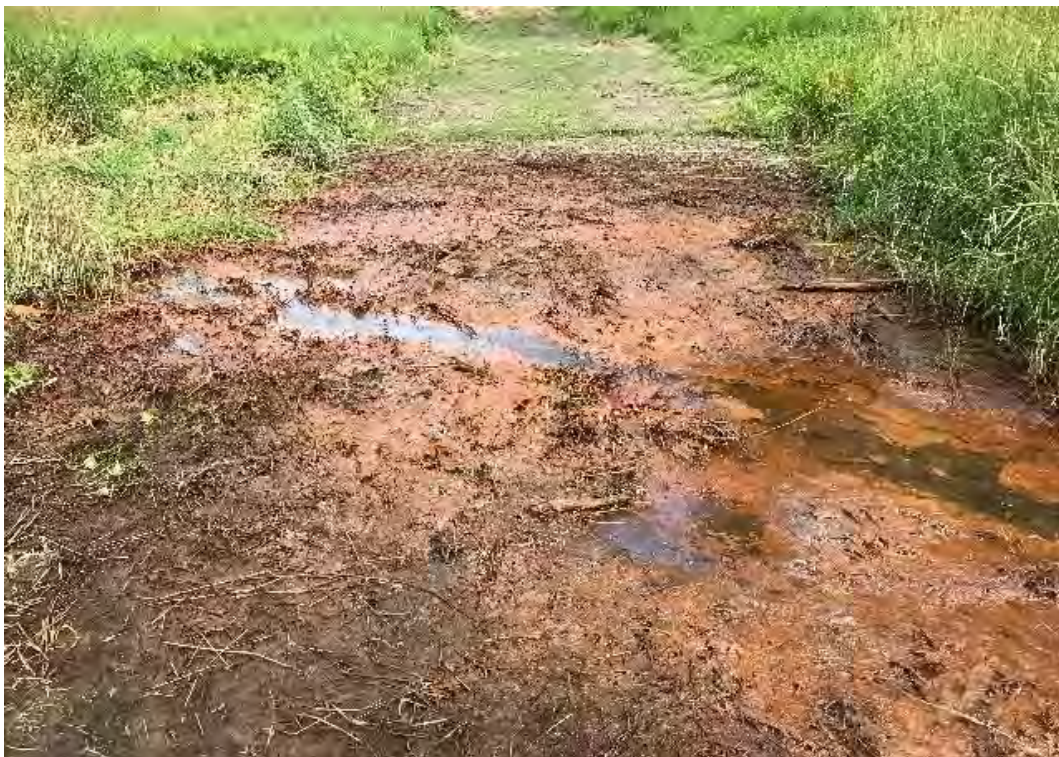
Fig 10: Restored wetland DW6 in access between Strs. 96 and 95. Note reddish iron-oxidizing bacteria, a naturally occurring condition associated with iron rich groundwater/soil. Viewing northwest. (07-20-20).

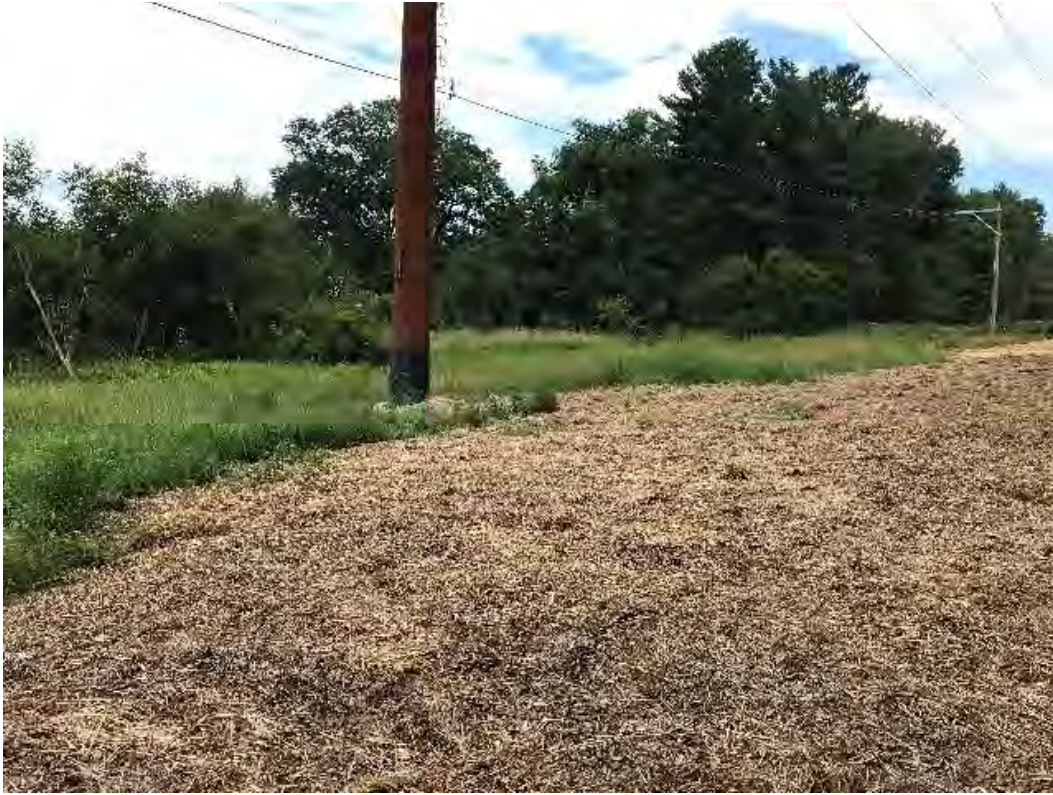
Fig 11: Str. 95 work area restored. Viewing west. (07-20-20).

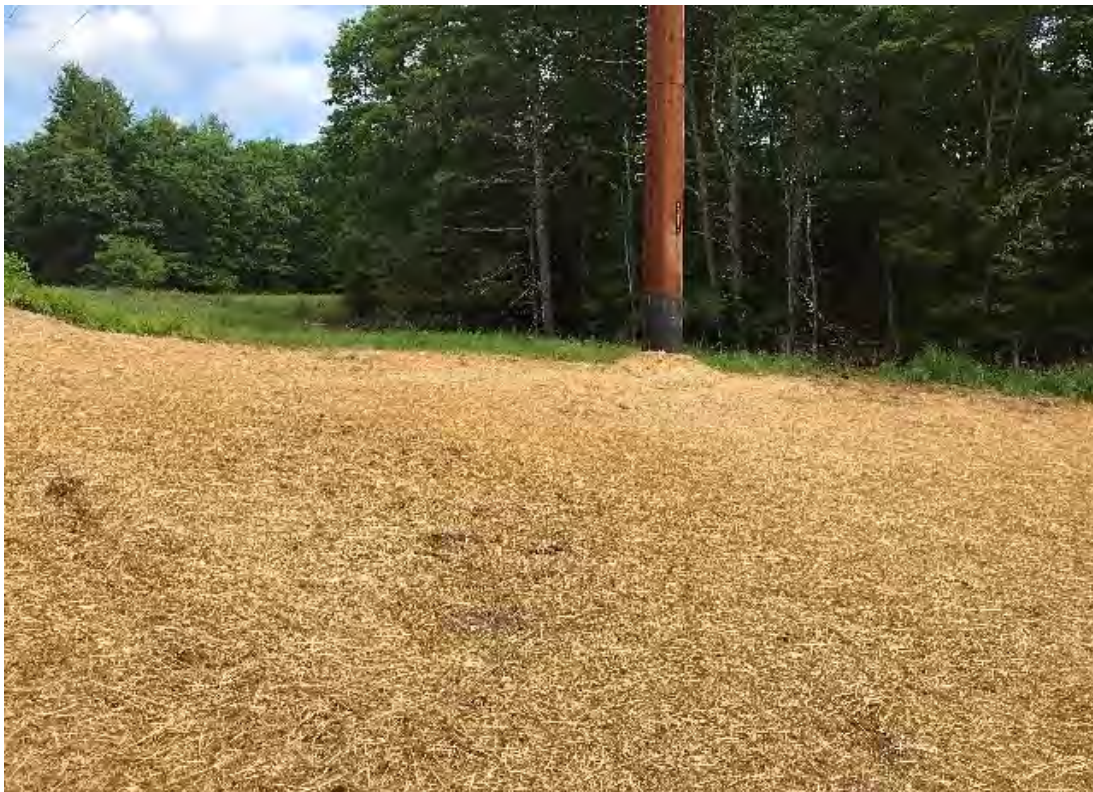
Fig 12: Str. 93 work area restored. Viewing northeast. (07-20-20).

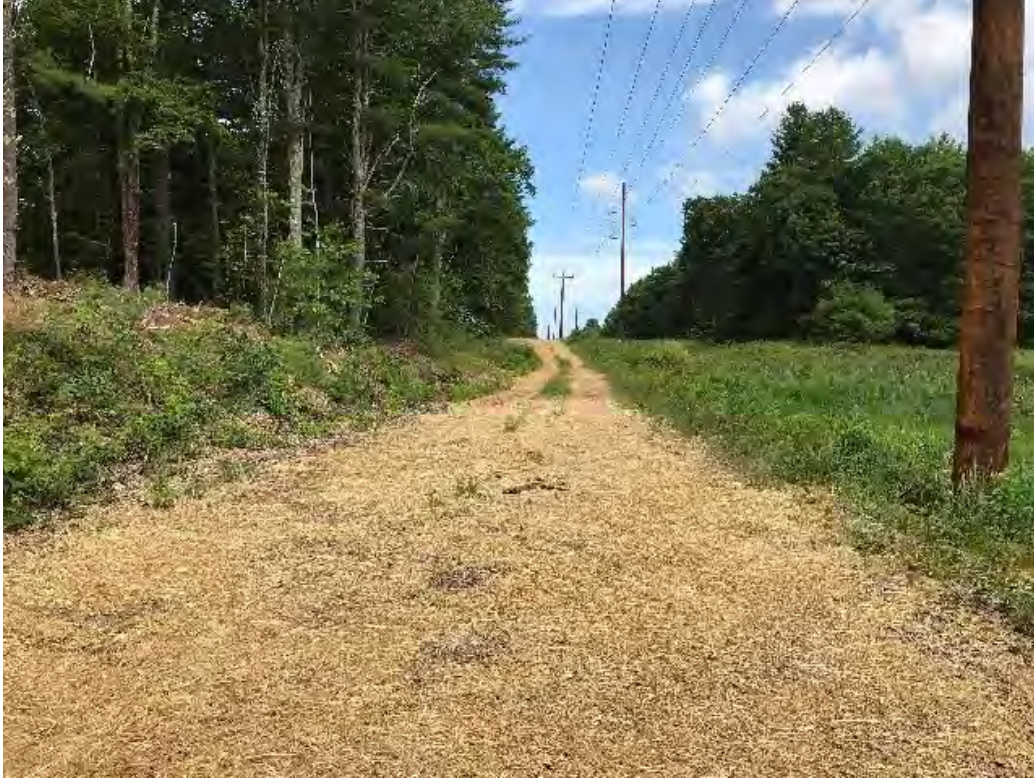
Fig 13: Access road between Strs. 93 and 92 restored. Viewing northwest. (07-20-20).

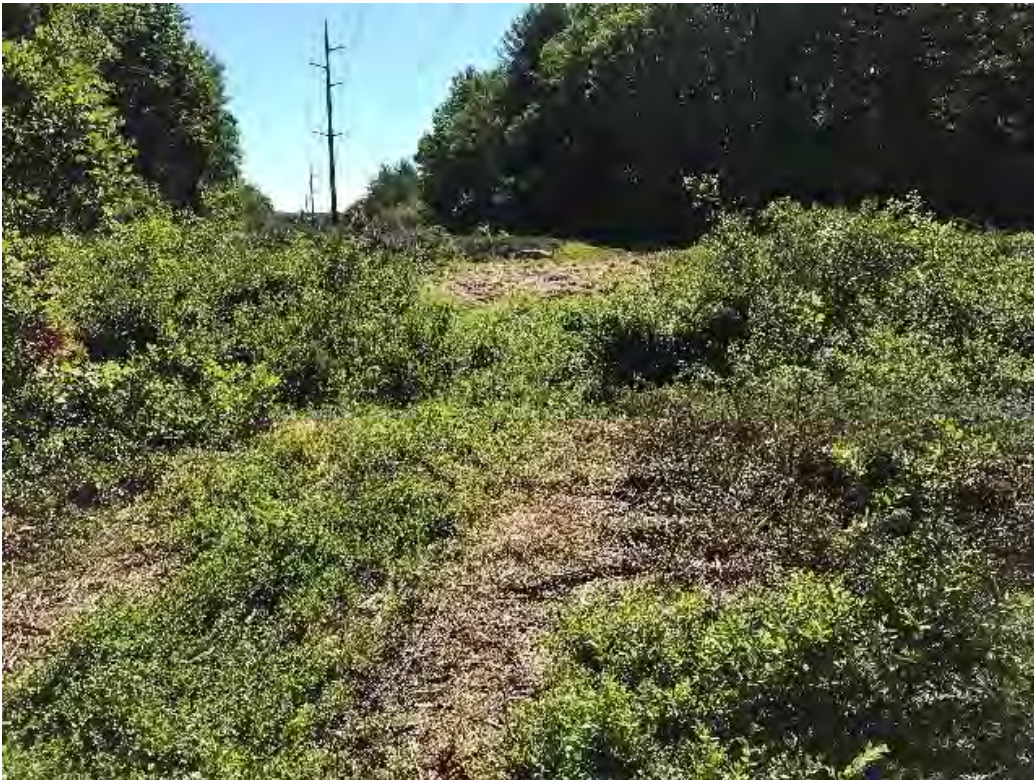
Fig 14: Re-vegetating access road crossing of wetland DW40. Viewing east. (07-21-20).

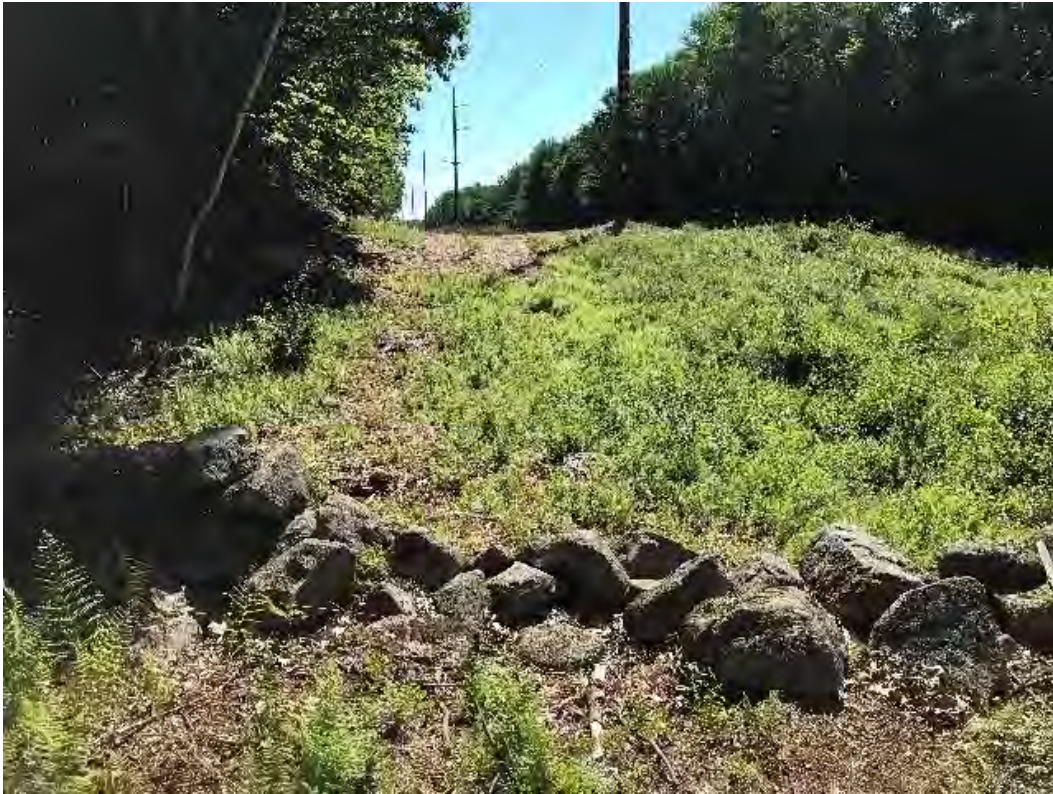
Fig 15: Re-vegetating access road with stonewall adjacent to wetland DW27. Viewing east. (07-21-20).

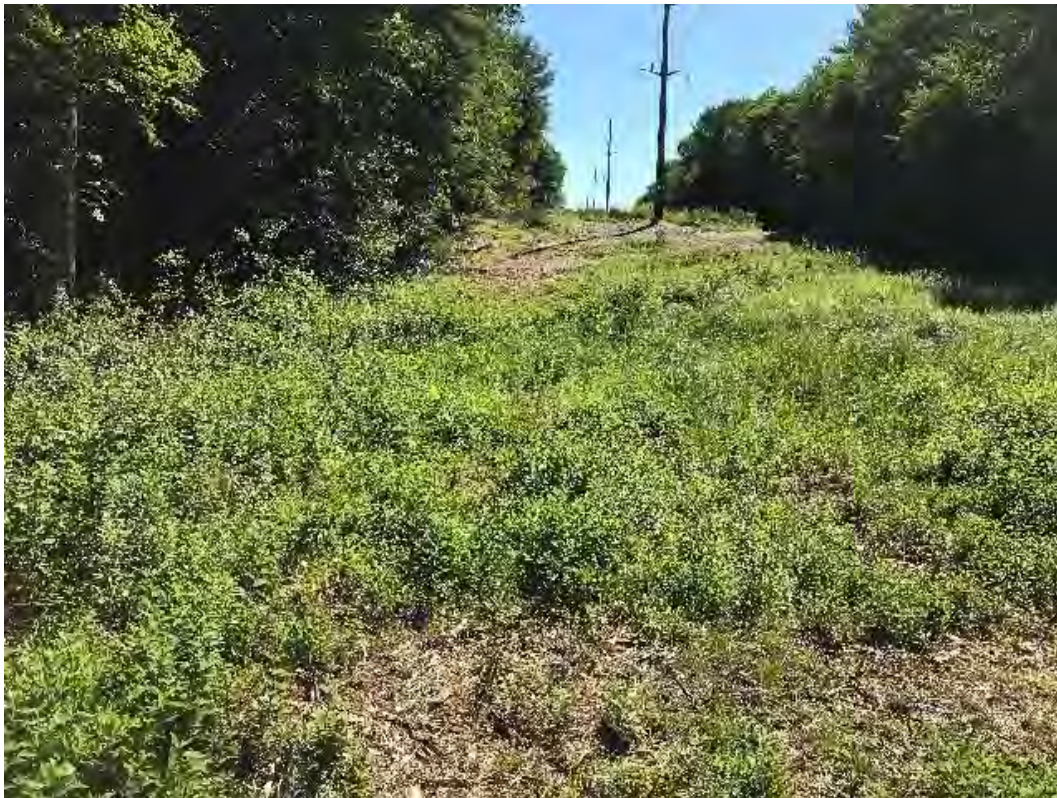
Fig 16: Re-vegetating access road crossing wetland DW25. Viewing east. (07-21-20).

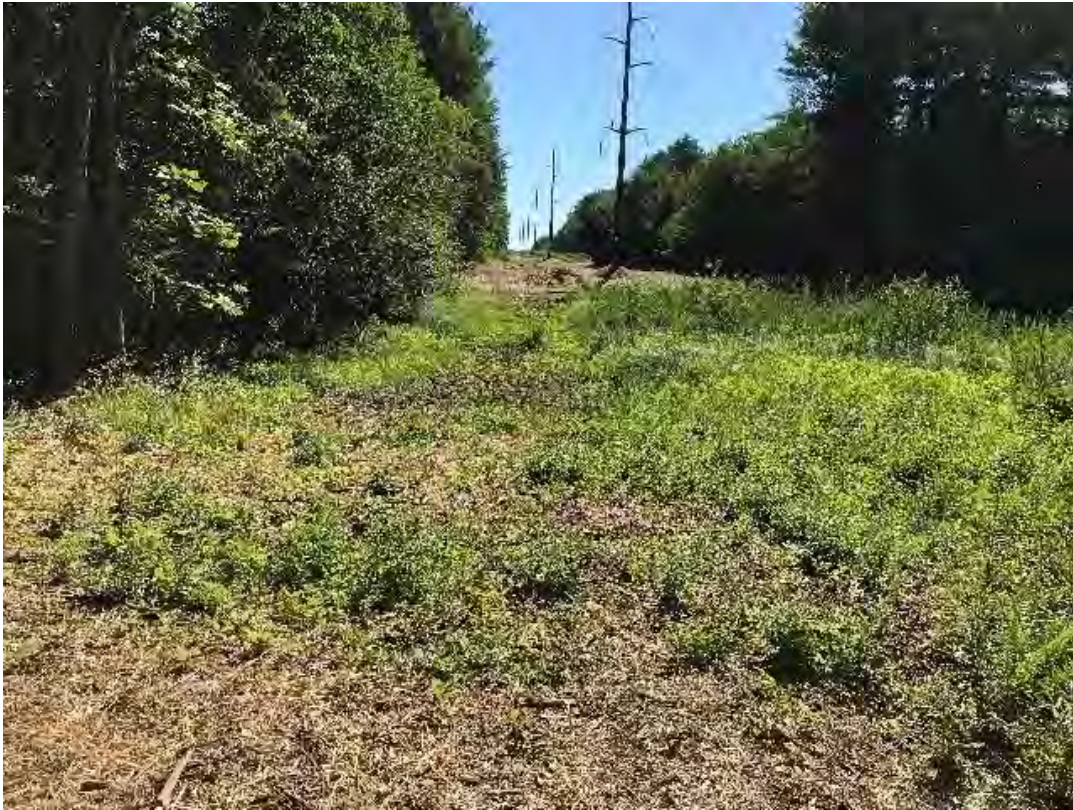
Fig 17: Re-vegetating access road crossing wetland DW21. Viewing east. (07-21-20).

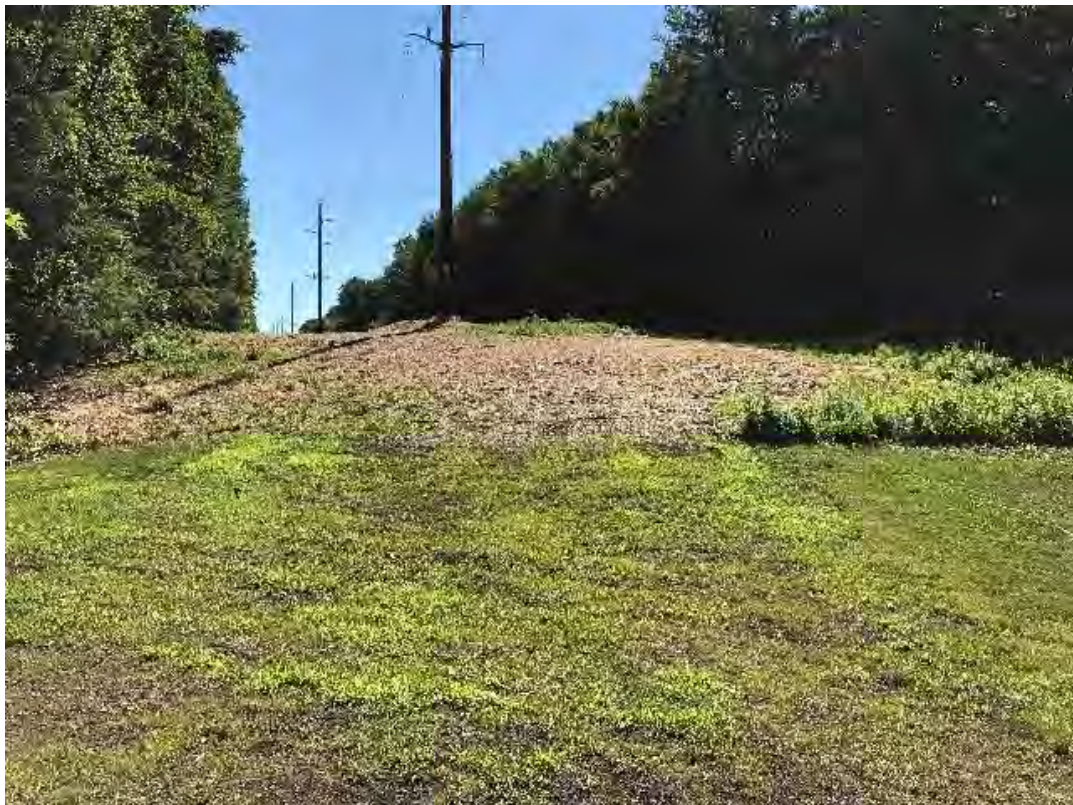
Fig 18: Re-vegetating access to Str. 73 from Sandy Brook Dr. Viewing east. (07-21-20).

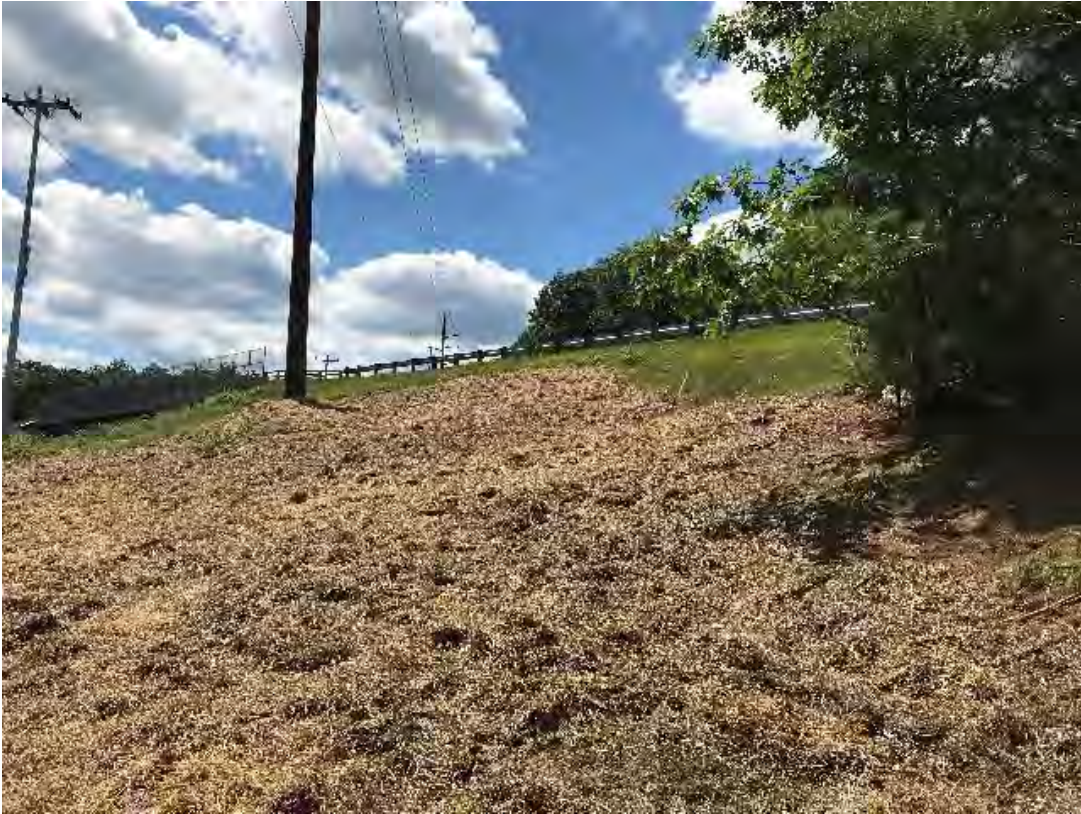
Fig 19: Str. 6 work area restored. Viewing southeast. (07-21-20).

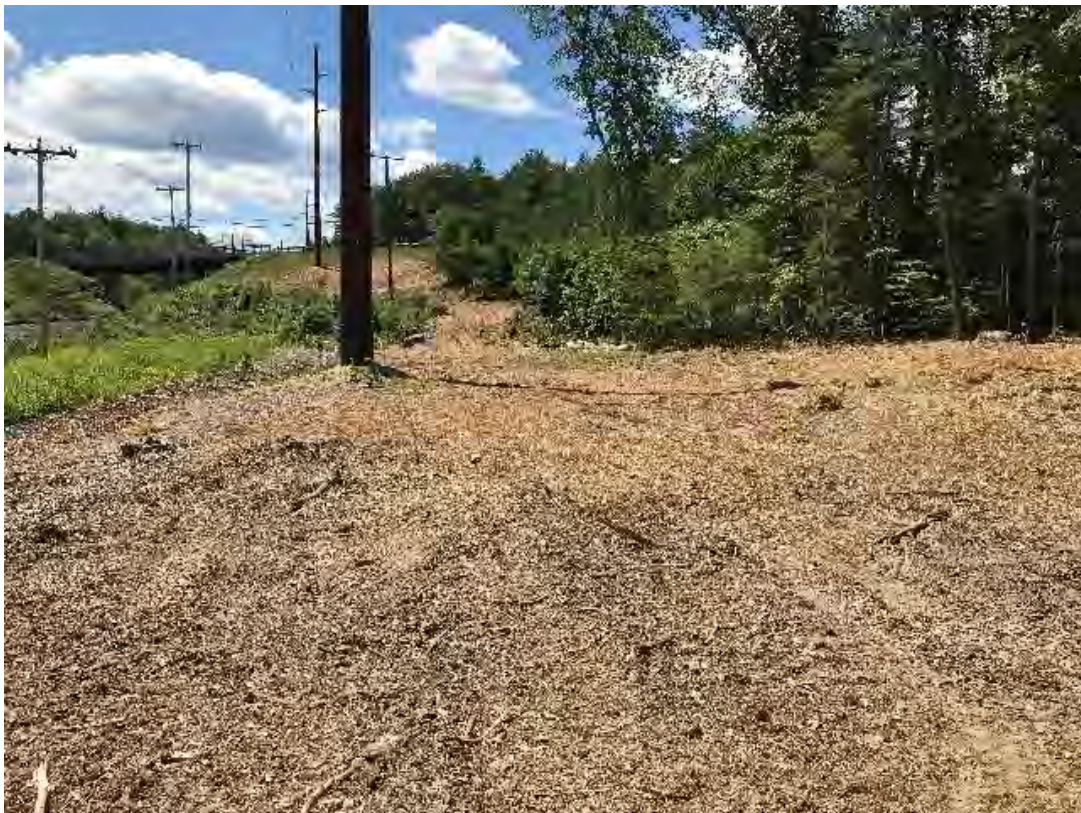
Fig 20: Str. 5 work area restored. Viewing south. (07-21-20).

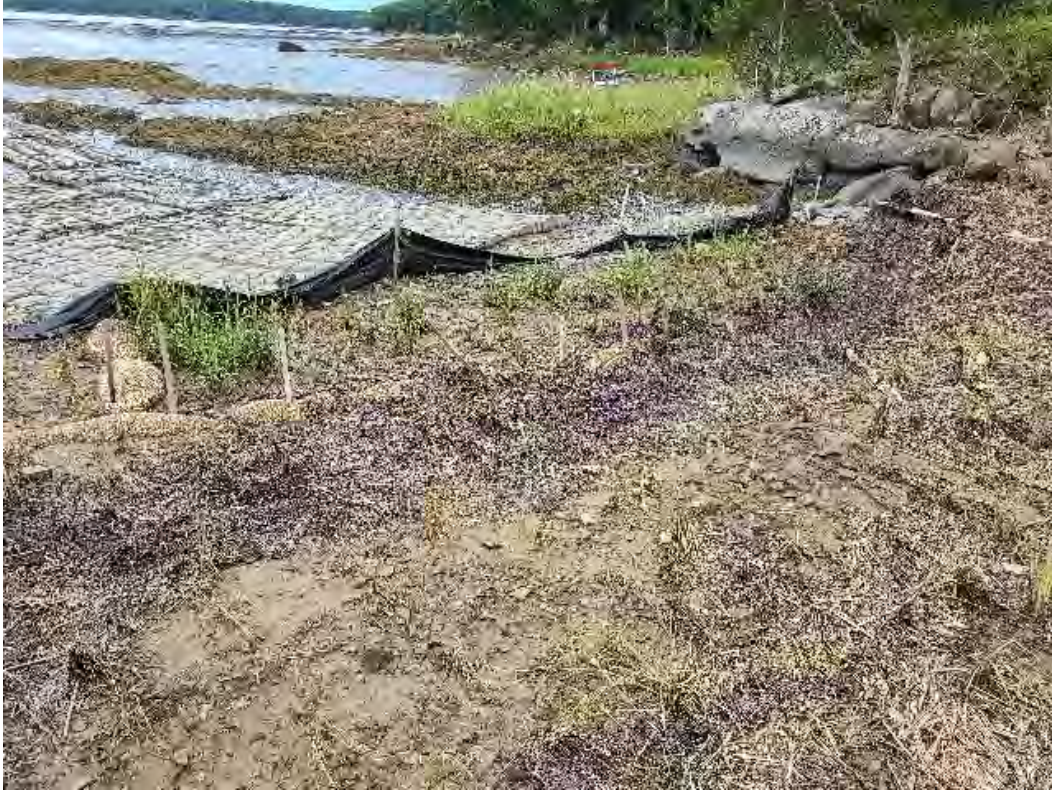
Fig 21: Salt marsh restoration at Getchell property/west side of the bay. Viewing southeast. (07-22-20).

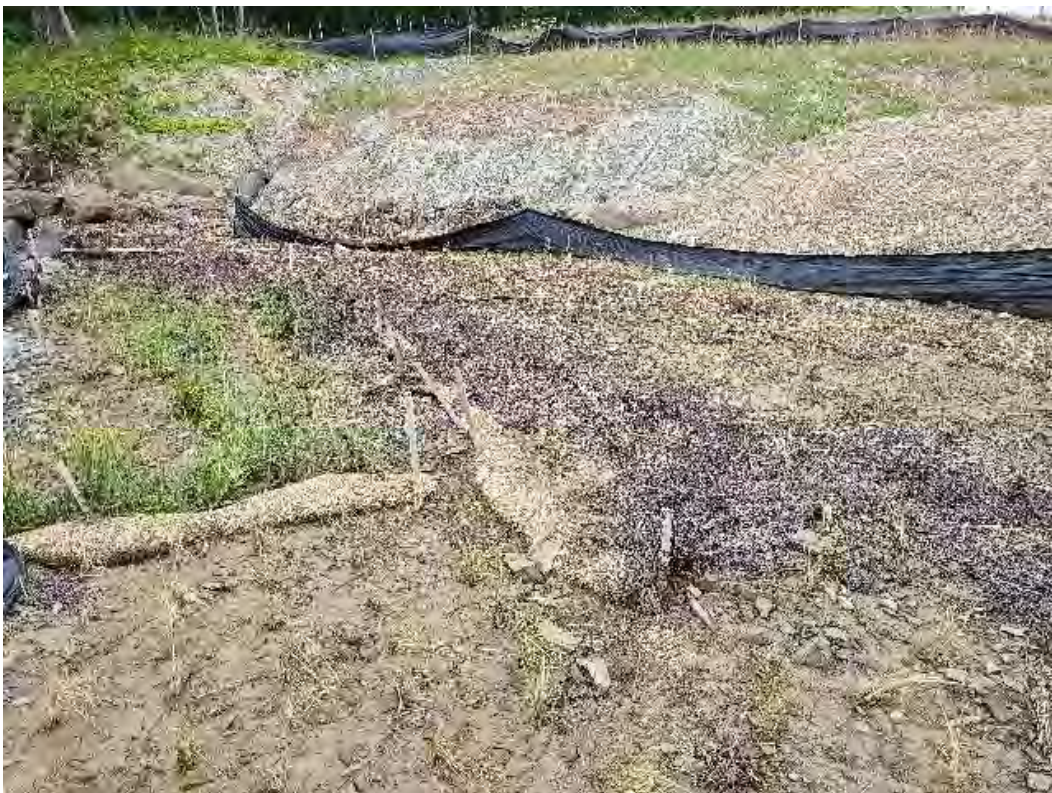
Fig 22: Salt marsh restoration at Getchell property/west side of the bay. Viewing southwest. (07-22-20).

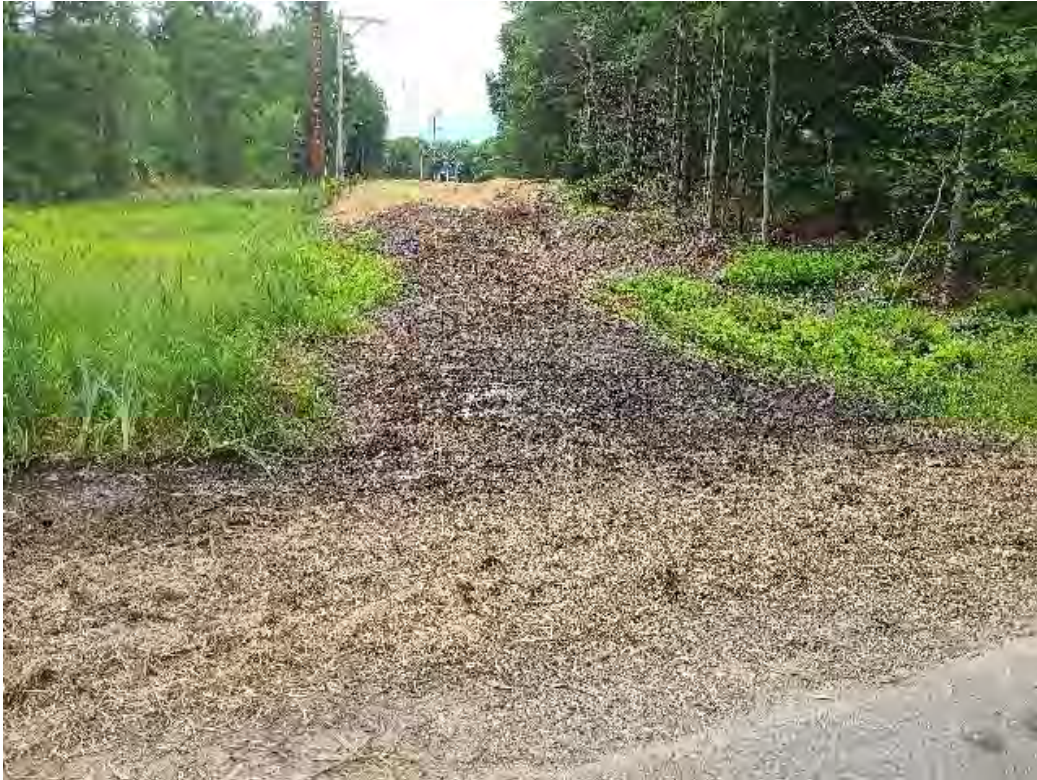
Fig 23: Wetland DW12 off Durham Point Rd. restored. Viewing southeast. (07-22-20).

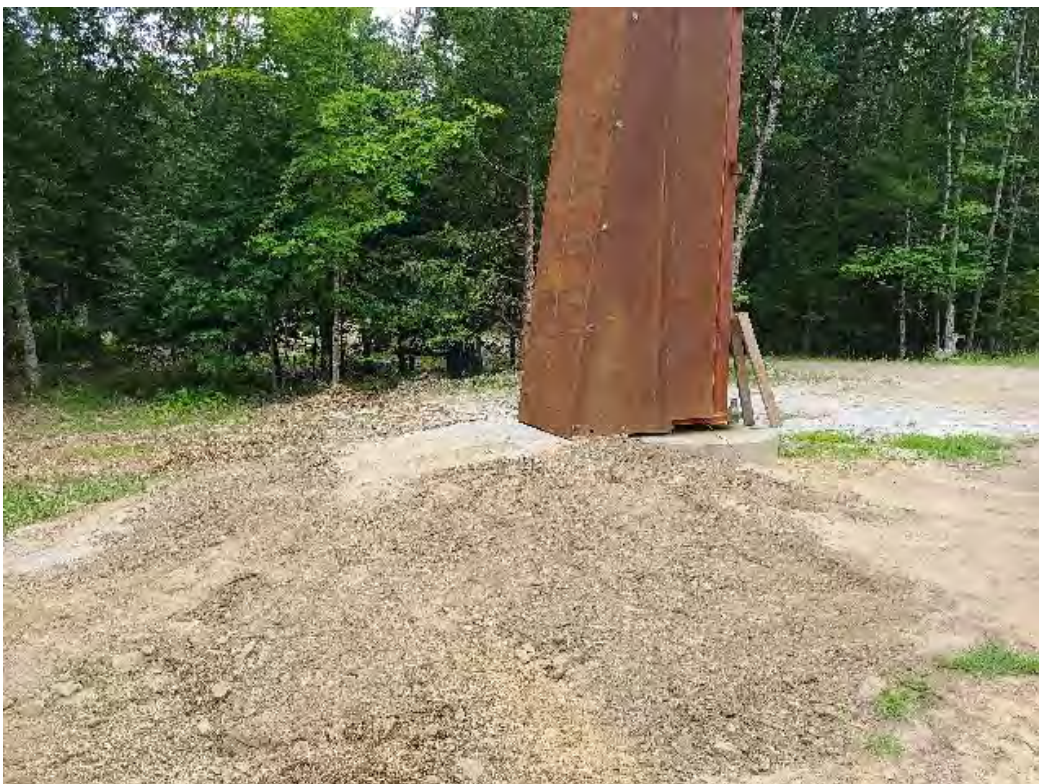
Fig 24: Concrete block added to Str. 99 at Getchell property/west side of the bay. Viewing southwest. (07-22-20).

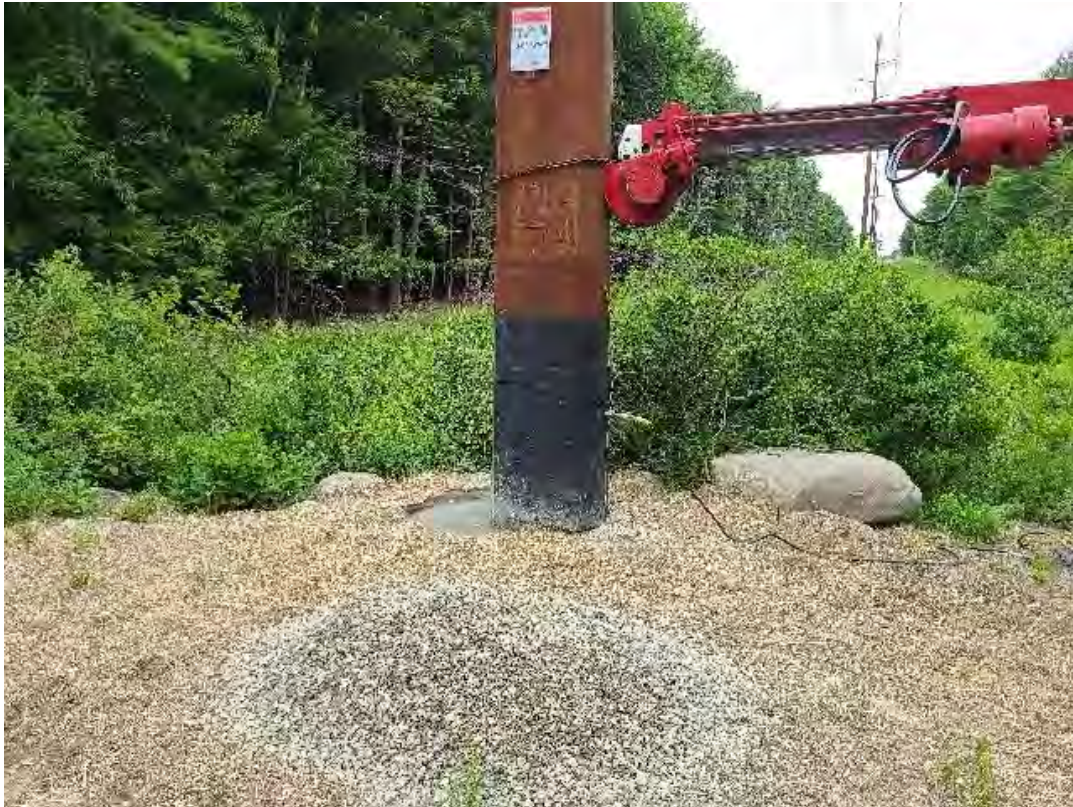
Fig 25: Pouring float fill for Str. 70 foundation. Viewing east. (07-22-20).

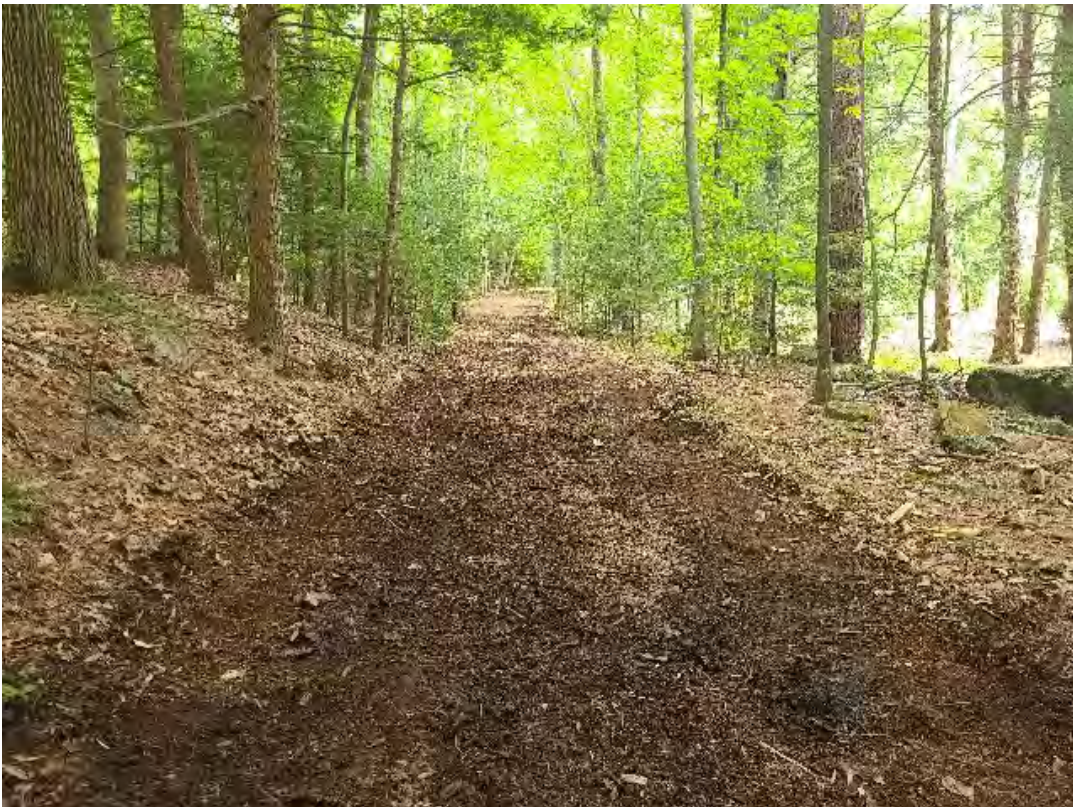
Fig 26: Restoring access road off Foss Farm Rd. Viewing southwest. (07-22-20).
