CONSTRUCTION MONITORING REPORT

Eversource Transmission Lines:
F107

**Madbury, Durham,
Newington, Portsmouth, NH**

TYPE OF INSPECTION: Weekly Storm Event Incident Corrective Action

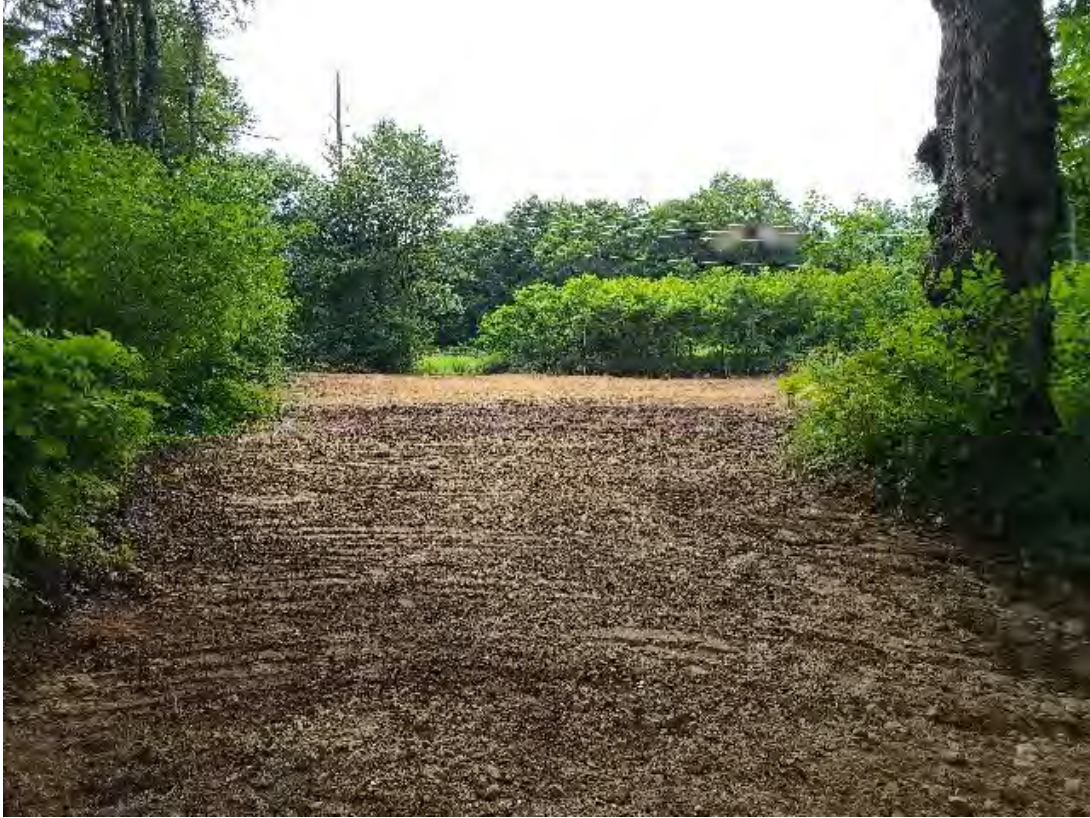
Fig 27: Restoring staging area off Foss Farm Rd. Viewing southwest. (07-22-20).
