# DRAINAGE MONITORING REPORT

## F107 - Seacoast Reliability Project

### Newington, New Hampshire

Date: **7/29/2020** Time: **0925** <sup>+</sup>Was this inspection triggered by a 0.25" storm event?  Yes  No

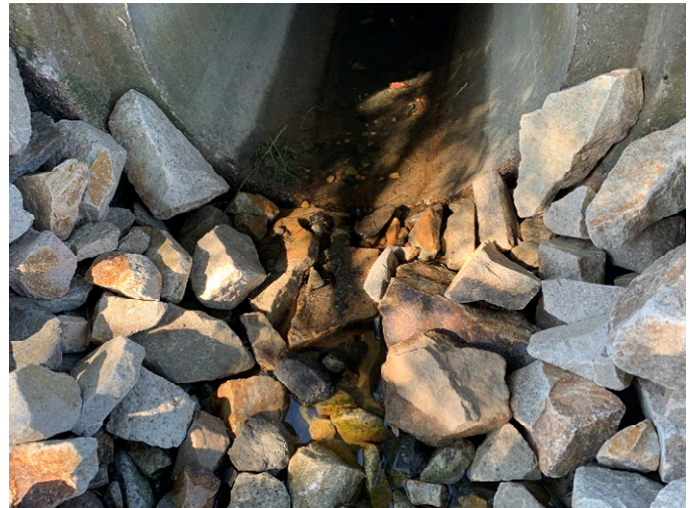
64 Gundalow - 2 (Drainage Course)

pH: **6.6**

Observations/Notes: Small area of standing water adjacent to culvert inlet, approx. 1" deep

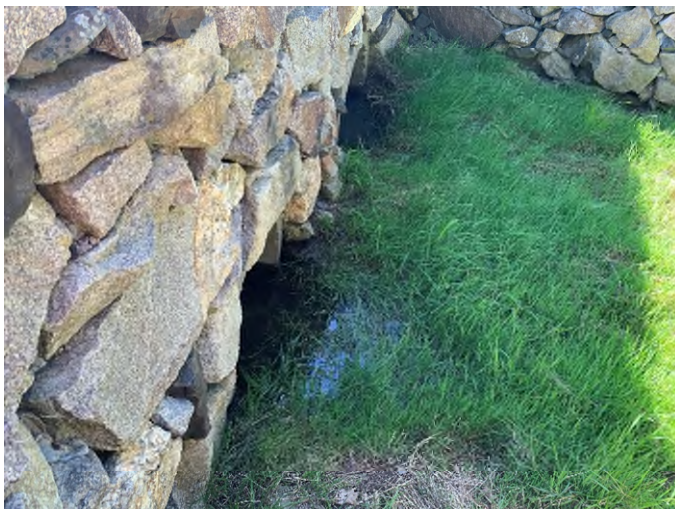
4 Brickyard Circle - 1 (Drainage Course)

pH: **6.8**

Observations/Notes: ~ 8" of standing water extending ~ 12" beyond culvert outlet in grassed raceway

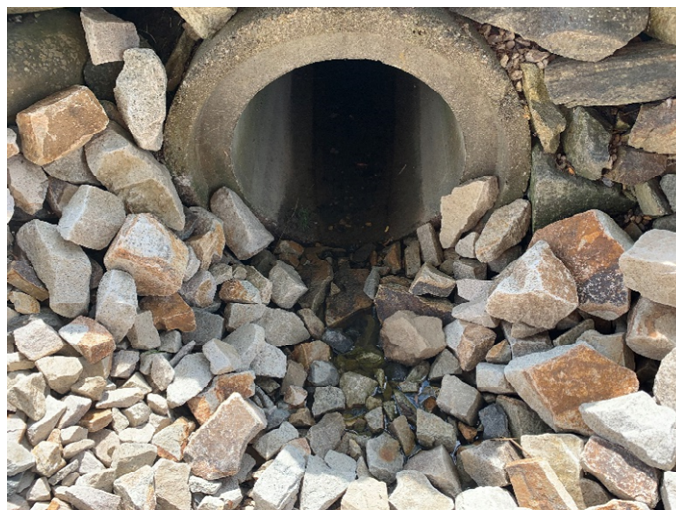
64 Gundalow - 2 (Drainage Course)

pH: **6.9**

Observations/Notes: Small area of standing water adjacent to culvert inlet, approx. 1" deep

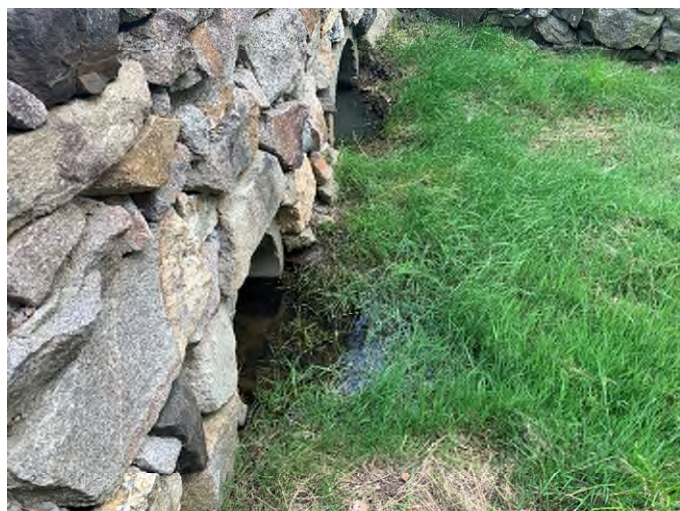
4 Brickyard Circle - 1 (Drainage Course)

pH: **7.1**

Observations/Notes: ~ 8" of standing water extending ~ 12" beyond culvert outlet in grassed raceway

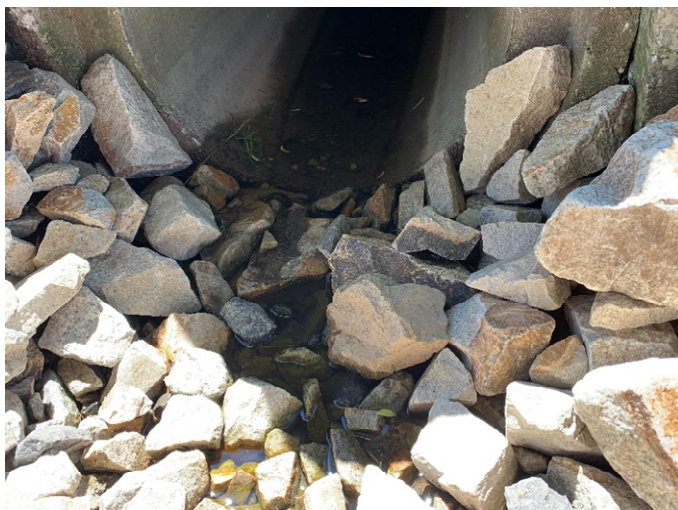
64 Gundalow - 2 (Drainage Course)

pH: 6.7

Observations/Notes: Small area of standing water adjacent to culvert inlet, approx. 1" deep

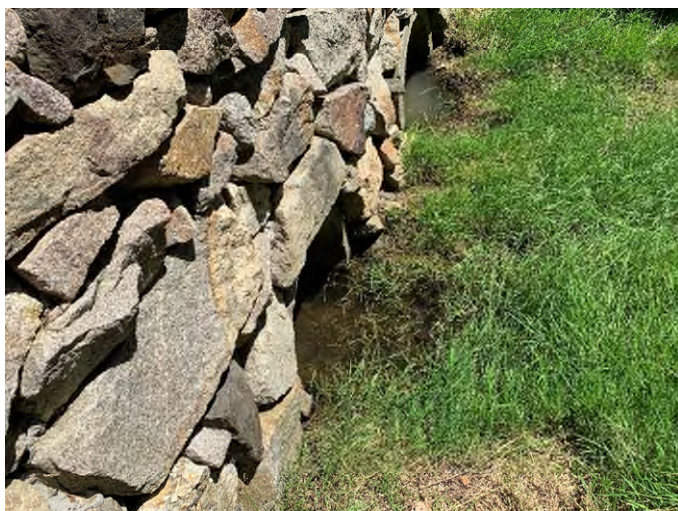
4 Brickyard Circle - 1 (Drainage Course)

pH: 7.0

Observations/Notes: ~ 8" of standing water extending ~ 12" beyond culvert outlet in grassed raceway
