CONSTRUCTION MONITORING REPORT

Eversource Transmission Lines:
F107

**Madbury, Durham,
Newington, Portsmouth, NH**

NAI Project No:
23840.39

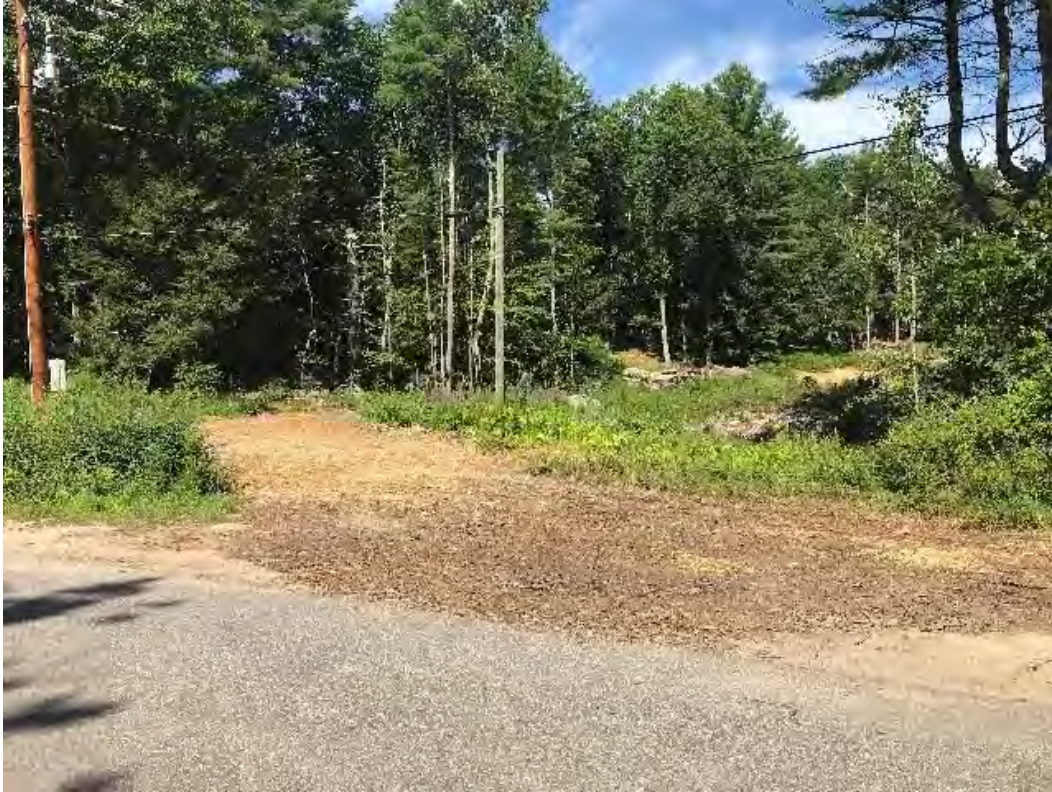
Fig 1: Culvert replacement in access road to Str. 93 off Durham Point Rd. complete. Seeded and lightly mulched. Viewing west. (08-03-20).

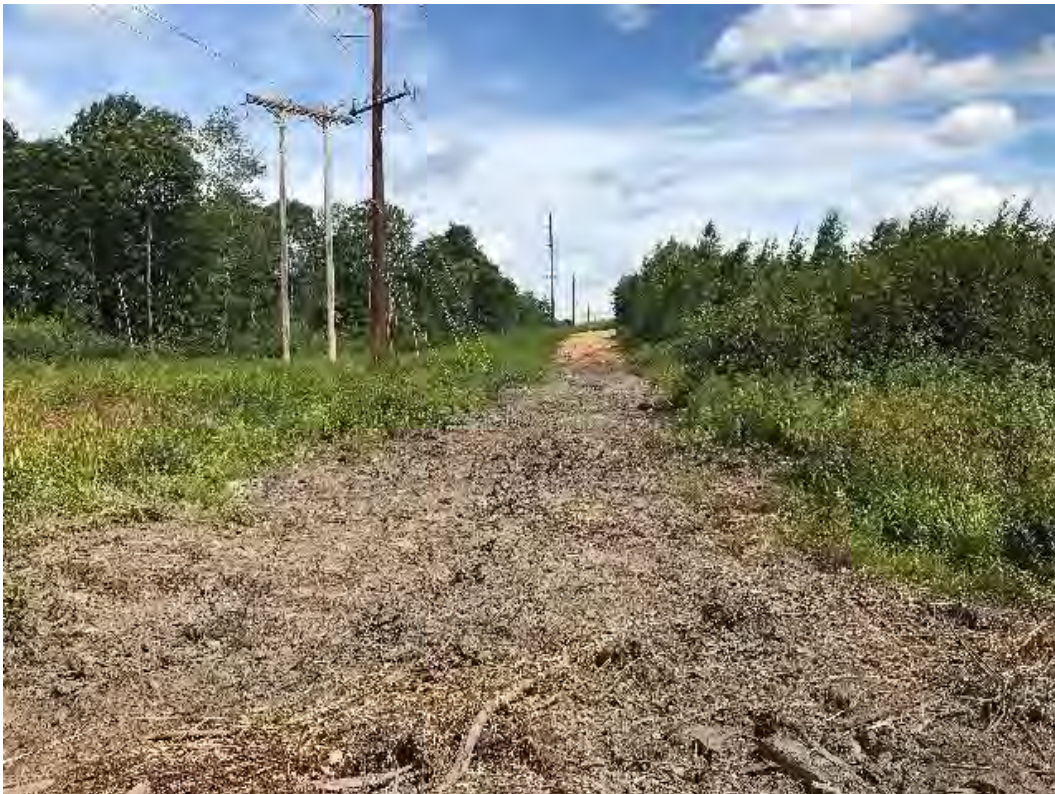
Fig 2: Access road across DW56, between Strs. 47 and 48. Timber mats removed and wetland seeded. Viewing north. (08-03-20).

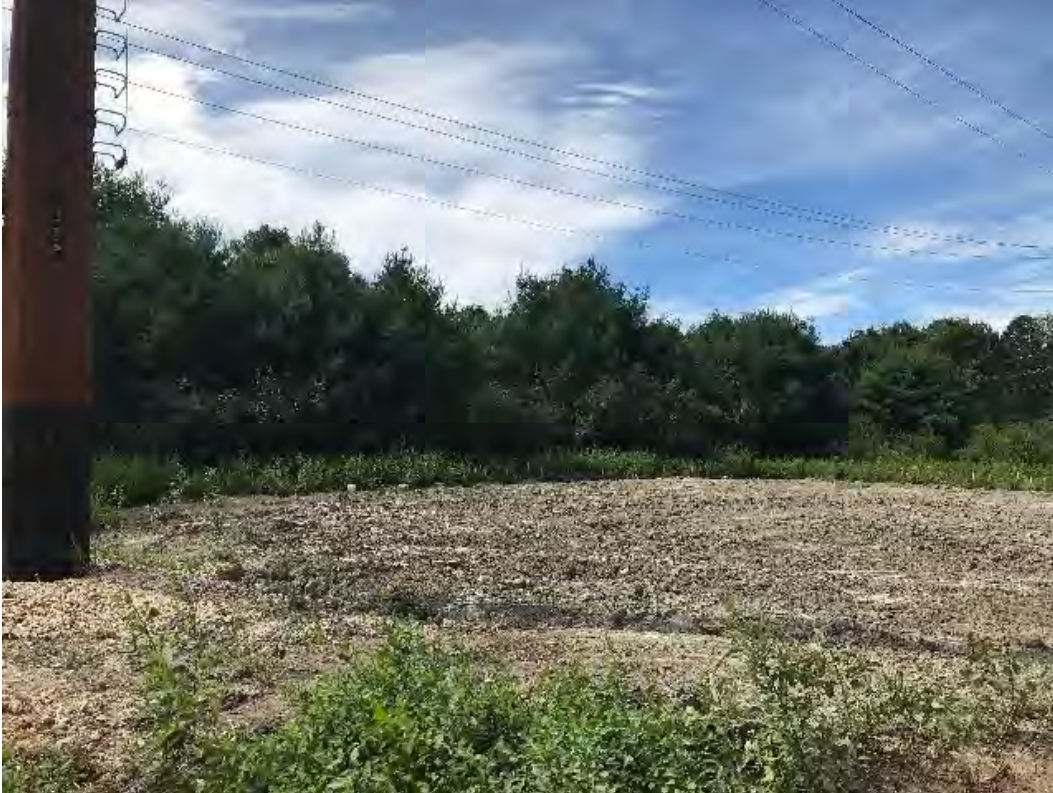
Fig 3: Turtle nesting area next to Str. 49. Viewing southwest. (08-03-20).

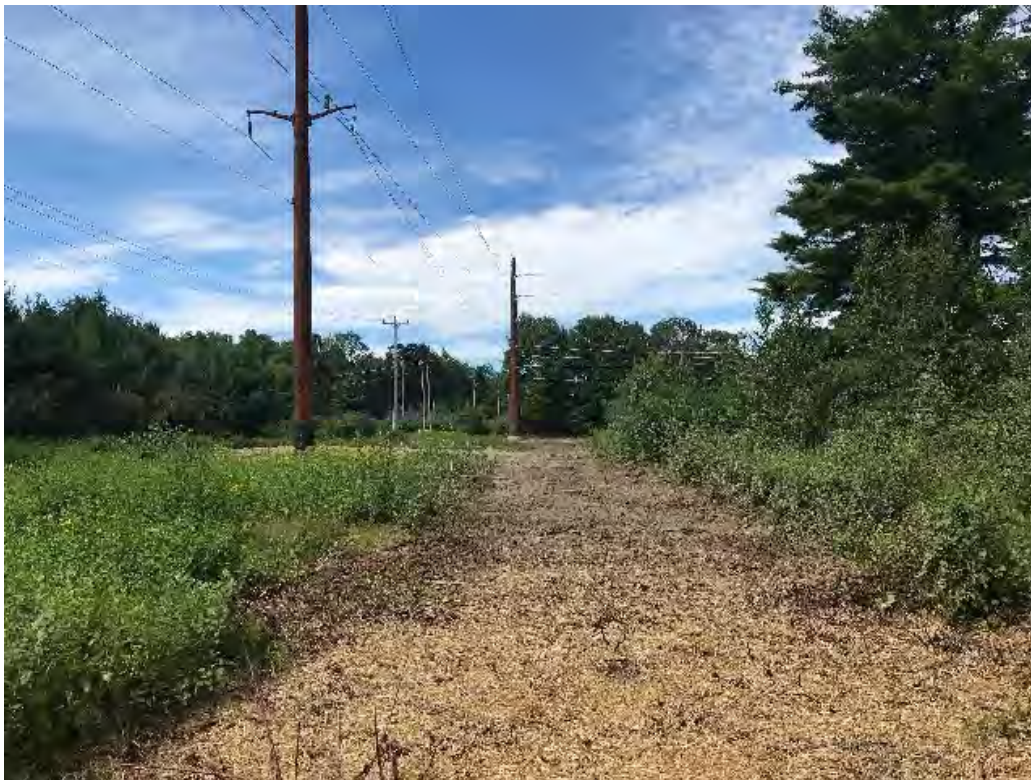
Fig 4: Access road across wetland DW54. Timber mats removed and wetland seeded. View southwest. (08-03-20).

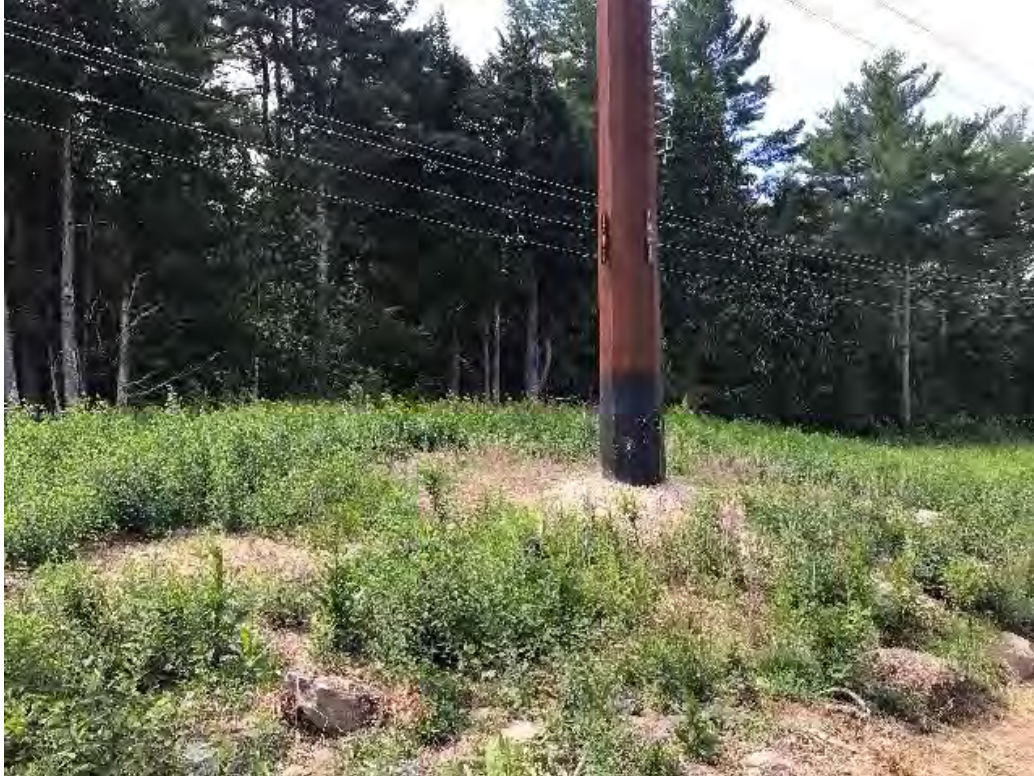
Fig 5: Str. 50 work area re-vegetating. Viewing south. (08-03-20).

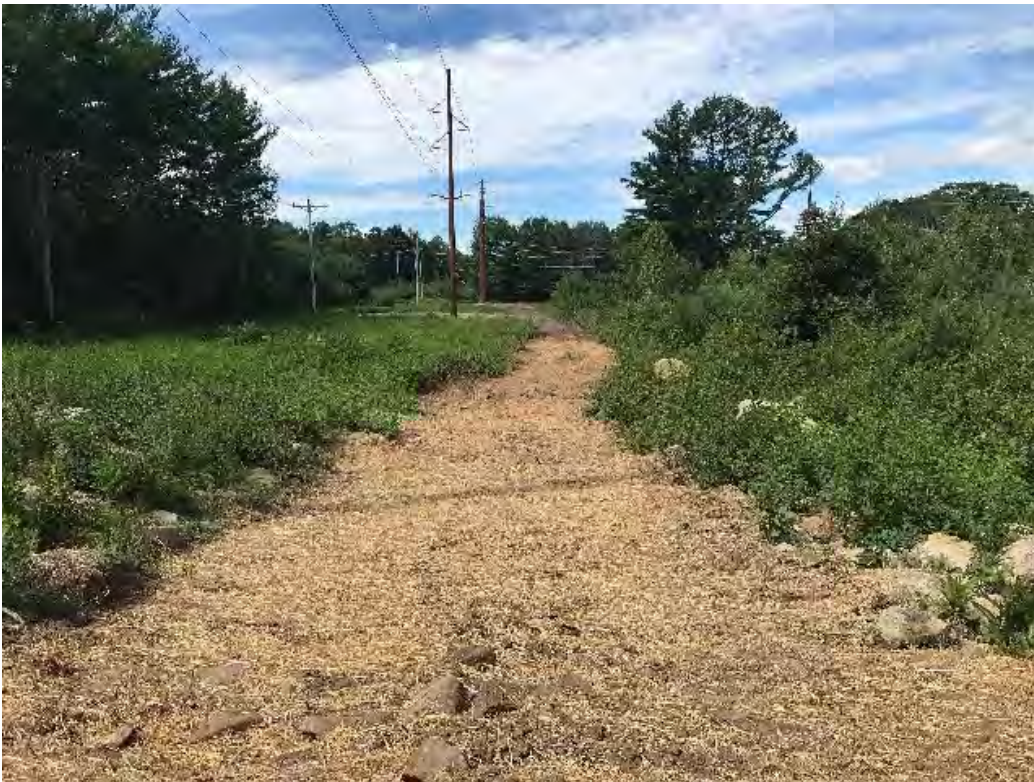
Fig 6: Access road from Strs. 50 to 49 seeded and mulched. Viewing southwest. (08-03-20).

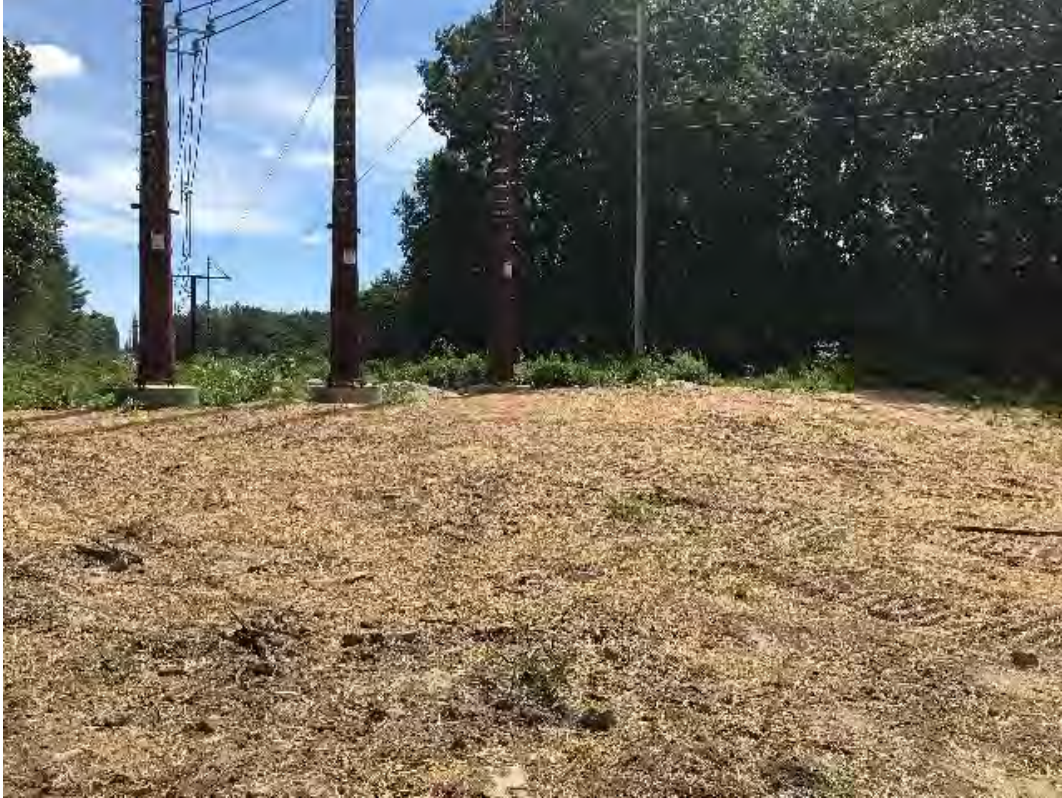
Fig 7: Str. 58 work area. Initial germination observed. Viewing northeast. (08-03-20).

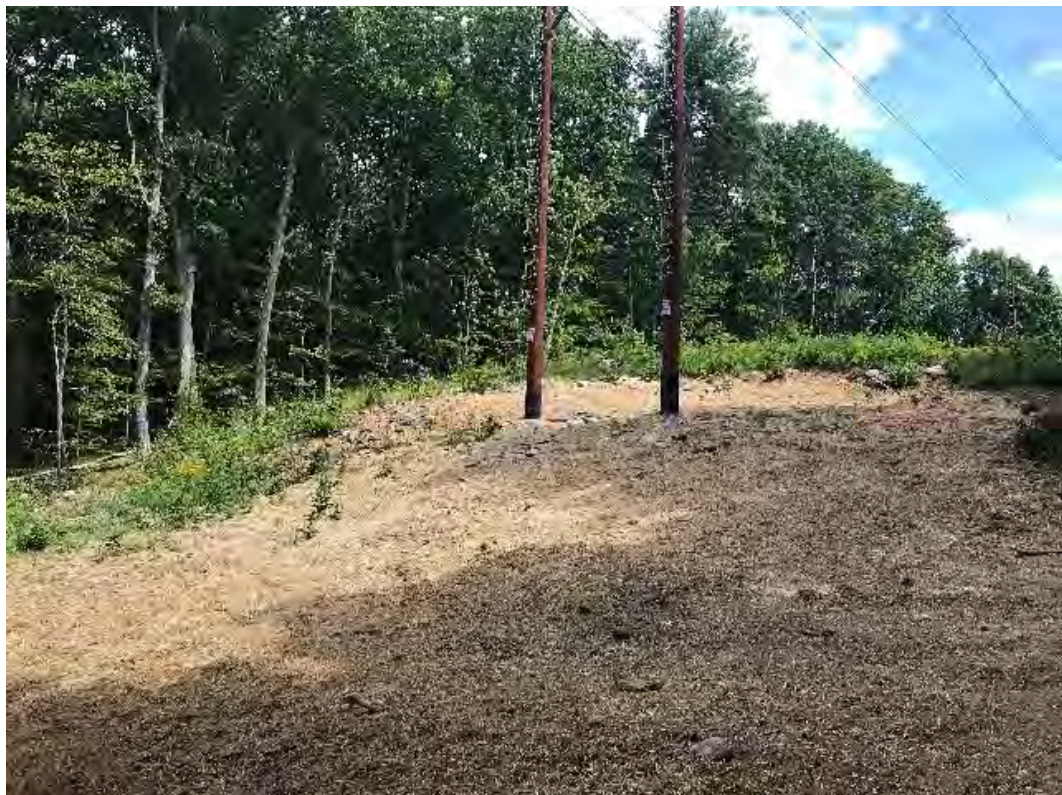
Fig 8: Str. 57 work area mulched and seeded. Viewing northeast. (08-03-20).

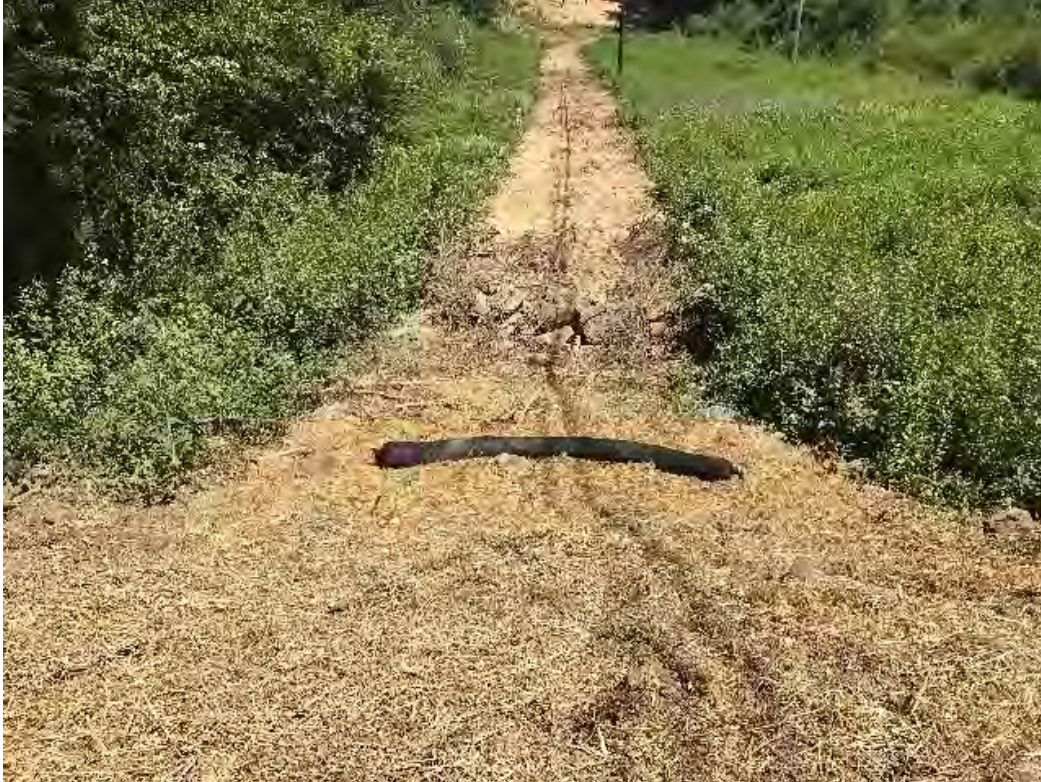
Fig 9: Timber mats removed from access road across wetland DW31. Wetland and slope down into wetland seeded and mulched. Silt sock BMP place in preparation for potential storm event. Viewing northeast. (08-03-20).

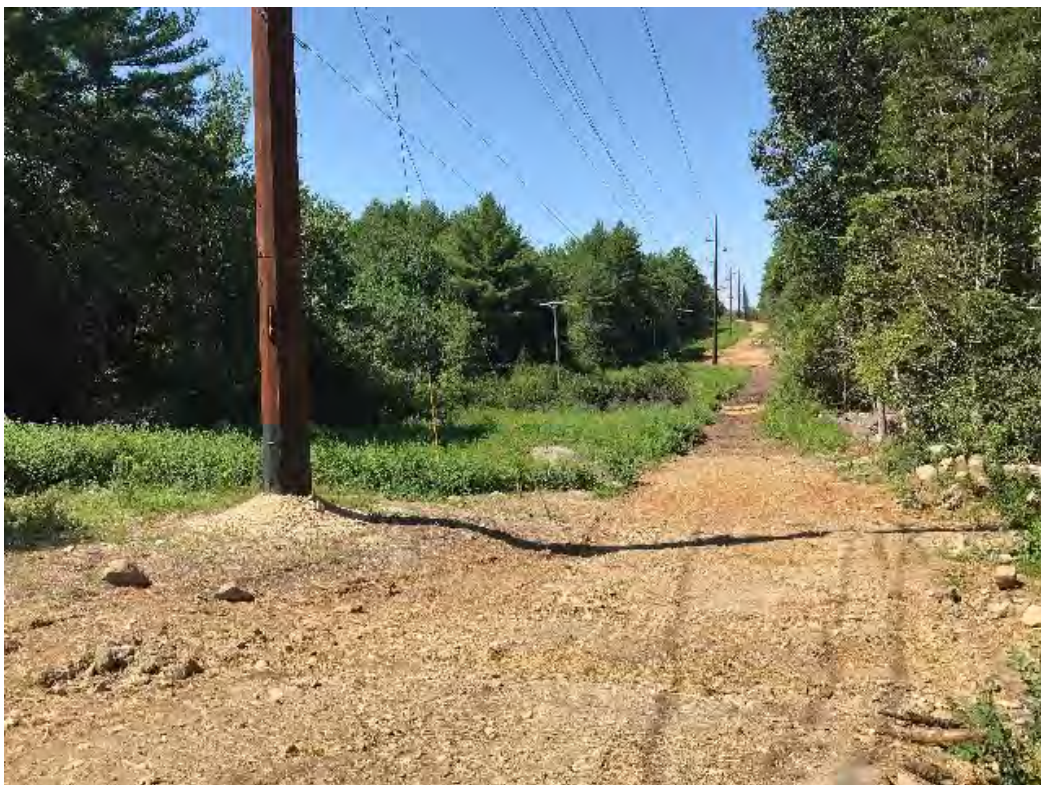
Fig 10: Str. 55 work area and access road seeded and mulched. Viewing southwest. (08-05-20).

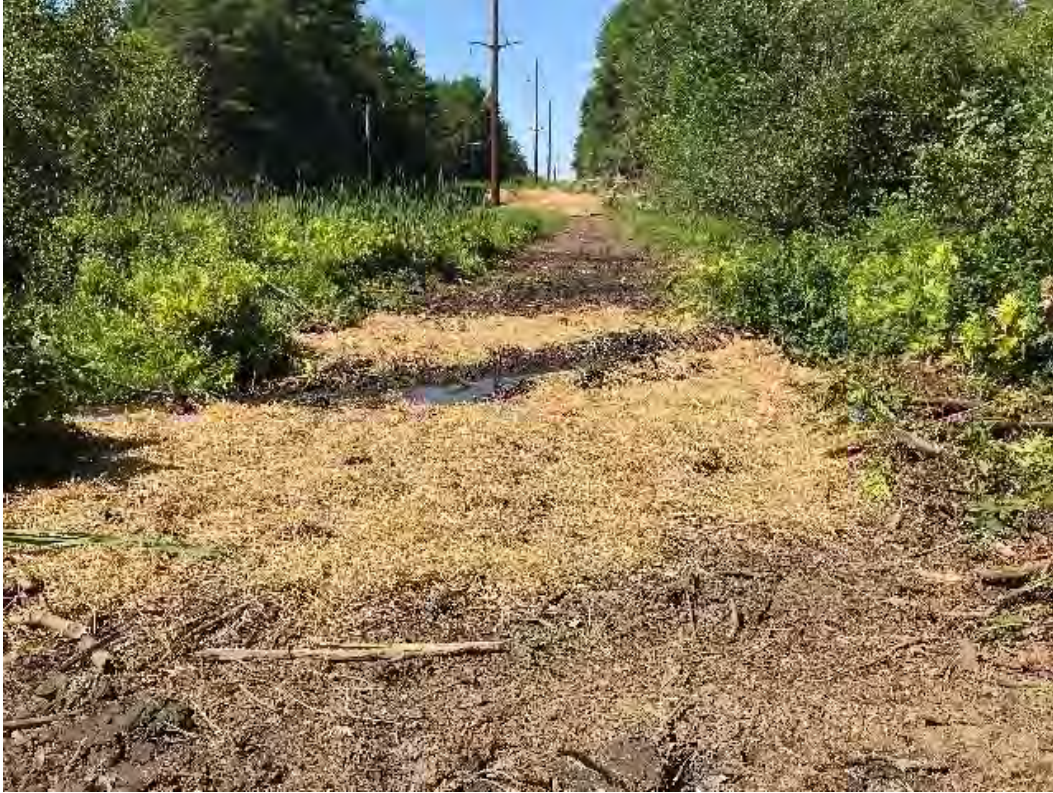
Fig 11: Access road crossing of stream DS35 in wetland DW33. Viewing southwest. (08-05-20).

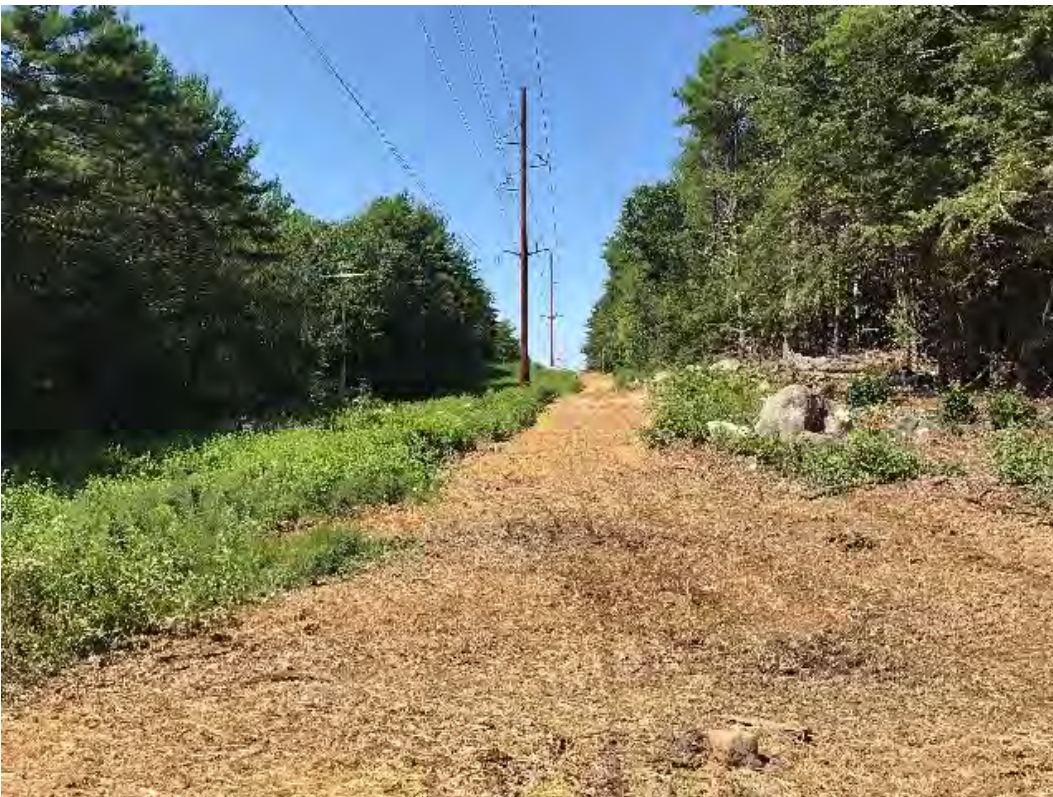
Fig 12: Access road from Strs. 54 to 53 seeded and mulched. (08-05-20).

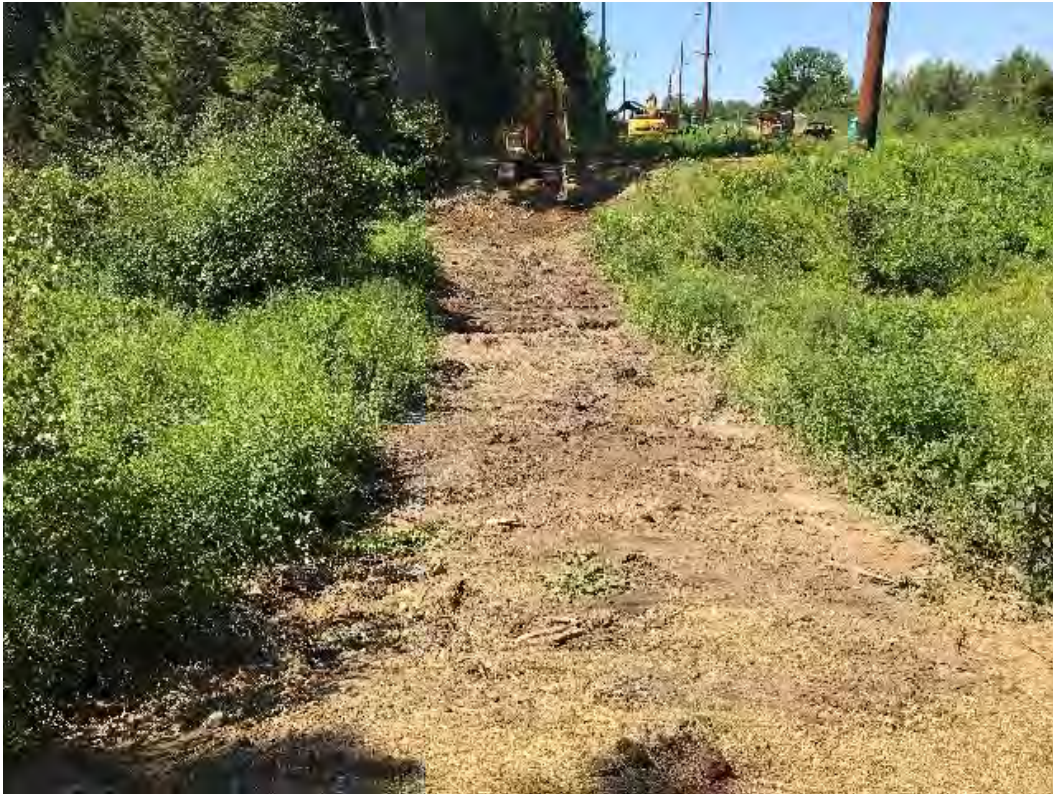
Fig 13: Timber mat removal and access road restoration at DS46 stream crossing. Viewing southwest. (08-05-20).

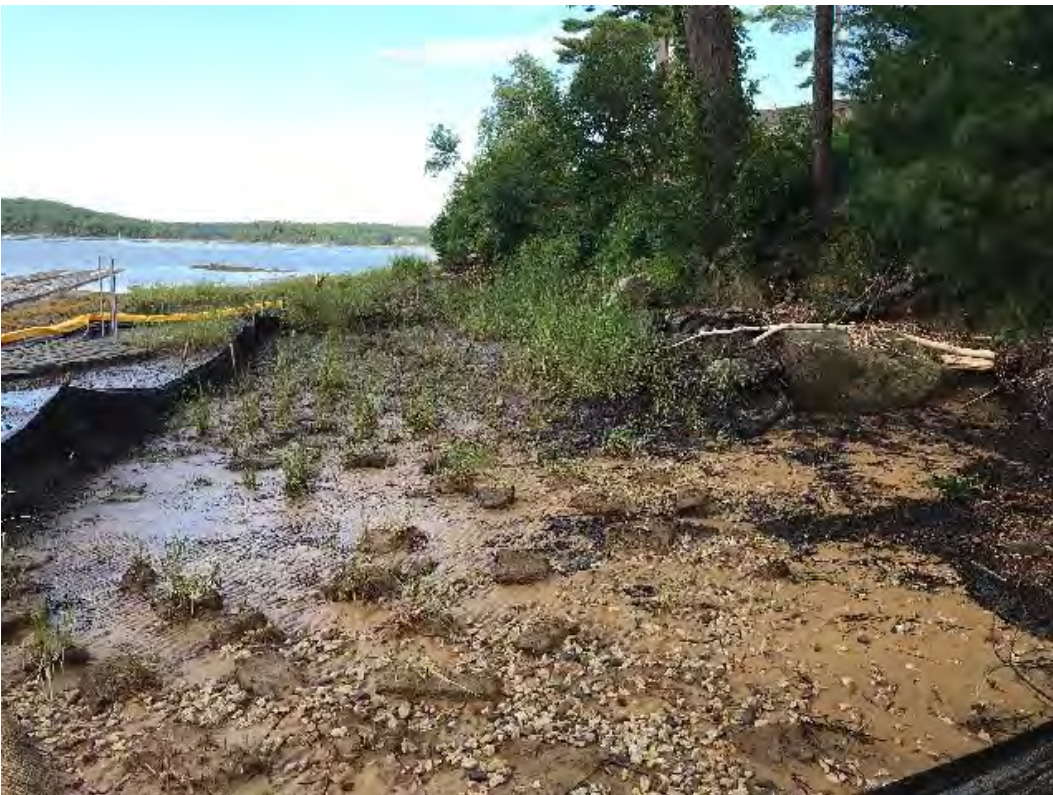
Fig 14: Salt marsh restoration at Gundalow Landing/east side of the bay. Viewing northwest. (08-05-20).

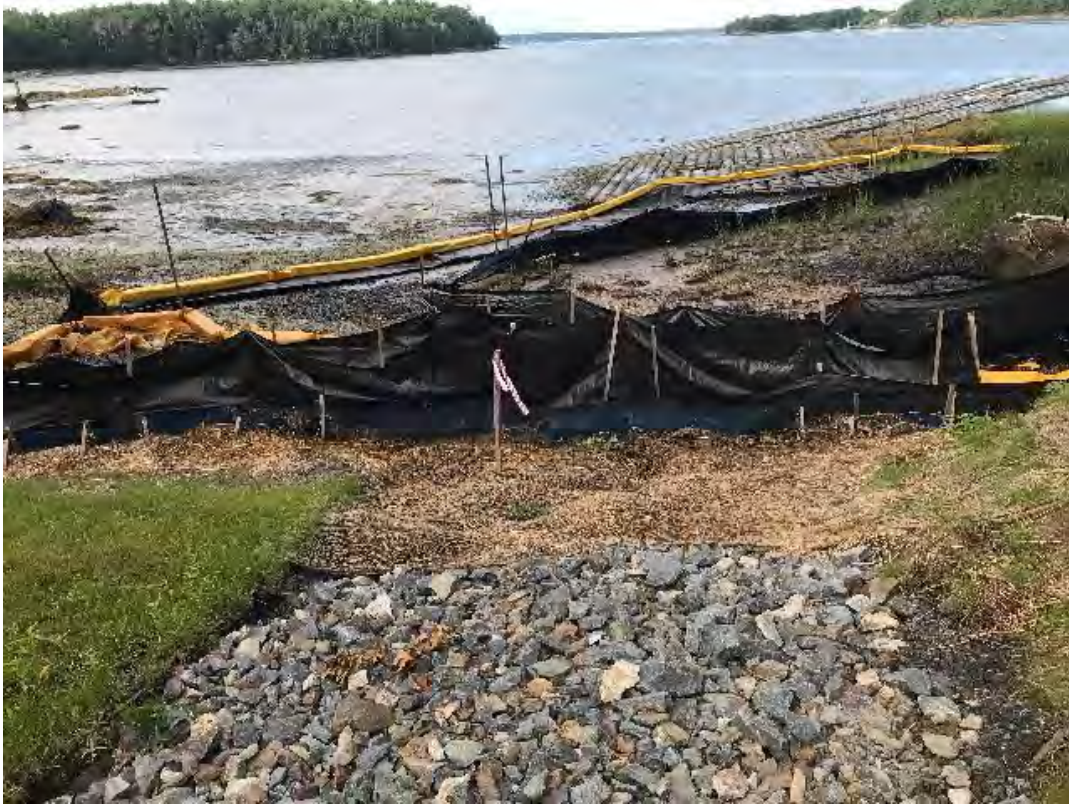
Fig 15: Toe of slope below manhole at Gundalow Landing/east side of the bay. Viewing southwest. (08-05-20).

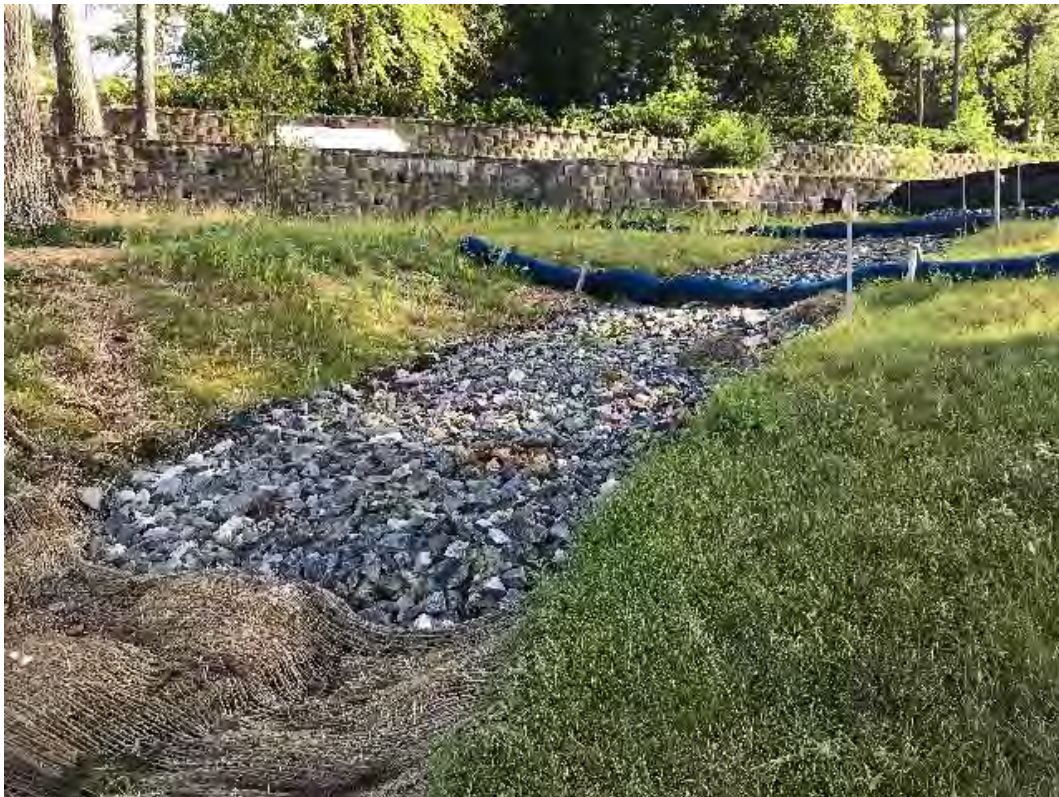
Fig 16: Slope below manhole at Gundalow Landing/east side of the bay. Viewing northeast. (08-05-20).

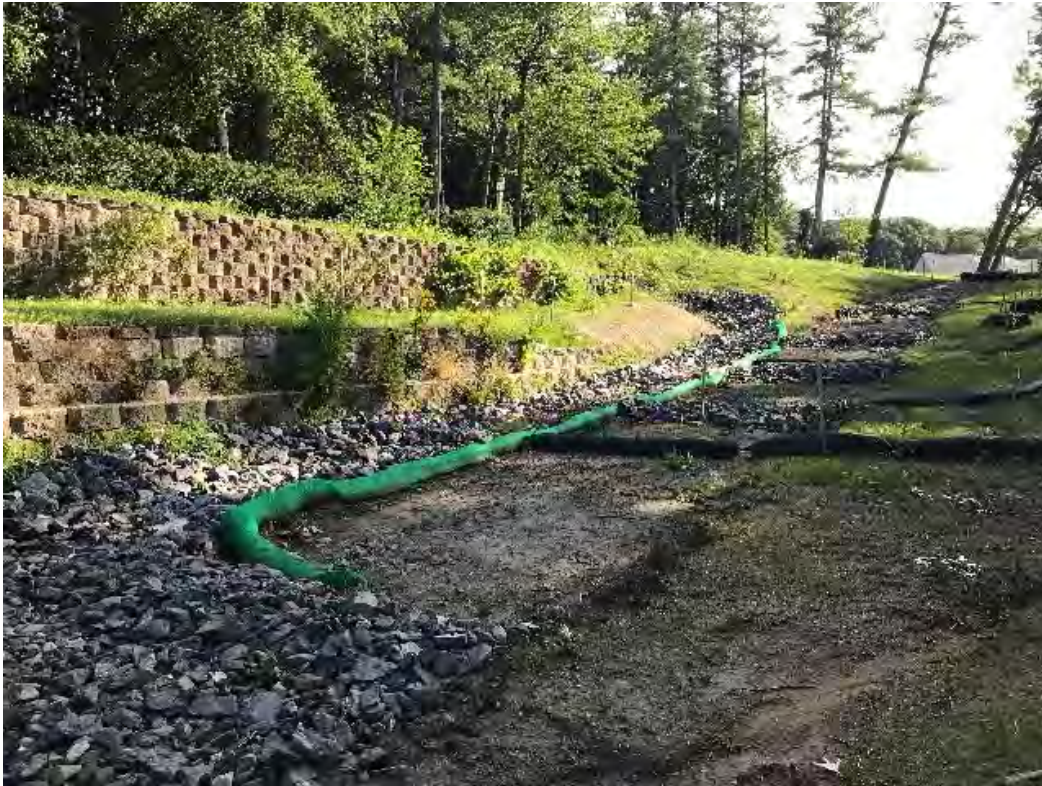
Fig 17: Slope above the manhole at Gundalow Landing/east side of the bay. Viewing northeast. (08-05-20).

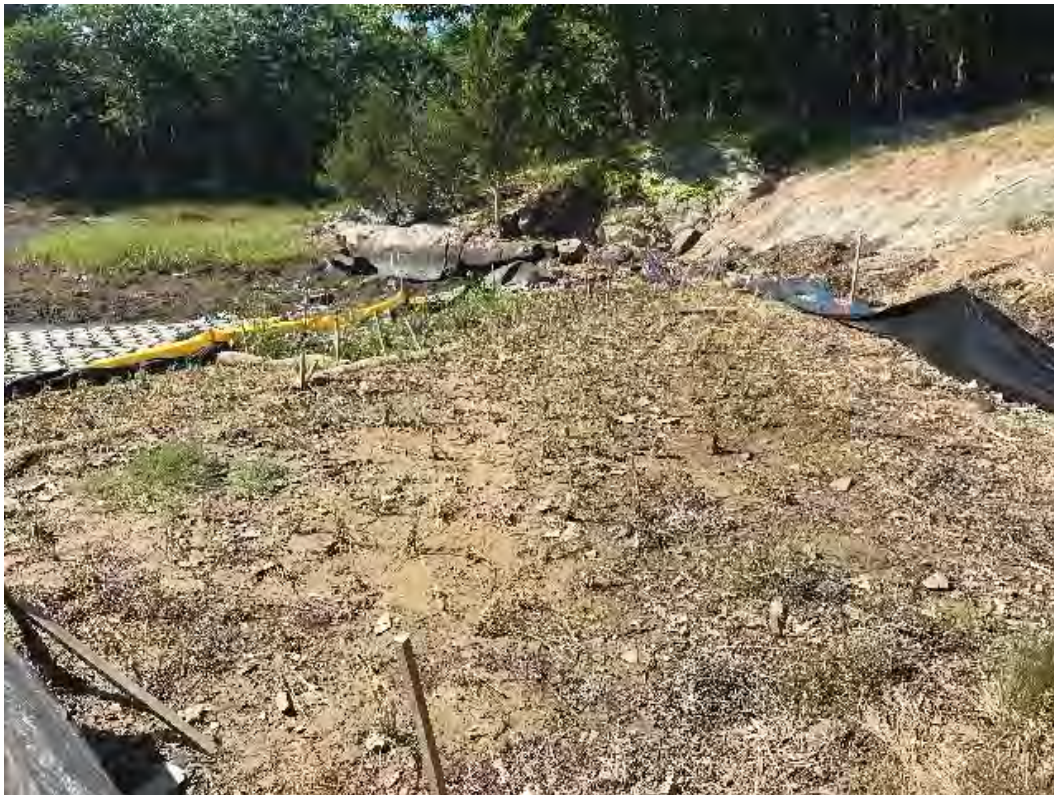
Fig 18: Salt marsh restoration at Eversource property/west side of the bay. Viewing south. (08-05-20).

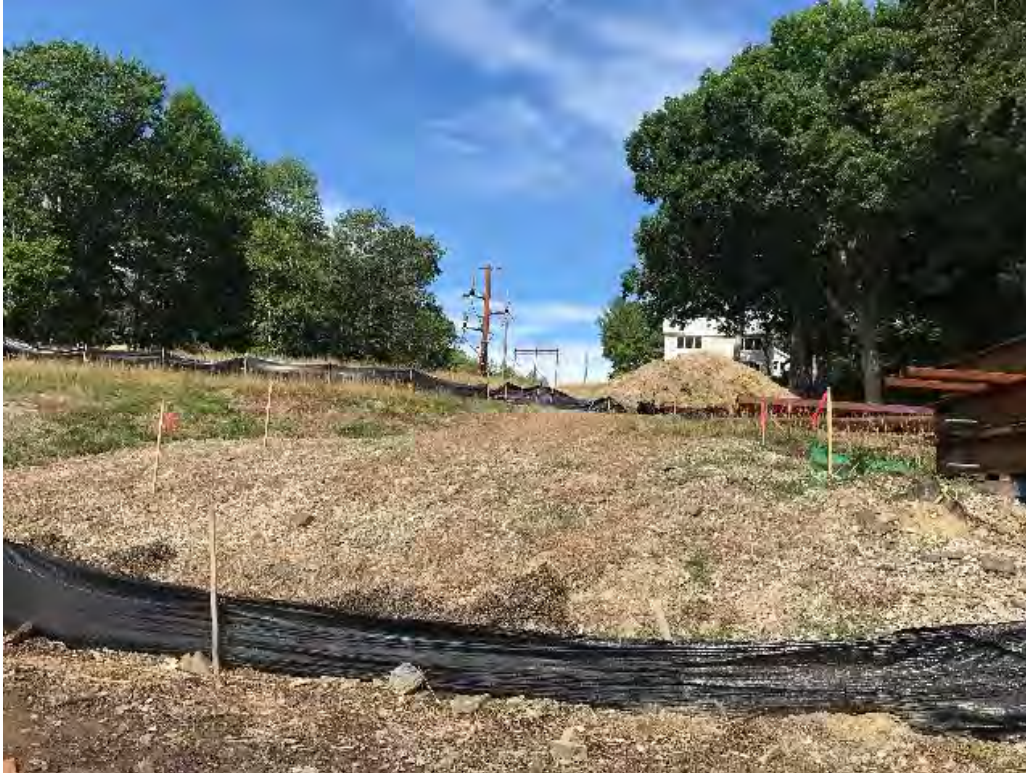
Fig 19: Slope above salt marsh restoration at Eversource property/west side of the bay. Planned final location of the cable house marked with orange flagged stakes. Viewing west. (08-03-20).
