DRAINAGE MONITORING REPORT

F107 - Seacoast Reliability Project

Newington, New Hampshire

04.0190967.00

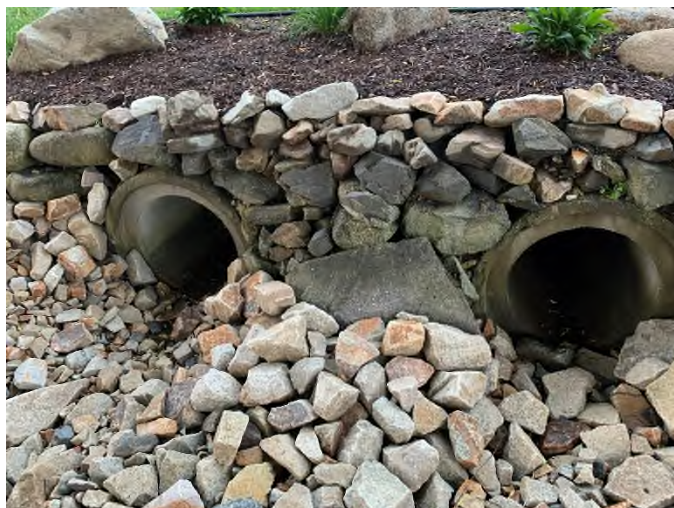
64 Gundalow - 2 (Drainage Course)

pH: 7.4

Observations/Notes: Small area of standing water adjacent to culvert inlet, approx. 1" deep

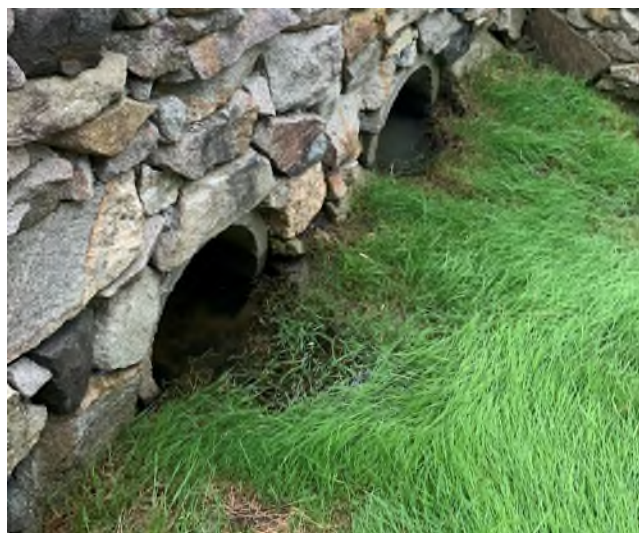
4 Brickyard Circle - 1 (Drainage Course)

pH: 7.9

Observations/Notes: ~ 8" of standing water extending ~ 12" beyond culvert outlet in grassed raceway

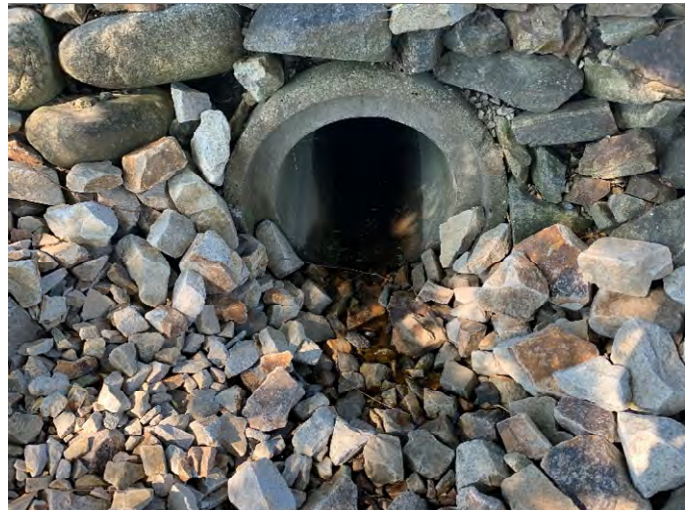
64 Gundalow - 2 (Drainage Course)

pH: **6.6**

Observations/Notes: Small area of standing water adjacent to culvert inlet, approx. 1" deep

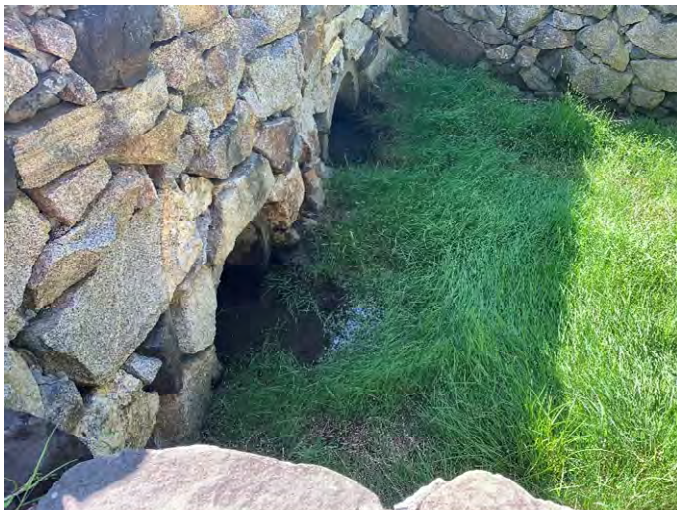
4 Brickyard Circle - 1 (Drainage Course)

pH: **7.1**

Observations/Notes: ~ 8" of standing water extending ~ 12" beyond culvert outlet in grassed raceway

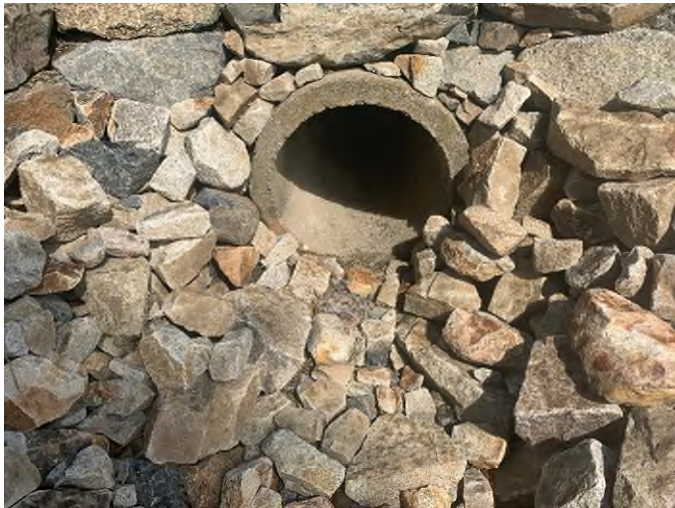
64 Gundalow - 1 (Drainage Course)

- Watering occurring in the vicinity of 64 Gundalow – 1 at time of inspection.

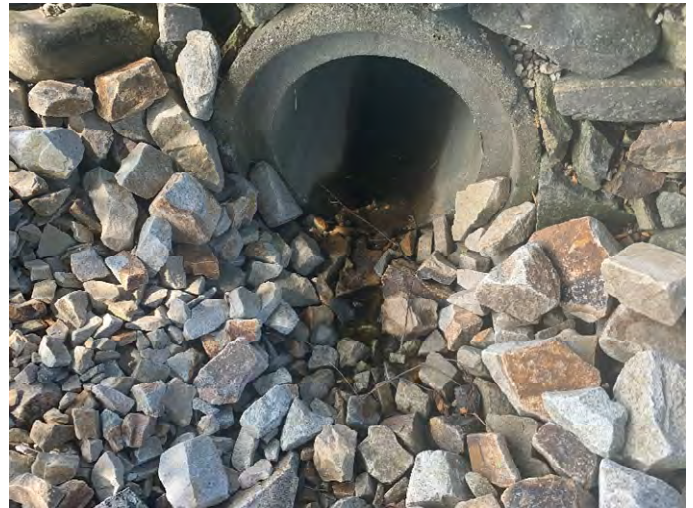
64 Gundalow - 2 (Drainage Course)

pH: **6.6**

Observations/Notes: Small area of standing water adjacent to culvert inlet, approx. 1" deep

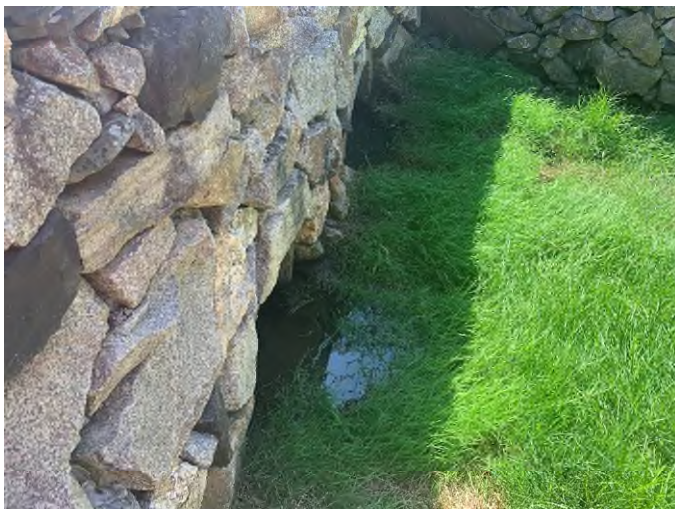
4 Brickyard Circle - 1 (Drainage Course)

pH: **7.3**

Observations/Notes: ~ 8" of standing water extending ~ 12" beyond culvert outlet in grassed raceway
