### CONSTRUCTION MONITORING REPORT

Eversource Transmission Lines: F107

Madbury, Durham, Newington, Portsmouth, NH

### **Construction Monitoring Report #84**

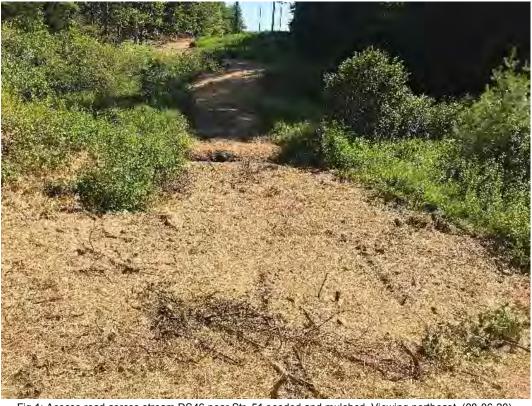
Fig 1: Access road across stream DS46 near Str. 51 seeded and mulched. Viewing northeast. (08-06-20).

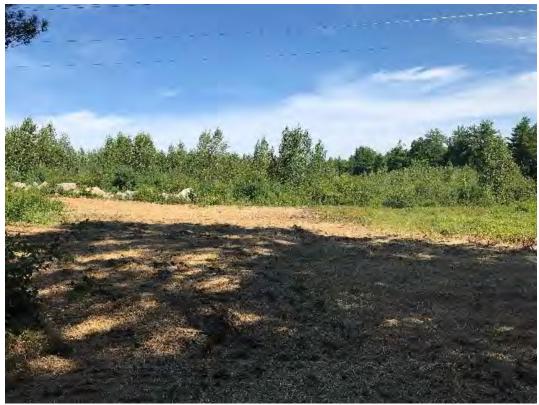
Fig 2: Bennett Rd. access entrance near Str. 51 seeded and mulched. Viewing northwest. (08-06-20).

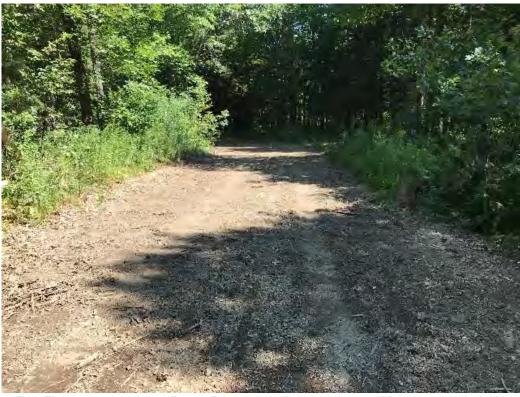
Fig 3: Timber mat removal along Bennett Rd. access road up to staging area. Viewing north. (08-10-20).

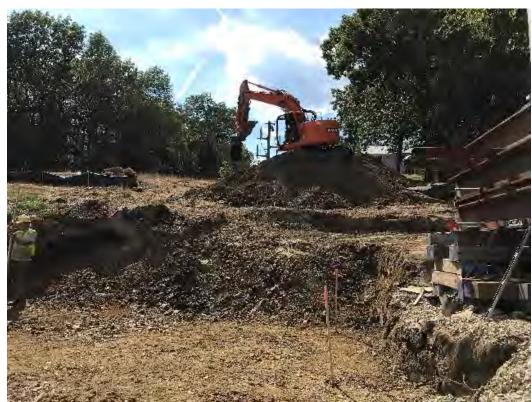
Fig 4: Excavation for the new cable house foundation at the Eversource property/west side of the bay. View west. (08-10-20).

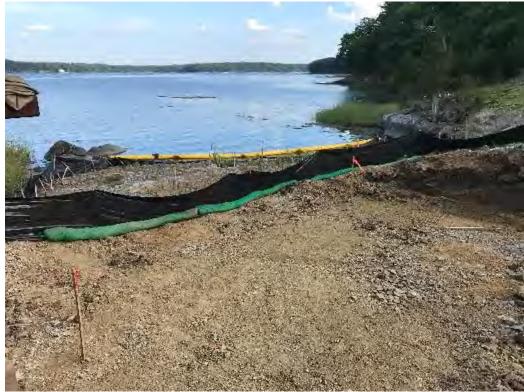
Fig 5: Installation of silt fence and sock along at downstream edge of cable house foundation excavation to protect the salt marsh. Viewing southeast. (08-10-20).

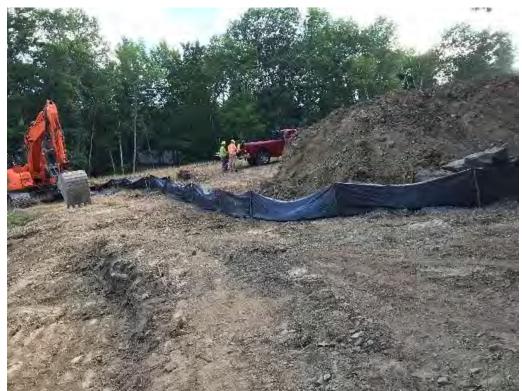
Fig 6: Installation of silt fence around base of soil excavated for cable house foundation at Eversource property/west side of the bay. Viewing southwest. (08-10-20).

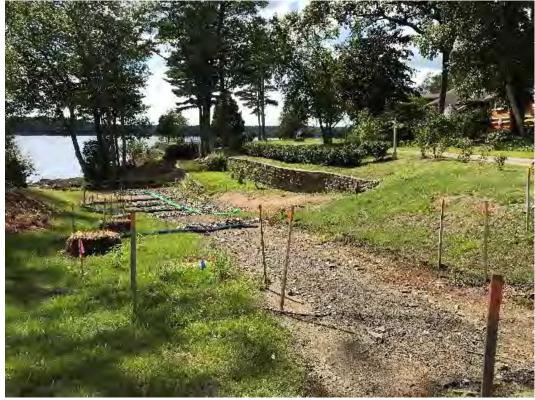
Fig 7: Slope above the manhole at Gundalow Landing/east side of the bay. Viewing west. (08-12-20).

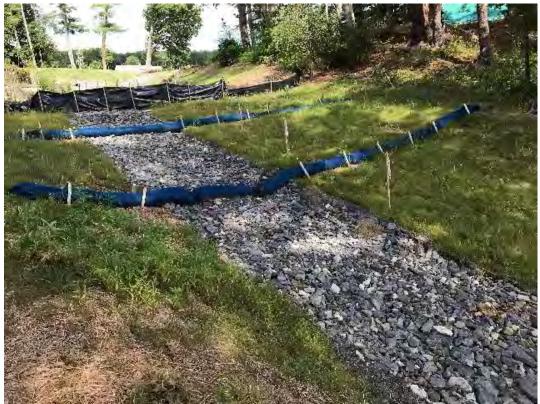
Fig 8: Slope below manhole at Gundalow Landing/east side of the bay. Viewing east. (08-12-20).

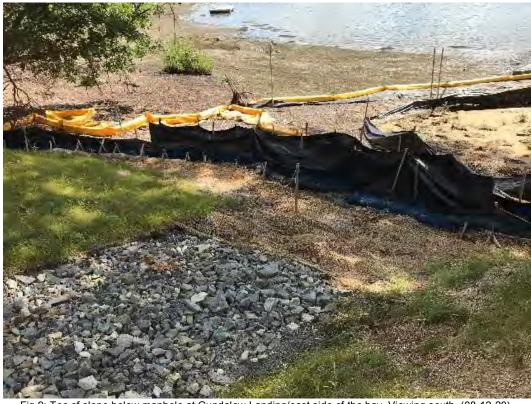
Fig 9: Toe of slope below manhole at Gundalow Landing/east side of the bay. Viewing south. (08-12-20).

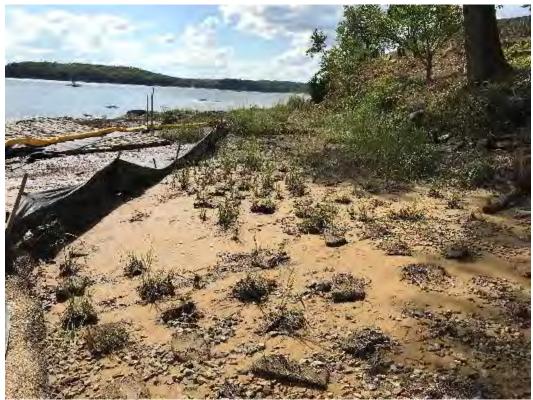
Fig 12: Salt marsh restoration at Gundalow Landing/east side of the bay. Viewing northwest. (08-12-20).

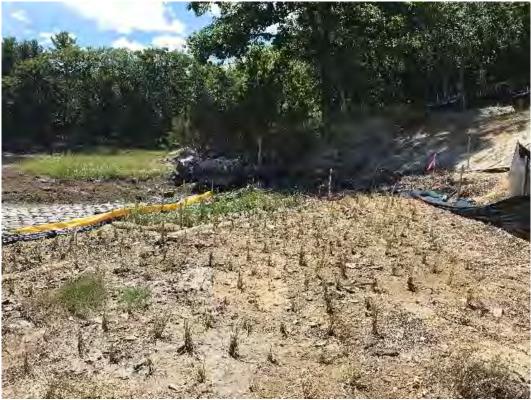
Fig 13: Salt marsh restoration at Eversource property/west side of the bay. Viewing south. (08-12-20).
