# DRAINAGE MONITORING REPORT

## F107 - Seacoast Reliability Project

### Newington, New Hampshire

04.0190967.00

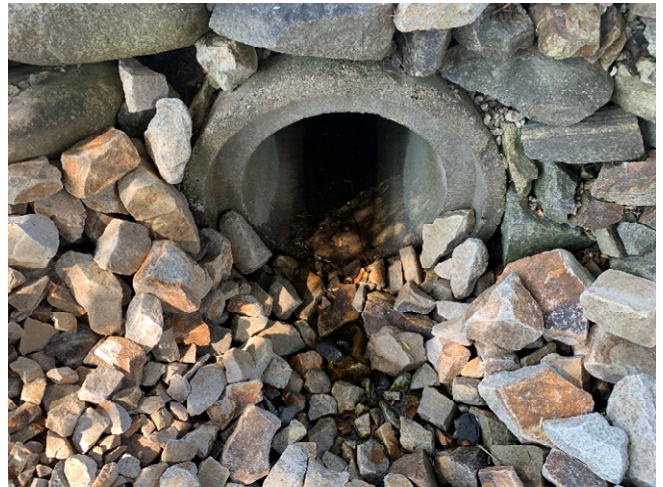
64 Gundalow - 2 (Drainage Course)

pH: **6.3**

Observations/Notes: Small area of standing water adjacent to culvert inlet, approx. 1" deep

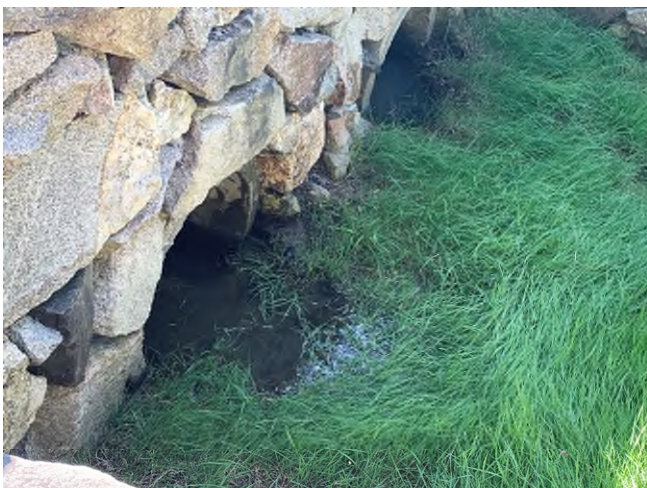
4 Brickyard Circle - 1 (Drainage Course)

pH: **7.1**

Observations/Notes: ~ 8" of standing water extending ~ 12" beyond culvert outlet in grassed raceway

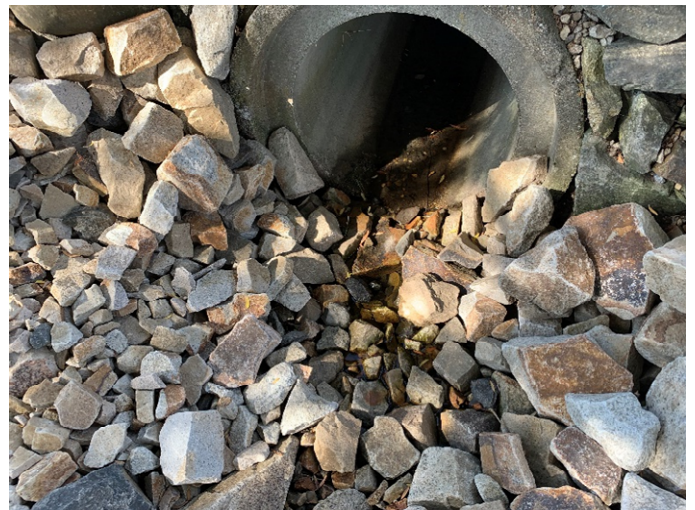
64 Gundalow - 2 (Drainage Course)

pH: 6.5

Observations/Notes: Small area of standing water adjacent to culvert inlet, approx. 1" deep

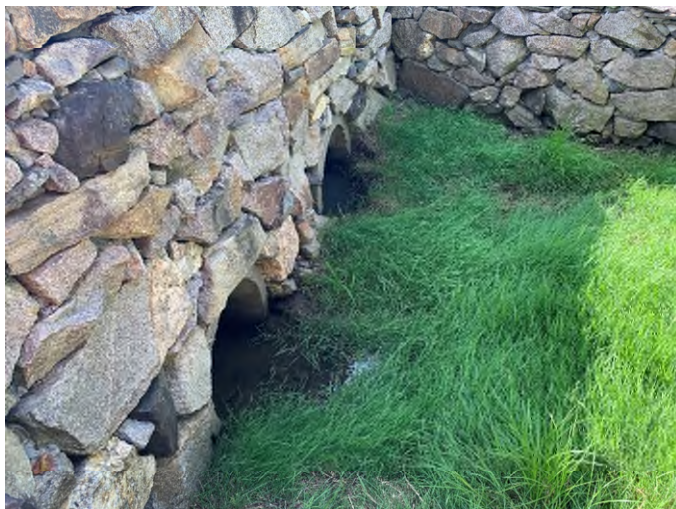
4 Brickyard Circle - 1 (Drainage Course)

pH: 7.8

Observations/Notes: ~ 8" of standing water extending ~ 12" beyond culvert outlet in grassed raceway

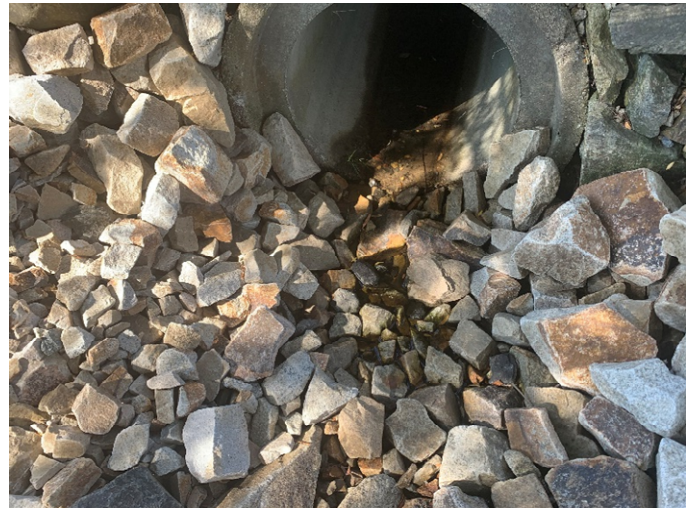
64 Gundalow - 2 (Drainage Course)

pH: 6.6

Observations/Notes: Small area of standing water adjacent to culvert inlet, approx. 1" deep

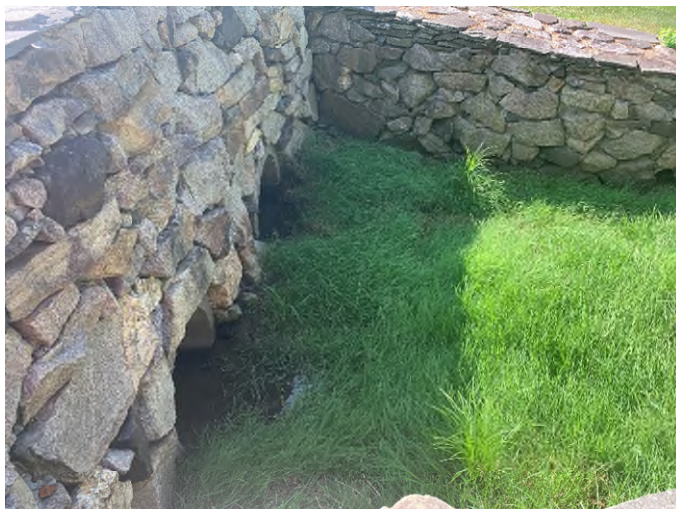
4 Brickyard Circle - 1 (Drainage Course)

pH: 7.5

Observations/Notes: ~ 8" of standing water extending ~ 12" beyond culvert outlet in grassed raceway
