CONSTRUCTION MONITORING REPORT

Eversource Transmission Lines:
TYPE OF INSPECTION: X Weekly Storm Event Incident Corrective Action	<u>F107</u>
Date: <u>08/19/20</u> Time: <u>8:00am</u> Does this report include a 0.25" storm event?Yes _X_No If yes, how did you determine whether a 0.25" storm event has occurred?Rain Gauge _Weather Station Storm event information is from Pease Air Force Base.	Madbury, Durham, Newington, Portsmouth, NH Alteration of Terrain Permit: SEC Docket No. 2015-004
+Storm event information (approx.): Start date: Amount (inches):	
	Environmental Permit: SEC Docket No. 2015-004
NOTE: * None	USEPA NOI Tracking No: NHR1000QN NHR1000QT NHR1000QO NHR1000S6
	NAI Project No: <u>23840.39</u>
Inspector name(s), title(s) and qualifications: Elizabeth Olliver, Normandeau Environmental Inspector and Marc Jacobs, CPESC, NHCWS	
Others present/qualifications(s): Sam Eames, Eversource construction representative	
Weather conditions (since last inspection): Sunny to partly cloudy Thursday to Wednesday. Temperatures in the mid 60's and mid 80's. Precipitation – 0.20 inches early Tuesday morning.

Eversource Seacoast Reliability Project

Construction Monitoring Report #85

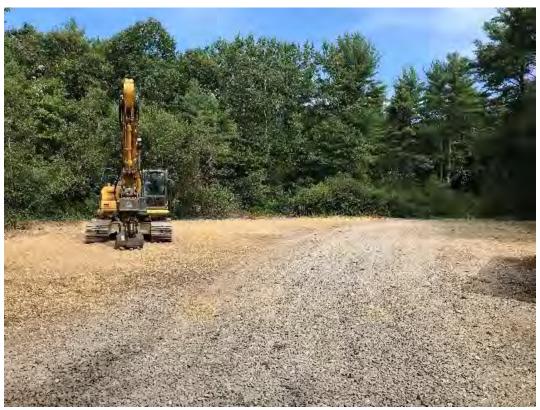
Fig 1: Bennett Rd. staging area. Gravel path restored and exposed soil seeded and mulched. Viewing north. (08-19-20).

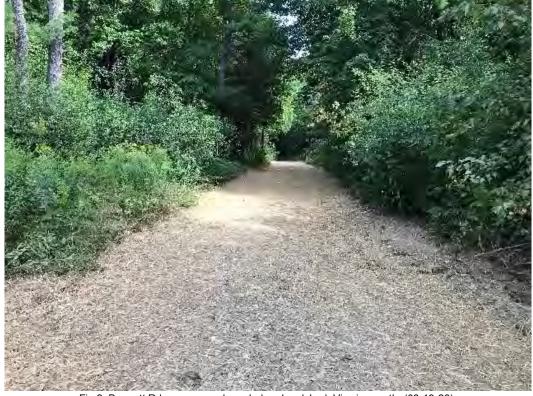
Fig 2: Bennett Rd. access road seeded and mulched. Viewing north. (08-19-20).

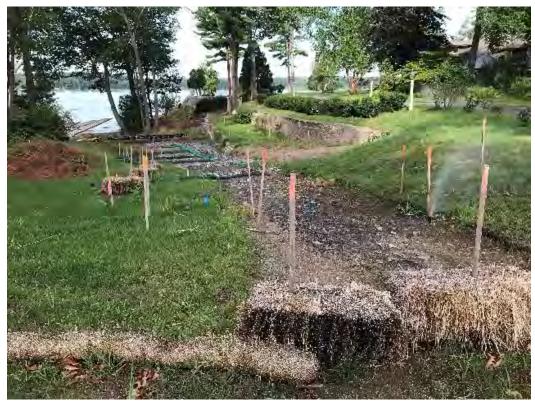
Fig 3: Slope above the manhole at Gundalow Landing/east side of the bay. Viewing west. (08-19-20).

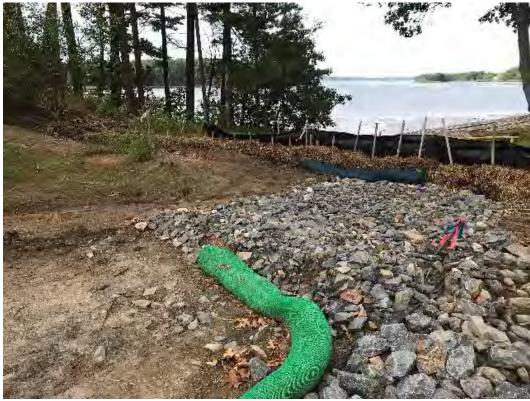
Fig 4: Toe of slope above the manhole at Gundalow Landing/east side of the bay. Viewing south. (08-19-20).

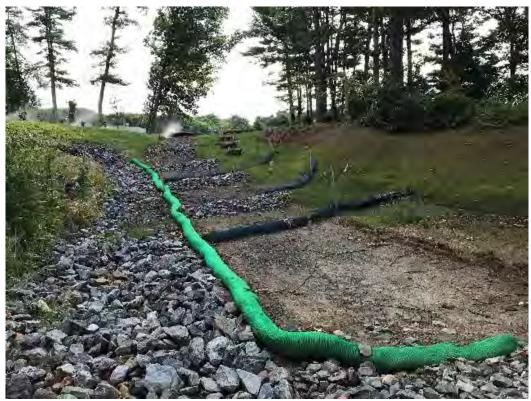
Fig 5: Slope above the manhole at Gundalow Landing/east side of the bay. Viewing east. (08-19-20).

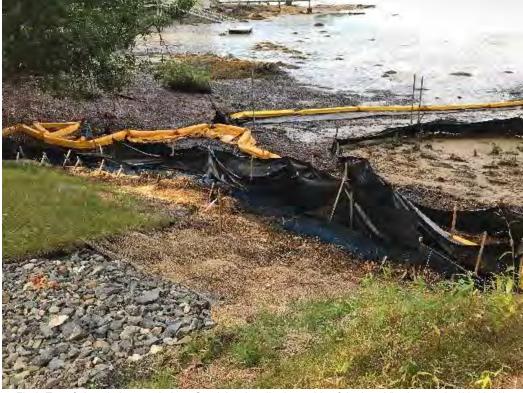
Fig 6: Toe of slope below manhole at Gundalow Landing/east side of the bay. Viewing south. (08-19-20).

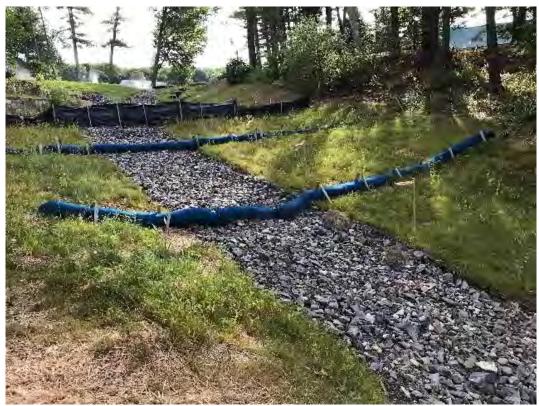
Fig 7: Slope below manhole at Gundalow Landing/east side of the bay. Viewing east. (08-19-20).

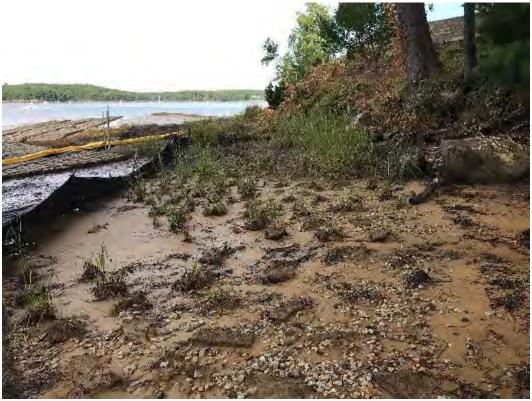
Fig 8: Salt marsh restoration at Gundalow Landing/east side of the bay. Viewing northwest. (08-19-20).

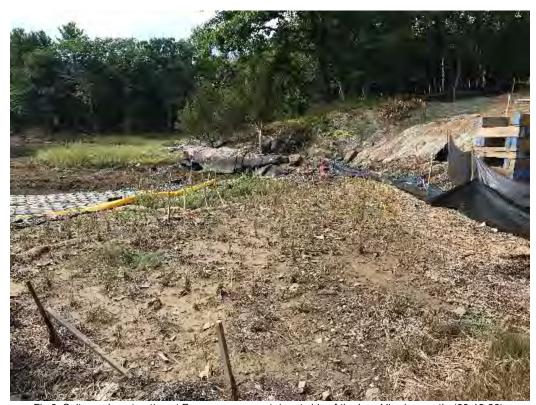
Fig 9: Salt marsh restoration at Eversource property/west side of the bay. Viewing south. (08-19-20).

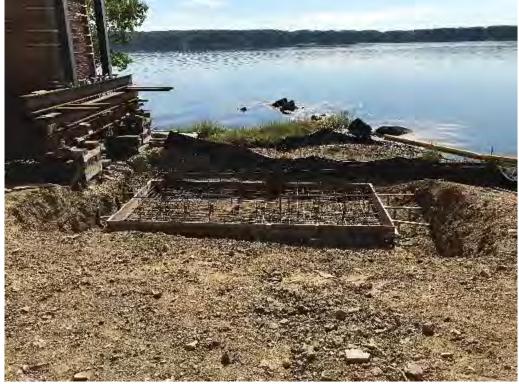
Fig 10: Form for the first part of the new cable house foundation at Eversource property/west side of the bay. Viewing east. (08-13-20).

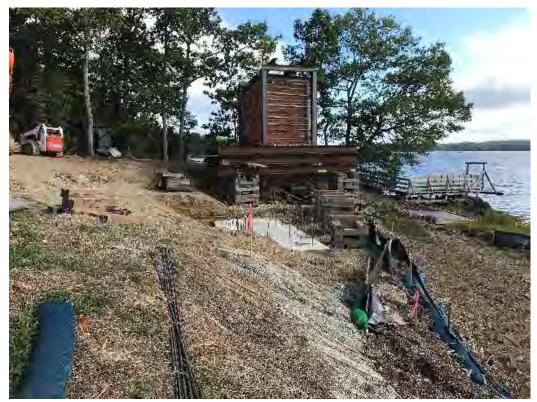
Fig 11: Site of the new cable house location at Eversource property/west side of the bay and the new cable house foundation partially constructed. Viewing north. (08-17-20).
