DRAINAGE MONITORING REPORT

F107 - Seacoast Reliability Project

Newington, New Hampshire

04.0190967.00

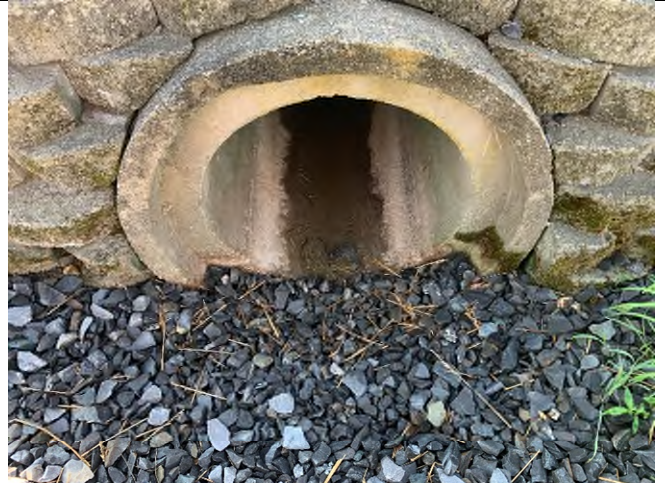
29 Gundalow - 2 (Culvert)

pH: Visible moisture on inside of culvert but no standing water

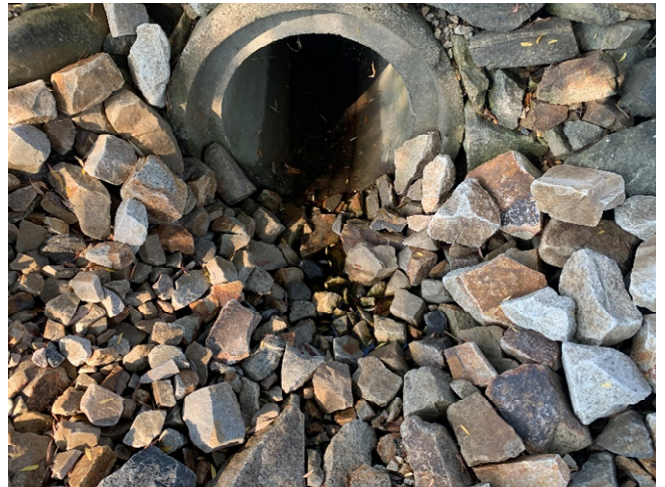
64 Gundalow - 2 (Drainage Course)

pH: 6.6

Observations/Notes: Small area of standing water adjacent to culvert inlet, approx. 1" deep

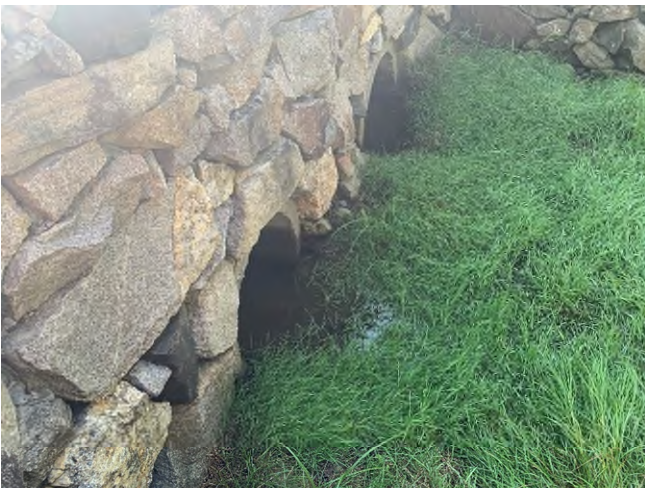
4 Brickyard Circle - 1 (Drainage Course)

pH: 7.1

Observations/Notes: ~ 8" of standing water extending ~ 12" beyond culvert outlet in grassed raceway

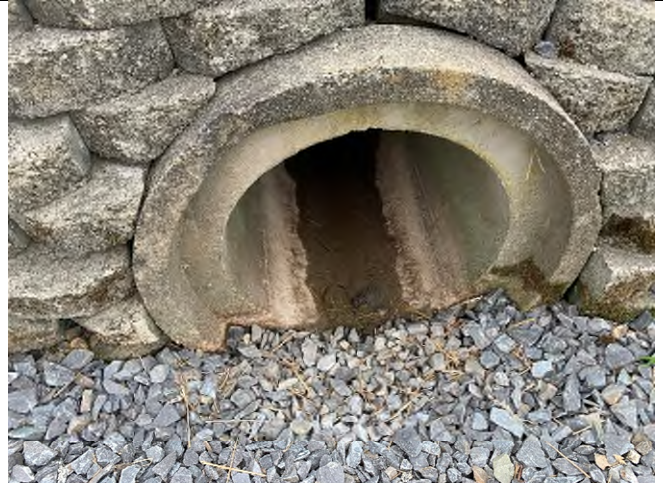
29 Gundalow - 2 (Culvert)

pH: Visible moisture on inside of culvert but no standing water

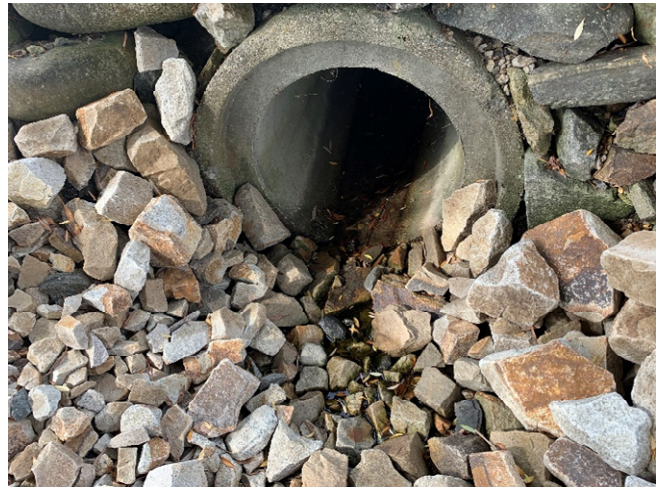
64 Gundalow - 2 (Drainage Course)

pH: 6.6

Observations/Notes: Small area of standing water adjacent to culvert inlet, approx. 1" deep

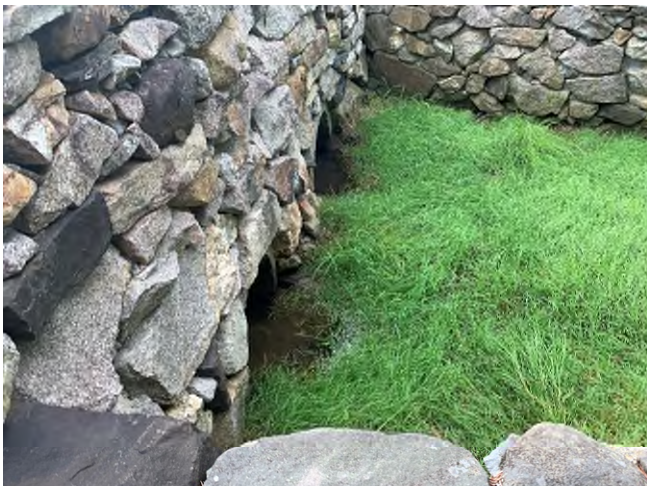
4 Brickyard Circle - 1 (Drainage Course)

pH: 6.9

Observations/Notes: ~ 8" of standing water extending ~ 12" beyond culvert outlet in grassed raceway
