CONSTRUCTION MONITORING REPORT

Eversource Transmission Lines:
F107

**Madbury, Durham,
Newington, Portsmouth, NH**

TYPE OF INSPECTION: Weekly Storm Event Incident Corrective Action

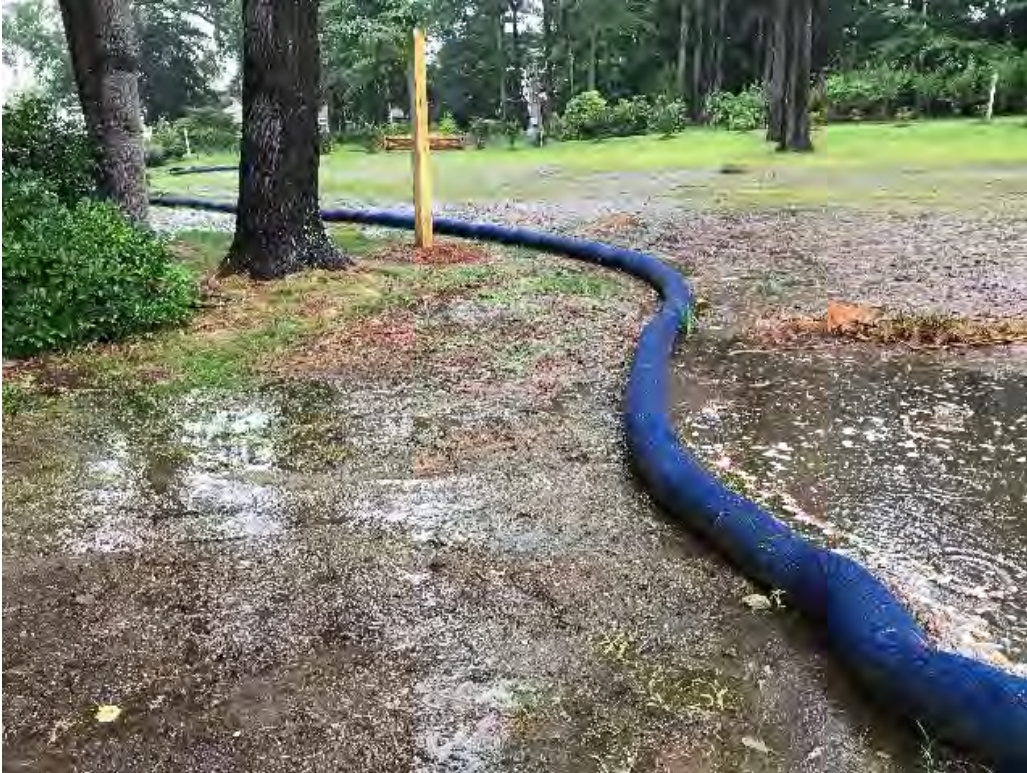
Fig 1: Silt sock on southern side of Beswick property at Gundalow Landing/east side of the Bay functioning as intended. Viewing northwest. (08-29-20).

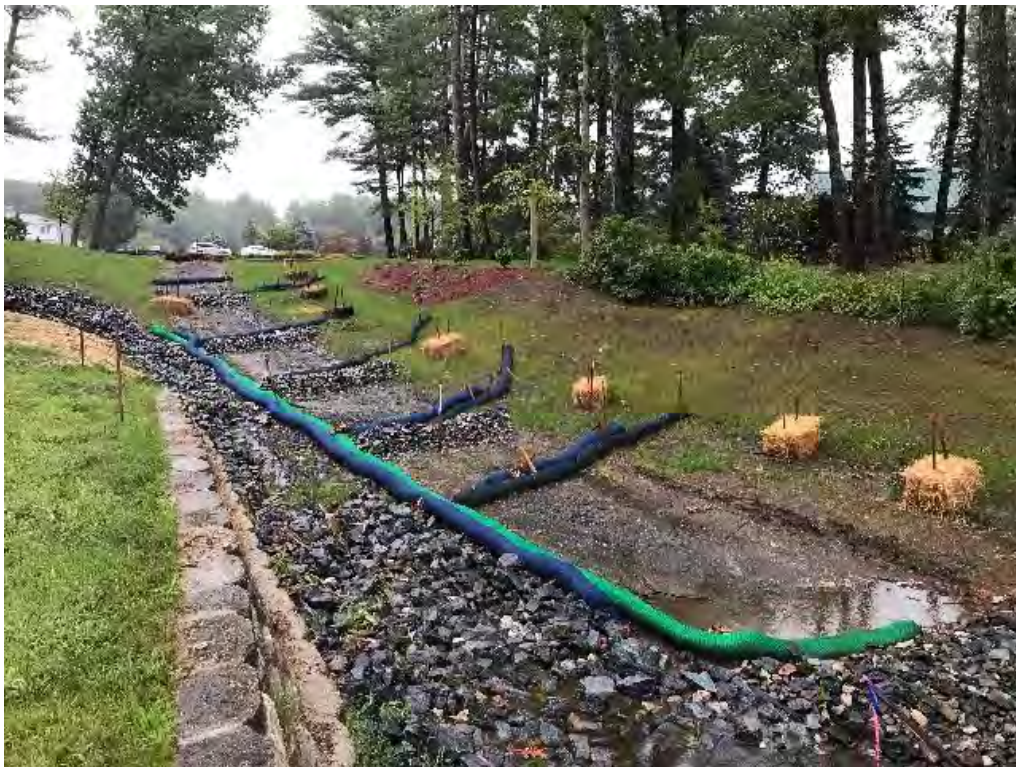
Fig 2: Slope above the manhole at Gundalow Landing/east side of the bay. Viewing east. (08-29-20).

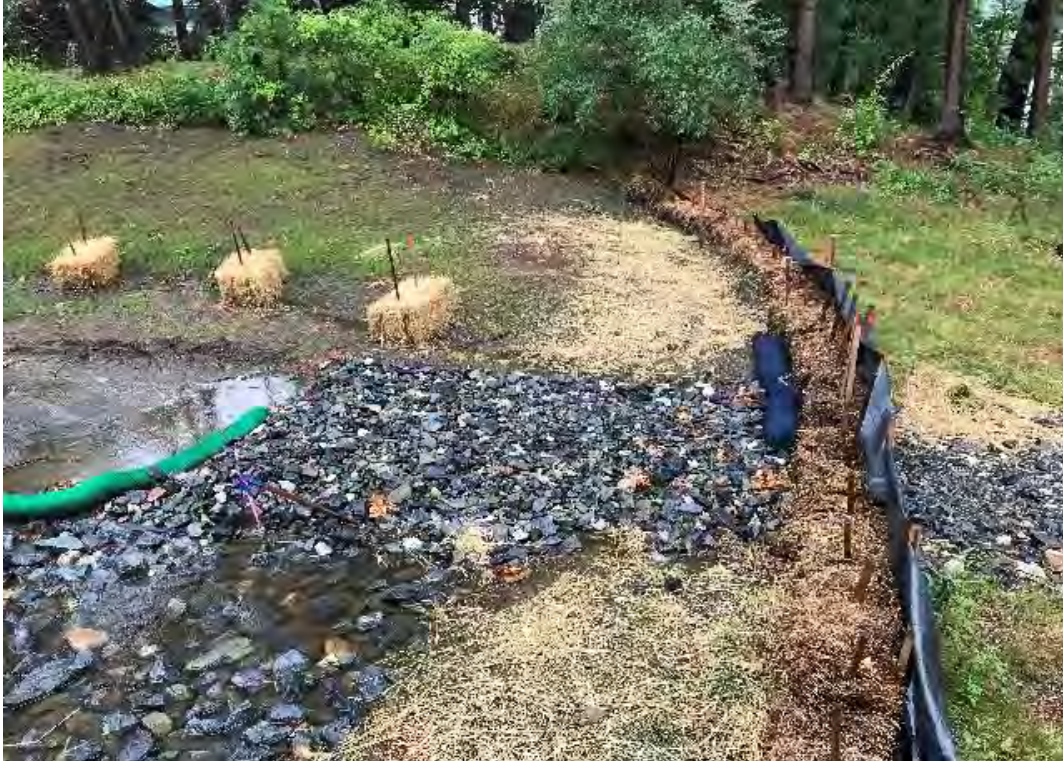
Fig 3: Bottom of the slope above the manhole at Gundalow Landing/east side of the bay. Viewing south. (08-29-20).

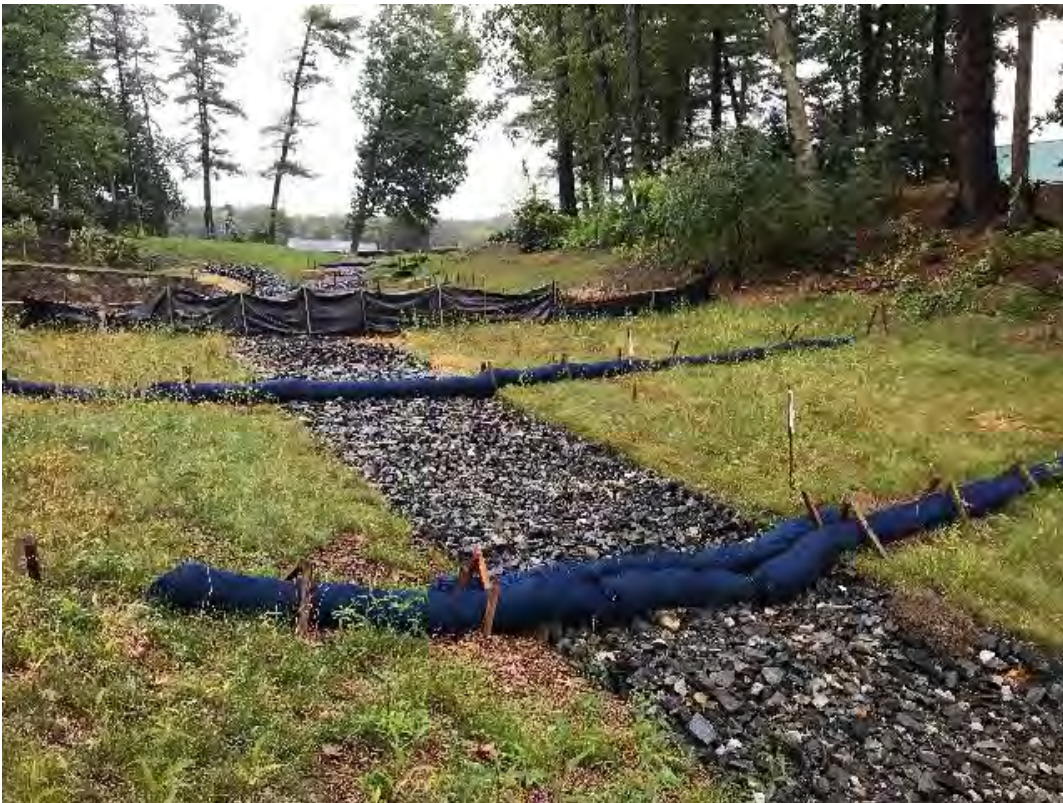
Fig 4: Slope below the manhole at Gundalow Landing/east side of the bay. Viewing northeast. (08-29-20).

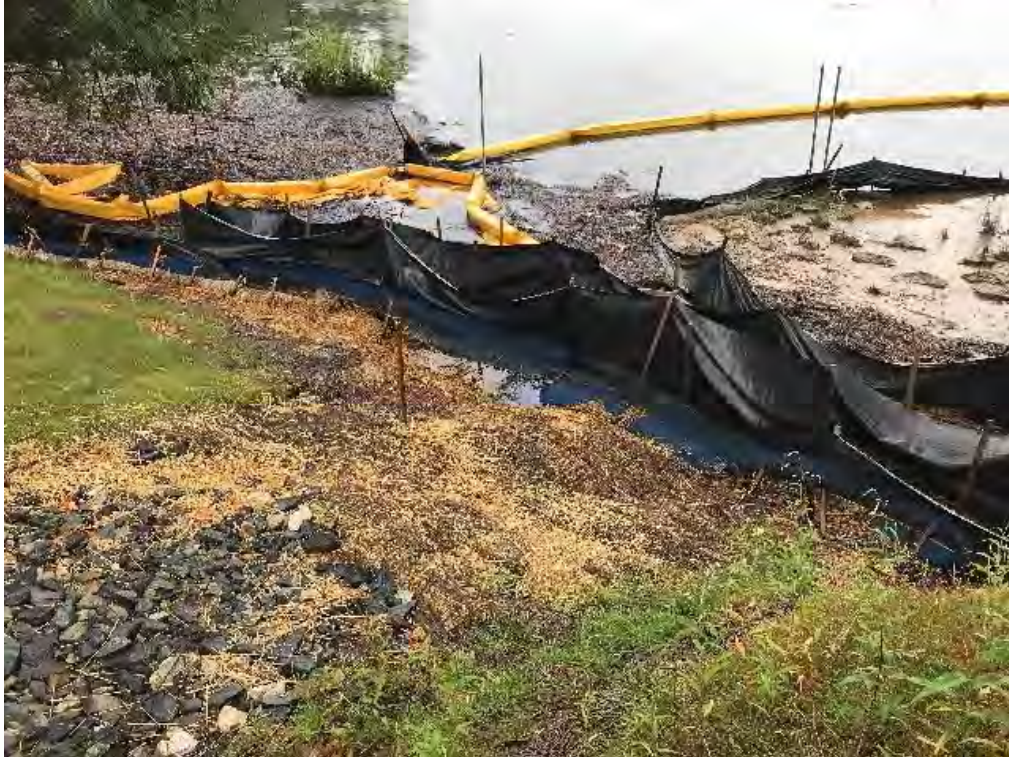
Fig 5: Toe of the slope below the manhole at Gundalow Landing/east side of the bay. Viewing south. (08-29-20).

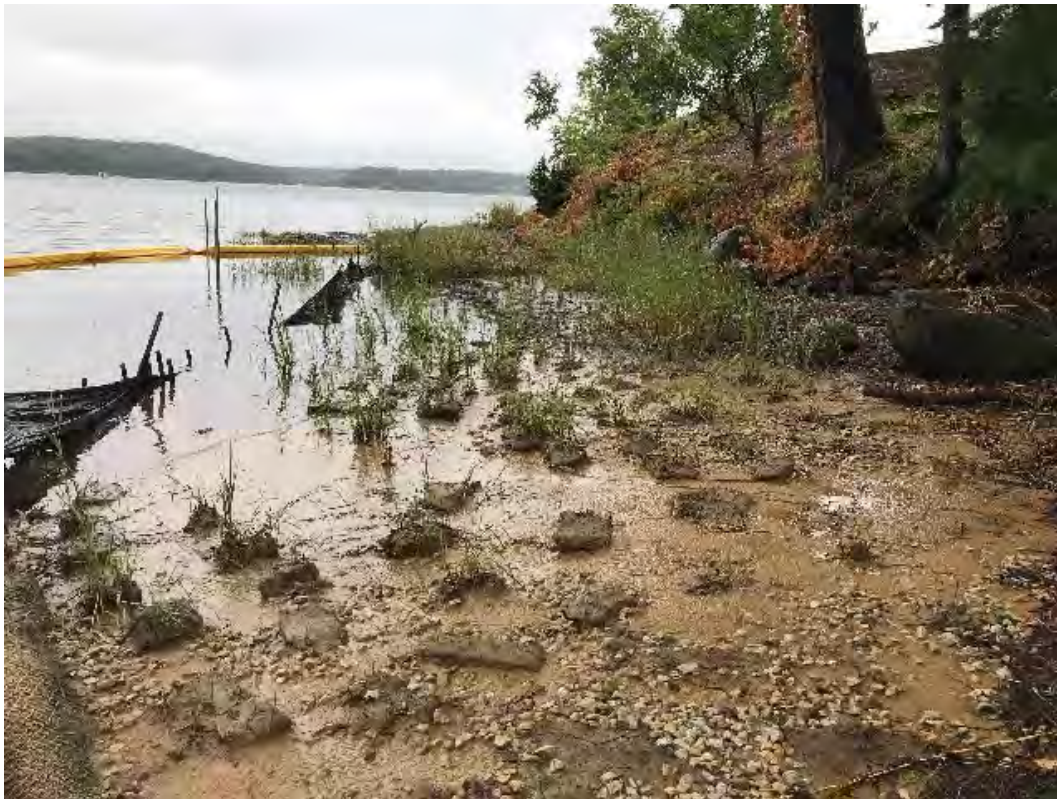
Fig 6: Salt marsh restoration at Gundalow Landing/east side of the bay. Viewing northwest. (08-29-20).

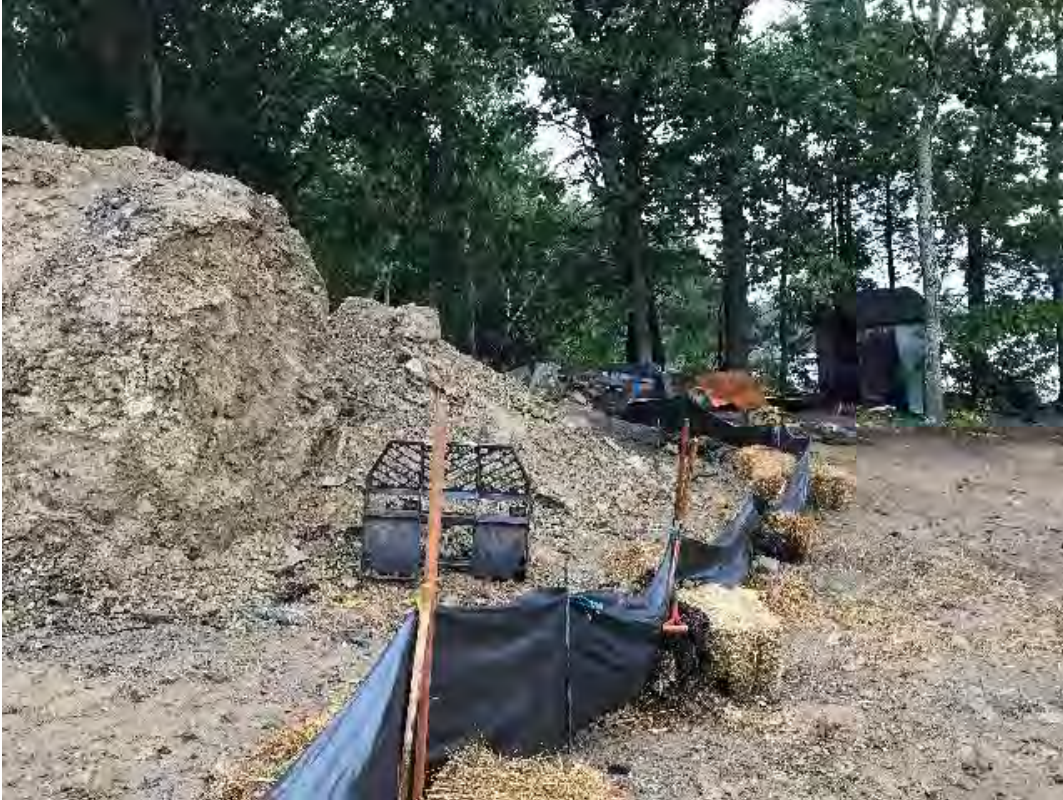
Fig 7: The BMPs stabilizing the soil stockpile at the Eversource property/west side of the bay are functioning. Viewing north. (08-29-20).

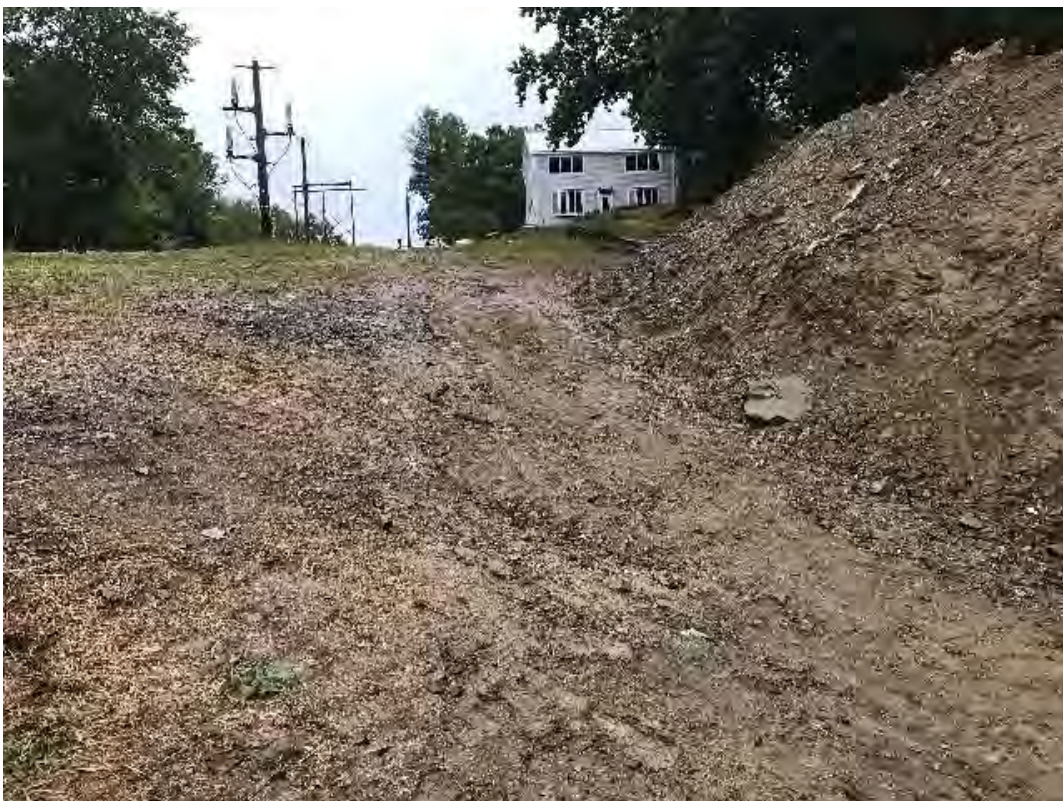
Fig 8: The slope above the new cable house location at the Eversource property/west side of the bay is stable. Viewing west. (08-29-20).

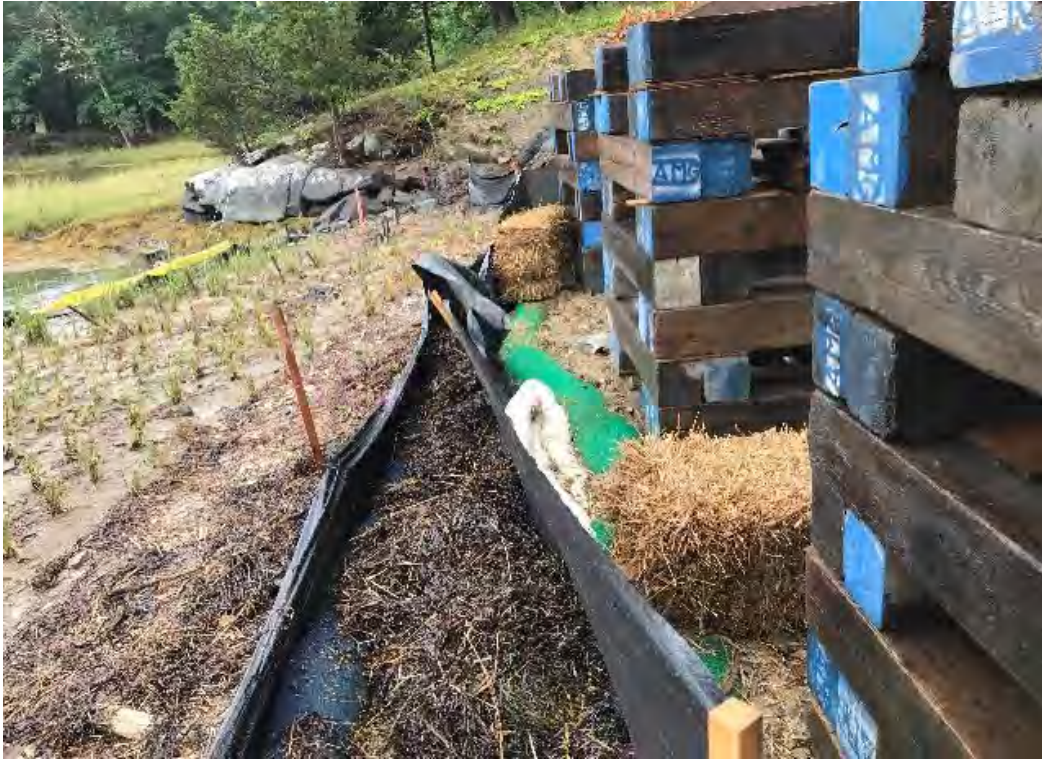
Fig 9: BMPs below the new cable house foundation at the Eversource property/west side of the bay are functioning. Viewing south. (08-29-20).

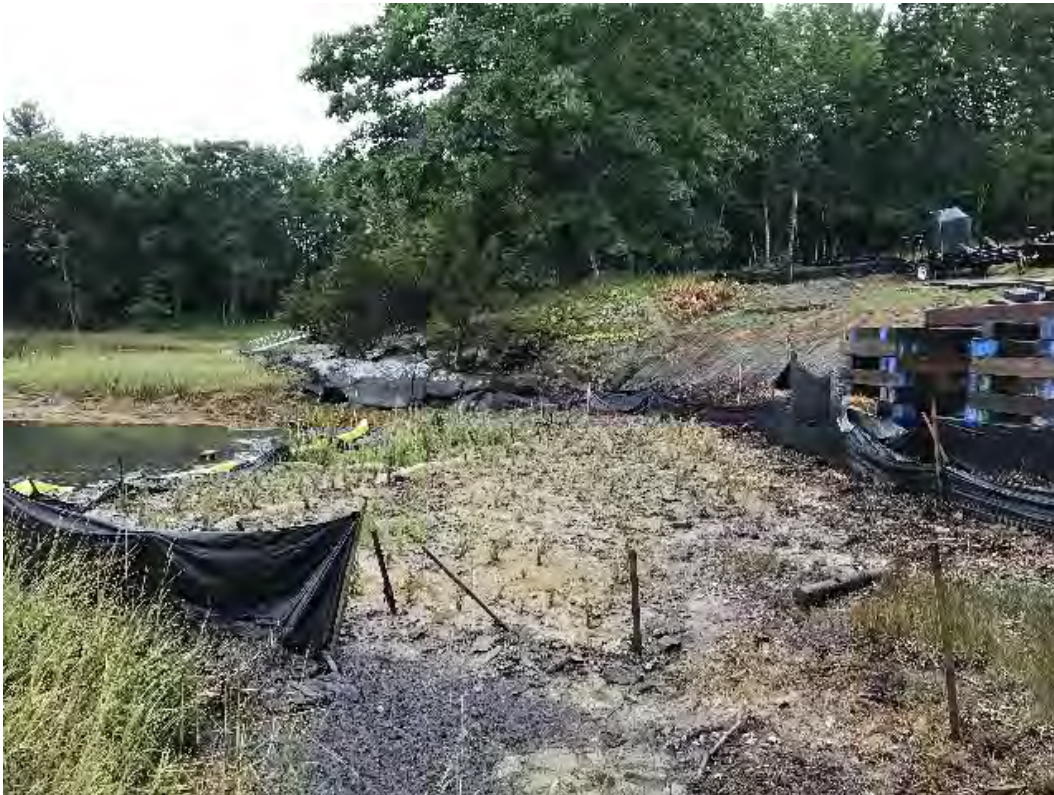
Fig 10: Salt marsh restoration at the Eversource property/west side of the bay. Viewing south. (08-29-20).

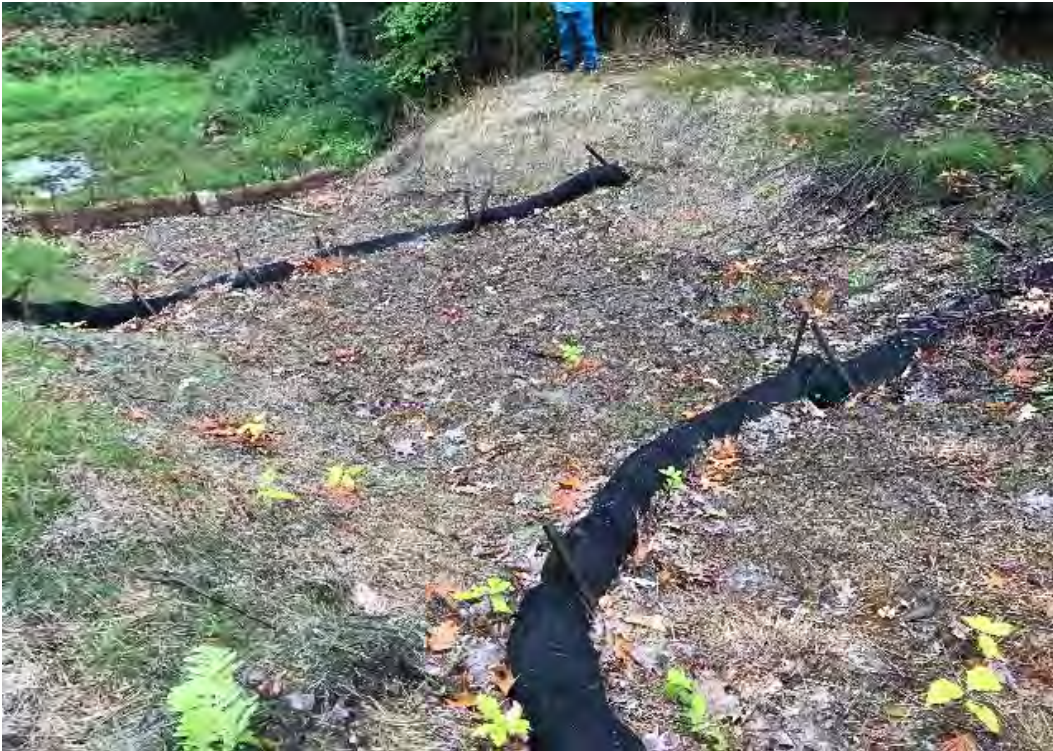
Fig 11: BMPs on the slope between Strs. 29 and 28 are functioning. Viewing north. (08-29-20).

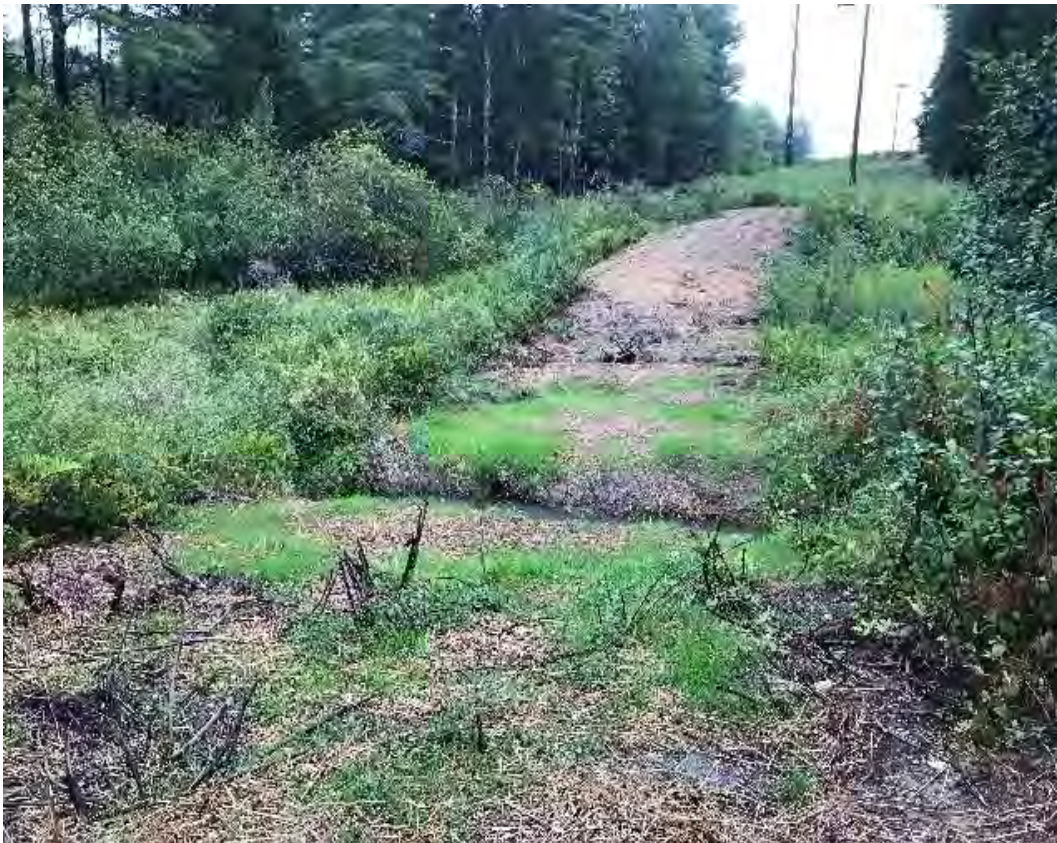
Fig 12: Crossing of stream DS46 is stable and vegetating. Viewing southwest. (08-29-20).
