DRAINAGE MONITORING REPORT

F107 - Seacoast Reliability Project

**Newington, New
Hampshire**

04.0190967.00

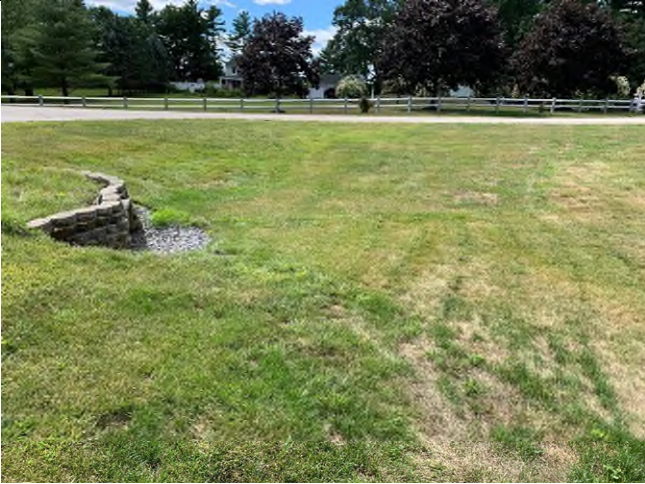
29 Gundalow -1 (Drainage Area)

Status of surface water at the time of inspection? ☒ Dry ☐ Standing ☐ Flowing

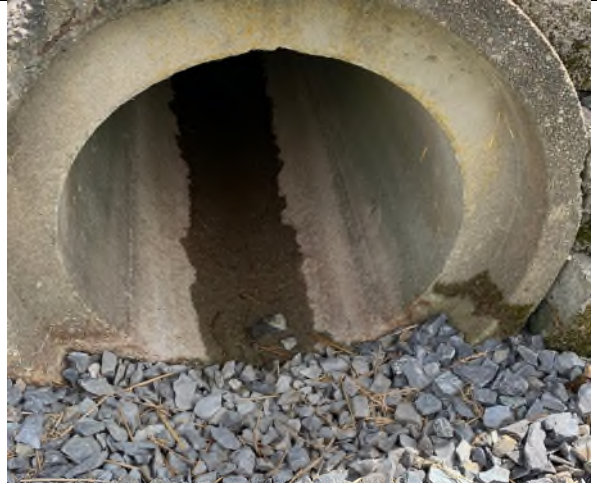
29 Gundalow -2 (Culvert)

Status of surface water at the time of inspection? ☒ Dry ☐ Standing ☐ Flowing

pH: Visible moisture on inside of culvert but no standing water

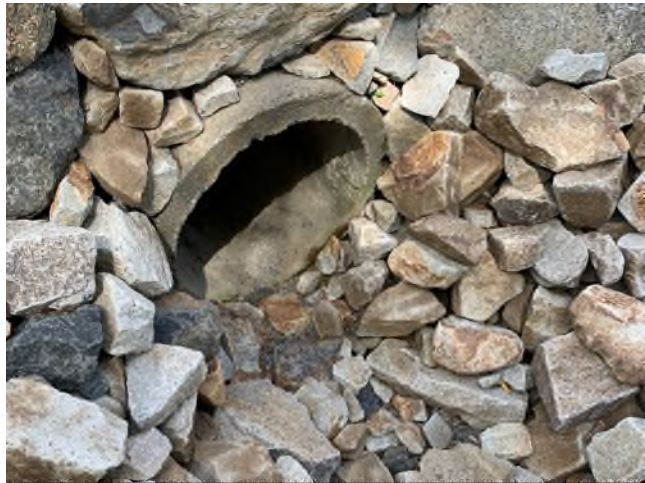
64 Gundalow - 1 (Drainage Course)

Status of surface water at the time of inspection? ☒ Dry ☐ Standing ☐ Flowing

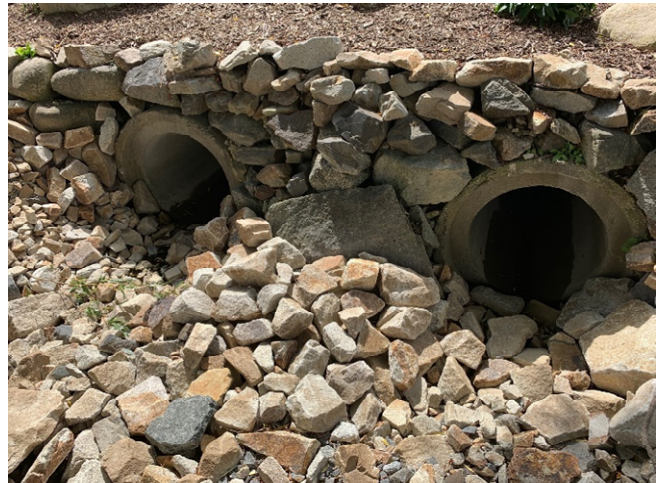
64 Gundalow – 2 (Drainage Course)

Status of surface water at the time of inspection? ☐ Dry ☒ Standing ☐ Flowing

pH: 7.3

Observations/Notes: Small area of standing water adjacent to culvert inlet, approx. 1" deep

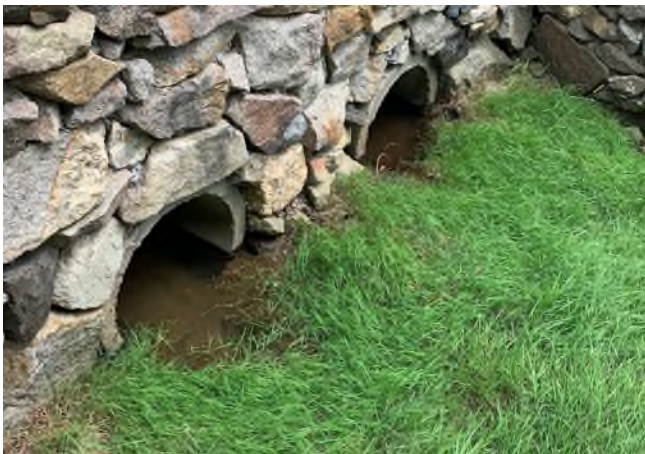
4 Brickyard Circle – 1 (Drainage Course)

Status of surface water at the time of inspection? ☐ Dry ☒ Standing ☐ Flowing

pH: 7.3

Observations/Notes: ~ 8" of standing water extending ~ 12" beyond culvert outlet in grassed raceway

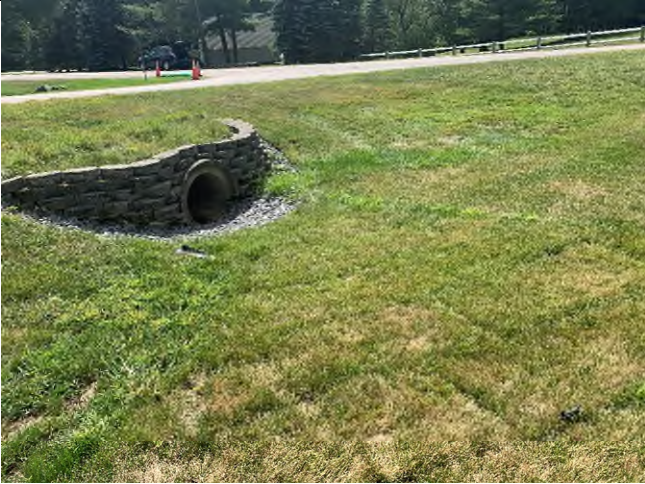
29 Gundalow -1 (Drainage Area)

Status of surface water at the time of inspection? ☒ Dry ☐ Standing ☐ Flowing

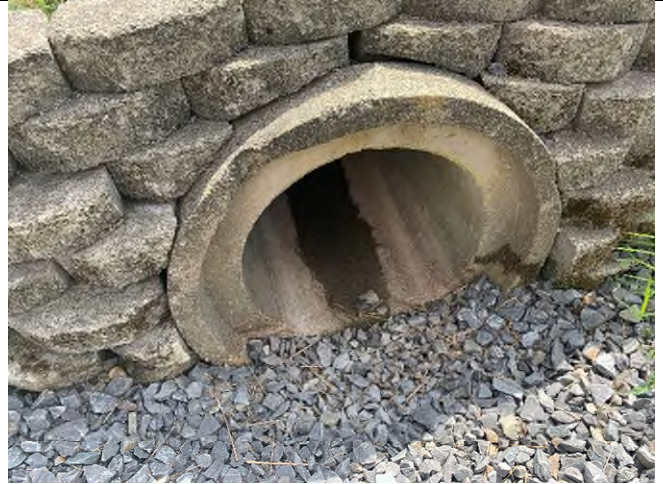
29 Gundalow -2 (Culvert)

Status of surface water at the time of inspection? ☒ Dry ☐ Standing ☐ Flowing

pH: Visible moisture on inside of culvert but no standing water

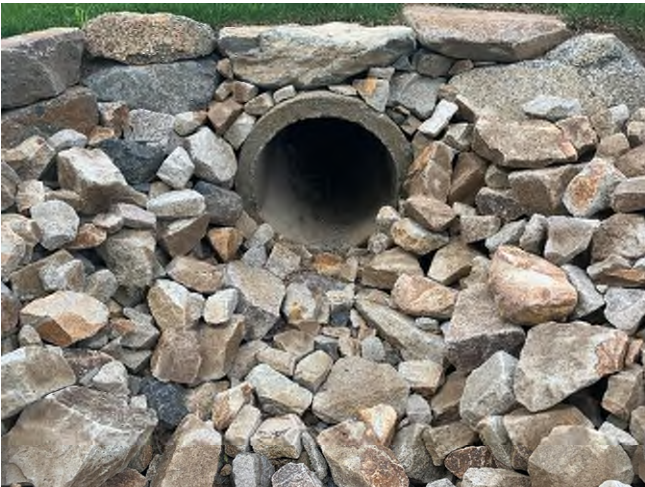
64 Gundalow - 1 (Drainage Course)

Status of surface water at the time of inspection? ☒ Dry ☐ Standing ☐ Flowing

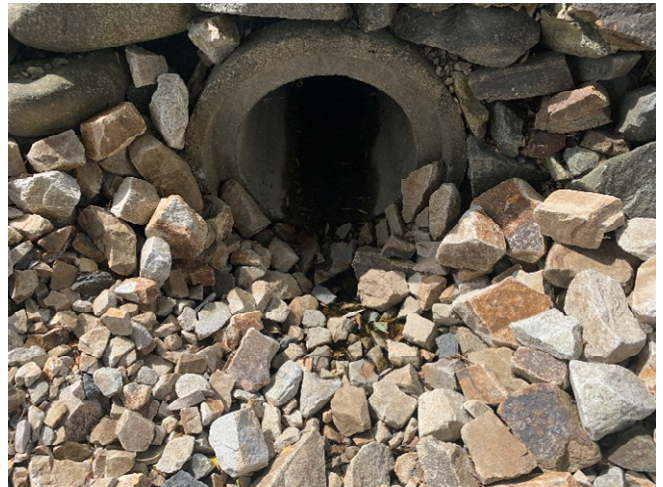
64 Gundalow – 2 (Drainage Course)

Status of surface water at the time of inspection? ☐ Dry ☒ Standing ☐ Flowing

pH: 6.5

Observations/Notes: Small area of standing water adjacent to culvert inlet, approx. 1" deep

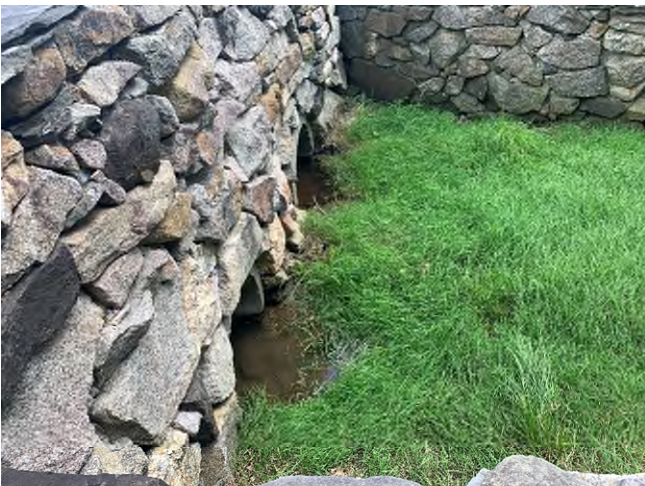
4 Brickyard Circle – 1 (Drainage Course)

Status of surface water at the time of inspection? ☐ Dry ☒ Standing ☐ Flowing

pH: 6.7

Observations/Notes: ~ 8" of standing water extending ~ 12" beyond culvert outlet in grassed raceway

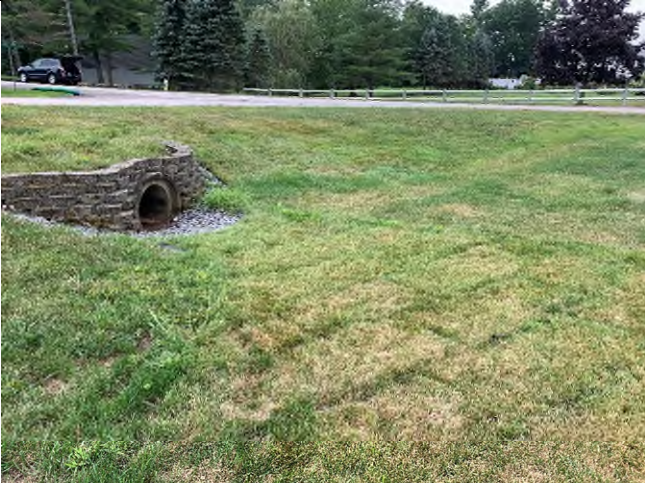
29 Gundalow -1 (Drainage Area)

Status of surface water at the time of inspection? ☒ Dry ☐ Standing ☐ Flowing

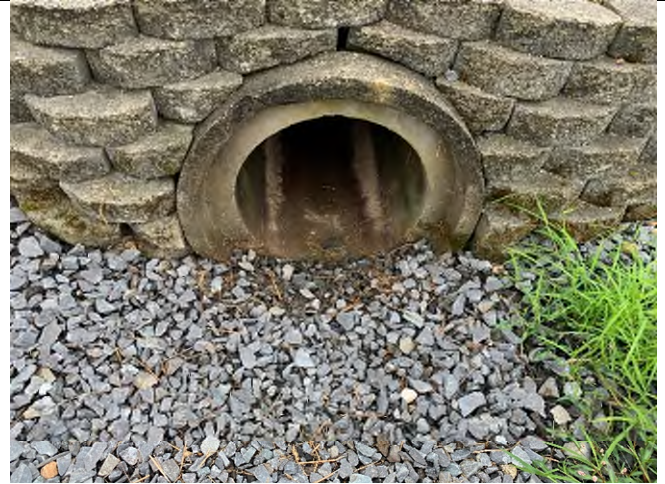
29 Gundalow -2 (Culvert)

Status of surface water at the time of inspection? ☒ Dry ☐ Standing ☐ Flowing

pH: Visible moisture on inside of culvert but no standing water

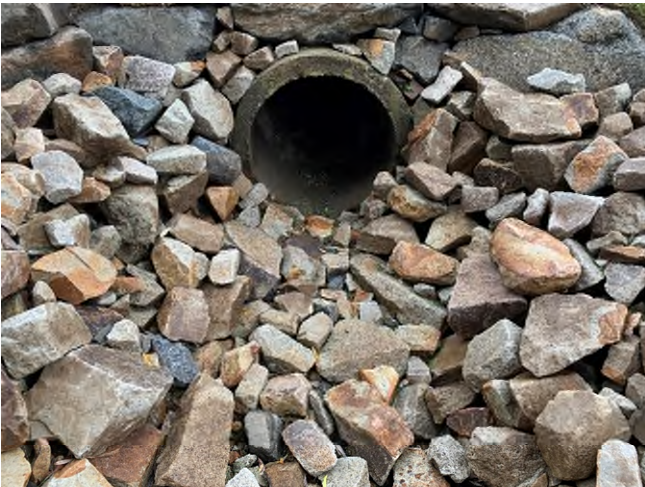
64 Gundalow - 1 (Drainage Course)

Status of surface water at the time of inspection? ☒ Dry ☐ Standing ☐ Flowing

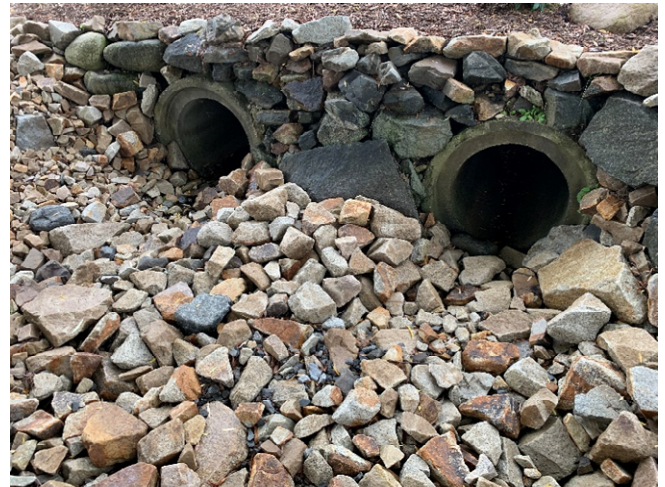
64 Gundalow – 2 (Drainage Course)

Status of surface water at the time of inspection? ☐ Dry ☒ Standing ☐ Flowing

pH: 6.5

Observations/Notes: Small area of standing water adjacent to culvert inlet, approx. 1" deep

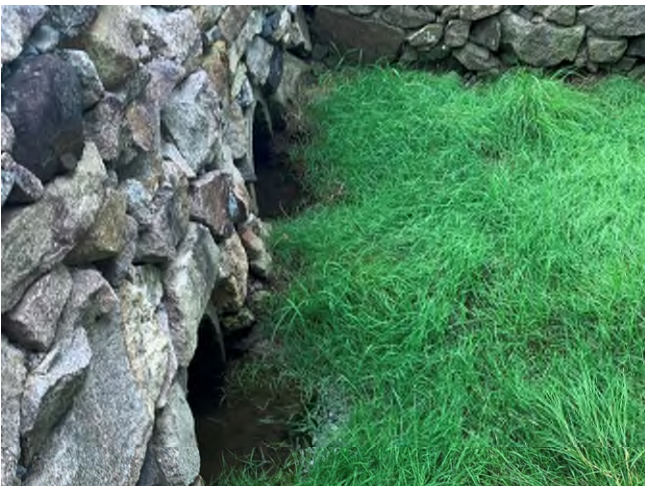
4 Brickyard Circle – 1 (Drainage Course)

Status of surface water at the time of inspection? ☐ Dry ☒ Standing ☐ Flowing

pH: 6.9

Observations/Notes: ~ 8" of standing water extending ~ 12" beyond culvert outlet in grassed raceway
