DRAINAGE MONITORING REPORT

F107 - Seacoast Reliability Project

Newington, New Hampshire

04.0190967.00

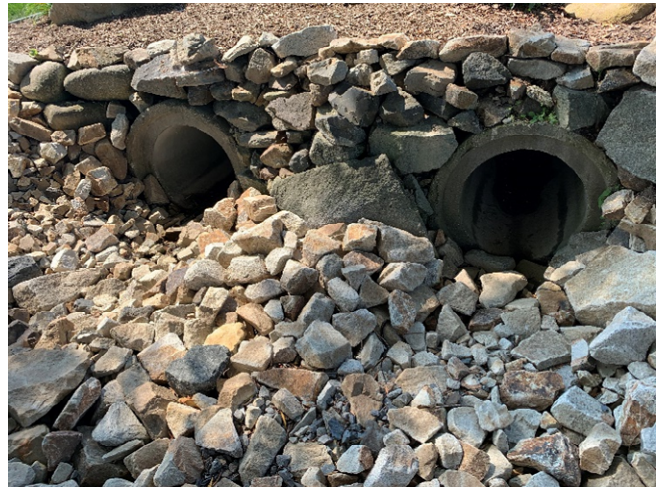
64 Gundalow - 2 (Drainage Course)

pH: 6.7

Observations/Notes: Small area of standing water adjacent to culvert inlet, approx. 1" deep

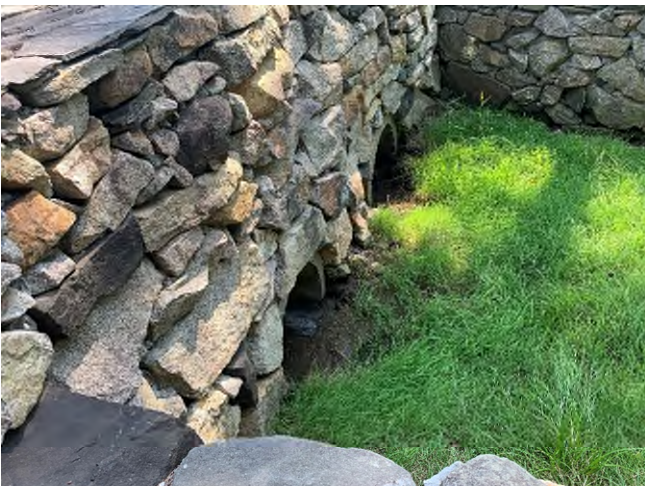
4 Brickyard Circle - 1 (Drainage Course)

Observations/Notes: Recently dried out, there was standing water during 9/3 monitoring event

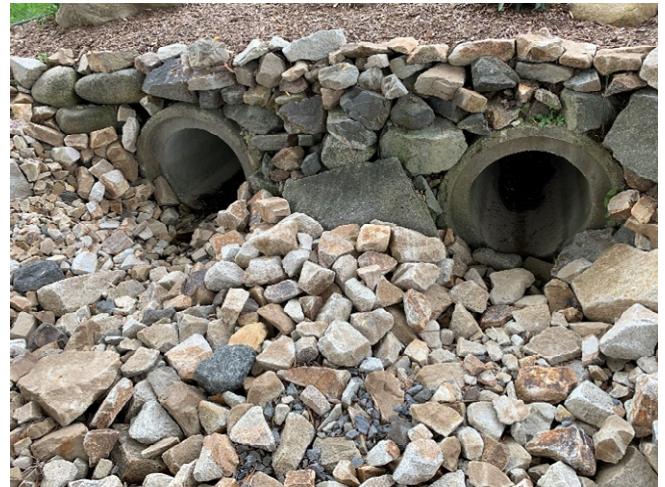
64 Gundalow - 2 (Drainage Course)

pH: **7.0**

Observations/Notes: Small area of standing water adjacent to culvert inlet, approx. 1" deep

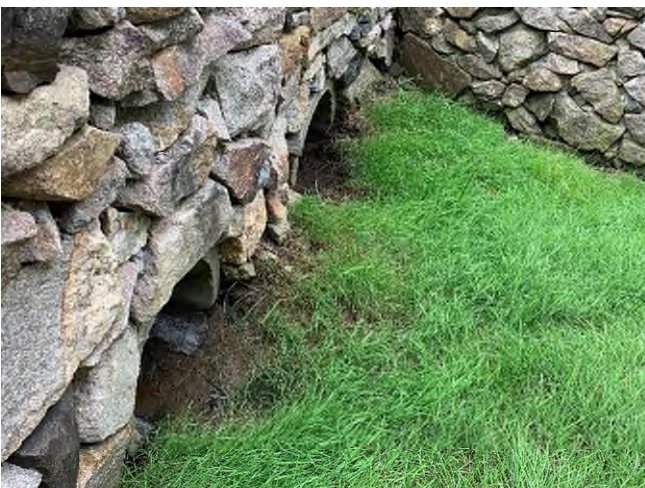
4 Brickyard Circle - 1 (Drainage Course)

Observations/Notes: Recently dried out, there was standing water during 9/3 monitoring event

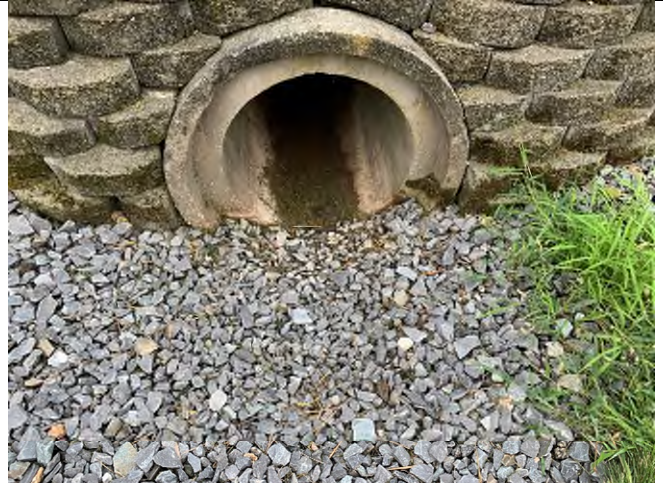
29 Gundalow -2 (Culvert)

pH: Visible moisture on inside of culvert but no standing water

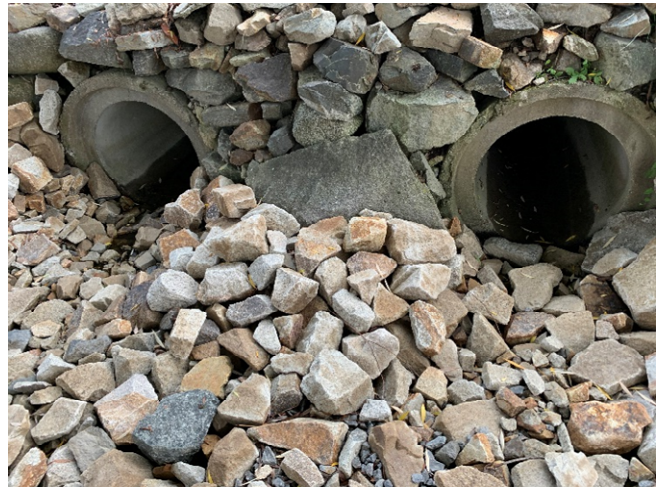
64 Gundalow - 2 (Drainage Course)

pH: 6.3

Observations/Notes: Small area of standing water adjacent to culvert inlet, approx. 1" deep

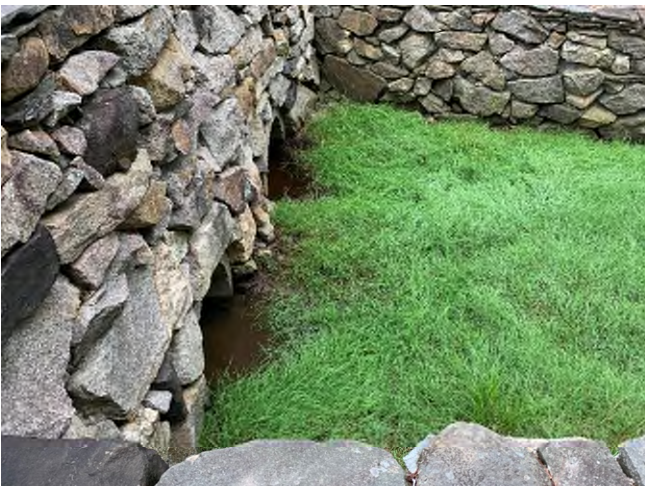
4 Brickyard Circle - 1 (Drainage Course)

pH: 6.7

Observations/Notes: ~ 6" of standing water extending ~ 10" beyond culvert outlet in grassed raceway
