DRAINAGE MONITORING REPORT

F107 - Seacoast Reliability Project

Newington, New Hampshire

04.0190967.00

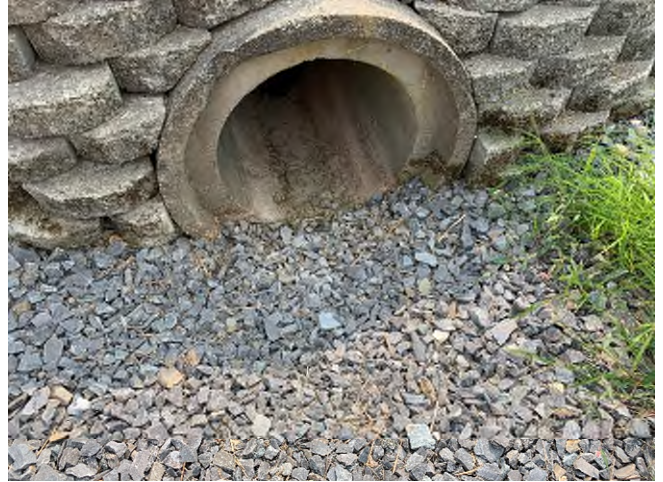
29 Gundalow - 2 (Culvert)

pH: Visible moisture on inside of culvert but no standing water

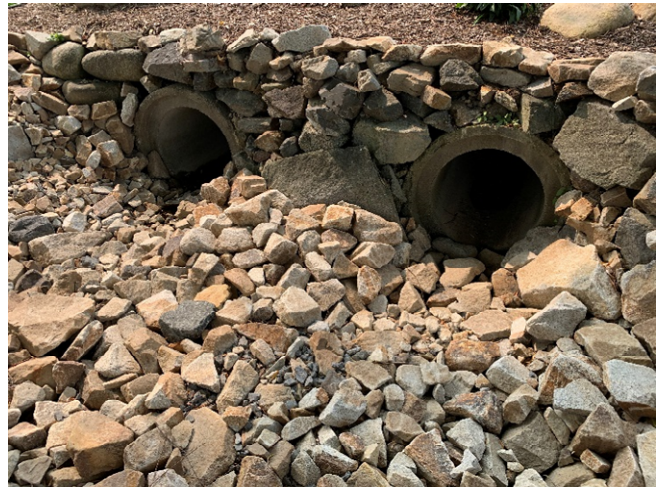
64 Gundalow - 2 (Drainage Course)

pH: 6.5

Observations/Notes: Small area of standing water adjacent to culvert inlet, approx. 1" deep

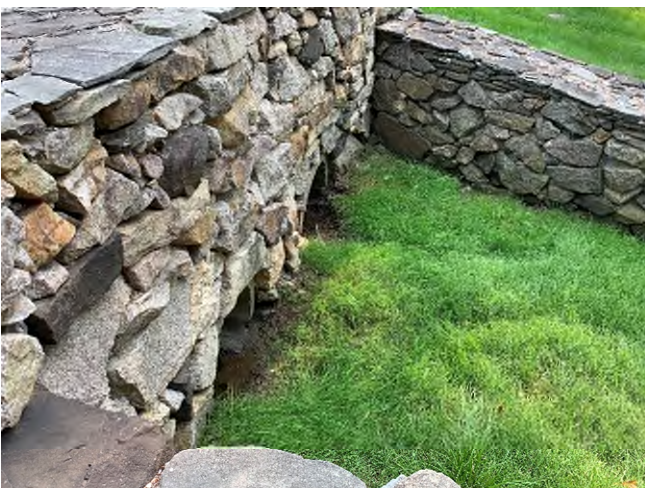
4 Brickyard Circle - 1 (Drainage Course)

Observations/Notes: Moisture at culvert outlet but no standing water

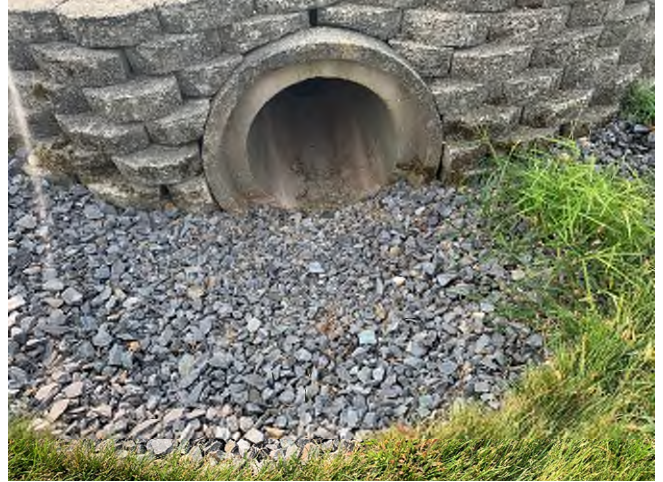
29 Gundalow - 2 (Culvert)

pH: Visible moisture on inside of culvert but no standing water

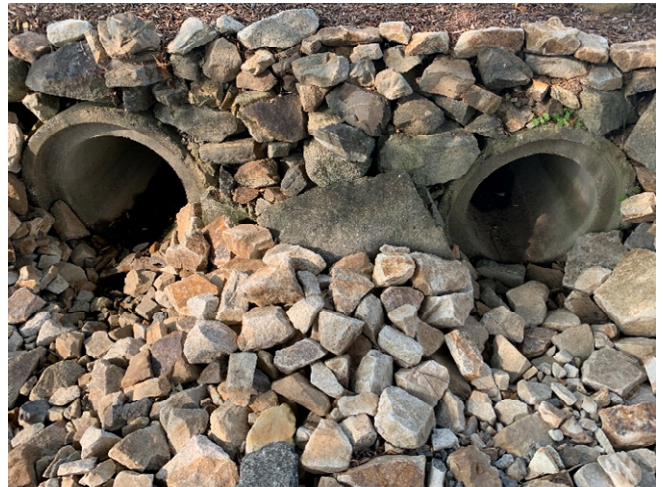
64 Gundalow - 2 (Drainage Course)

pH: 6.7

Observations/Notes: Small area of standing water adjacent to culvert inlet, approx. 1" deep

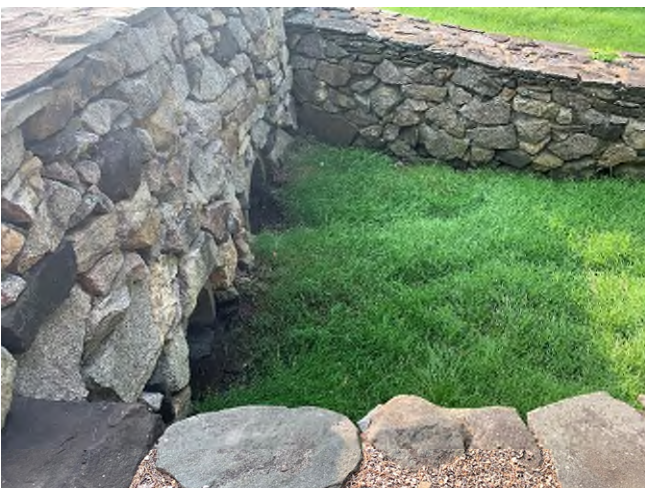
4 Brickyard Circle - 1 (Drainage Course)

Observations/Notes: Moisture at culvert outlet but no standing water
