DRAINAGE MONITORING REPORT

F107 - Seacoast Reliability Project

Newington, New Hampshire

04.0190967.00

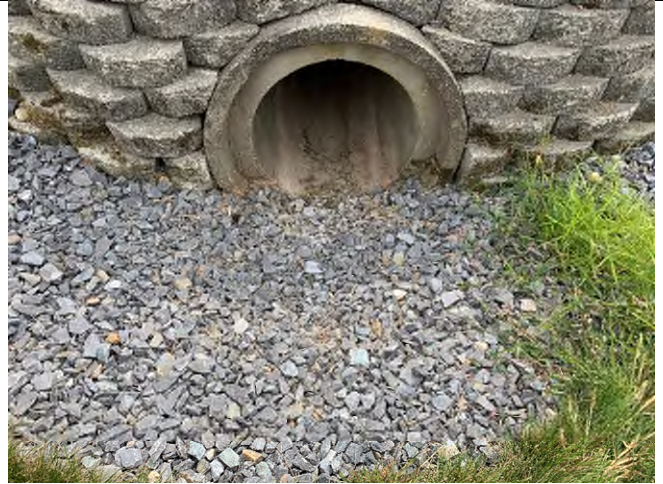
29 Gundalow -2 (Culvert)

pH: Visible moisture on inside of culvert but no standing water

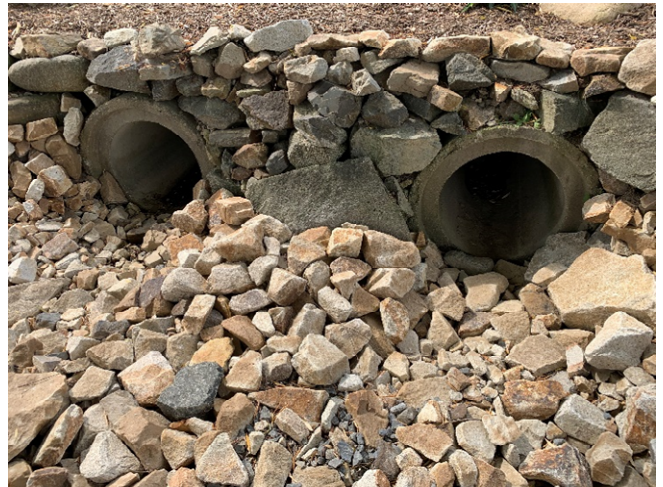
64 Gundalow - 2 (Drainage Course)

Observations/Notes: Very small, shallow pocket of water remaining but not sufficient to achieve pH reading

- 64 Gundalow – 2 location was dry for the first time since the June 29, 2020 monitoring event. This is the first time that all Newington monitoring locations have been dry since monitoring began on June 5, 2020.

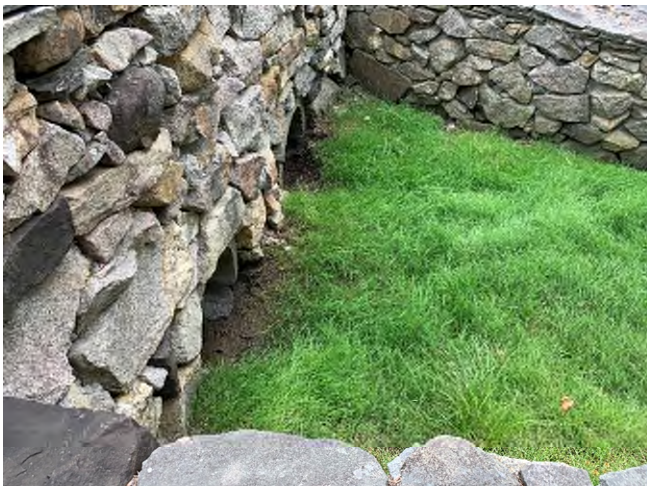
4 Brickyard Circle - 1 (Drainage Course)

Observations/Notes: Moisture at culvert outlet but no standing water
