CONSTRUCTION MONITORING REPORT

Eversource Transmission Lines:
F107

**Madbury, Durham,
Newington, Portsmouth, NH**

TYPE OF INSPECTION: Weekly Storm Event Incident Corrective Action

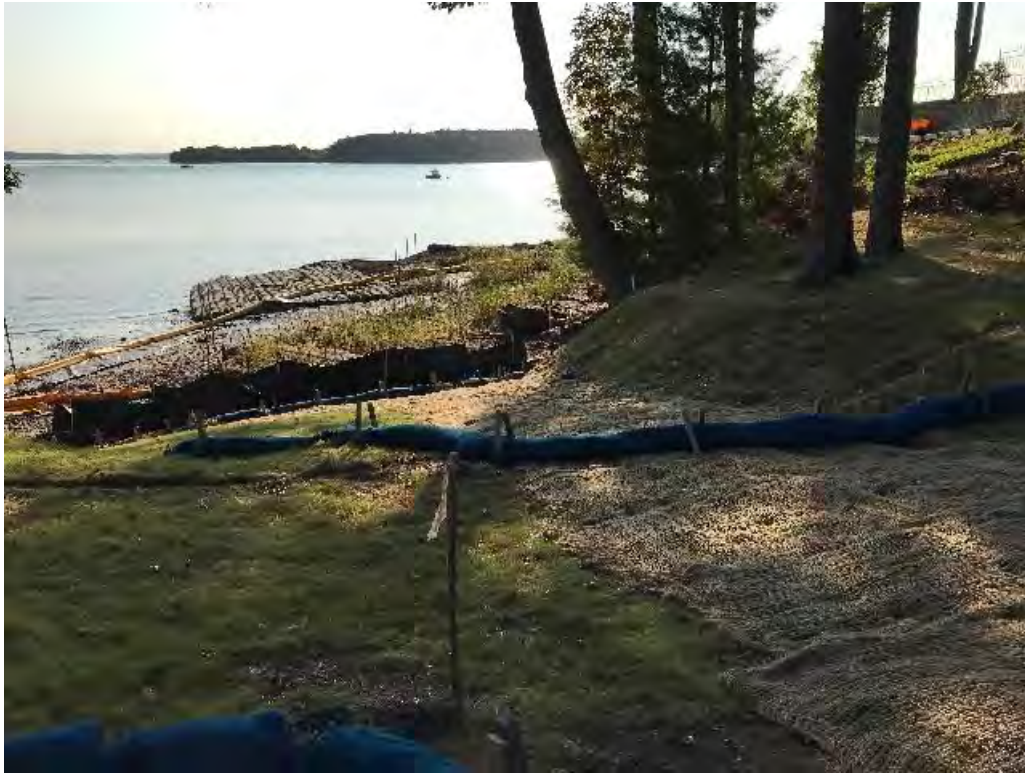
Fig 1: Jute matting securing sod on slope below manhole at Gundalow Landing/east side of the bay. Viewing west. (09-25-20)

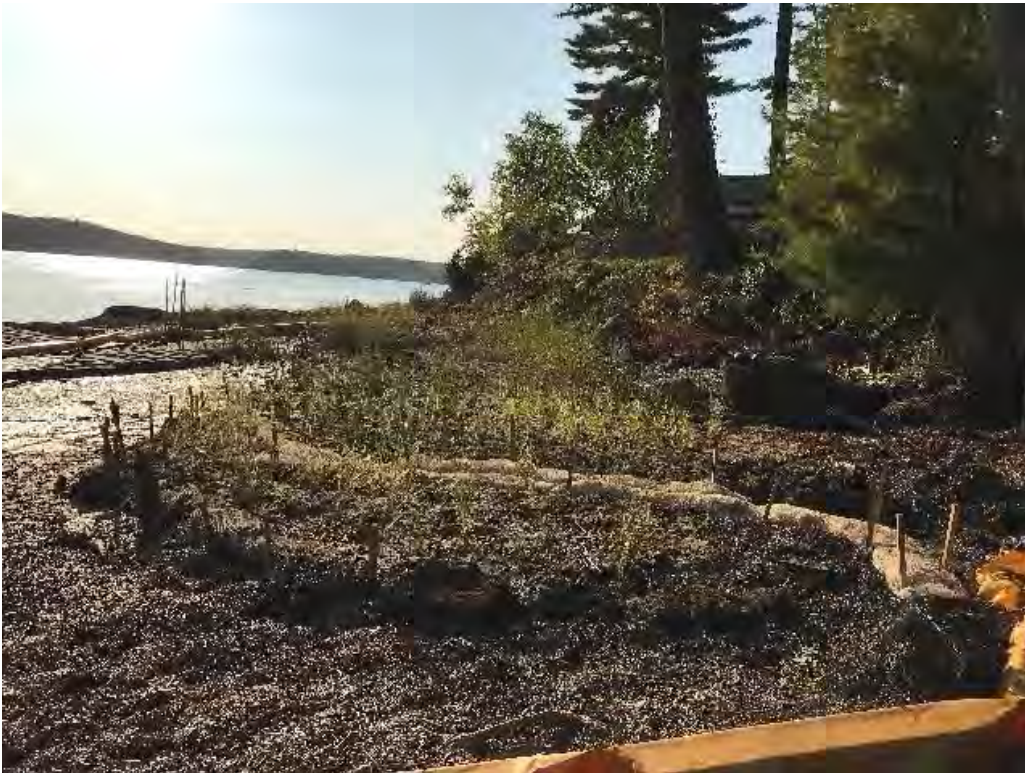
Fig 2: Restructuring of salt marsh restoration at Gundalow Landing/east side of the bay. Viewing northwest. (09-25-20)

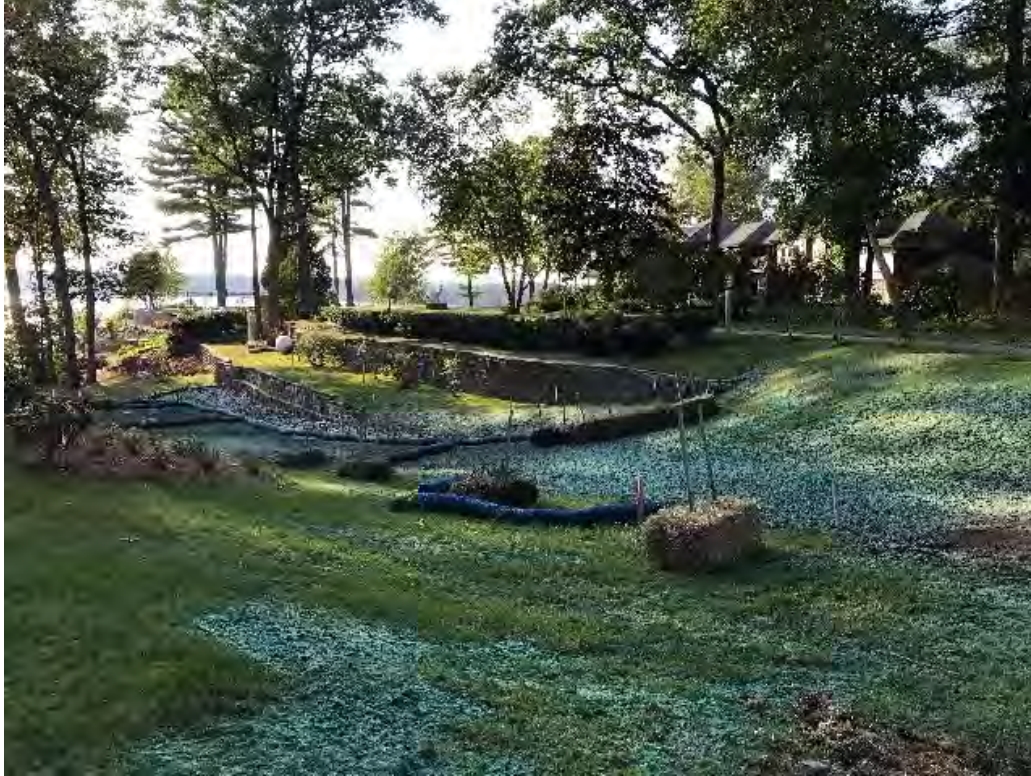
Fig 3: Hydroseeding the slope above the manhole at Gundalow Landing/east side of the bay. Viewing west. (09-25-20)

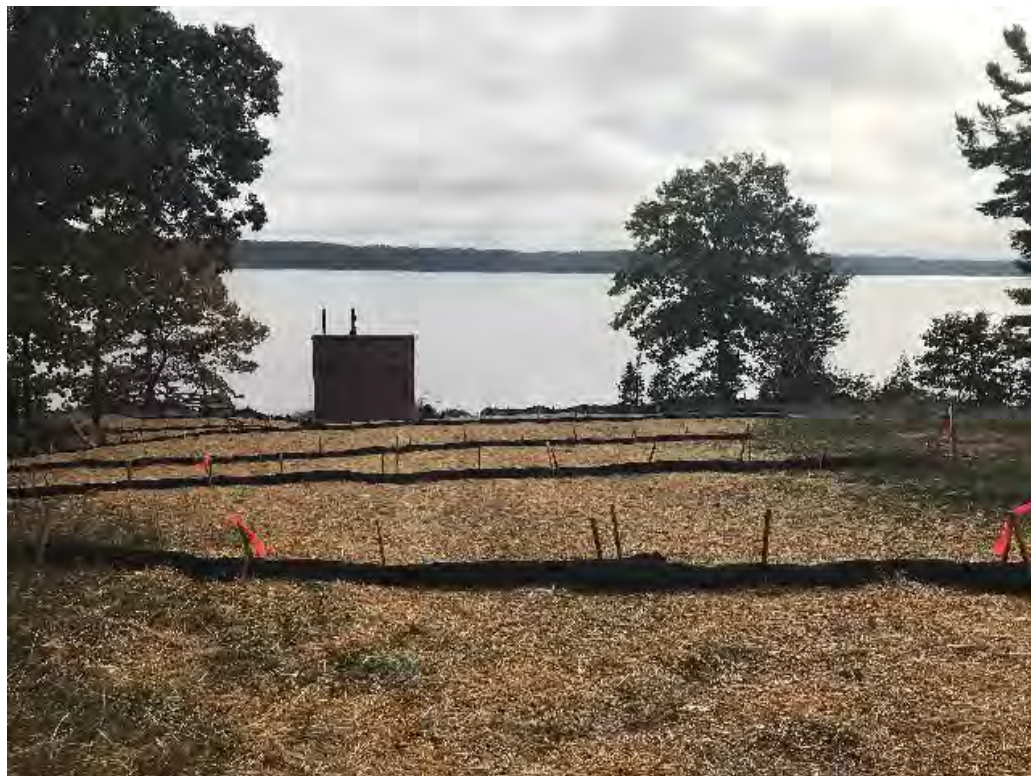
- *Portsmouth*
 - *None - construction and restoration complete. Post-construction inspections are continuing.*
- *Madbury*
 - *None - construction and restoration complete. Post-construction inspections are continuing.*
- *Newington*
 - *Rye Beach Landscaping completed final grading and seeding at Gundalow Landing.*
 - *Northeast Wetland Restoration panted the remaining seedlings and added coir logs to the swale in the salt marsh. See Figure 2.*
 - *Post-construction inspections elsewhere in the right-of-way are continuing.*
- *Durham.*
 - *Graton completed the cable house relocation and has demobilized.*
 - *JCR installed temporary erosion BMP's on the cable house work site. See Figure 4.*
 - *Post-construction inspections elsewhere in the right-of-way are continuing.*

Fig 4: Straw and silt socks installed on the slope at the Eversource property/west side of the bay. Viewing east. (09-28-20)

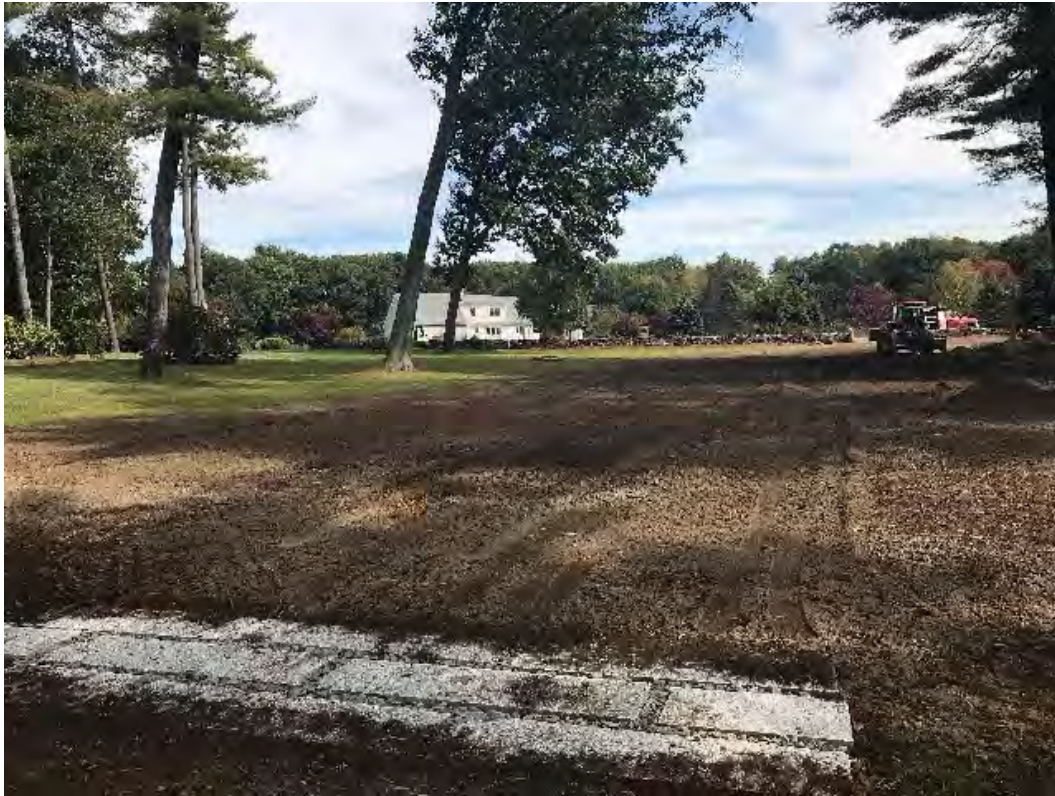
Fig 5: Spreading loam on the lawn above the slope at Gundalow Landing/east side of the bay. Viewing northeast. (09-28-20)

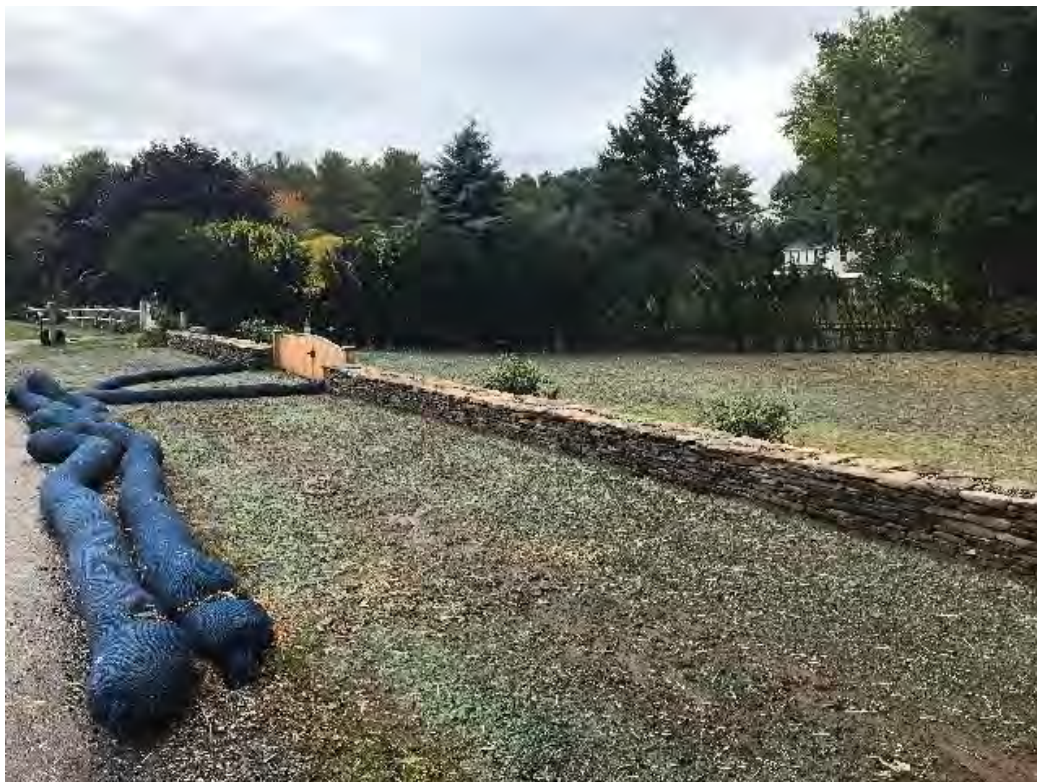
Fig 6: Loam and hydroseed spread on the lawn at Gundalow Lading/east side of the bay. Viewing southeast. (09-30-20)

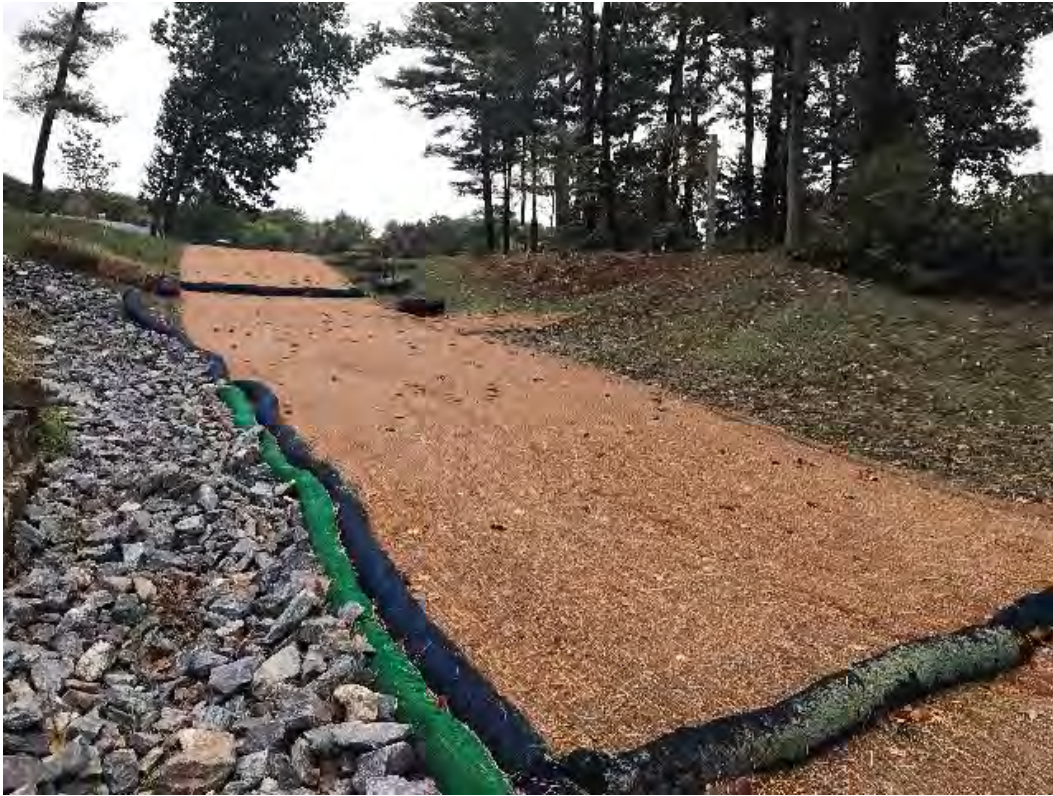
Fig 7: Jute matting securing the slope above the manhole at Gundalow Landing/east side of the bay. Viewing east. (09-30-20)

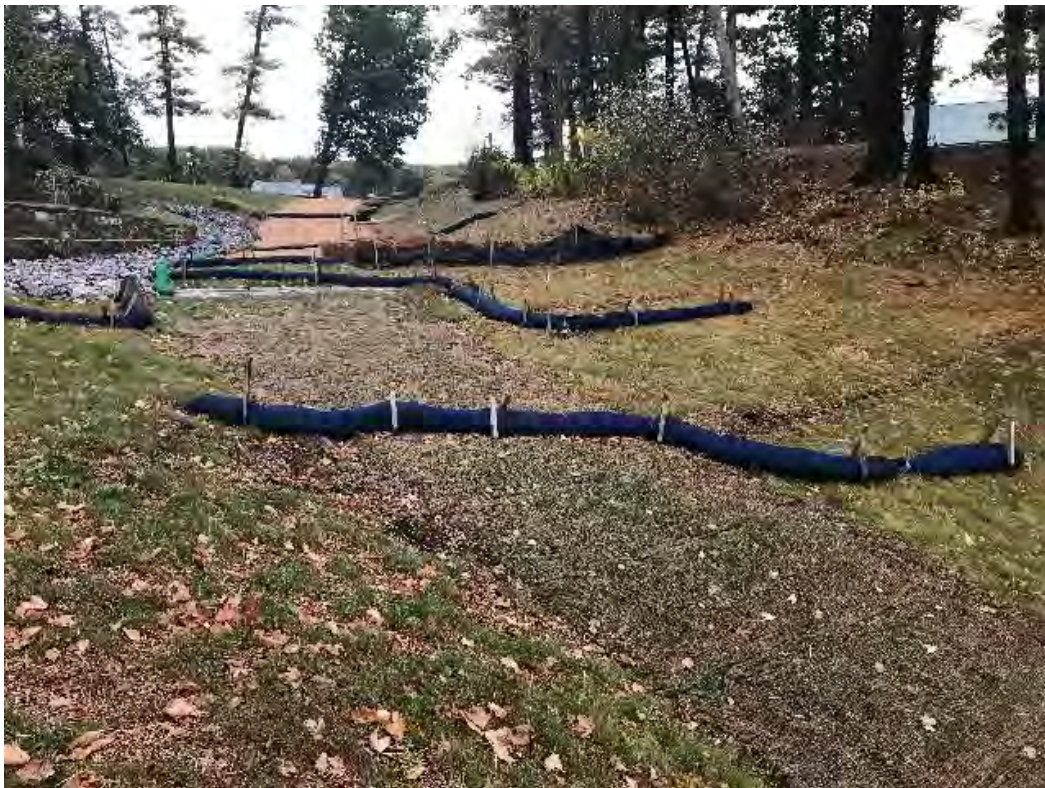
Fig 8: Slope below the manhole at Gundalow Landing/east side of the bay. Viewing east. (09-30-20)

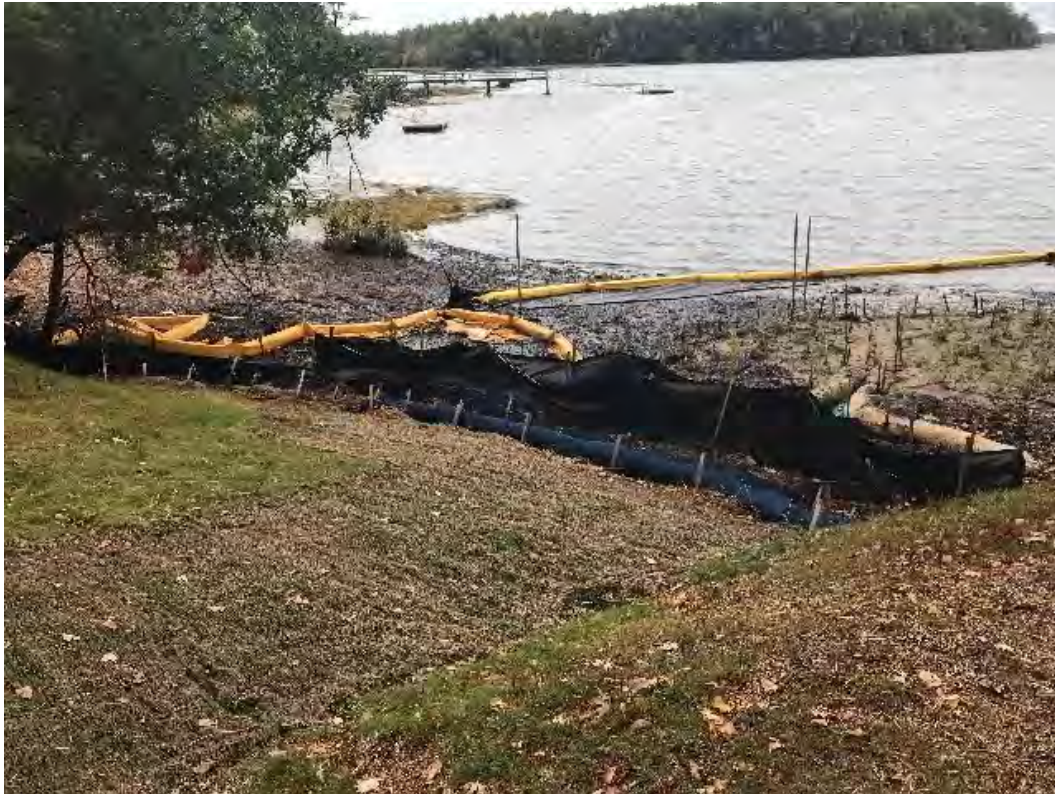
Fig 9: Toe of the slope below the manhole at Gundalow Landing/east side of the bay. Viewing south. (09-30-20)

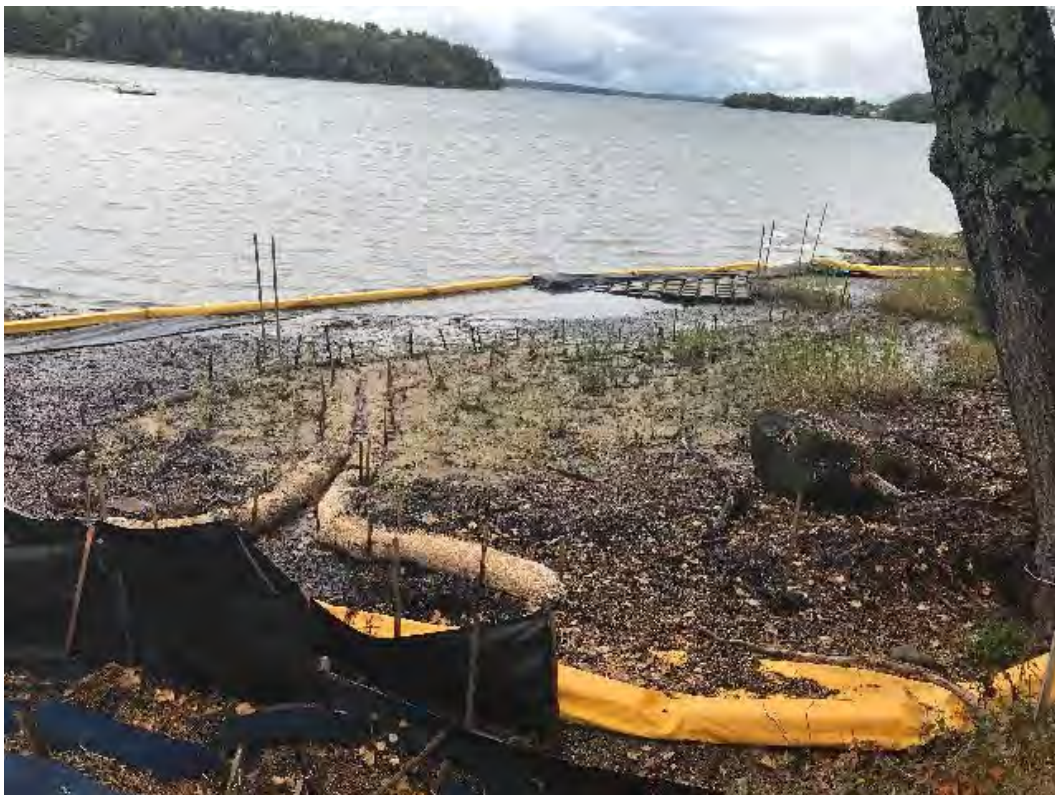
Fig 10: Salt marsh restoration at Gundalow Landing/east side of the bay. Viewing southwest. (09-30-20)

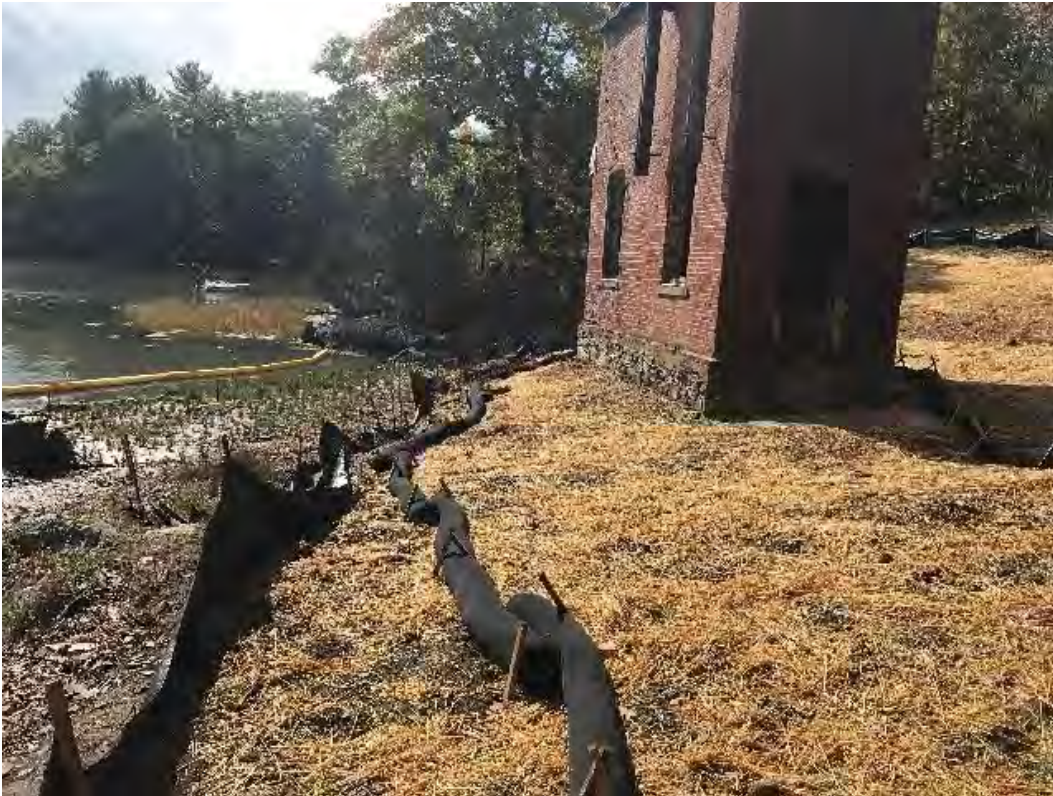
Fig 11: Toe of the slope at the Eversource property/west side of the bay. Viewing south. (09-30-20)

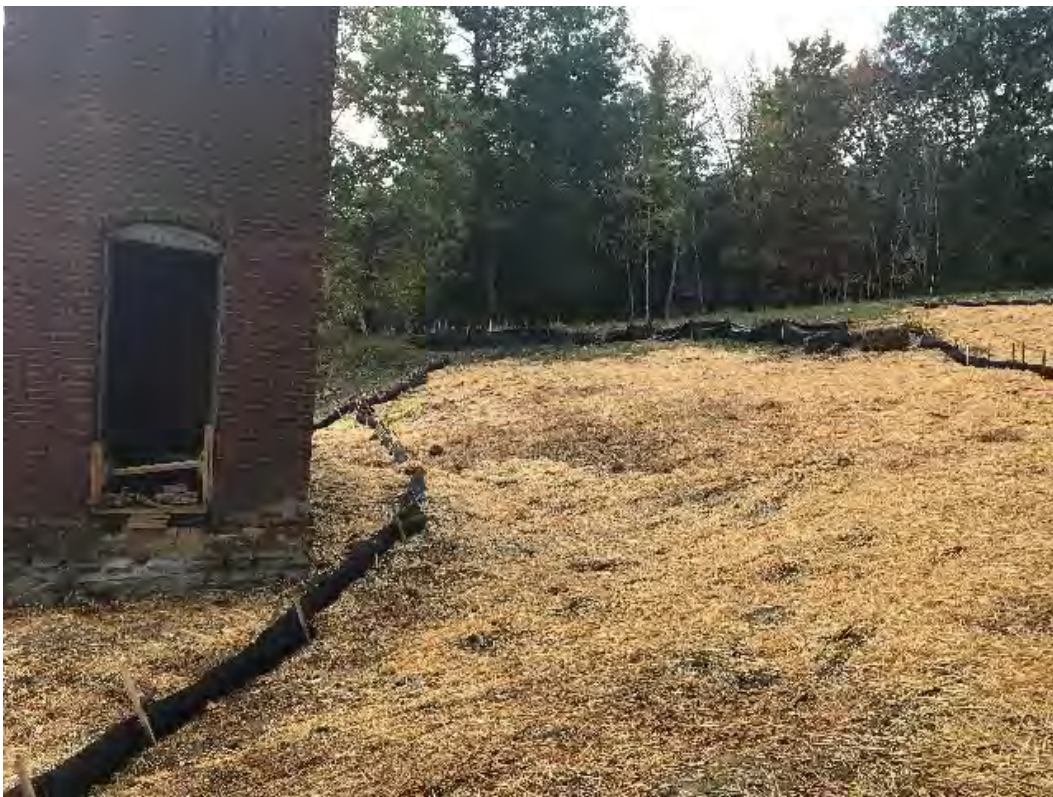
Fig 12: Swale upslope of the cable house at the Eversource property/west side of the bay. Viewing southwest. (09-30-20)

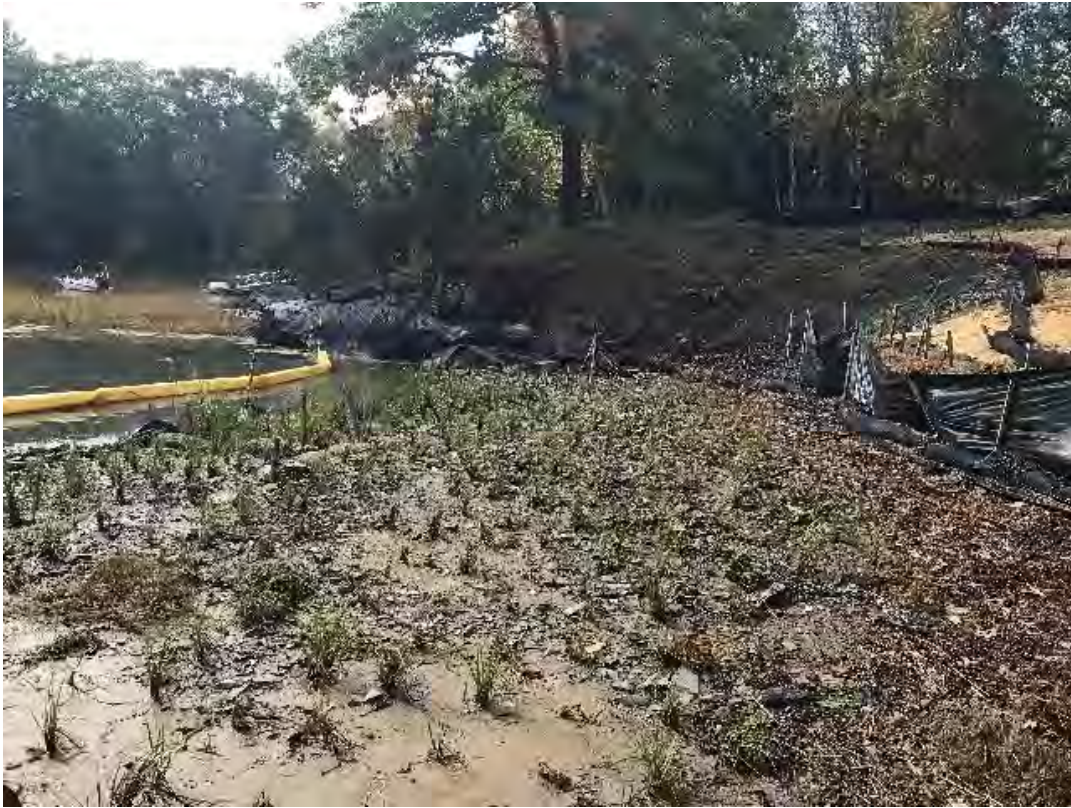
Fig 13: Salt marsh restoration at the Eversource property/west side of the bay. Viewing south. (09-30-20)

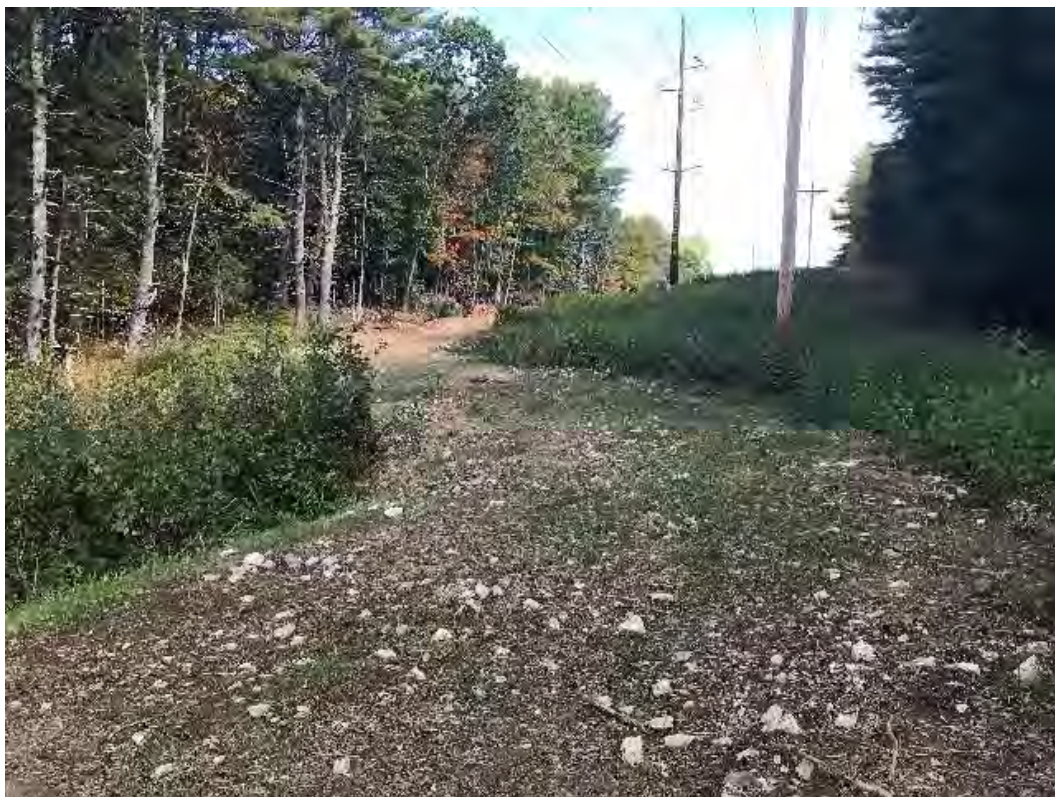
Fig 14: Slope northeast of DS46 between Strs. 51 and 52 is revegetating. Viewing north. (09-30-20)

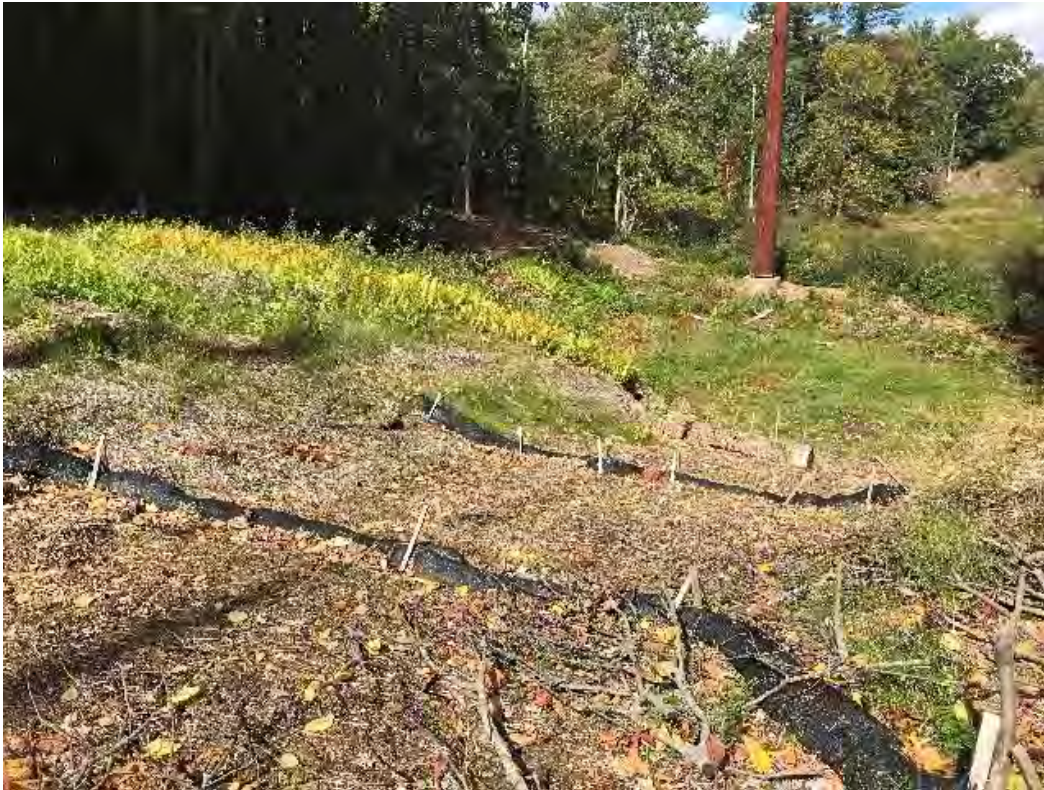
Fig 15: Swale between Strs. 28 and 29 is revegetating. Viewing northwest. (09-30-20)
