# DRAINAGE MONITORING REPORT

## F107 - Seacoast Reliability Project

### Newington, New Hampshire

04.0190967.00

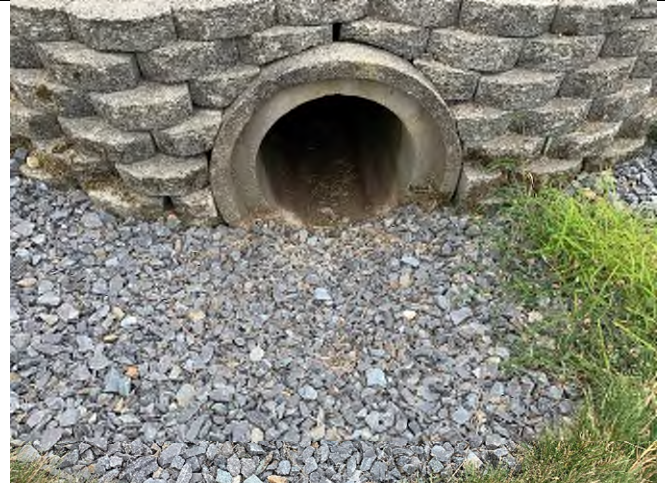
29 Gundalow - 2 (Culvert)

pH: Visible moisture on inside of culvert but no standing water

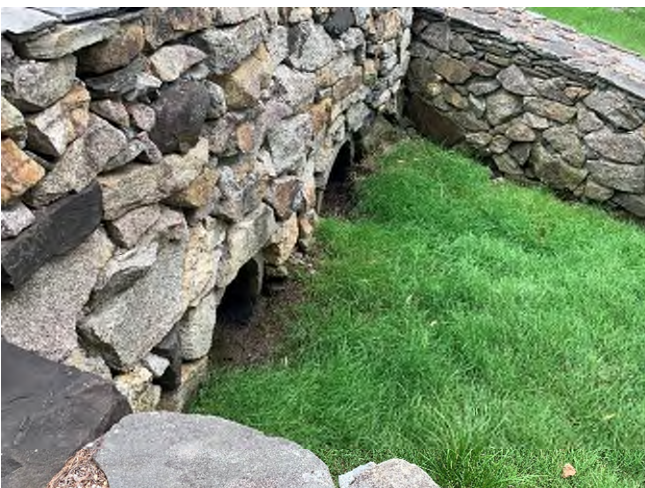
4 Brickyard Circle - 1 (Drainage Course)

Observations/Notes: Moisture at culvert outlet but no standing water

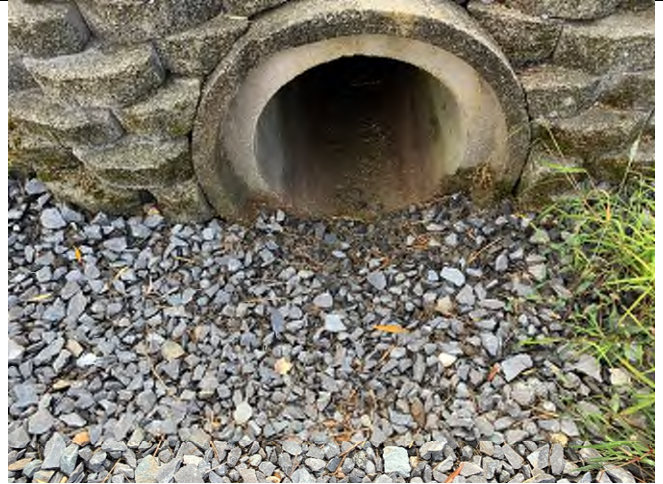
29 Gundalow - 2 (Culvert)

pH: Visible moisture on inside of culvert but no standing water

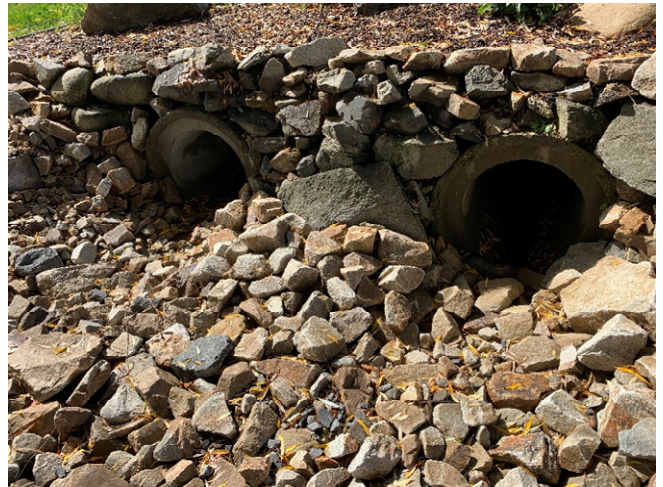
64 Gundalow - 2 (Drainage Course)

pH: 6.5

Observations/Notes: Small area of standing water near culvert inlet, approx. 3.5" deep

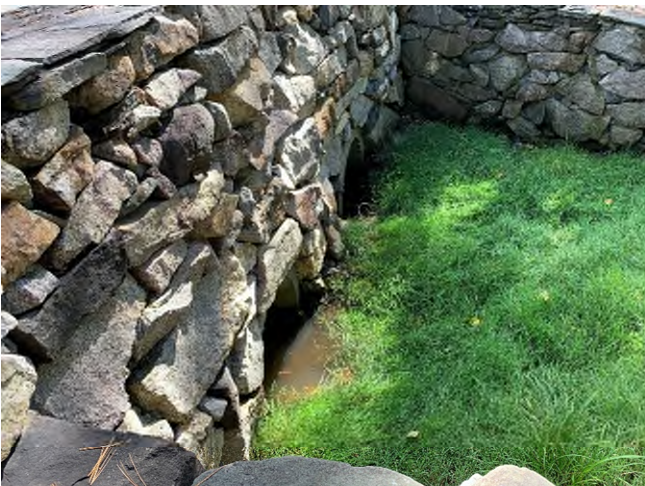
4 Brickyard Circle - 1 (Drainage Course)

pH: 6.6

Observations/Notes: Standing water extending approx. 12" beyond culvert outlet, approx. 8" deep

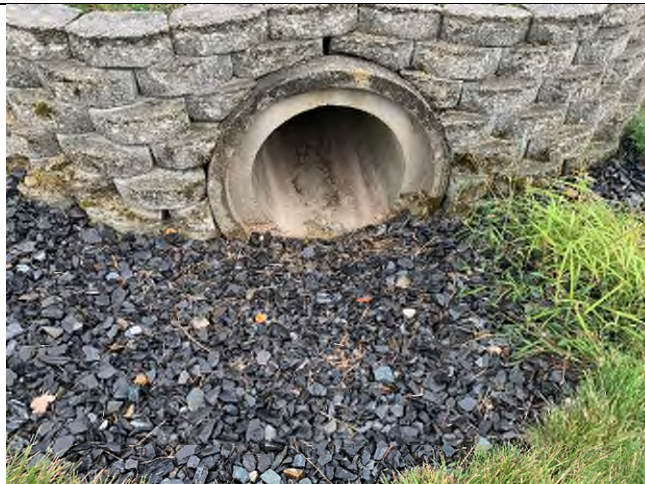
29 Gundalow - 2 (Culvert)

pH: Visible moisture on inside of culvert but no standing water

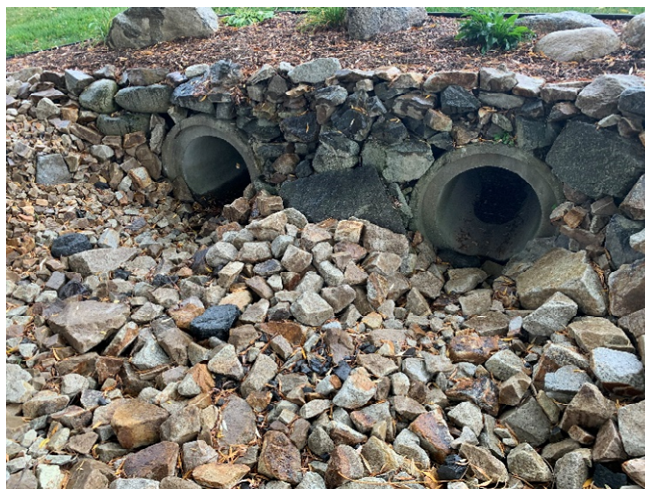
64 Gundalow - 2 (Drainage Course)

pH: 6.7

Observations/Notes: Small area of standing water near culvert inlet, approx. 3.5" deep

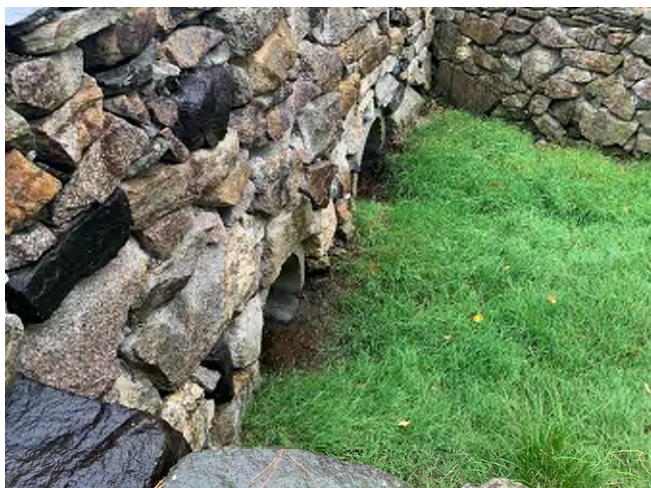
4 Brickyard Circle - 1 (Drainage Course)

Observations/Notes: Moisture at culvert outlet but no standing water
