CONSTRUCTION MONITORING REPORT

Eversource Transmission Lines:
F107

**Madbury, Durham,
Newington, Portsmouth, NH**

NAI Project No:
23840.39

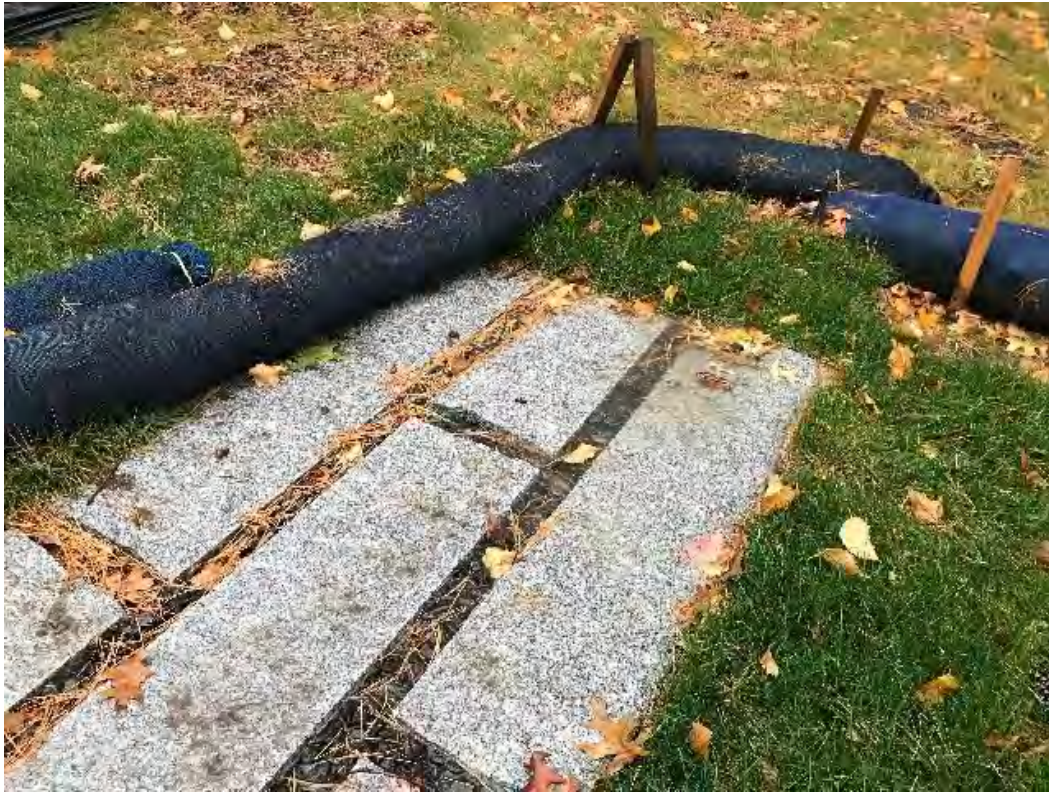
Fig 1: The level spreader below the manhole at Gundalow Landing/east side of the bay. Viewing southwest. (10-13-20)

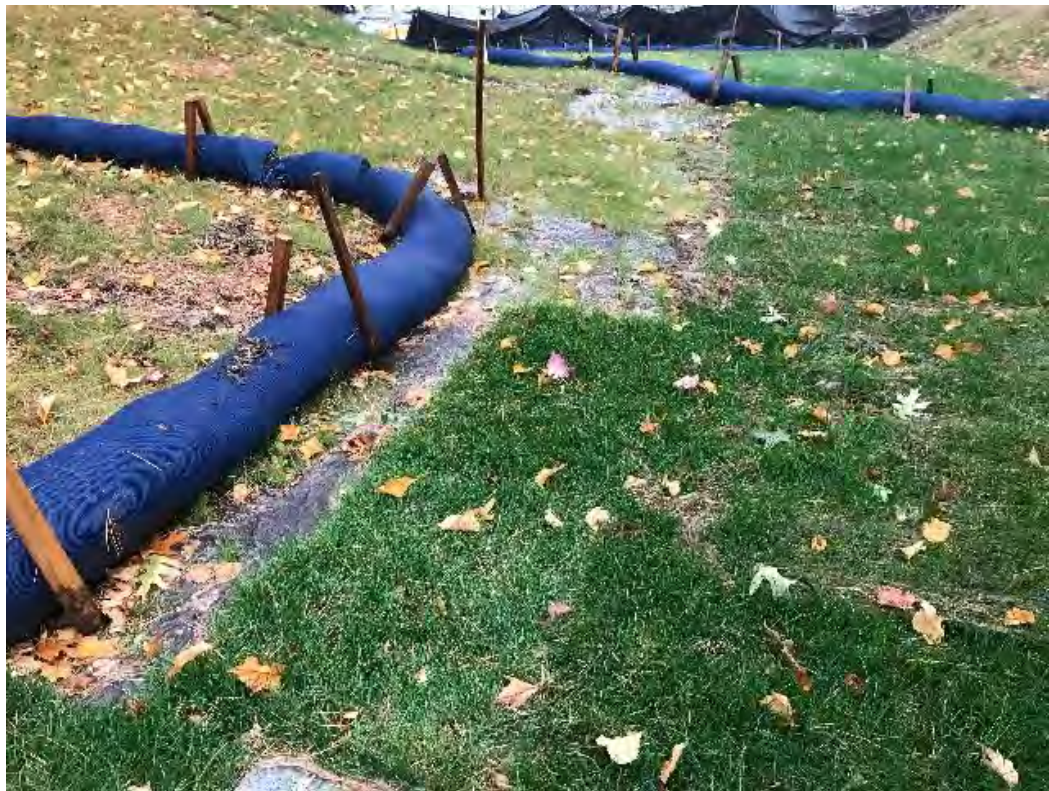
Fig 2: Initial positioning of silt sock along the southeastern side of the slope below the manhole at Gundalow Landing. Viewing southwest. (10-13-20)

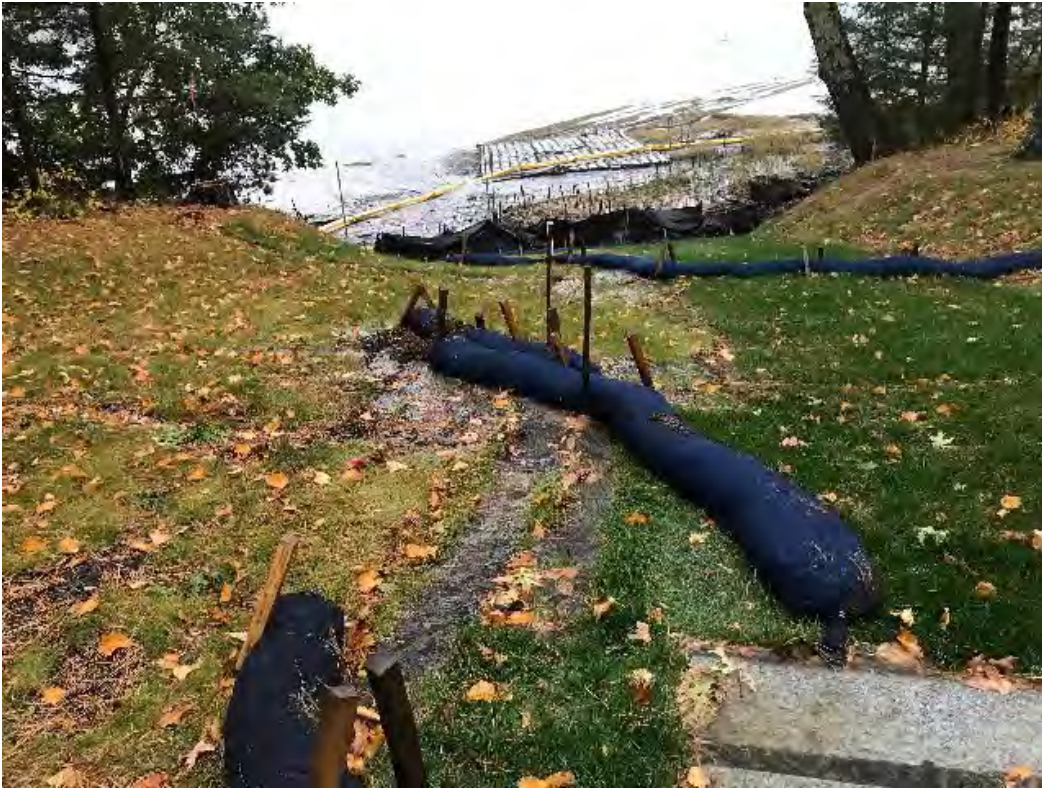
Fig 3: Adjusted positioning of silt sock along the southeastern side of the slope below the manhole at Gundalow Landing. Viewing southwest. (10-13-20)

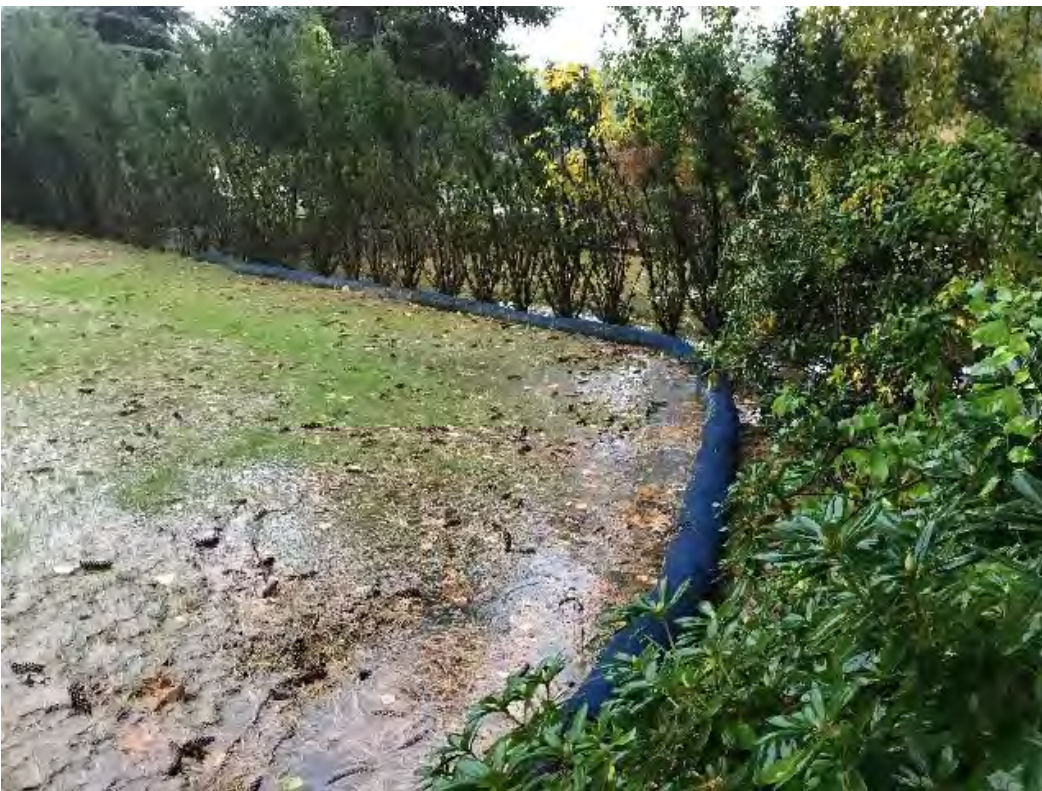
Fig 4: Corner in the southeastern portion of the lawn at Gundalow Landing. Viewing southeast. (10-13-20)

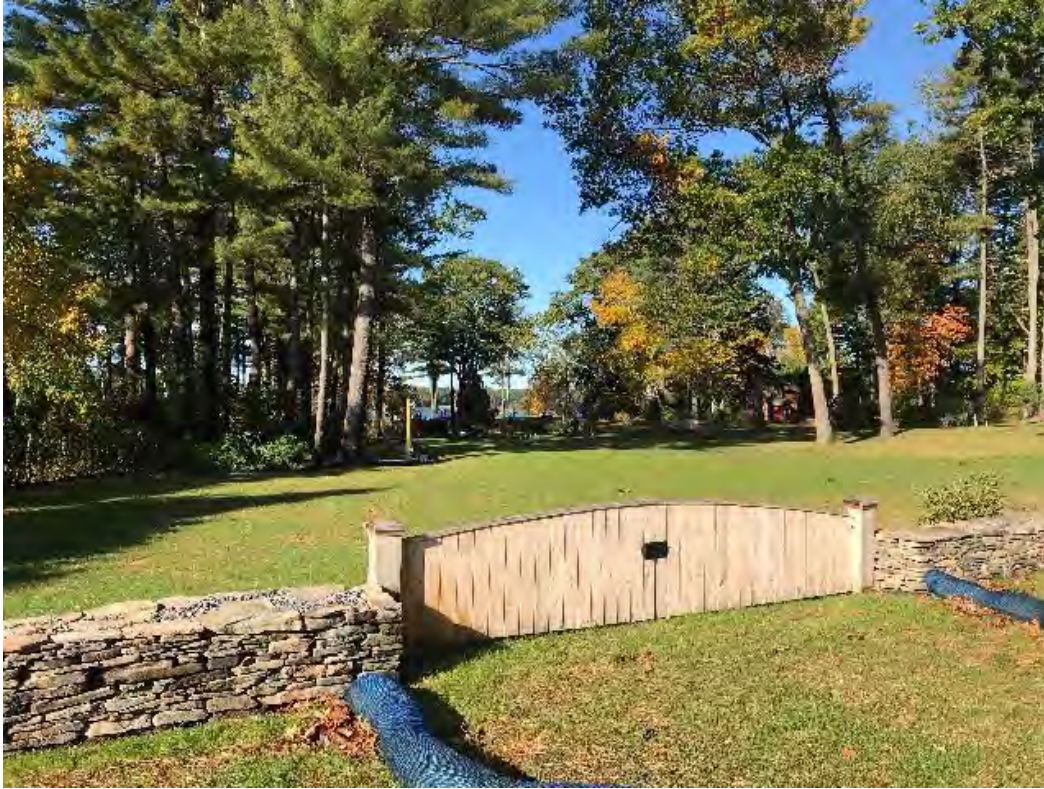
Fig 5: The lawn above the slope at Gundalow Landing/east side of the bay. Viewing west. (10-14-20)

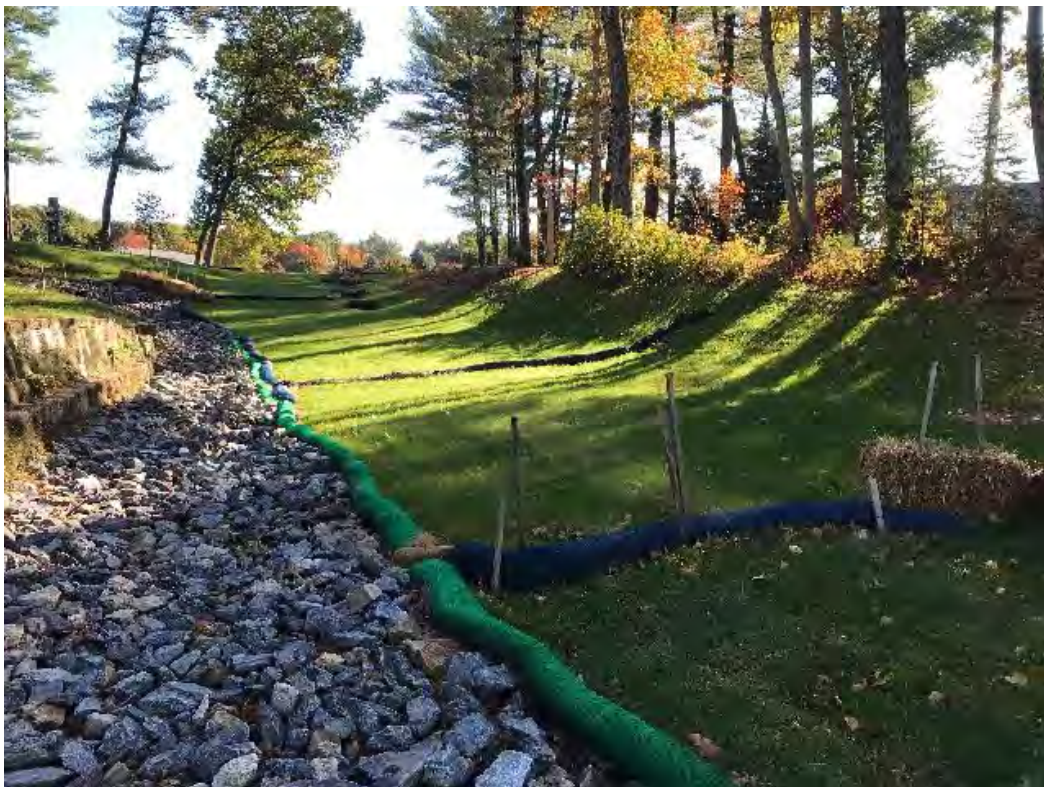
Fig 6: Slope above the manhole at Gundalow Landing/east side of the bay. Viewing east. (10-14-20)

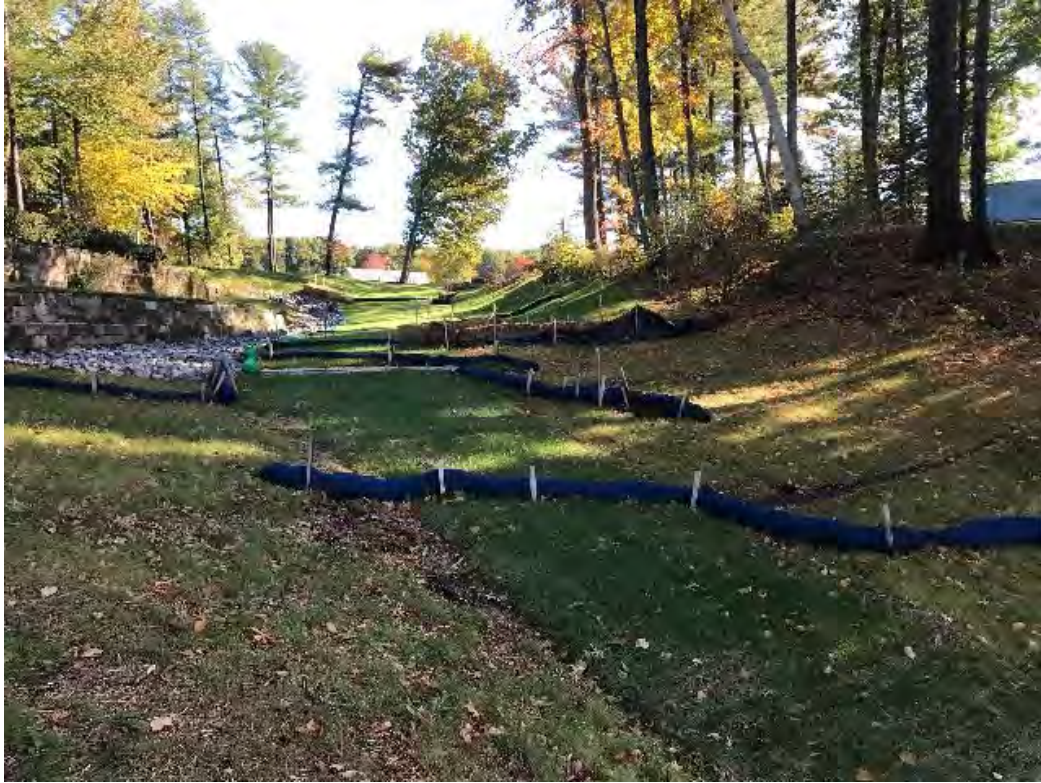
Fig 7: Slope below the manhole at Gundalow Landing/east side of the bay. Viewing east. (10-14-20)

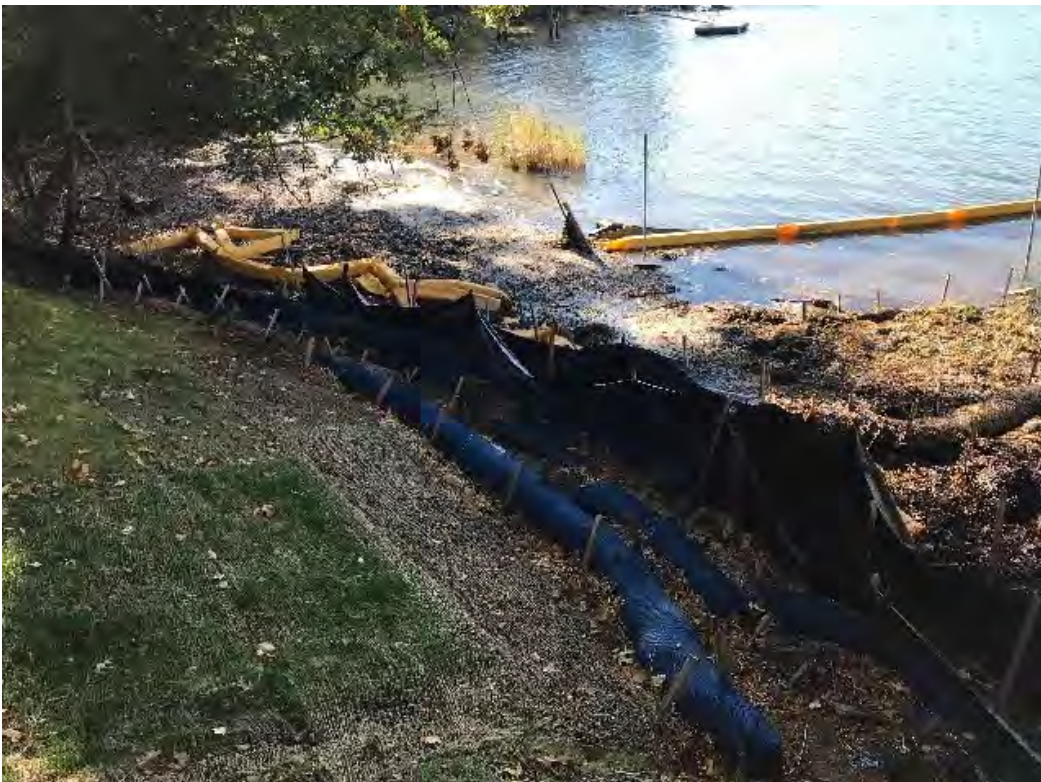
Fig 8: Toe of the slope below the manhole at Gundalow Landing/east side of the bay. Viewing south. (10-14-20)

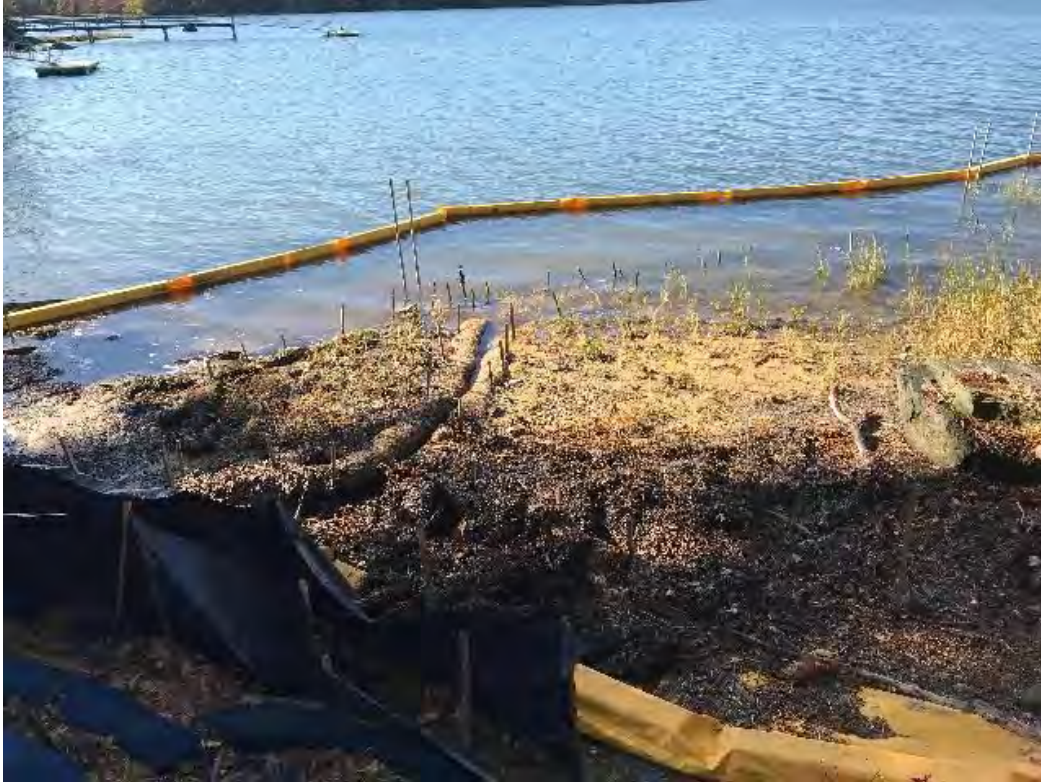
Fig 9: Salt marsh restoration at Gundalow Landing/east side of the bay. Viewing southwest. (10-14-20)

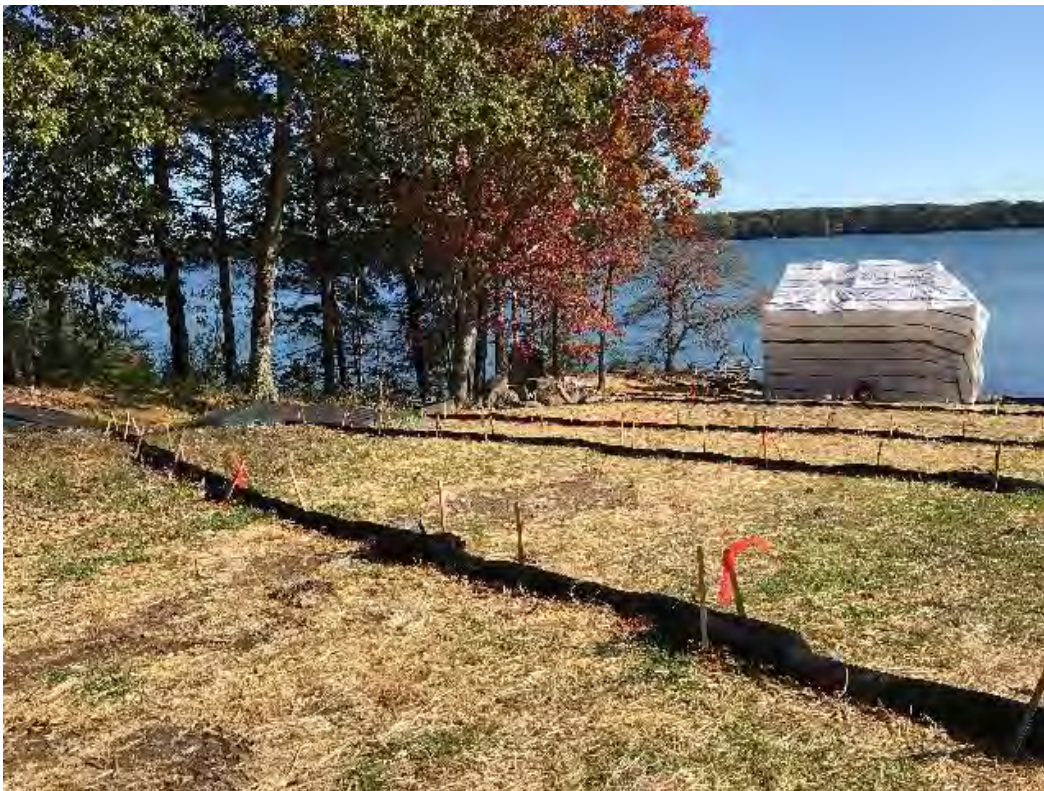
Fig 10: The slope above the cable house at the Eversource property/west side of the bay. Viewing east. (10-14-20)

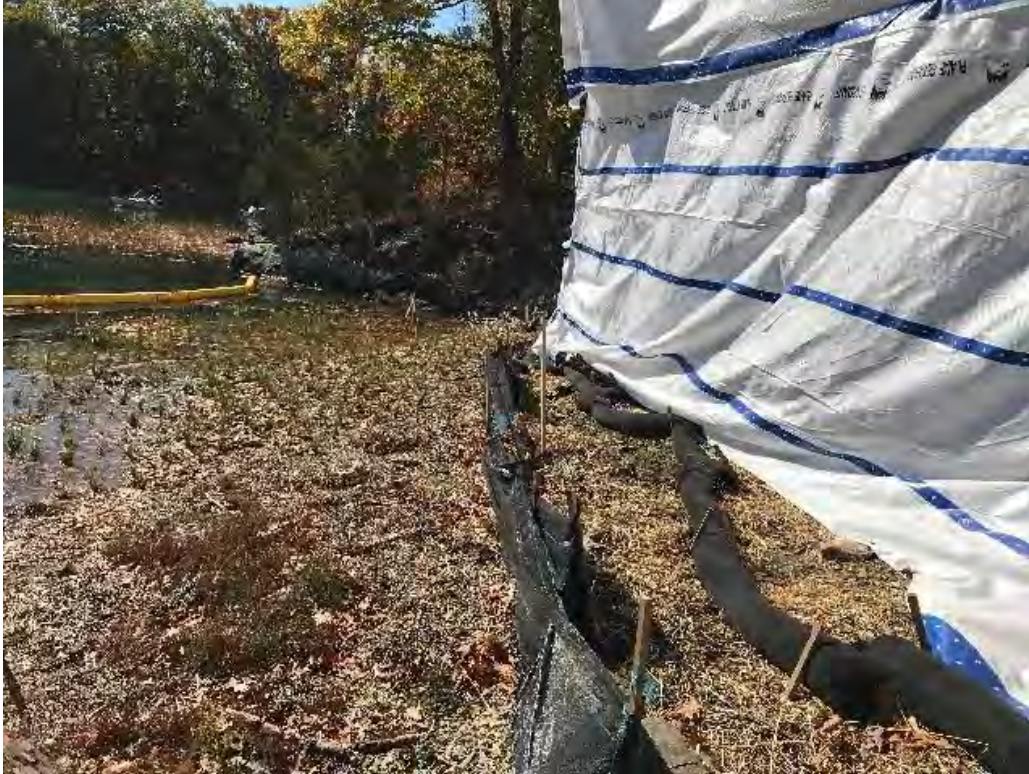
Fig 11: Toe of the slope below the cable house at Eversource property/west side of the bay. Viewing south. (10-14-20)

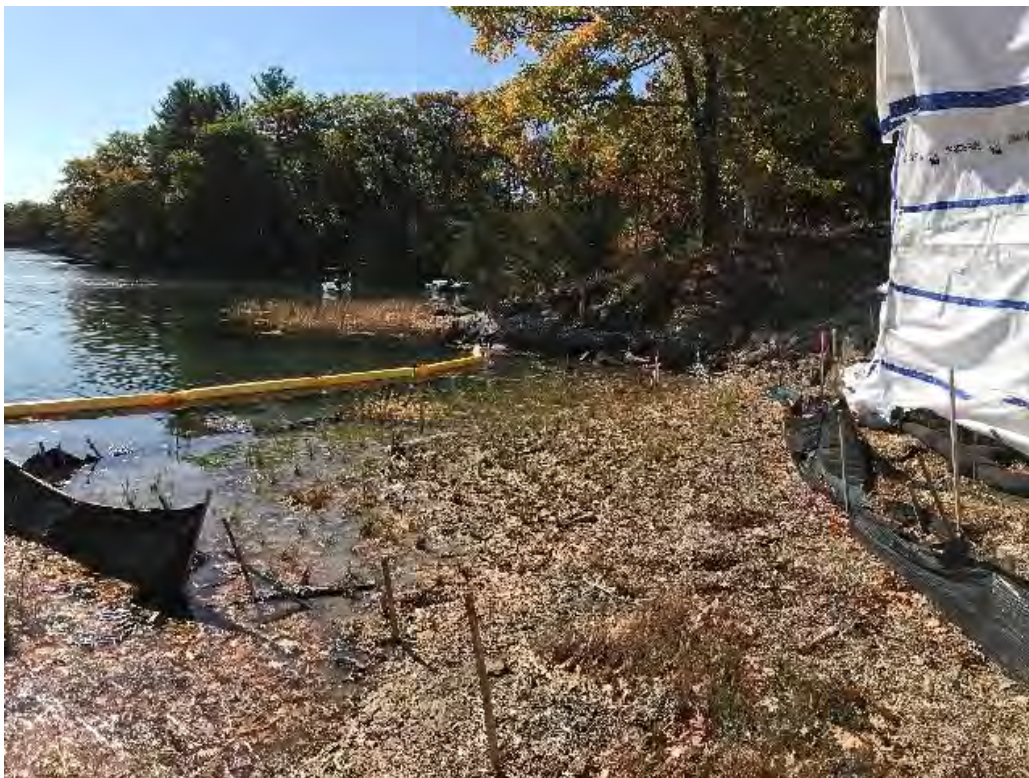
Fig 12: Salt marsh restoration at the Eversource property/west side of the bay. Viewing south. (10-14-20)

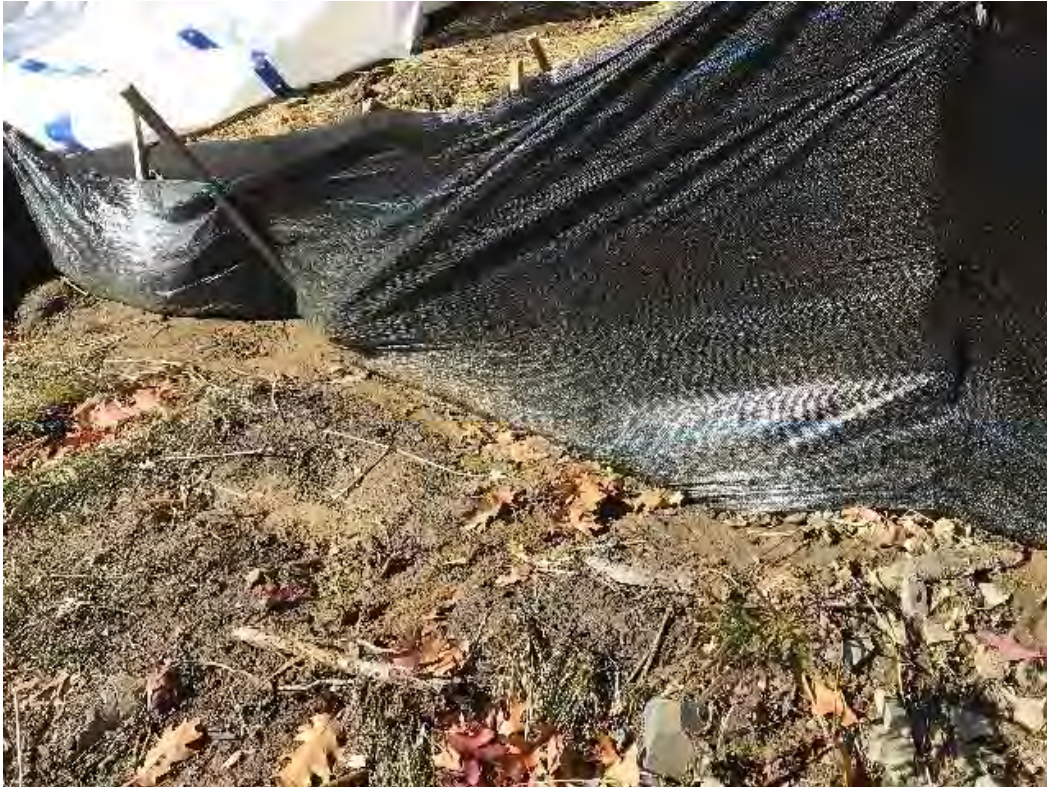
- **BMPs**
 - All remaining BMPs should be left in place until the sites are determined to be stabilized by the environmental monitor.
 - A portion of the silt fence along the toe of the slope north of the cable house was undercut during the 10/13/2020 storm event and a small amount of sediment leaked beyond the fence (See Photo 13). There were no impacts to the intertidal zone. The undercut portion of the silt fence will be re-installed prior to the next storm event.

Description: Silt fence was undercut and a small plume of sediment was observed on the ledge above the HOTL.

Fig 13: Silt fence needing repair along the toe of the slope north of the cable house. Viewing southwest. (10-14-20)

Silt fence repair at Eversource property on Durham Point Road will be done in advance of the next rain event on Friday.

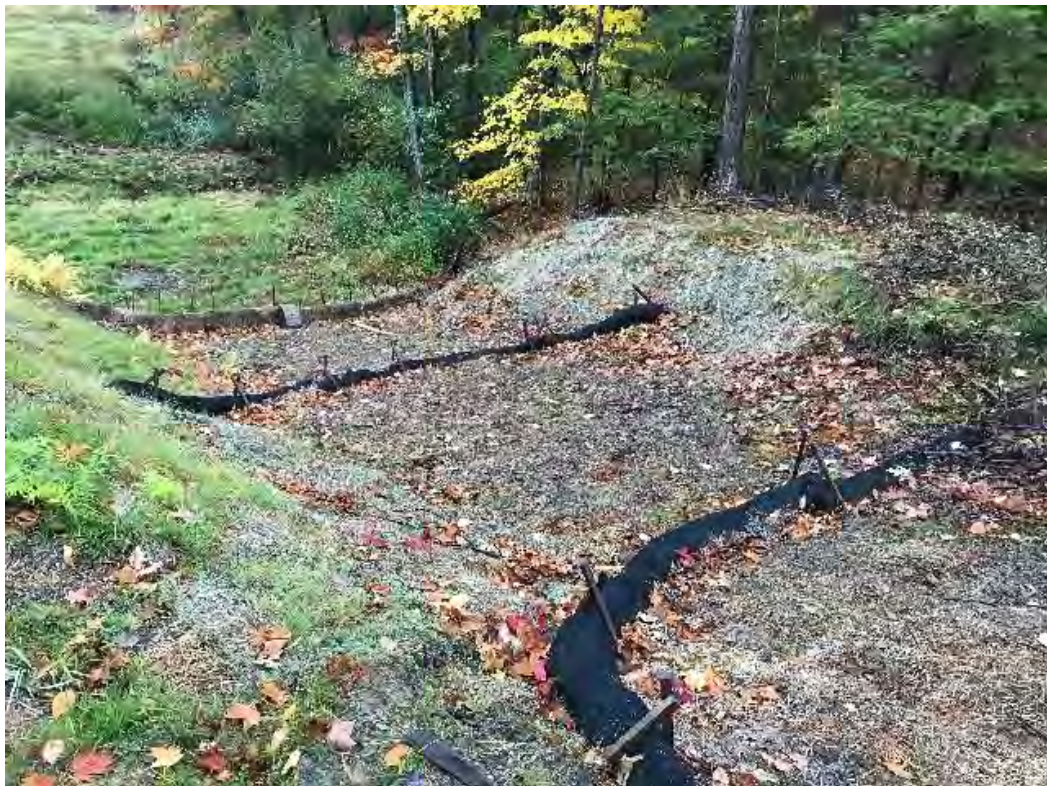
Fig 14: Slope between Strs. 28 and 29. Viewing northeast. (10-14-20)

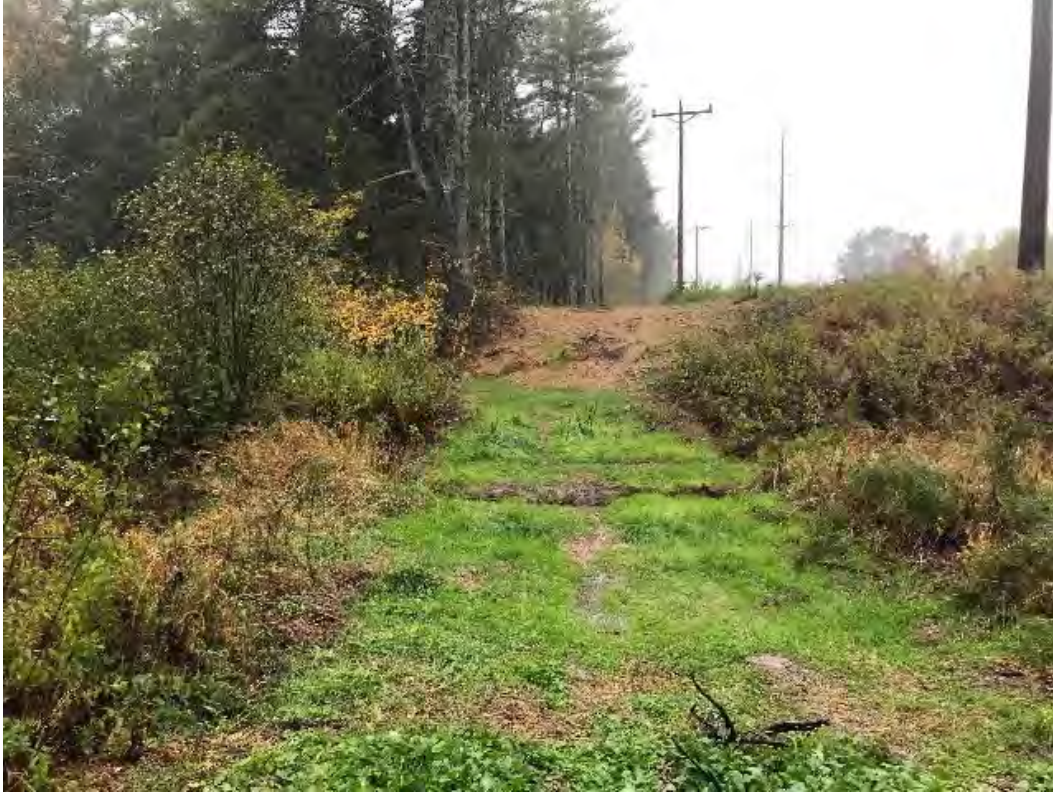
Fig 15: Stream DS46 between Strs. 51 and 52. Viewing southwest. (10-13-20)
