DRAINAGE MONITORING REPORT

F107 - Seacoast Reliability Project

Newington, New Hampshire

04.0190967.00

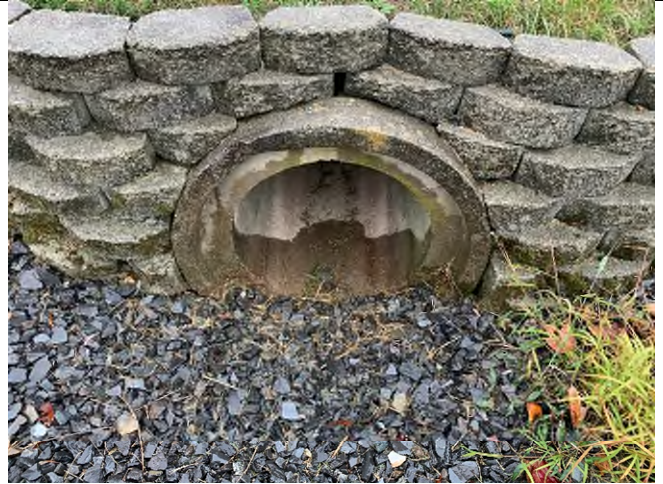
29 Gundalow - 2 (Culvert)

pH: Visible moisture on inside of culvert but no standing water

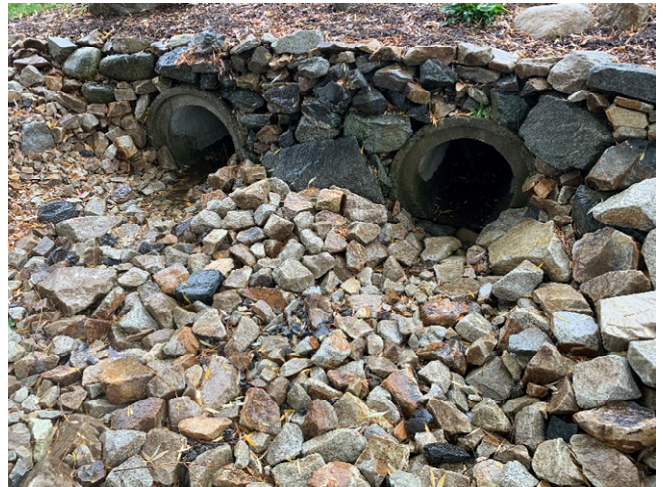
64 Gundalow - 2 (Drainage Course)

pH: 6.4

Observations/Notes: Standing water extending approx. 16" from culvert inlet into stone riprap area, standing water approx. 4" deep

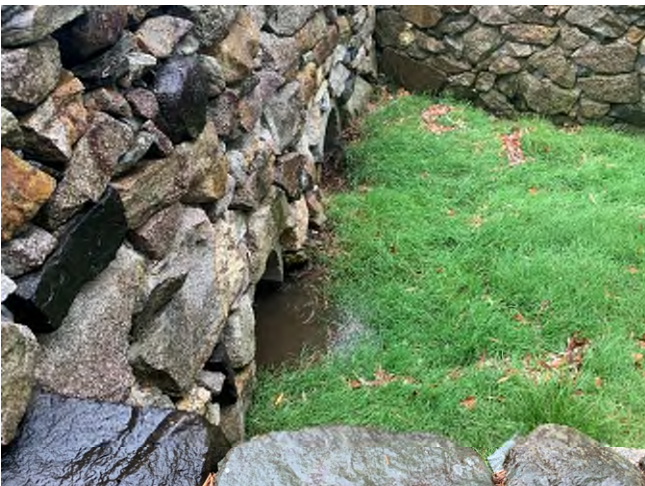
4 Brickyard Circle - 1 (Drainage Course)

pH: 6.5

Observations/Notes: Standing water extending approx. 18" beyond culvert outlet, approx. 10" deep

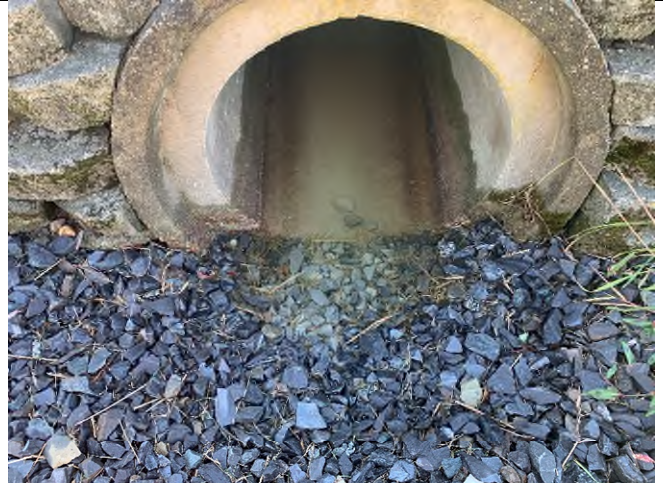
29 Gundalow - 2 (Culvert)

pH: 10.2

Observations/Notes: Standing water observed in the culvert and extending approx. 10" beyond culvert inlet into stone area, approx. max depth 3.5"

- Standing water present in 29 Gundalow – 2 for the first time since the July 23rd monitoring event. No flow through culvert observed.

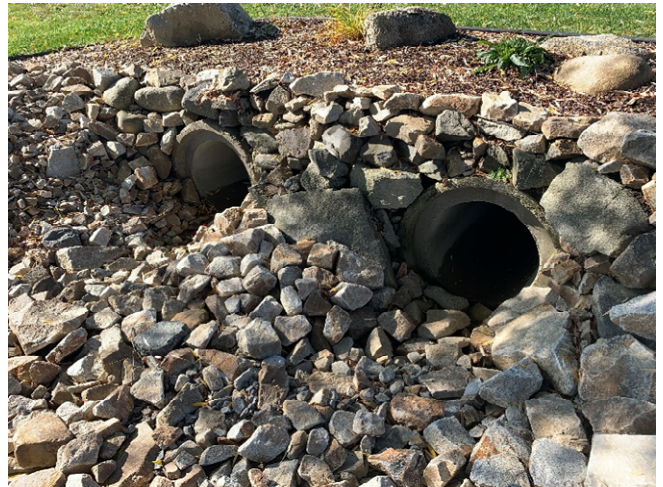
64 Gundalow - 2 (Drainage Course)

pH: 6.3

Observations/Notes: Standing water extending approx. 12" from culvert inlet into stone riprap area, standing water approx. 3" deep

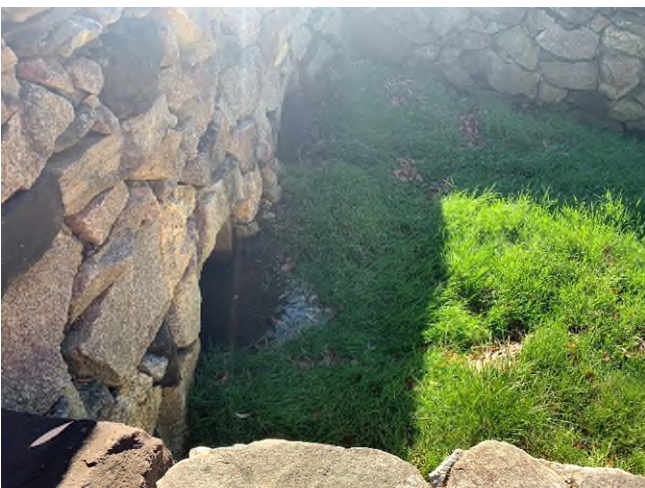
4 Brickyard Circle - 1 (Drainage Course)

pH: 6.5

Observations/Notes: Standing water extending approx. 16" beyond culvert outlet, approx. 8" deep

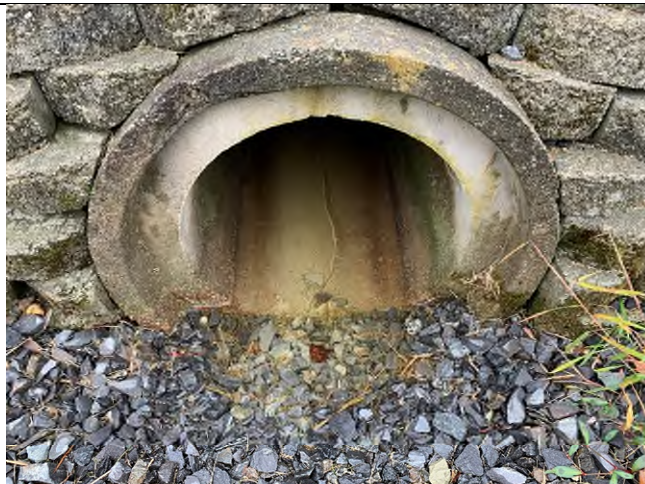
29 Gundalow - 2 (Culvert)

pH: 9.4

Observations/Notes: Standing water within and extending approx. 10" beyond culvert inlet into stone area, approx. max depth 3.5"

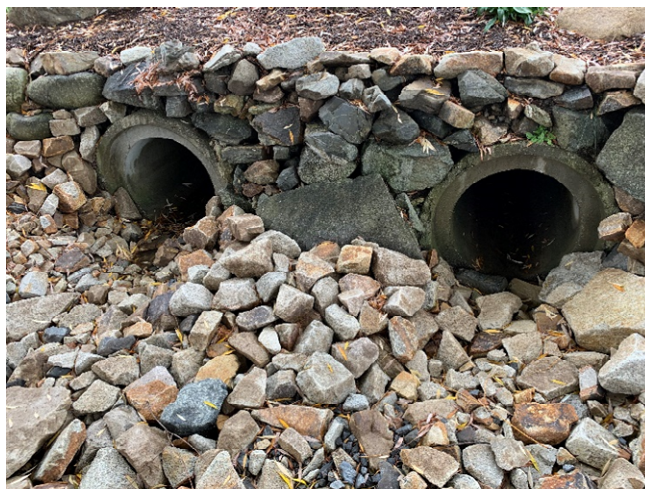
64 Gundalow - 2 (Drainage Course)

pH: 6.6

Observations/Notes: Standing water extending approx. 10" from culvert inlet into stone riprap area, standing water approx. 3" deep

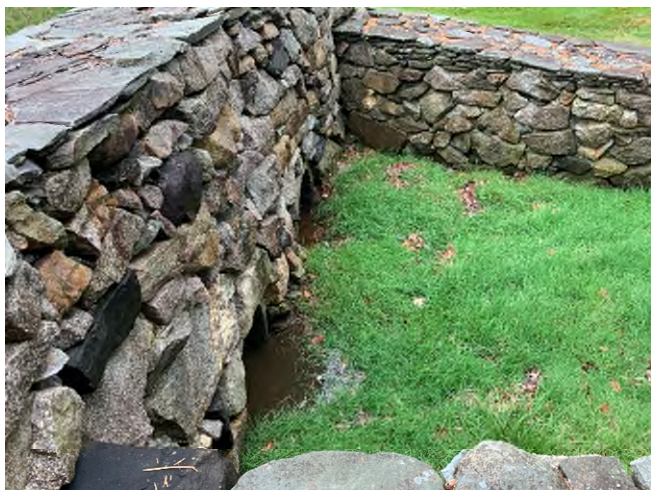
4 Brickyard Circle - 1 (Drainage Course)

pH: 6.8

Observations/Notes: Standing water extending approx. 16" beyond culvert outlet, approx. 8" deep
