CONSTRUCTION MONITORING REPORT

Eversource Transmission Lines:
F107

**Madbury, Durham,
Newington, Portsmouth, NH**

NAI Project No:
23840.39

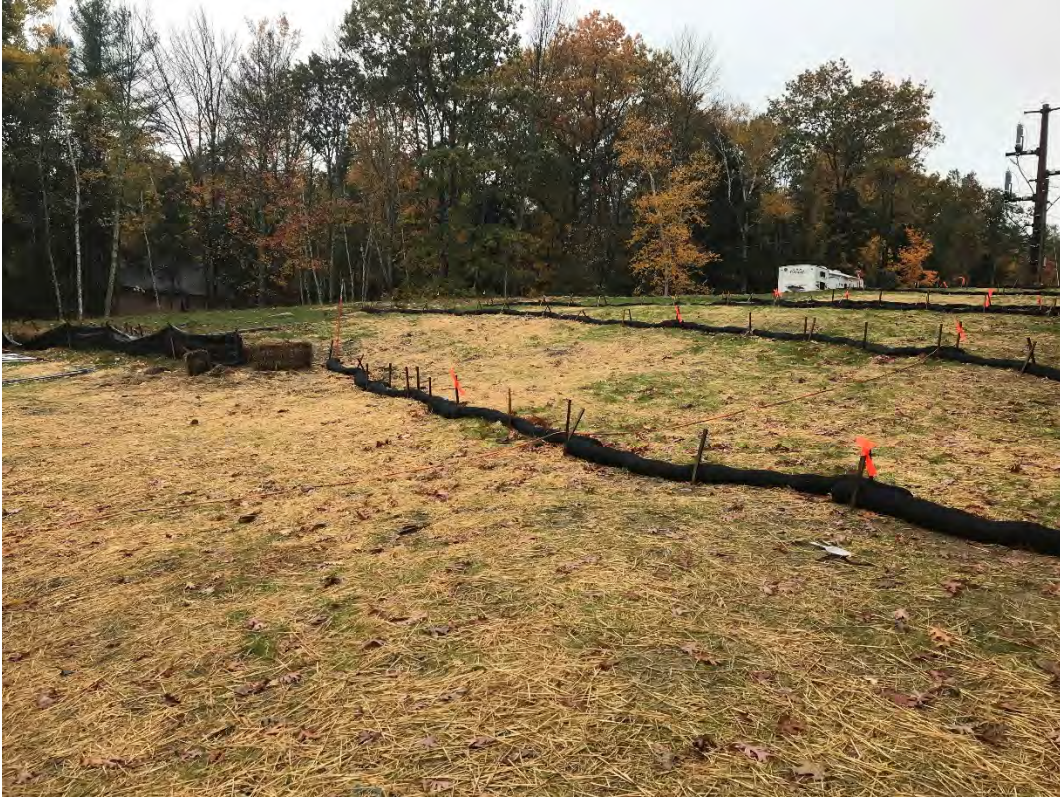
Fig 1: Slope above the cable house at the Eversource property/west side of the bay. Viewing southwest. (10-17-20)

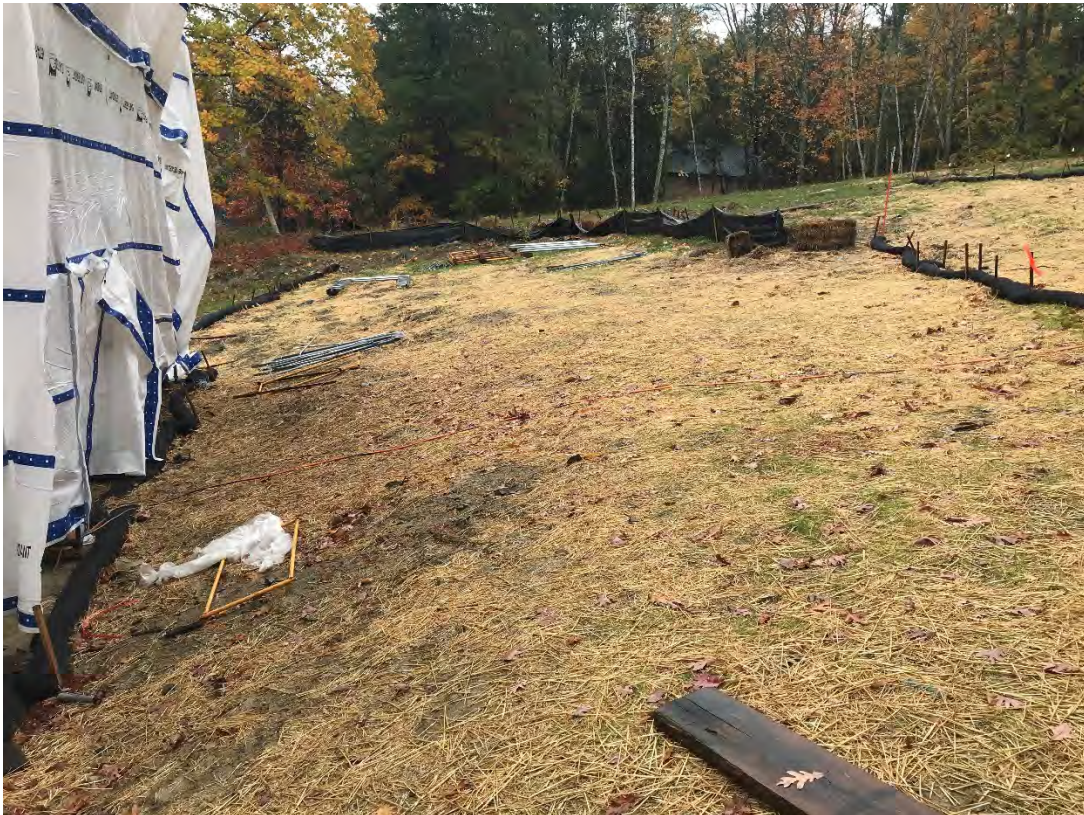
Fig 2: Slope above the cable house at the Eversource property/west side of the bay. Viewing south. (10-17-20)

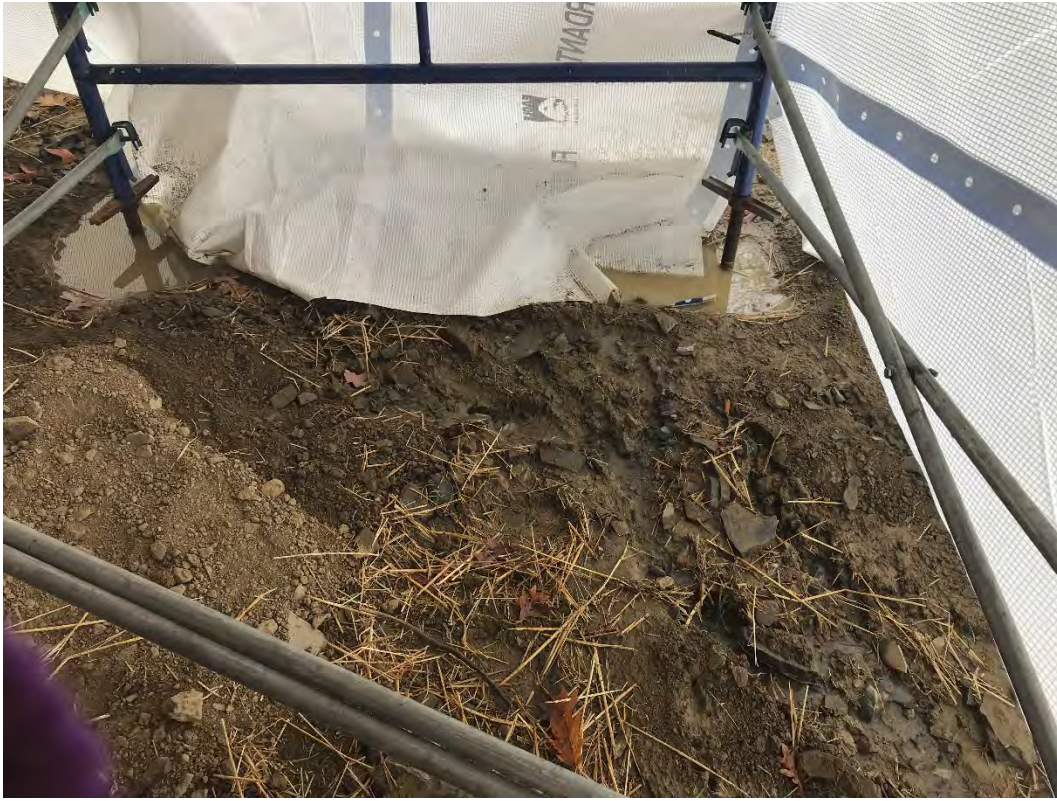
- **BMPs**
 - All remaining BMPs should be left in place until the sites are determined to be stabilized by the environmental monitor.
 - Minor rills formed on the slopes off the northeastern corner and southern side of the cable house (Photos 3-5). The rills will be hand repaired on the next workday.
 - Evidence of minor overtopping of the internal silt sock below the southeastern corner of the cable house was observed (Photo 5). There was no indication this sedimentation reached the perimeter BMPs located downslope of the internal silt sock. The internal silt sock will be excavated and re-installed on the next workday.

Fig 3: Rill observed off the northeast corner of the cable house at the Eversource property/west side of the bay. Viewing north. (10-17-20)

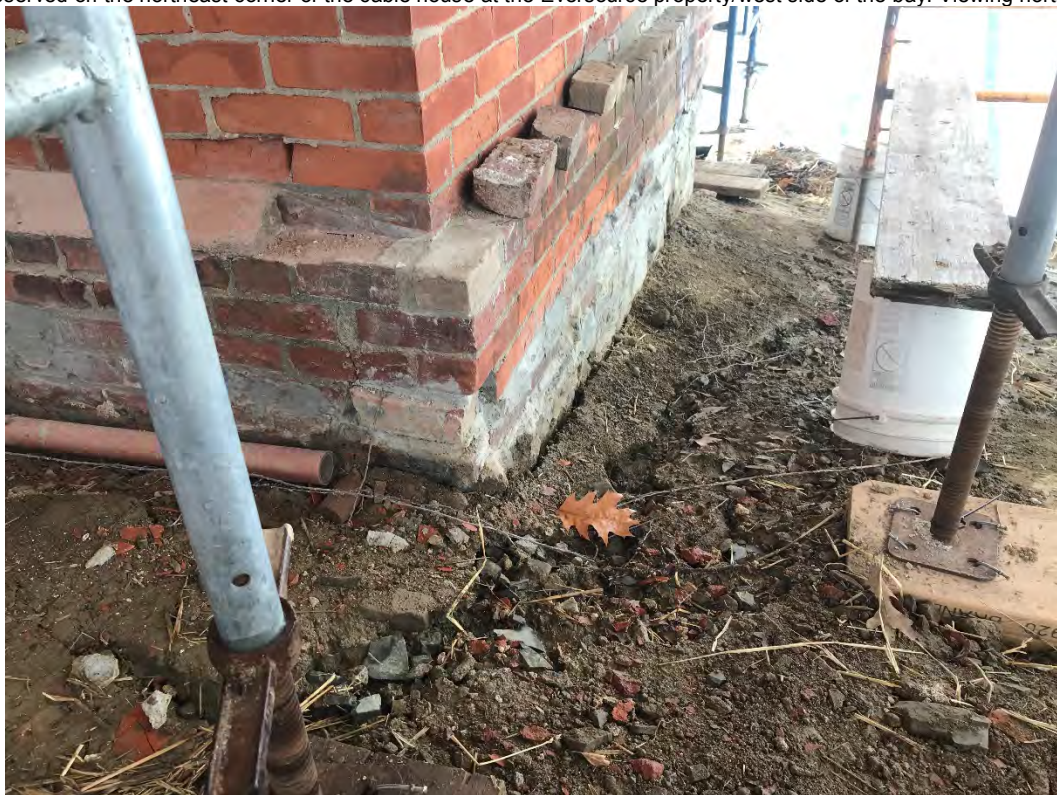
Fig 4: Rill observed on the southwest corner of the cable house at the Eversource property/west side of the bay. Viewing east. (10-17-20)

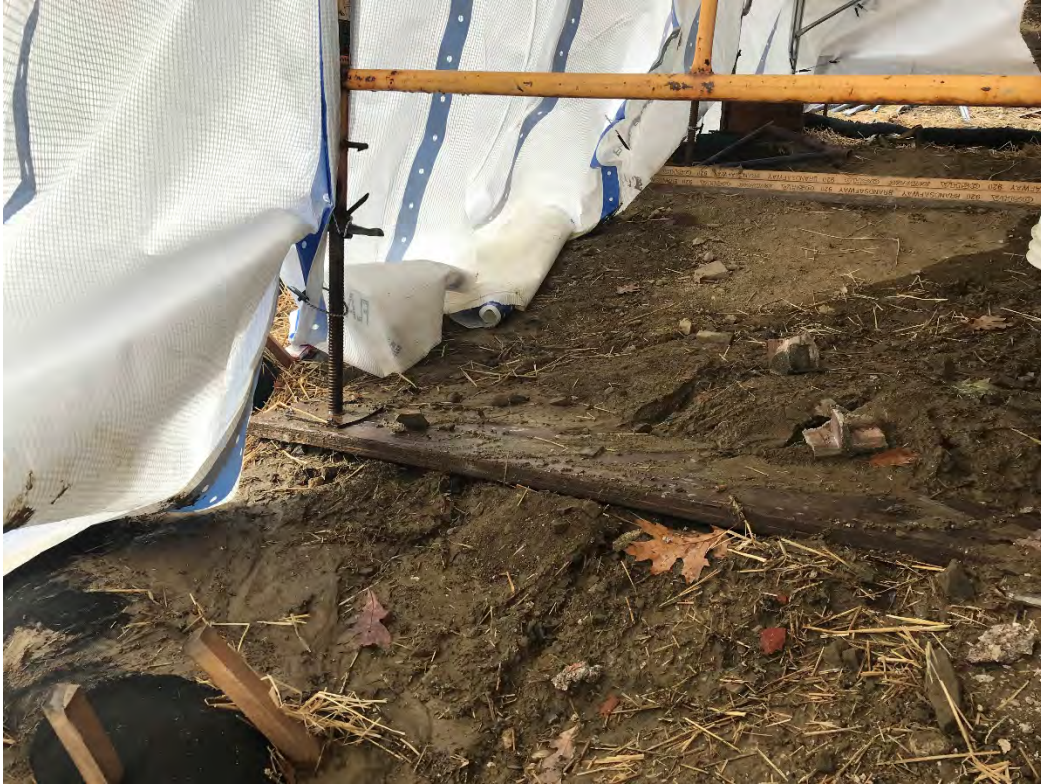
Fig 5. Rills observed off the southeast corner of the cable house at the Eversource property/west side of the bay. Viewing southwest. (10-17-20)

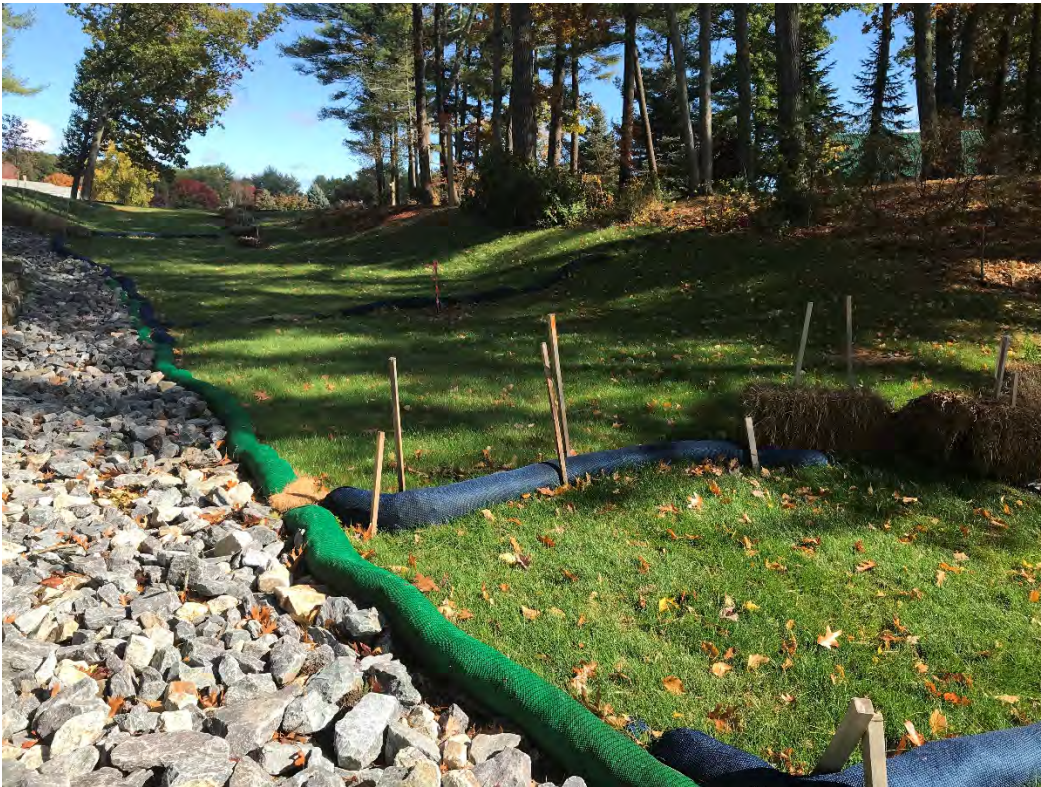
Fig 6: Slope above below the manhole at Gundalow Landing/east side of the bay. Viewing east. (10-17-20)

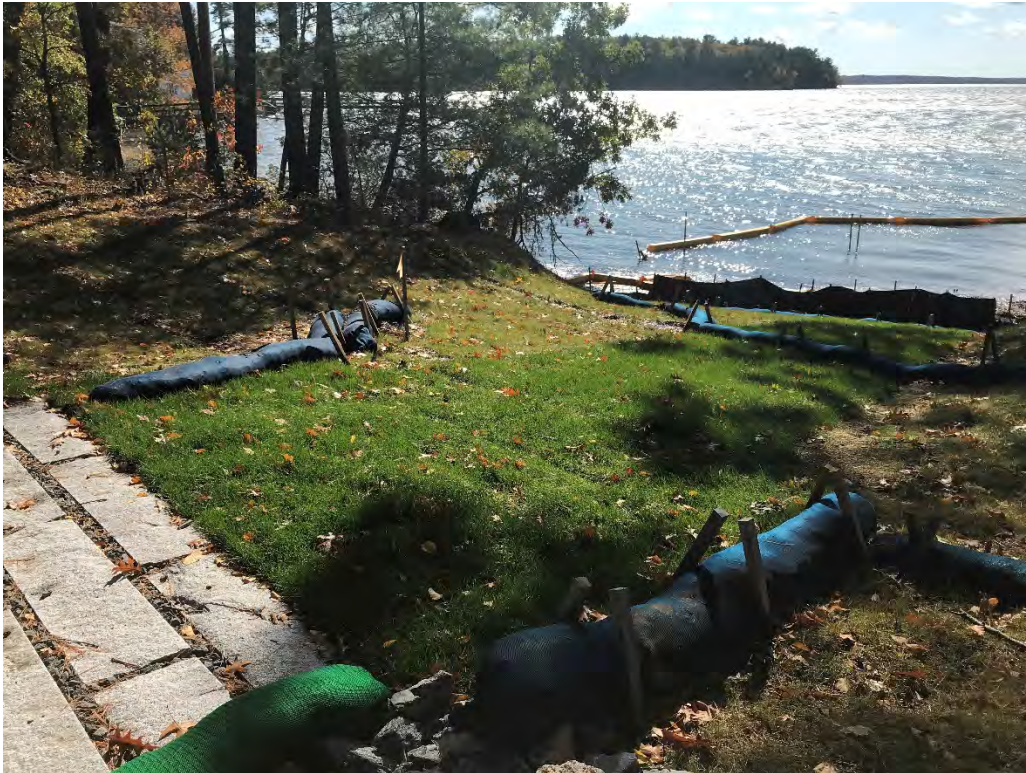
Fig 7: Slope below the manhole at Gundalow Landing/east side of the bay. Viewing south. (10-17-20)

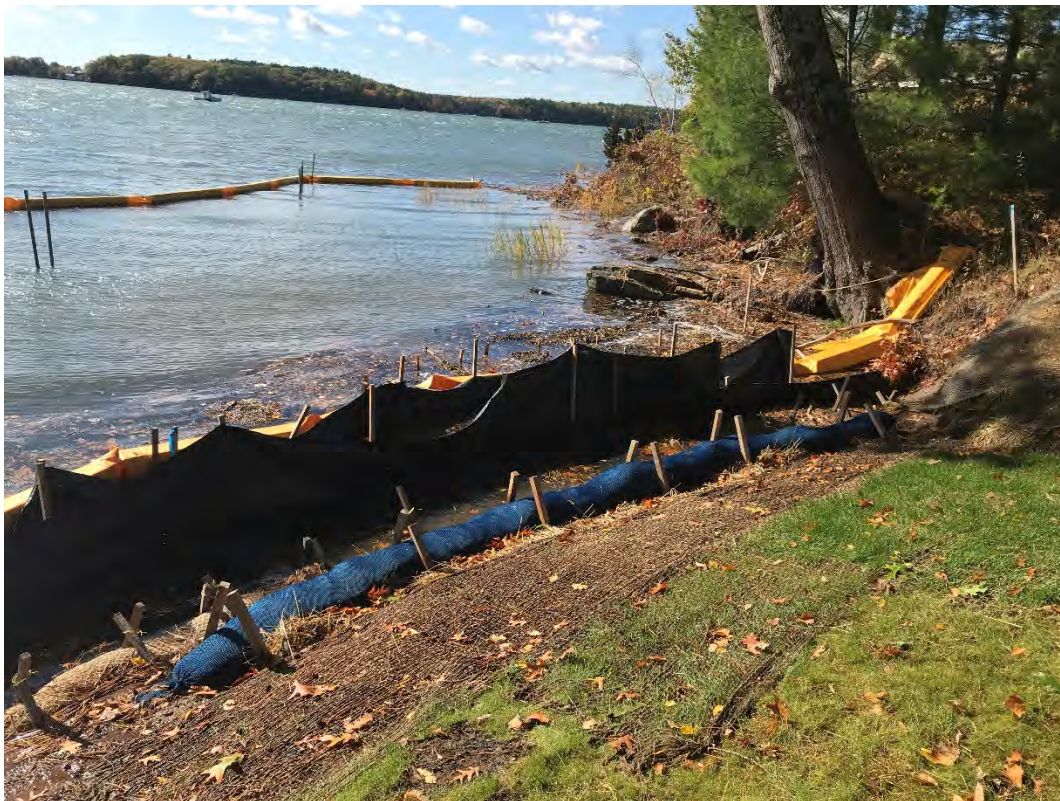
Fig 8: Toe of the slope and salt marsh restoration at Gundalow Landing/east side of the bay. Viewing west. (10-17-20)

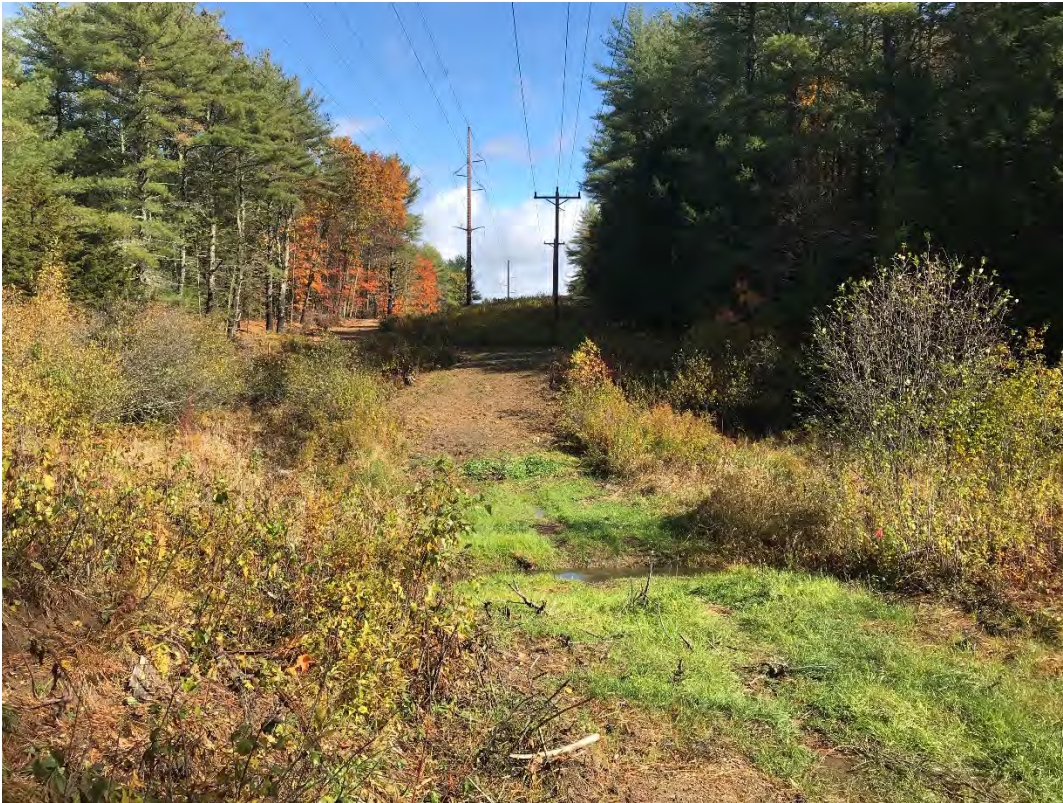
Fig 9: Stream DS46 between Strs. 51 and 52. Viewing east. (10-17-20)

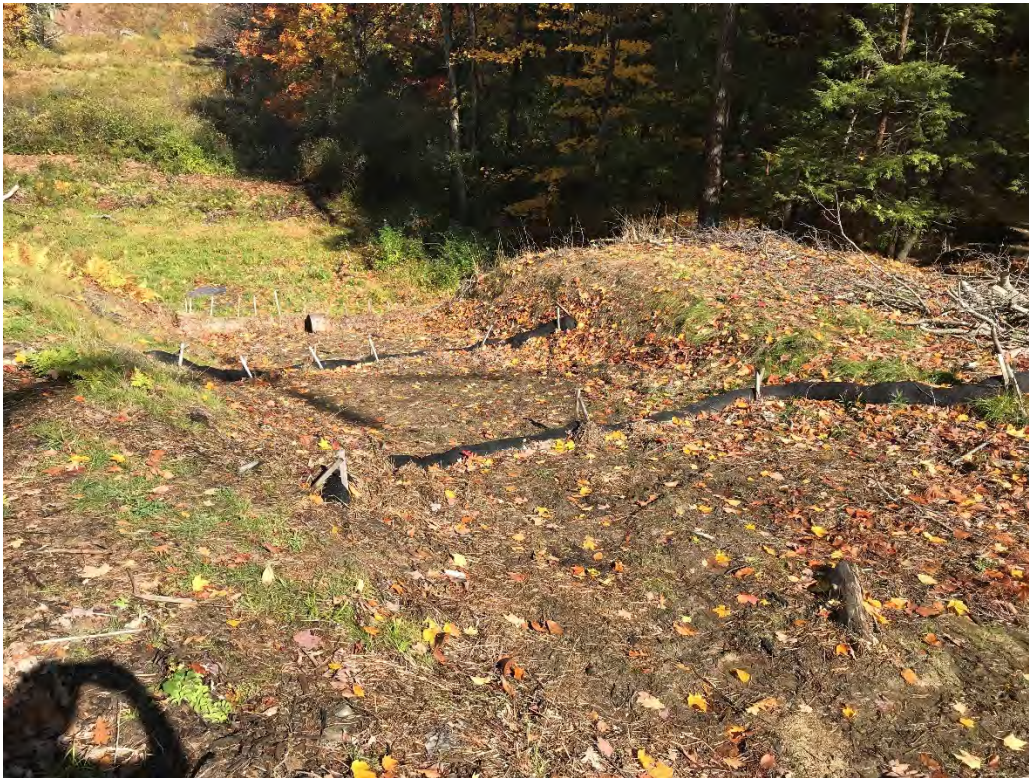
Fig 10: Slope between Strs. 28 and 29. Viewing northeast. (10-17-20)
