CONSTRUCTION MONITORING REPORT

> NAI Project No: 23840.39

Construction Monitoring Report #96

Eversource Seacoast Reliability Project

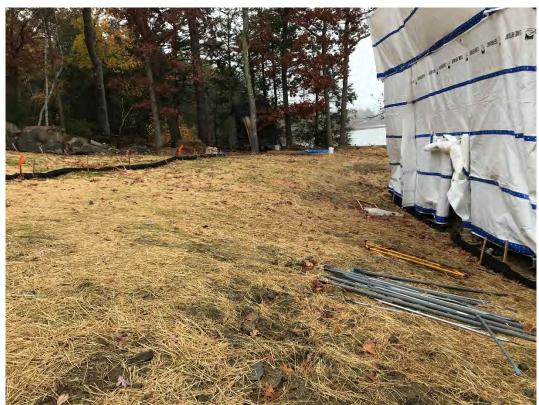
Fig 1: Slope above the cable house at the Eversource property/west side of the bay. Viewing north. (10-21-20)

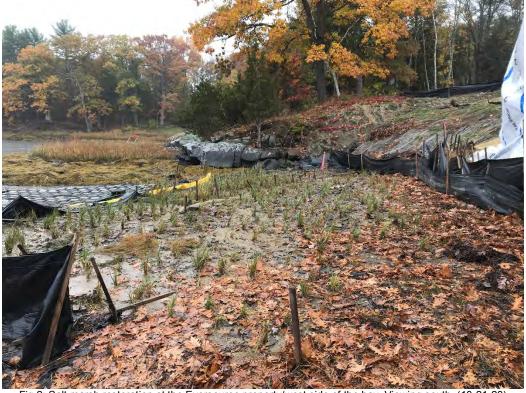
Fig 2: Salt marsh restoration at the Eversource property/west side of the bay. Viewing south. (10-21-20)

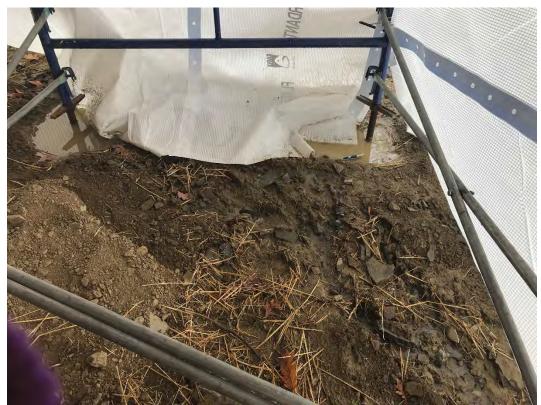
- All remaining BMPs should be left in place until the sites are determined to be stabilized by the environmental monitor.
- Minor rills were observed on the slopes off the northeastern corner and southern side of the cable house on 10/17/20 (Photos 3-7). The rills were repaired on 10/19/20 and silt socks installed on the slope to prevent future rill development.
- Evidence of minor overtopping of the internal silt sock below the southeastern corner of the cable house was observed on 10/17/20 (Photo 6). There was no indication this sedimentation reached the perimeter BMPs located downslope of the internal silt sock. The internal silt sock was excavated and re-installed on 10/19/20.

Fig 3: Rill observed off the northeast corner of the cable house at the Eversource property/west side of the bay. Viewing north. (10-17-20)

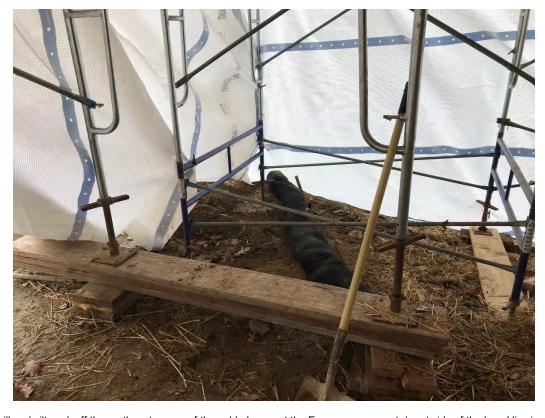
Fig 4: Repaired rill and silt sock off the northeast corner of the cable house at the Eversource property/west side of the bay. Viewing east. (10-19-20)

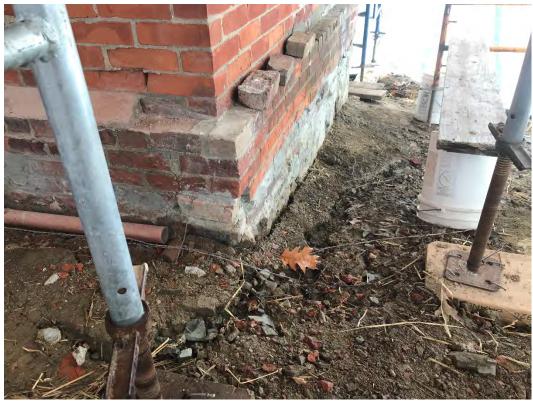
Fig 5: Rill observed on the southwest corner of the cable house at the Eversource property/west side of the bay. Viewing east. (10-17-20)

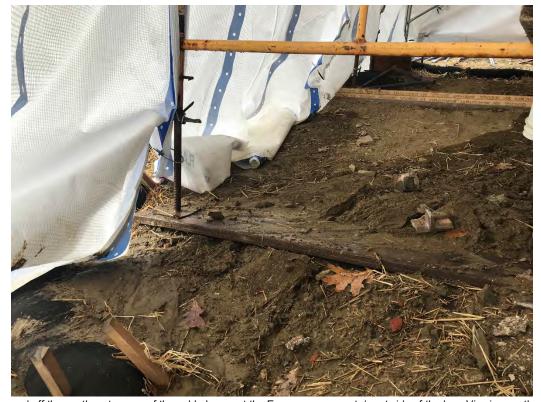
Fig 6: Rills observed off the southeast corner of the cable house at the Eversource property/west side of the bay. Viewing southwest. (10-17-20)

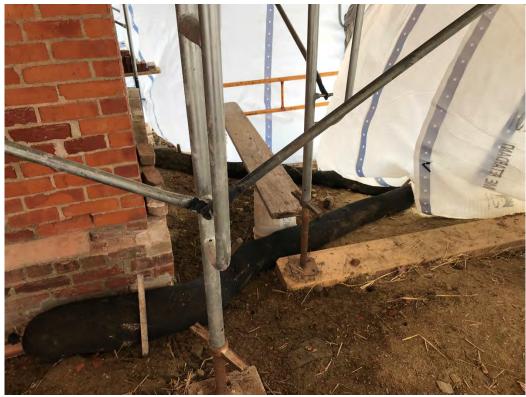
Fig 7: Repaired rill and silt socks off the southern side of the cable house at the Eversource property/west side of the bay. Viewing southeast. (10-19-20)

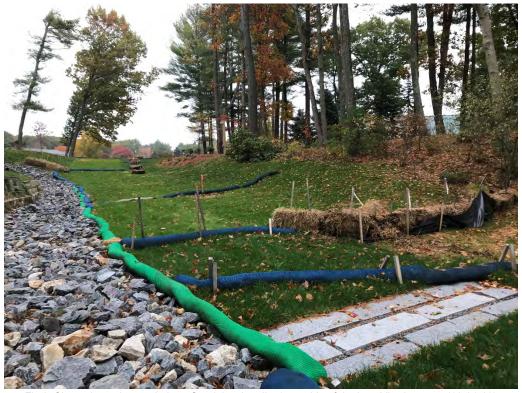
Fig 8: Slope above the manhole at Gundalow Landing/east side of the bay. Viewing east. (10-21-20)

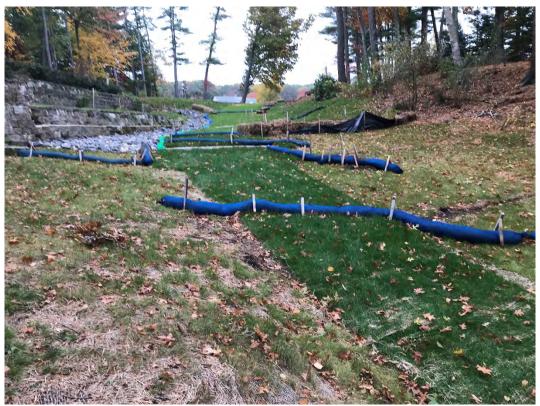
Fig 9: Slope below the manhole at Gundalow Landing/east side of the bay. Viewing east. (10-21-20)

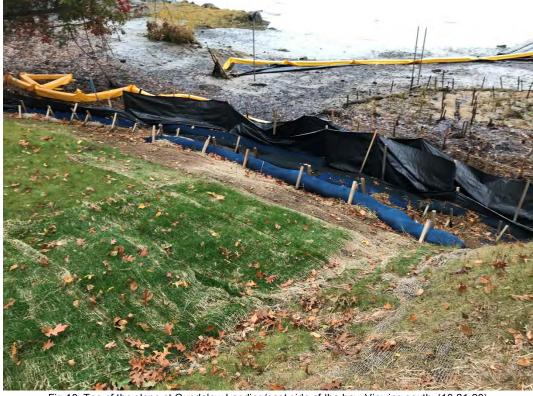
Fig 10: Toe of the slope at Gundalow Landing/east side of the bay. Viewing south. (10-21-20)

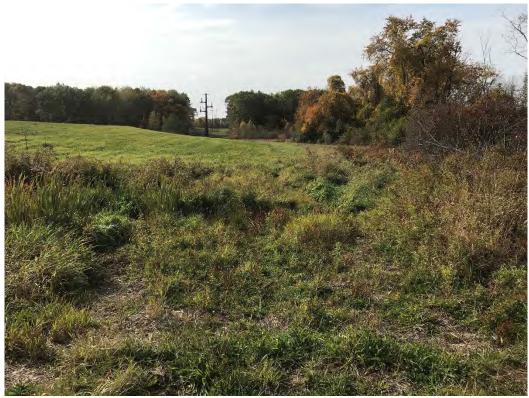
Fig 11: Wetland NW18 on between Strs. 106 and 107. Viewing southwest. (10-19-20)
