DRAINAGE MONITORING REPORT

F107 - Seacoast Reliability Project

Newington, New Hampshire

04.0190967.00

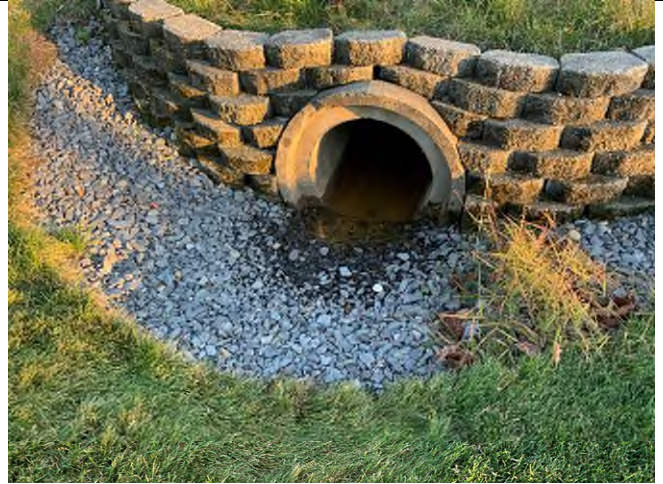
29 Gundalow - 2 (Culvert)

pH: 10.3

Observations/Notes: Water observed in the culvert and extending approx. 10" beyond culvert inlet into stone area, approx. max depth 4"

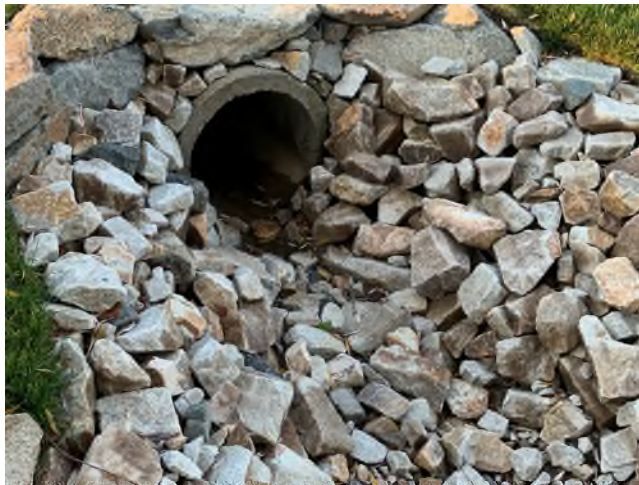
64 Gundalow - 1 (Drainage Course)

pH: 7.4

Observations/Notes: Small area of water extending approx. 6" from culvert outlet. Slow trickle of flow observed through culvert.

- First time water was reported at 64 Gundalow – 1 since the July 9, 2020 monitoring event.

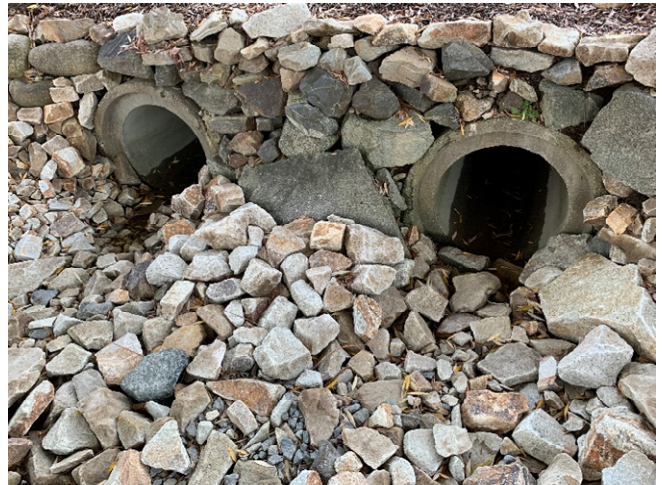
64 Gundalow - 2 (Drainage Course)

pH: 6.8

Observations/Notes: Small area of water in stone riprap approx. 3" deep. Slow trickle of flow observed through culvert.

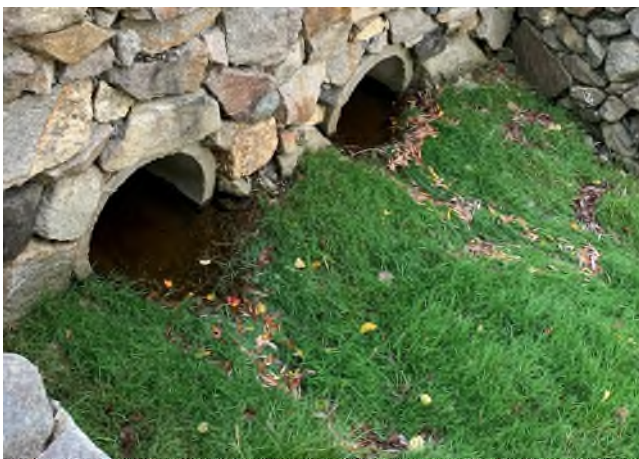
4 Brickyard Circle - 1 (Drainage Course)

pH: 6.7

Observations/Notes: Water extending approx. 16" beyond culvert outlet, approx. 8" deep. Slow trickle of flow observed through culvert.

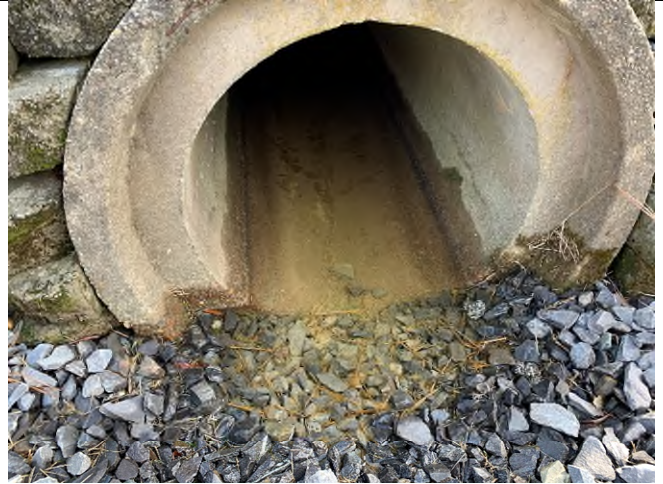
29 Gundalow - 2 (Culvert)

pH: **10.3**

Observations/Notes: Standing water observed in the culvert and extending approx. 10" beyond culvert inlet into stone area, approx. max depth 3.5"

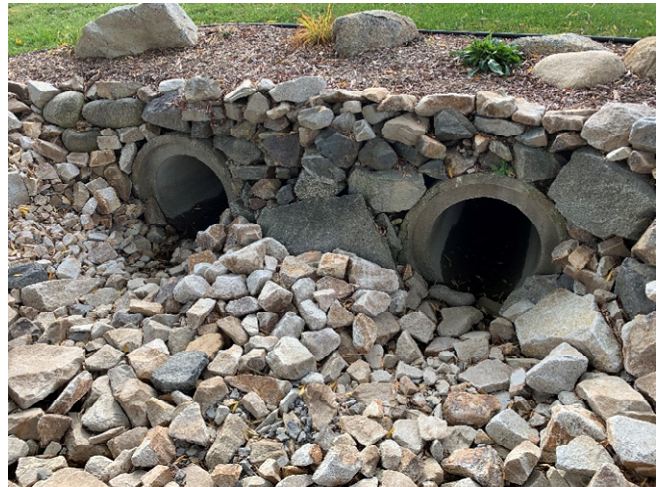
64 Gundalow - 2 (Drainage Course)

pH: **6.5**

Observations/Notes: Small area of standing water in stone riprap approx. 3" deep

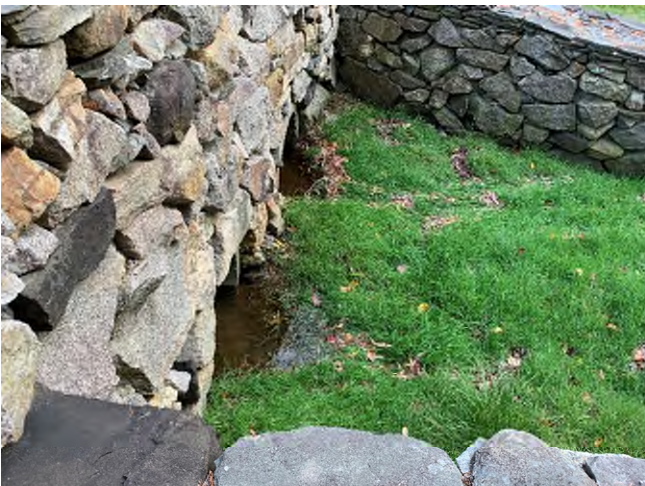
4 Brickyard Circle - 1 (Drainage Course)

pH: **6.4**

Observations/Notes: Standing water extending approx. 16" beyond culvert outlet, approx. 8" deep

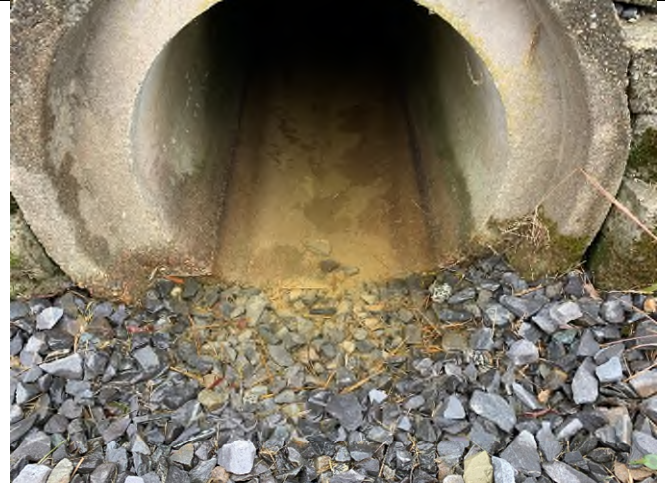
29 Gundalow - 2 (Culvert)

pH: 9.6

Observations/Notes: Standing water observed in the culvert and extending approx. 10" beyond culvert inlet into stone area, approx. max depth 3.5"

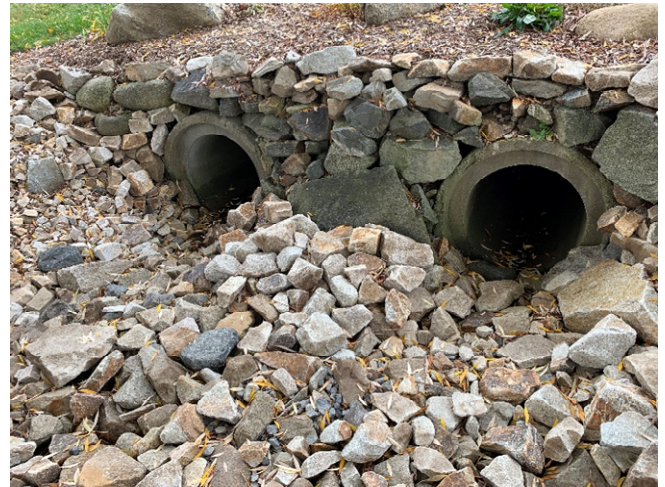
64 Gundalow - 2 (Drainage Course)

pH: 6.6

Observations/Notes: Small area of standing water in stone riprap approx. 3" deep

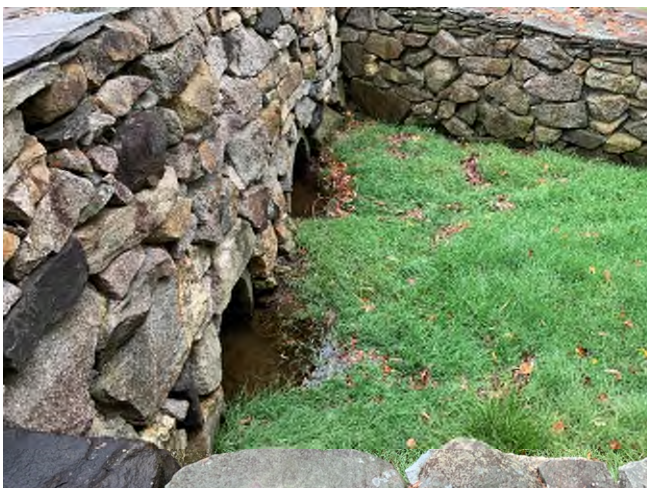
4 Brickyard Circle - 1 (Drainage Course)

pH: 6.7

Observations/Notes: Standing water extending approx. 16" beyond culvert outlet, approx. 8" deep
