## CONSTRUCTION MONITORING REPORT

Eversource Transmission Lines:  
**F107**

**Madbury, Durham,  
Newington, Portsmouth, NH**

NAI Project No:  
**23840.39**

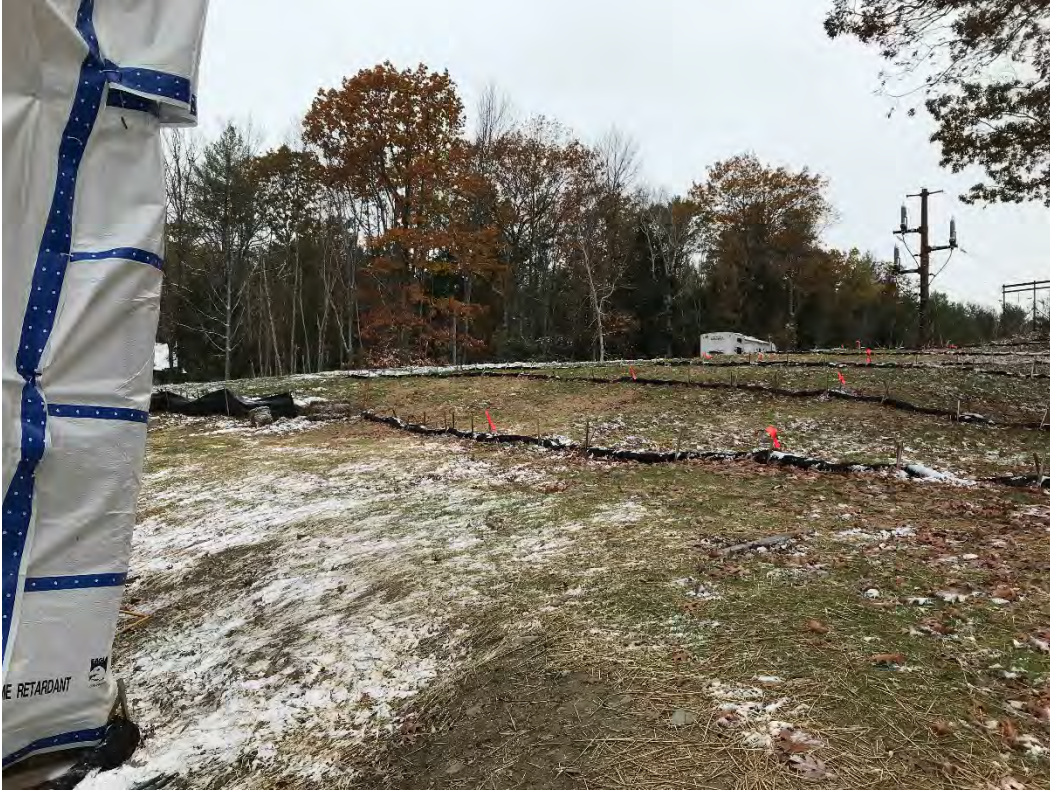
**Areas that have been restored and mulched, but have little germination:** Hannah Ln, Eversource property/west side of bay, 89  
**Moderate germination:** Str. 4-6, Strs. 7-21, 25-34, 36-88, 91-101, 107, 109-112, 122-127, 129-130, and Gundalow Landing/east side of bay.  
**Stabilized (85%+ germination):** Strs. 1-3, 22-24, 35, 67, 102-106 (including Frink farm), 108, 113-121, 128, 131-144, UNH UG.

Fig 1: Slope above the cable house at the Eversource property/west side of the bay. Viewing southwest. (10-30-20)

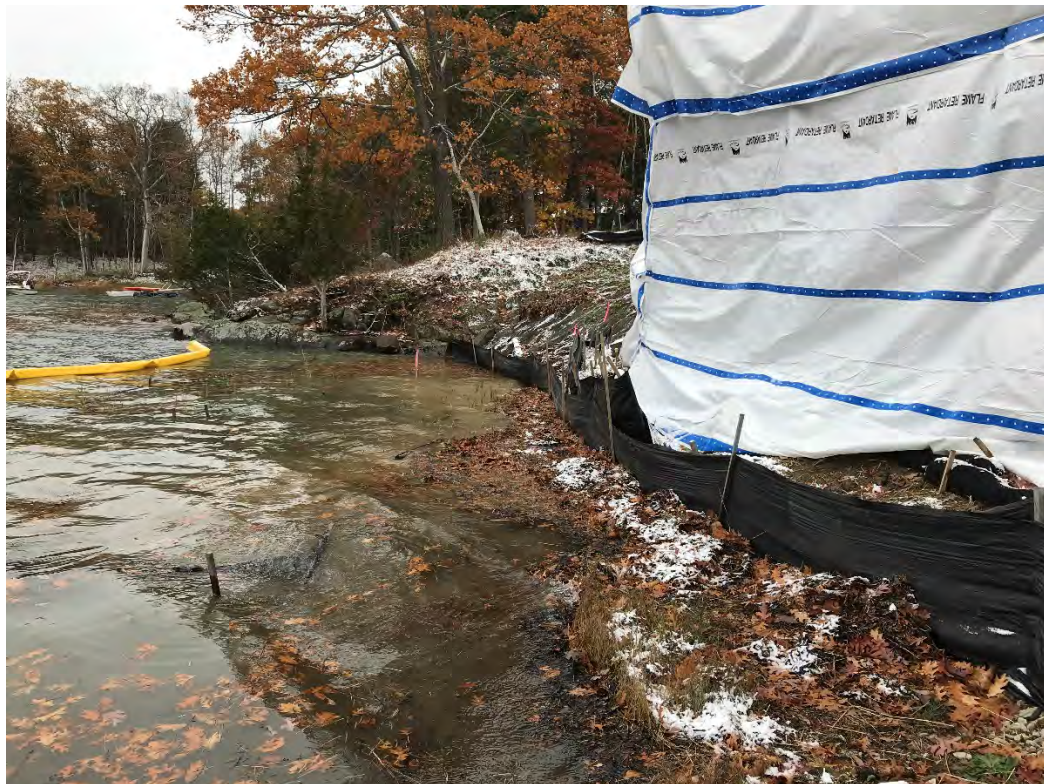
Fig 2: Toe of the slope and salt marsh restoration at the Eversource property/west side of the bay. Viewing south. (10-30-20)

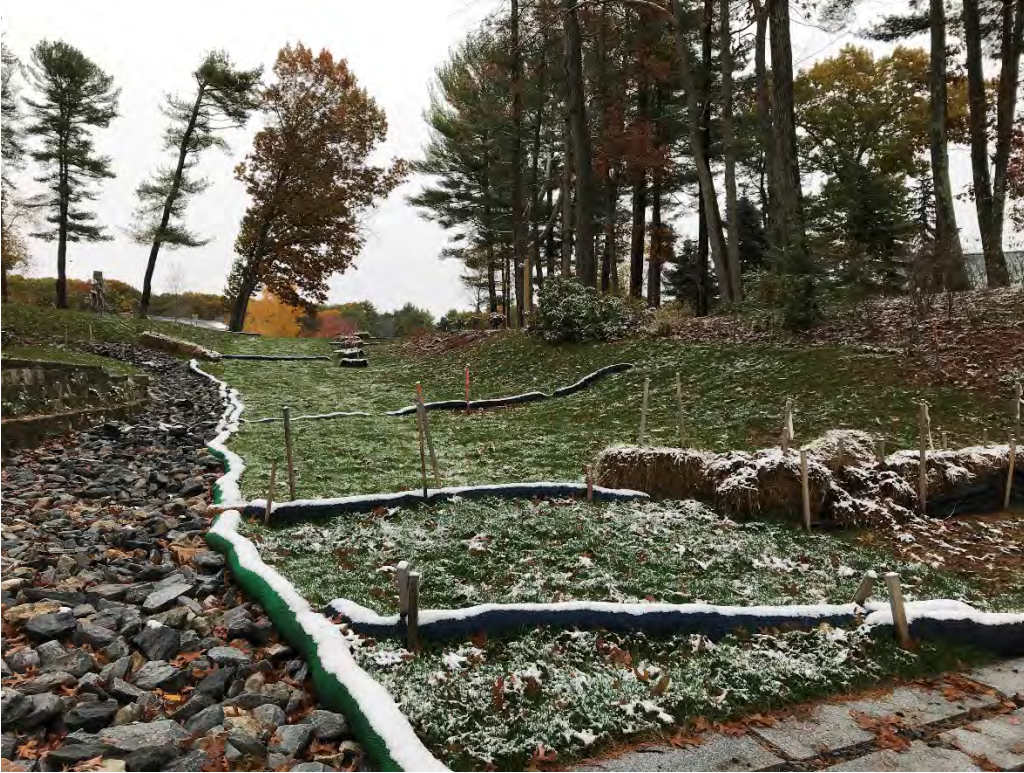
Fig 3: Slope above the manhole at Gundalow Landing/east side of the bay. Viewing east. (10-30-20)

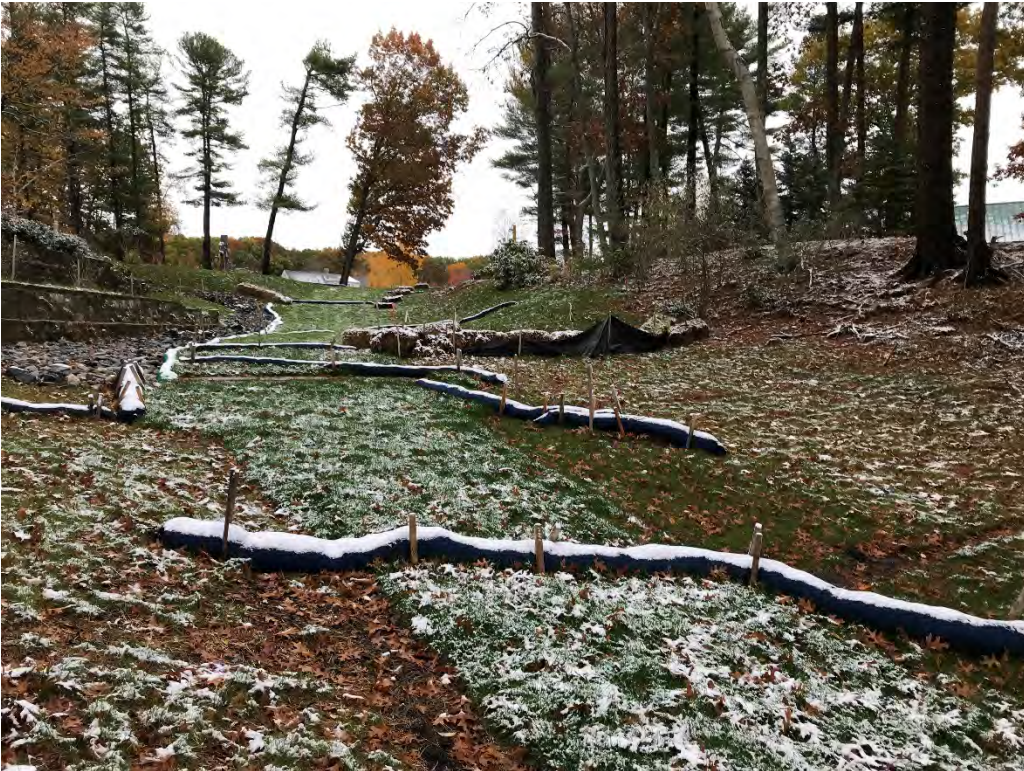
Fig 4: Slope below the manhole at Gundalow Landing/east side of the bay. Viewing east. (10-30-20)

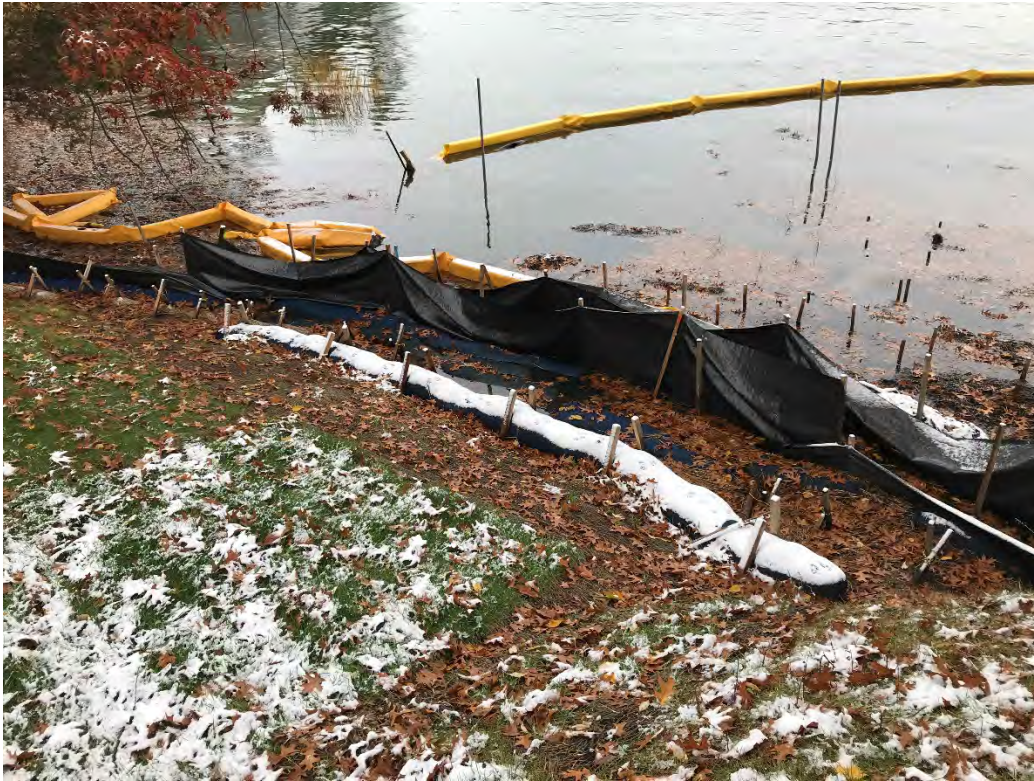
Fig 5: Toe of the slope at Gundalow Landing/east side of the bay. Viewing south. (10-30-20)

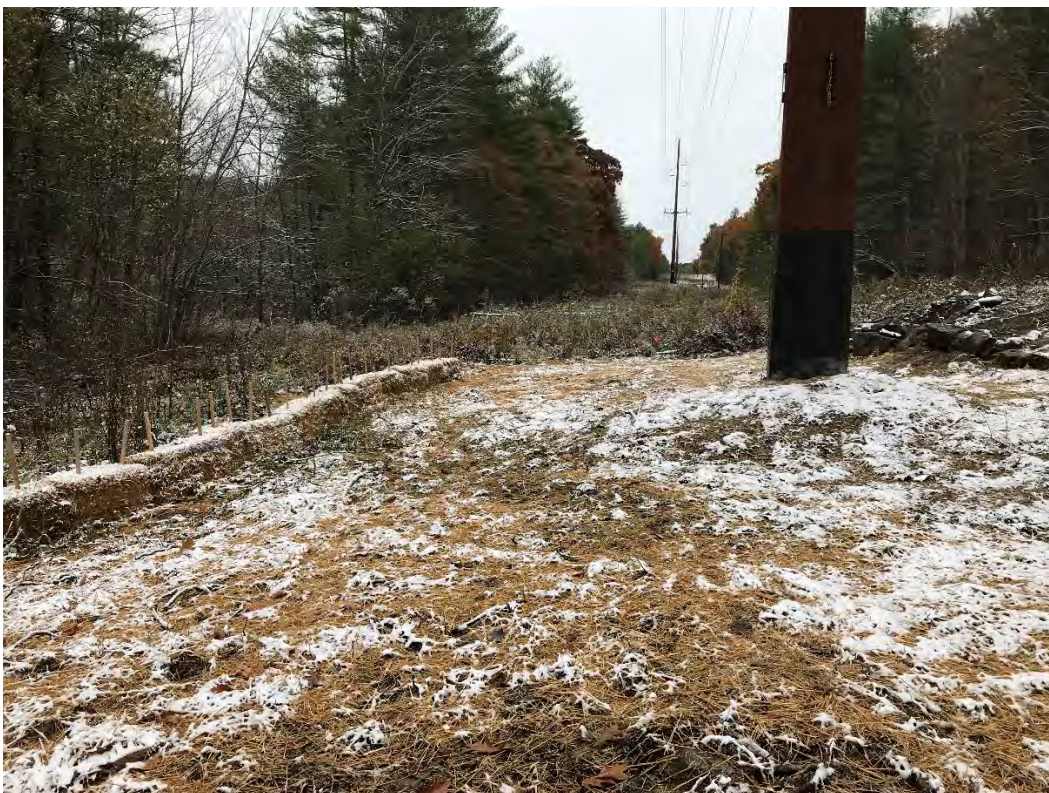
Fig 6: Restored and straw mulched Str. 89 work area. (10-30-20)

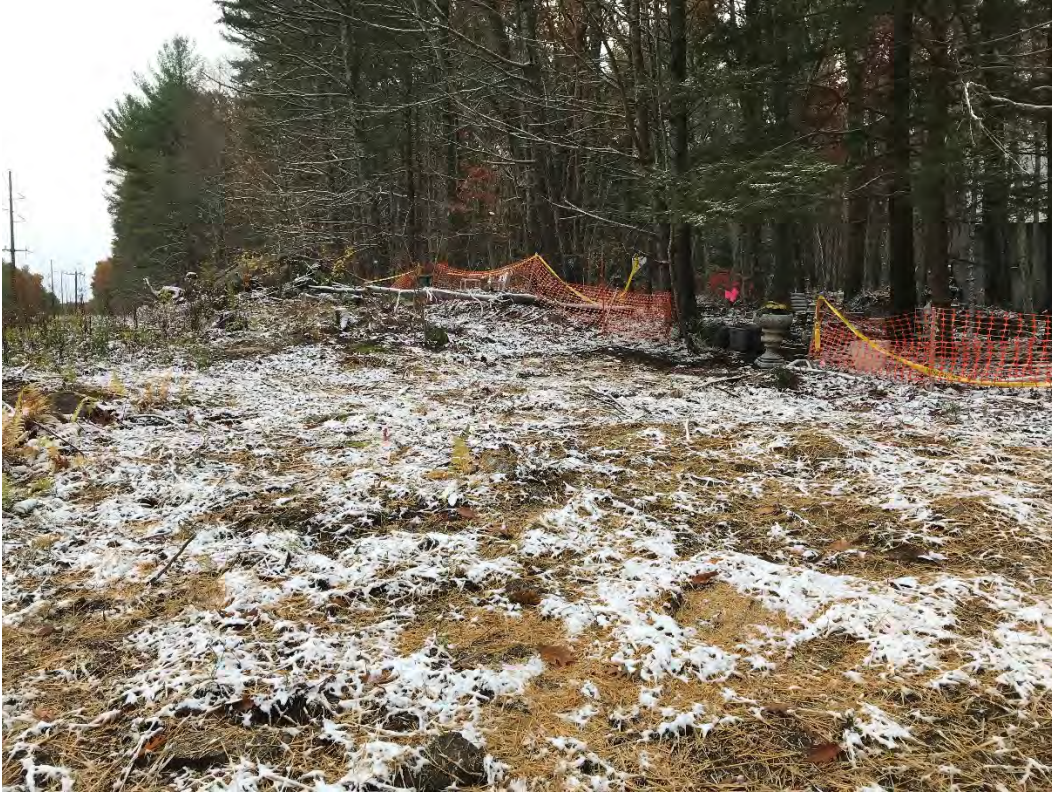
Fig 7: Restored and straw mulched access route southwest of Str. 89. Viewing south. (10-30-20)

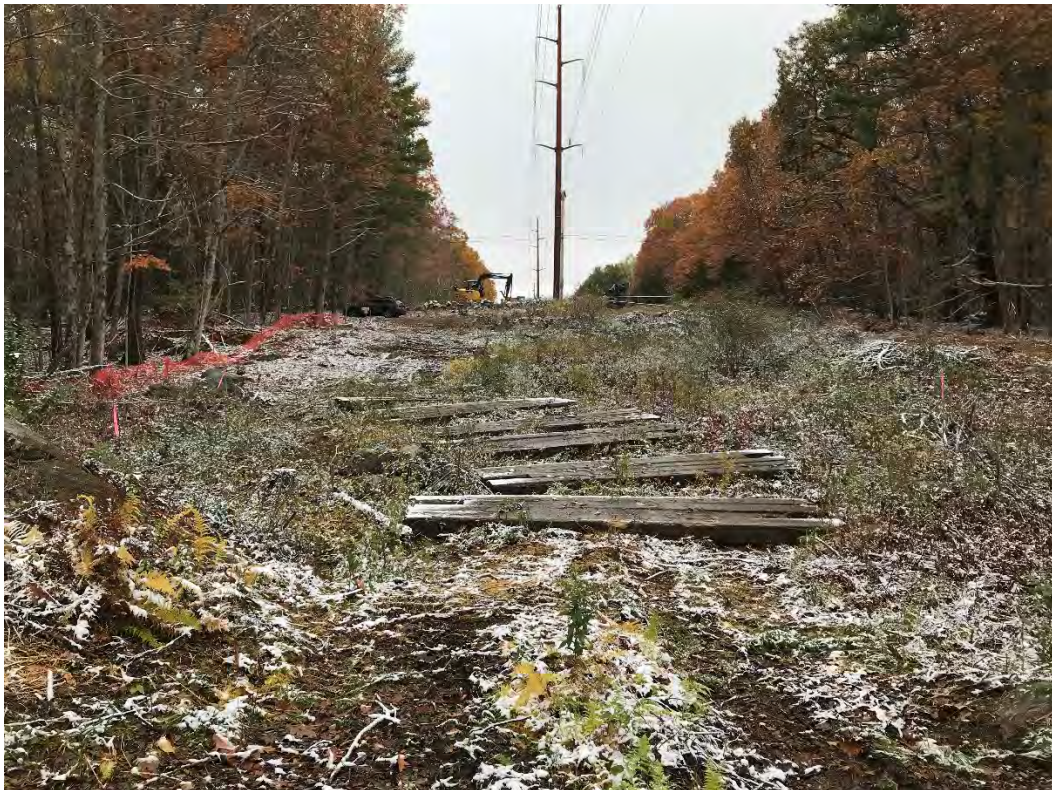
Fig 8: Matted access route across wetland DW22. Viewing southeast. (10-30-20)

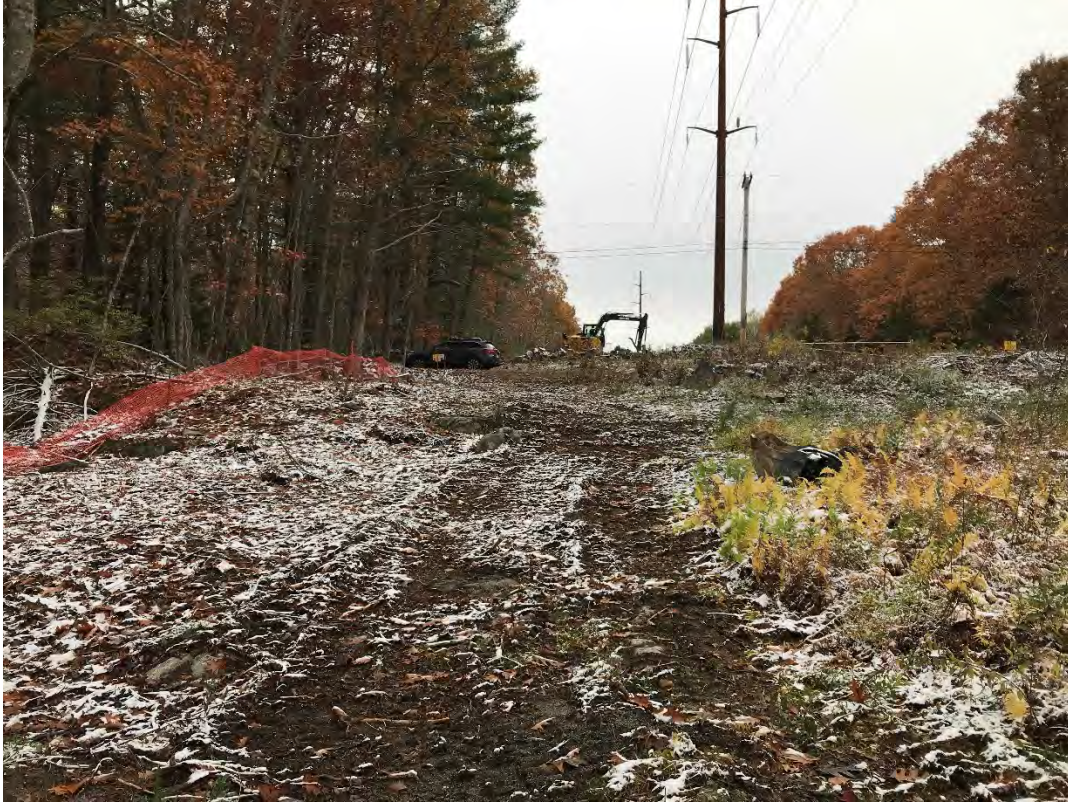
Fig 9: Access leading from wetland DW22 to Longmarsh Rd. Viewing northwest. (10-30-20)
