DRAINAGE MONITORING REPORT

F107 - Seacoast Reliability Project

Newington, New Hampshire

04.0190967.00

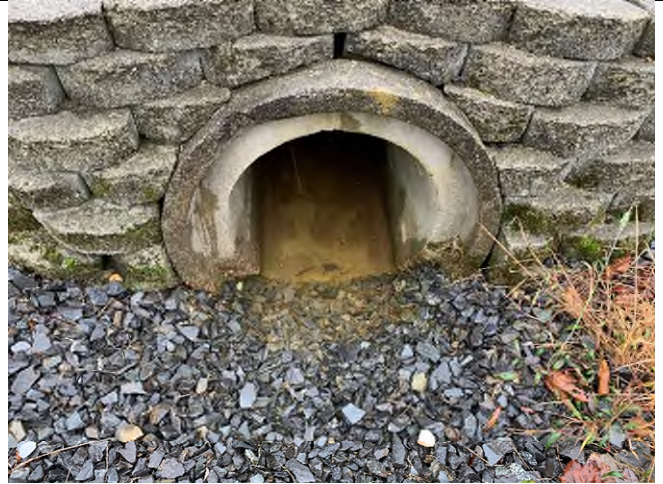
29 Gundalow - 2 (Culvert)

Observations/Notes: Standing water observed in the culvert and extending approx. 10" beyond culvert inlet into stone area, approx. max depth 3.5"

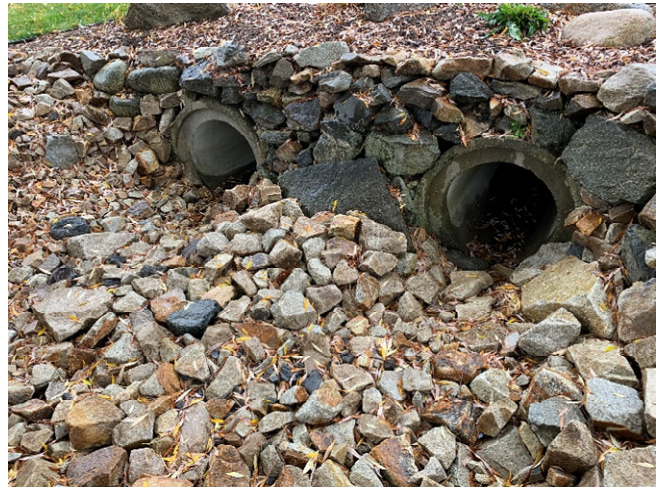
64 Gundalow - 2 (Drainage Course)

Observations/Notes: Small area of standing water in stone riprap approx. 3" deep

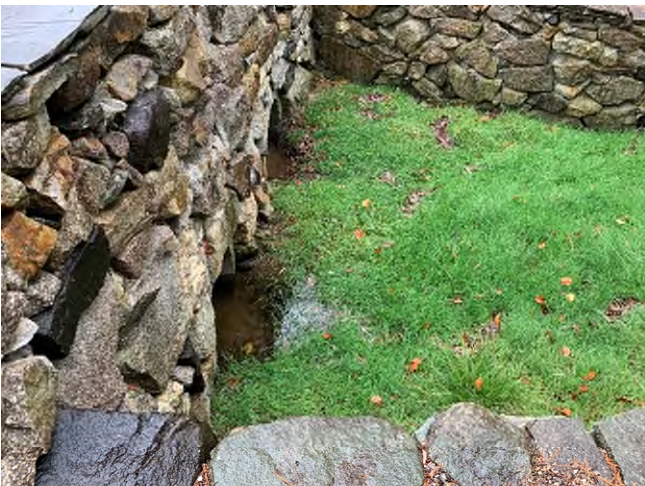
4 Brickyard Circle - 1 (Drainage Course)

Observations/Notes: Standing water extending approx. 24" beyond culvert outlet, approx. 10" deep

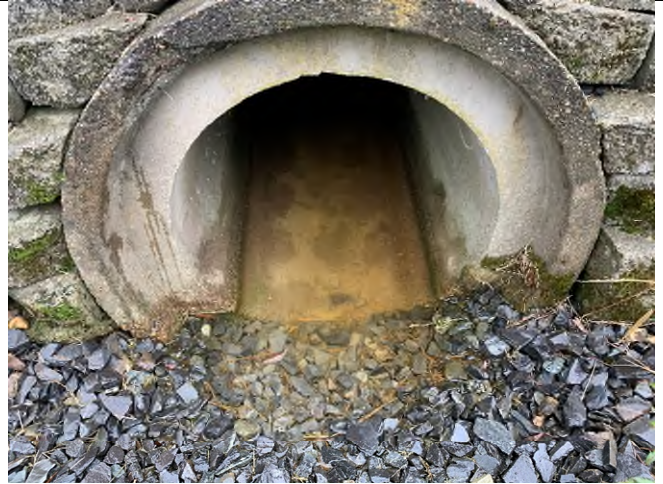
29 Gundalow - 2 (Culvert)

Observations/Notes: Standing water observed in the culvert and extending approx. 12" beyond culvert inlet into stone area, approx. max depth 3.5"

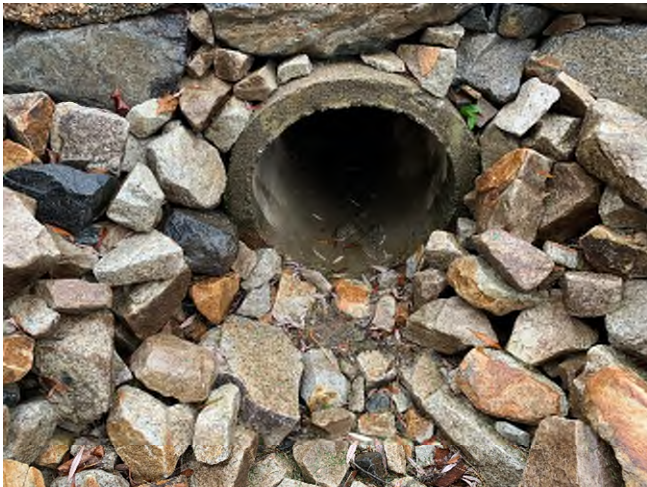
64 Gundalow - 1 (Drainage Course)

Observations/Notes: Approx. 0.25" standing water at culvert outlet, not enough to obtain reading

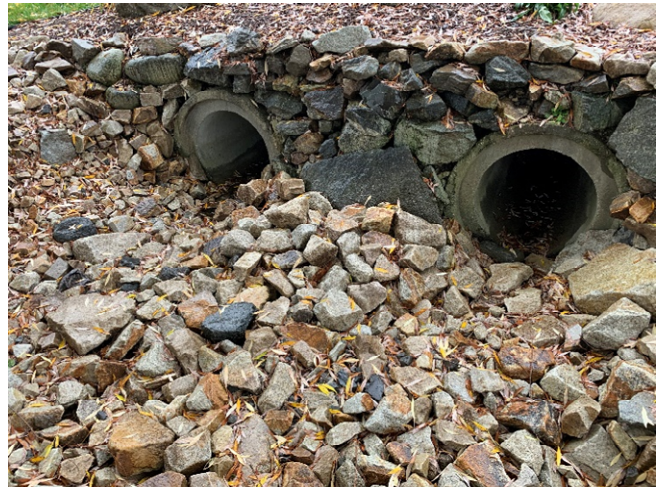
64 Gundalow - 2 (Drainage Course)

Observations/Notes: Small area of standing water in stone riprap approx. 3" deep

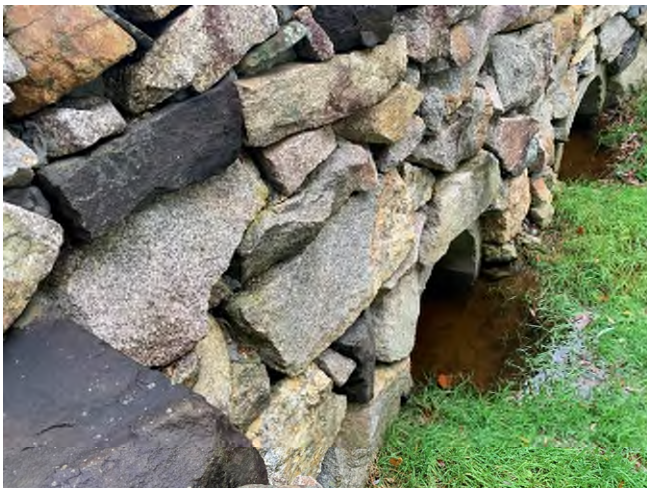
4 Brickyard Circle - 1 (Drainage Course)

Observations/Notes: Standing water extending approx. 24" beyond culvert outlet, approx. 10" deep

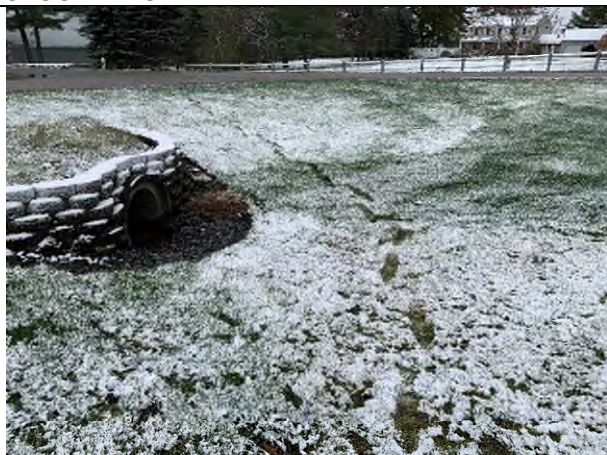
29 Gundalow - 1 (Drainage Area)

Observations/Notes: Some areas of saturated soil but no standing water

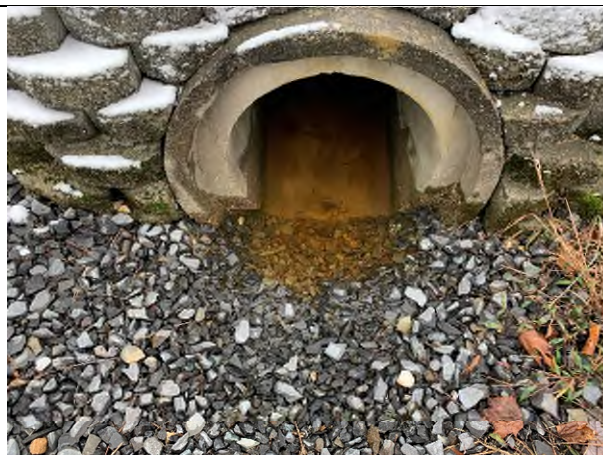
29 Gundalow - 2 (Culvert)

Observations/Notes: Water observed in the culvert and extending approx. 12" beyond culvert inlet into stone area, approx. max depth 5"

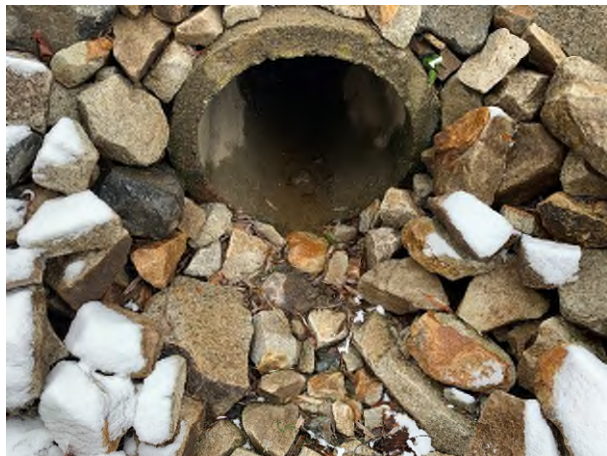
64 Gundalow - 1 (Drainage Course)

Observations/Notes: ****Measurement taken from just inside culvert outlet as water entering drainage course was inaccessible under stone riprap, water approx. 0.5" deep**

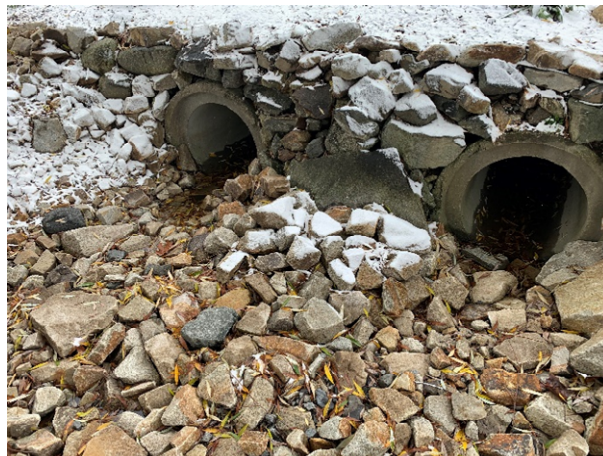
64 Gundalow - 2 (Drainage Course)

Observations/Notes: Large area of standing water in stone riprap approx. 5" deep

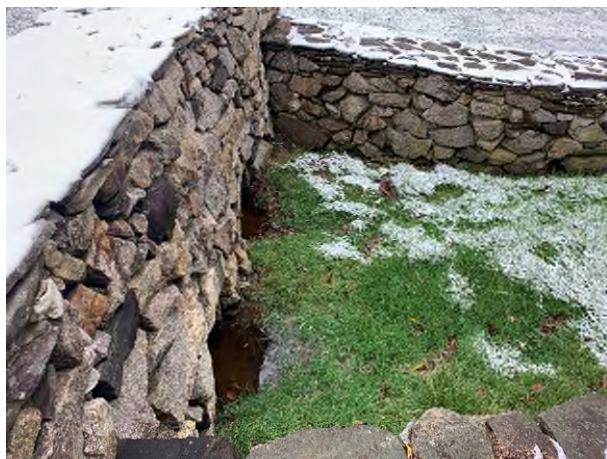
4 Brickyard Circle - 1 (Drainage Course)

Observations/Notes: Standing water extending approx. 24" beyond culvert outlet, approx. 12" deep

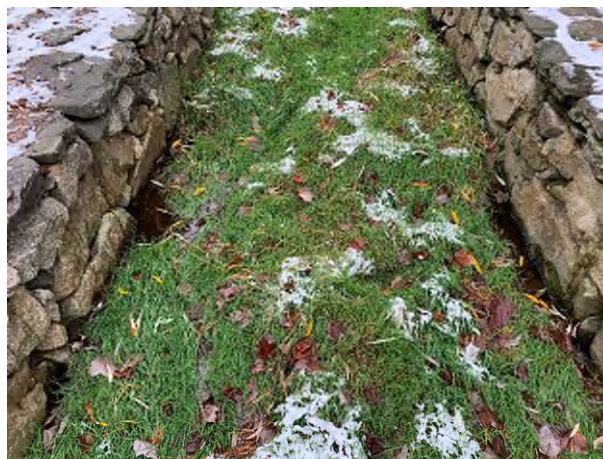
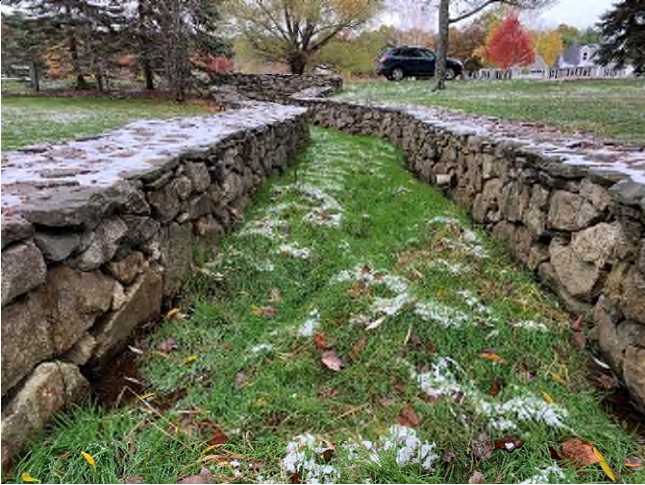
4 Brickyard Circle - 2 (Drainage Course)

Observations/Notes: Water running along east wall of raceway, approx. 2" deep

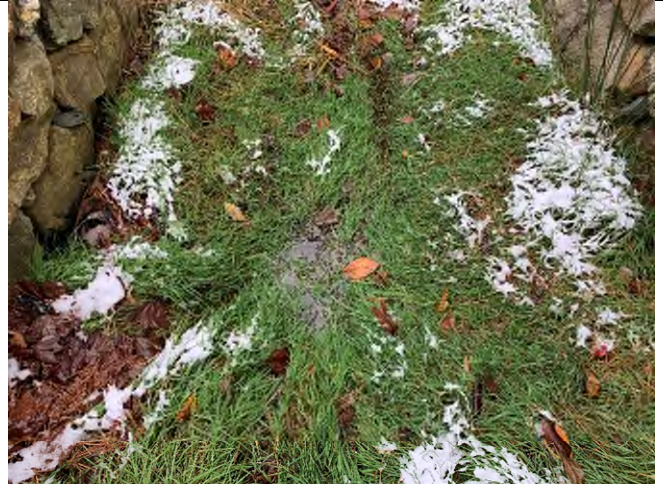
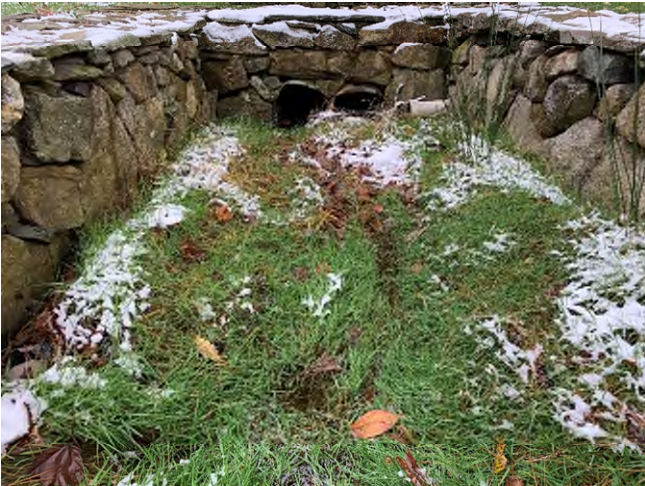
4 Brickyard – 3 (Drainage Area)

Observations/Notes: Small area of water in center of raceway, approx. 3" deep
