# DRAINAGE MONITORING REPORT

## F107 - Seacoast Reliability Project

### Newington, New Hampshire

04.0190967.00

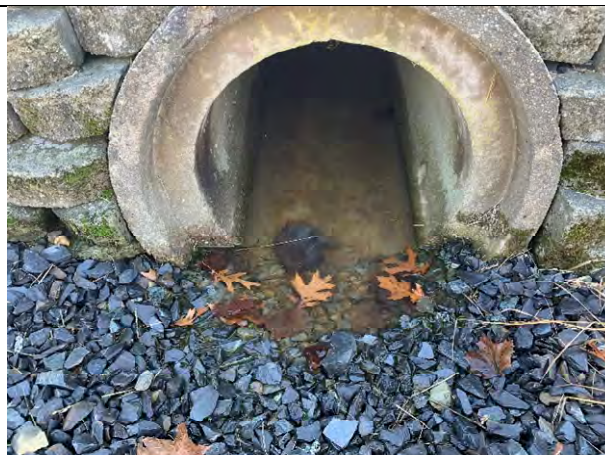
29 Gundalow - 2 (Culvert)

pH: 12.5

Observations/Notes: Water observed in the culvert and extending approx. 8" beyond culvert inlet into stone area, approx. max depth 4"

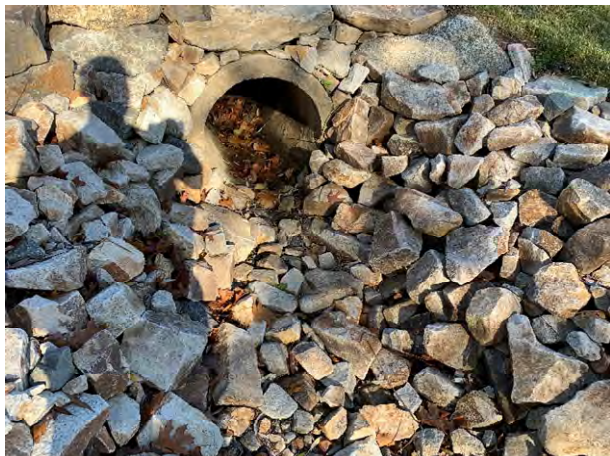
64 Gundalow - 1 (Drainage Course)

pH: \*\*11.1

Observations/Notes: \*\*Measurement taken from standing water just inside culvert outlet (no standing water in drainage course), water approx. 0.5" deep.

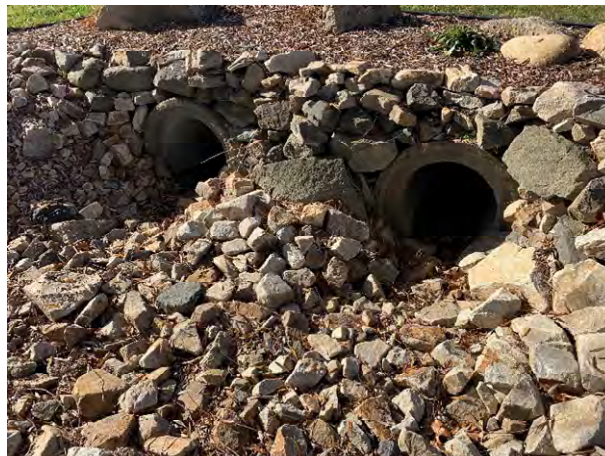
64 Gundalow - 2 (Drainage Course)

pH: 7.5

Observations/Notes: Small area of standing water in stone riprap approx. 3" deep. No visible flow through culvert.

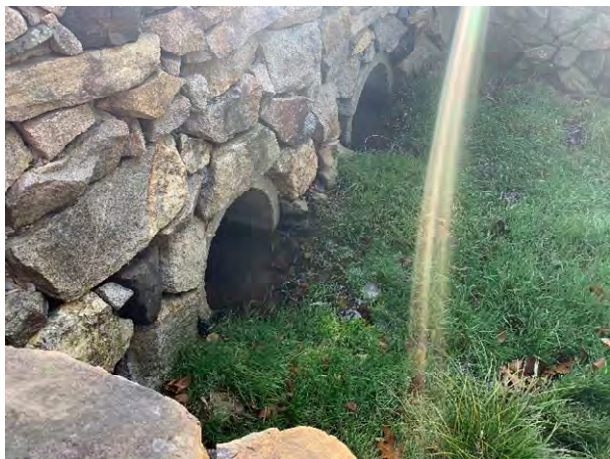
4 Brickyard Circle - 1 (Drainage Course)

pH: 7.2

Observations/Notes: Standing water extending approx. 20" beyond culvert outlet, approx. 10" deep. No visible flow through culvert.

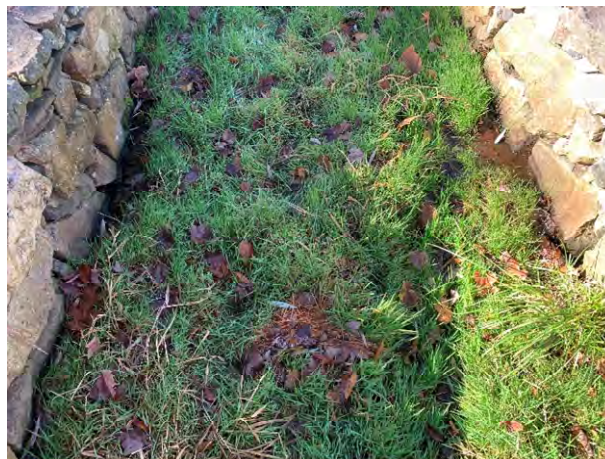
4 Brickyard Circle - 2 (Drainage Course)

pH: 7.3

Observations/Notes: Standing water adjacent to east wall of raceway, approx. 2" deep. No visible flow.

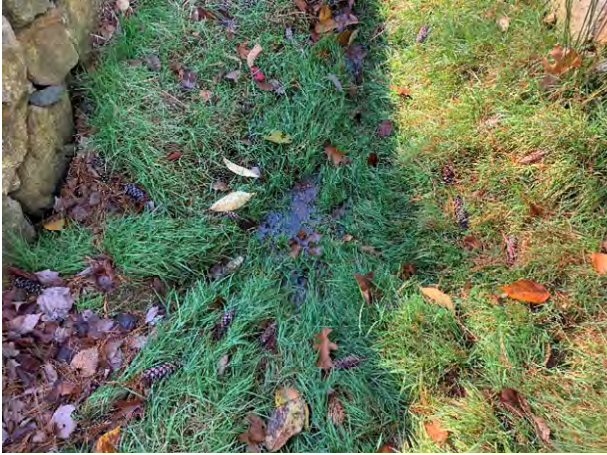
4 Brickyard Circle – 3 (Drainage Area)

pH: 7.2

Observations/Notes: Small area of standing water in center of raceway, approx. 3" deep. No visible flow.

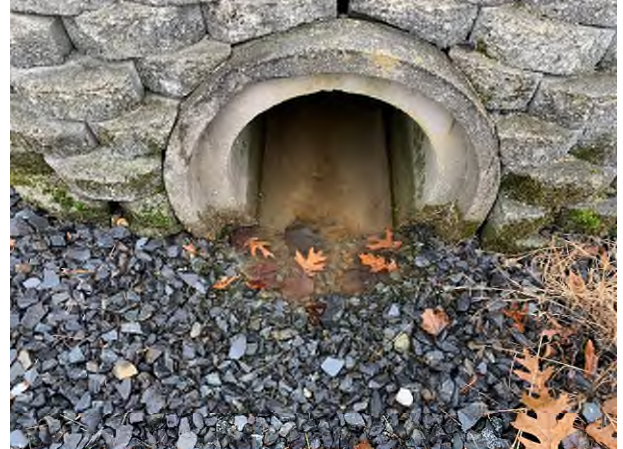
29 Gundalow - 2 (Culvert)

pH: 12.5

Observations/Notes: Water observed in the culvert and extending approx. 8" beyond culvert inlet into stone area, approx. max depth 4"

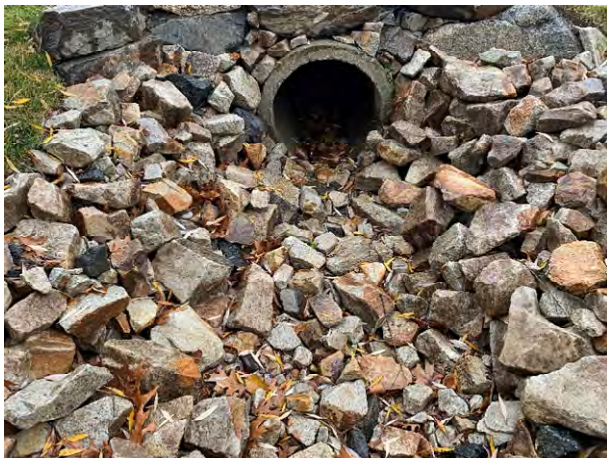
64 Gundalow - 1 (Drainage Course)

pH: \*\*10.6

Observations/Notes: \*\*Measurement taken from standing water just inside culvert outlet (no standing water in drainage course), water approx. 0.5" deep.

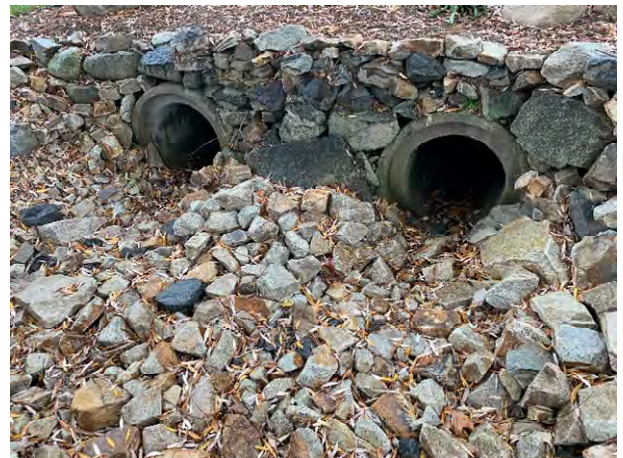
64 Gundalow - 2 (Drainage Course)

pH: 7.3

Observations/Notes: Small area of standing water in stone riprap approx. 3" deep. No visible flow through culvert.

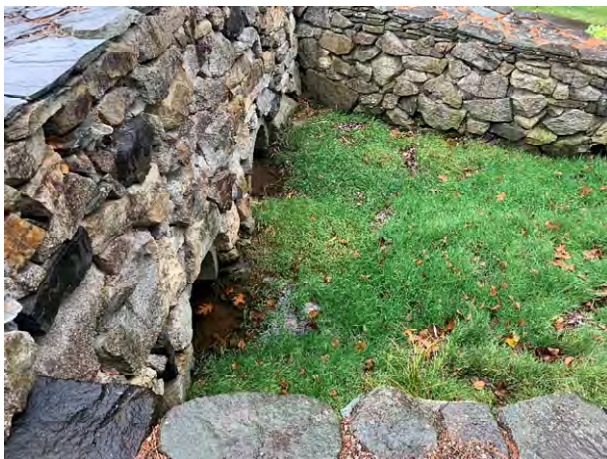
4 Brickyard Circle - 1 (Drainage Course)

pH: 6.8

Observations/Notes: Standing water extending approx. 20" beyond culvert outlet, approx. 10" deep. No visible flow through culvert.

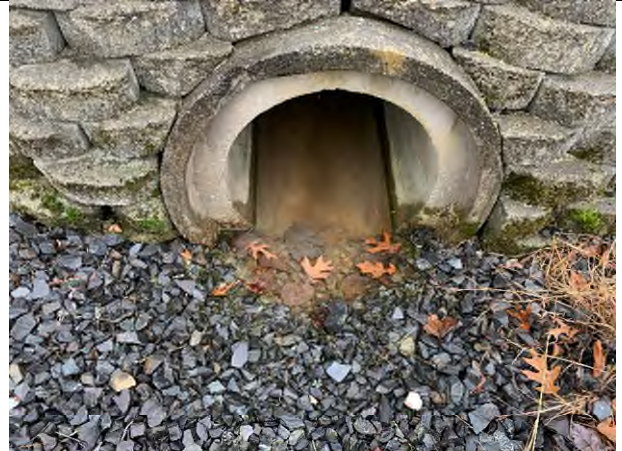
29 Gundalow - 2 (Culvert)

pH: 12.4

Observations/Notes: Water observed in the culvert and extending approx. 8" beyond culvert inlet into stone area, approx. max depth 4"

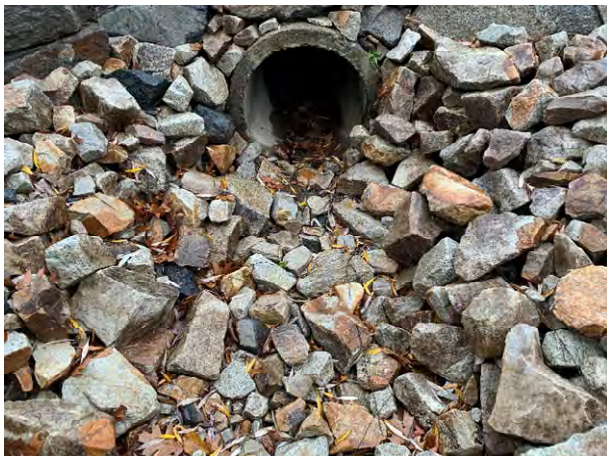
64 Gundalow - 1 (Drainage Course)

pH: \*\*10.4

Observations/Notes: \*\*Measurement taken from standing water just inside culvert outlet (no standing water in drainage course), water approx. 0.5" deep.

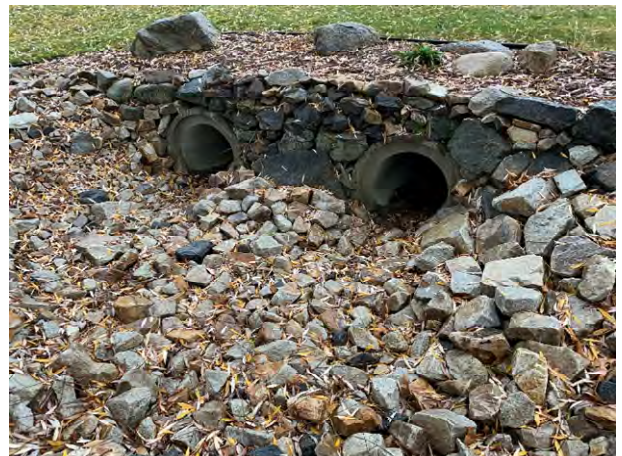
64 Gundalow - 2 (Drainage Course)

pH: 7.3

Observations/Notes: Small area of standing water in stone riprap approx. 3" deep. No visible flow through culvert.

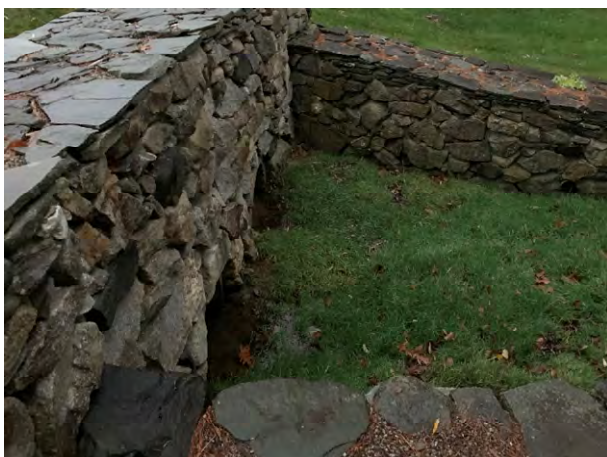
4 Brickyard Circle - 1 (Drainage Course)

pH: 7.3

Observations/Notes: Standing water extending approx. 20" beyond culvert outlet, approx. 10" deep. No visible flow through culvert.

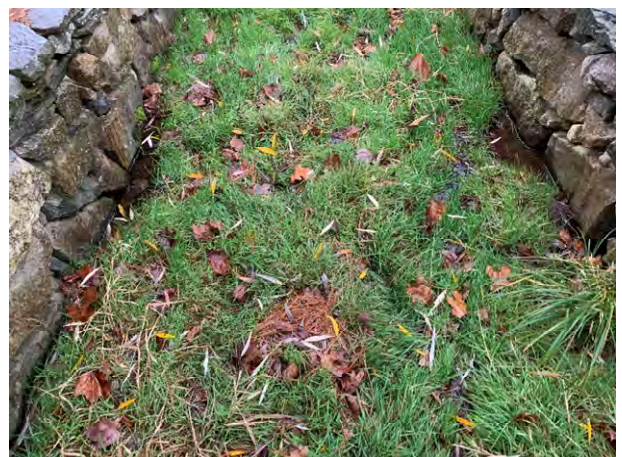
4 Brickyard Circle - 2 (Drainage Course)

pH: 7.3

Observations/Notes: Standing water adjacent to east wall of raceway, approx. 2" deep. No visible flow.

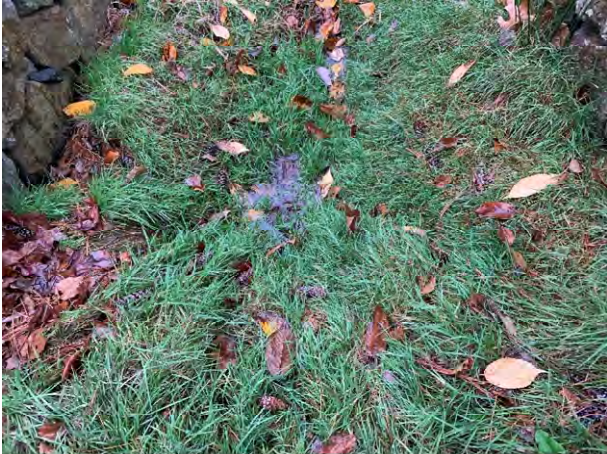
4 Brickyard Circle – 3 (Drainage Course)

pH: 7.2

Observations/Notes: Small area of standing water in center of raceway, approx. 3" deep. No visible flow.
