DRAINAGE MONITORING REPORT

F107 - Seacoast Reliability Project

Newington, New Hampshire

04.0190967.00

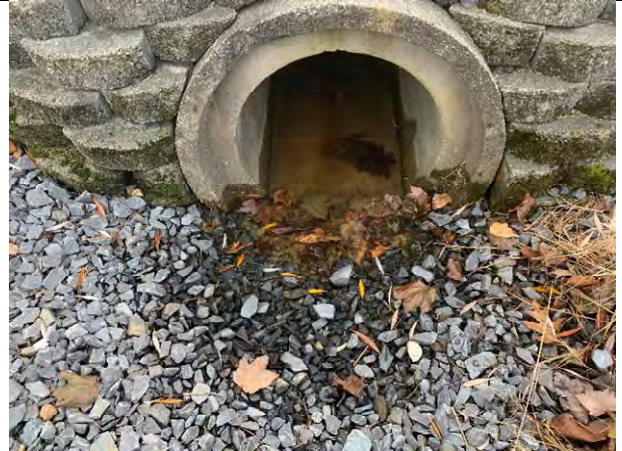
29 Gundalow - 2 (Culvert)

pH: 12.6

Observations/Notes: Water observed in the culvert and extending approx. 8" beyond culvert inlet into stone area, approx. max depth 4". No visible flow.

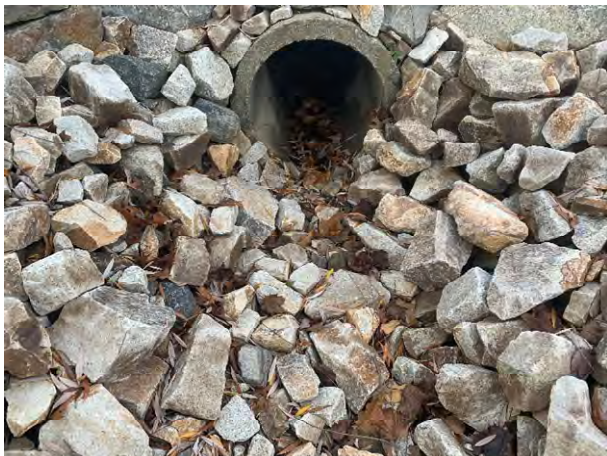
64 Gundalow - 1 (Drainage Course)

pH: **12.3

Observations/Notes: **Measurement taken from standing water just inside culvert outlet (no standing water in drainage course), water approx. 0.5" deep. No visible flow.

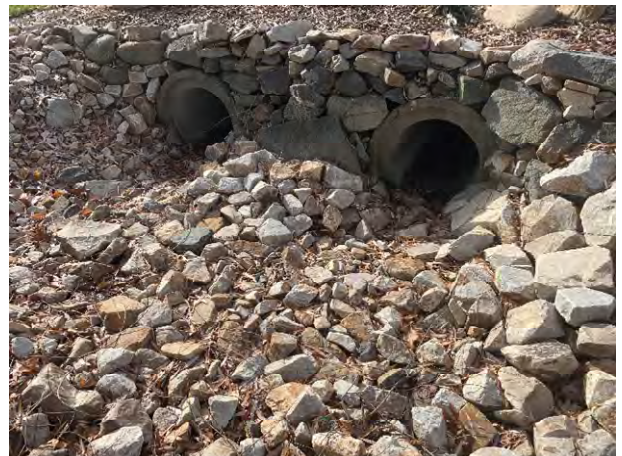
64 Gundalow - 2 (Drainage Course)

pH: 10.4

Observations/Notes: Small area of standing water in stone riprap approx. 3" deep. No visible flow through culvert.

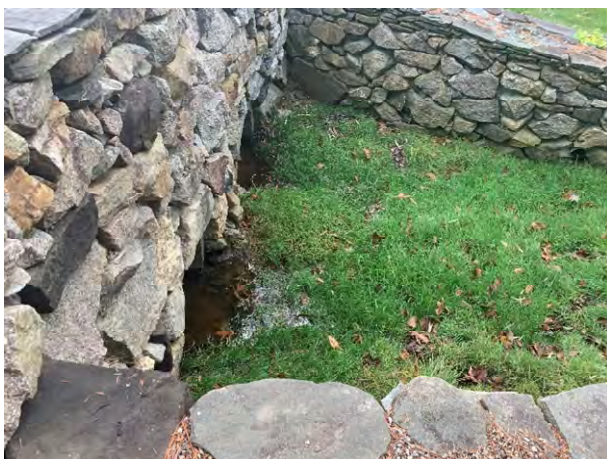
4 Brickyard Circle - 1 (Drainage Course)

pH: 9.6

Observations/Notes: Standing water extending approx. 20" beyond culvert outlet, approx. 10" deep. No visible flow through culvert.

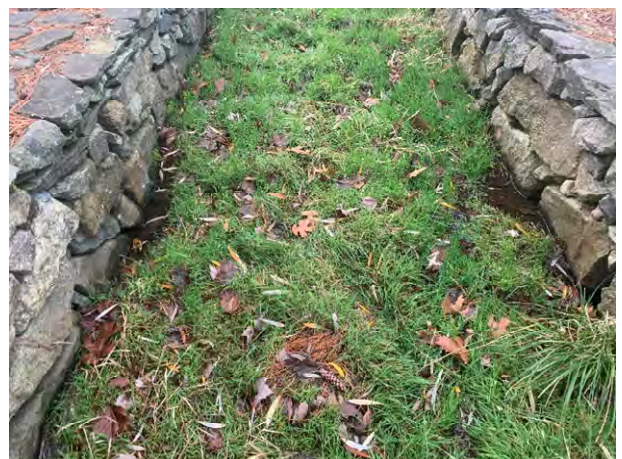
4 Brickyard Circle - 2 (Drainage Course)

pH: 7.8

Observations/Notes: Standing water adjacent to east wall of raceway, approx. 2" deep. No visible flow.

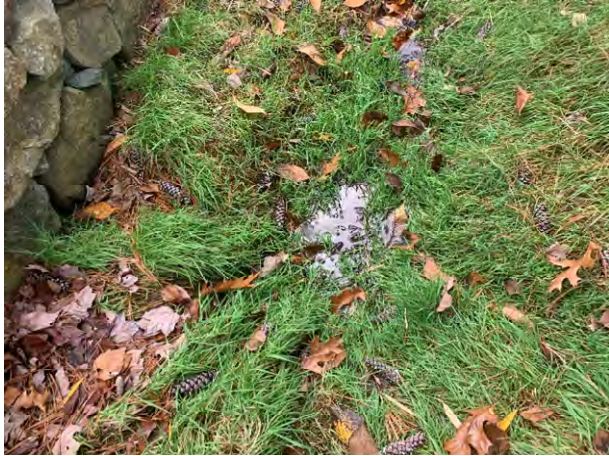
4 Brickyard Circle – 3 (Drainage Course)

pH: 7.6

Observations/Notes: Small area of standing water in center of raceway, approx. 3" deep. No visible flow.

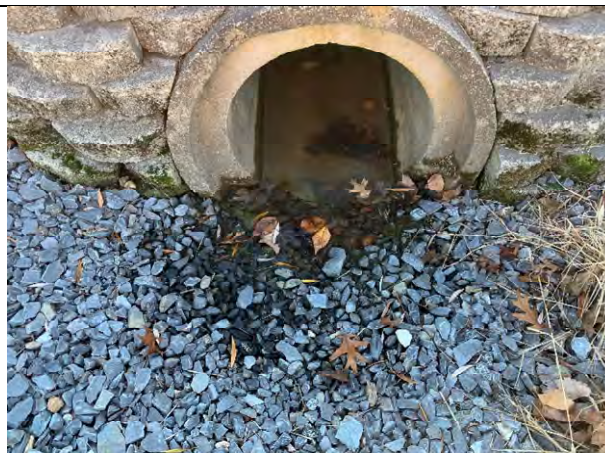
29 Gundalow - 2 (Culvert)

pH: 12.8

Observations/Notes: Water observed in the culvert and extending approx. 8" beyond culvert inlet into stone area, approx. max depth 4". No visible flow. Dull gray film observed on water surface.

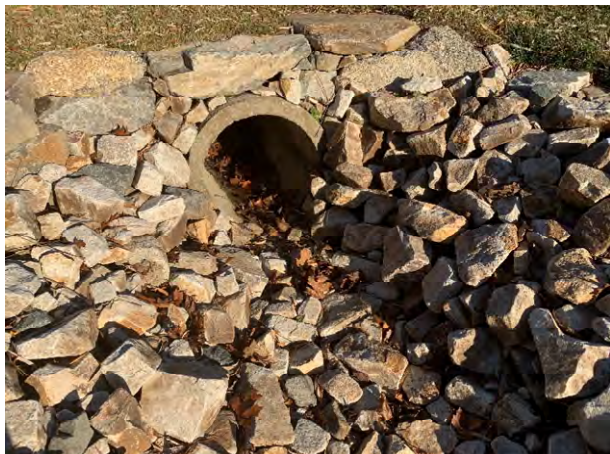
64 Gundalow - 1 (Drainage Course)

pH: **12.7

Observations/Notes: **Measurement taken from standing water just inside culvert outlet (no standing water in drainage course), water approx. 0.5" deep. No visible flow.

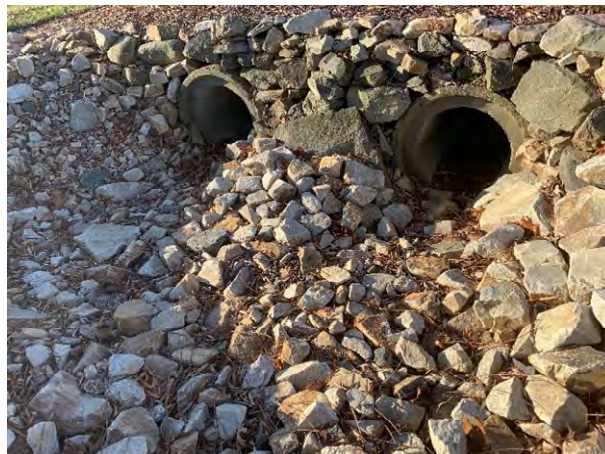
64 Gundalow - 2 (Drainage Course)

pH: 9.4

Observations/Notes: Small area of standing water in stone riprap approx. 3" deep. No visible flow through culvert.

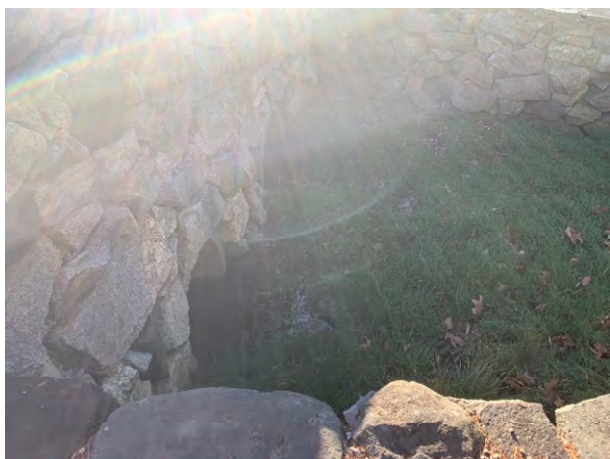
4 Brickyard Circle - 1 (Drainage Course)

pH: 7.2

Observations/Notes: Standing water extending approx. 20" beyond culvert outlet, approx. 10" deep. No visible flow through culvert.

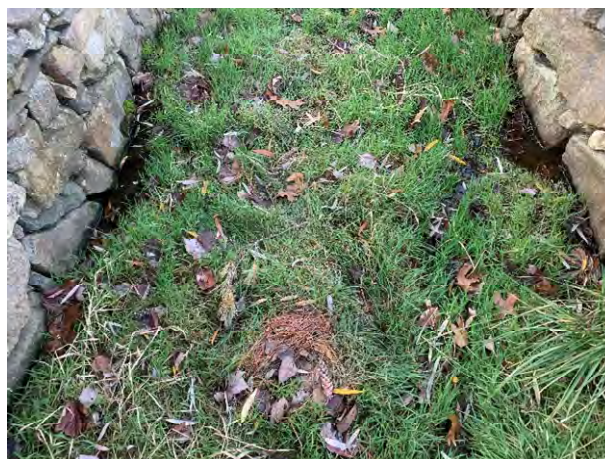
4 Brickyard Circle - 2 (Drainage Course)

pH: 7.6

Observations/Notes: Standing water adjacent to east wall of raceway, approx. 2" deep. No visible flow.

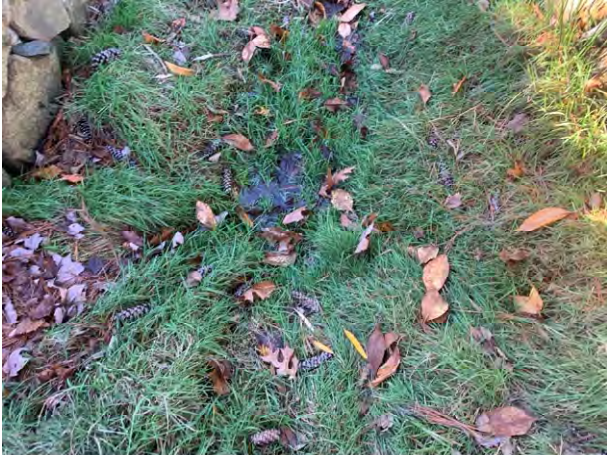
4 Brickyard Circle – 3 (Drainage Course)

pH: 7.5

Observations/Notes: Small area of standing water in center of raceway, approx. 3" deep. No visible flow.

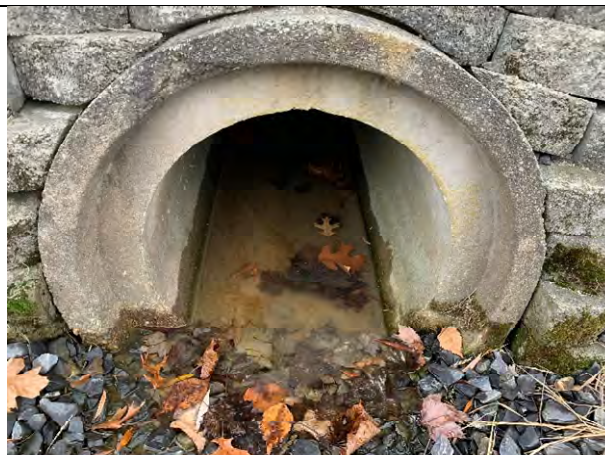
29 Gundalow - 2 (Culvert)

pH: **12.8**

Observations/Notes: Water observed in the culvert and extending approx. 8" beyond culvert inlet into stone area, approx. max depth 4". No visible flow. Dull gray film observed on water surface.

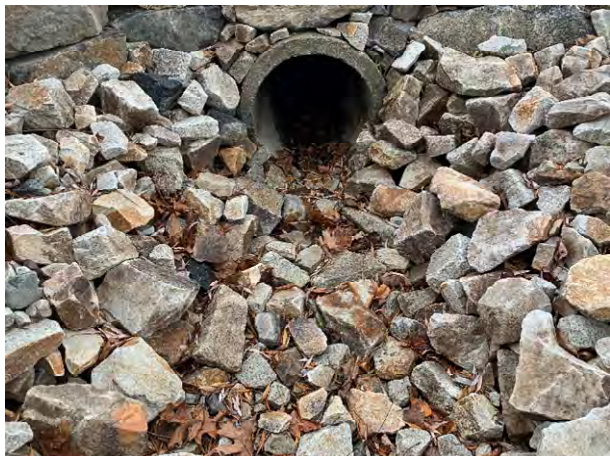
64 Gundalow - 1 (Drainage Course)

pH: ****12.4**

Observations/Notes: **Measurement taken from standing water just inside culvert outlet (no standing water in drainage course), water approx. 0.5" deep. No visible flow.

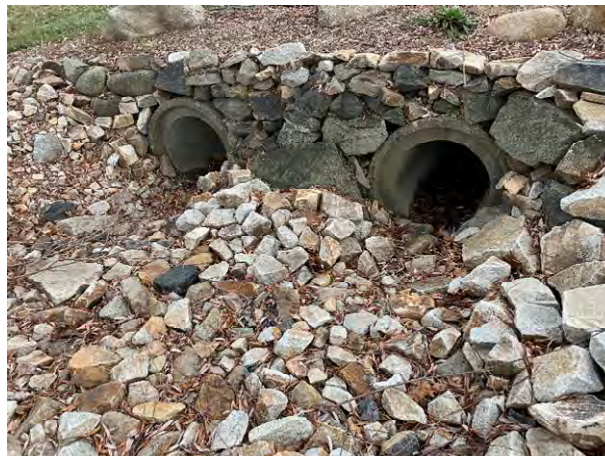
64 Gundalow - 2 (Drainage Course)

pH: **9.0**

Observations/Notes: Small area of standing water in stone riprap approx. 3" deep. No visible flow through culvert.

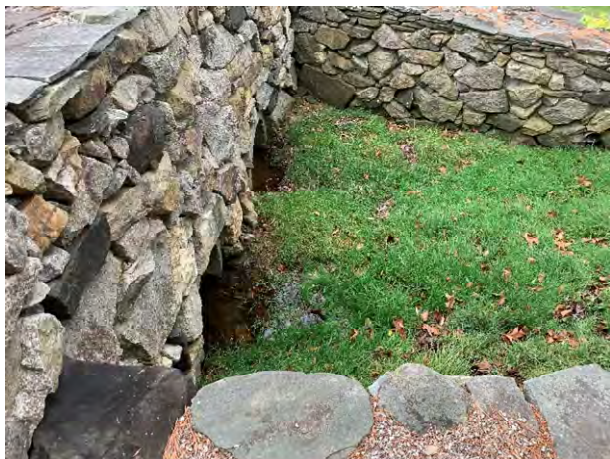
4 Brickyard Circle - 1 (Drainage Course)

pH: **7.1**

Observations/Notes: Standing water extending approx. 18" beyond culvert outlet, approx. 8" deep. No visible flow through culvert.

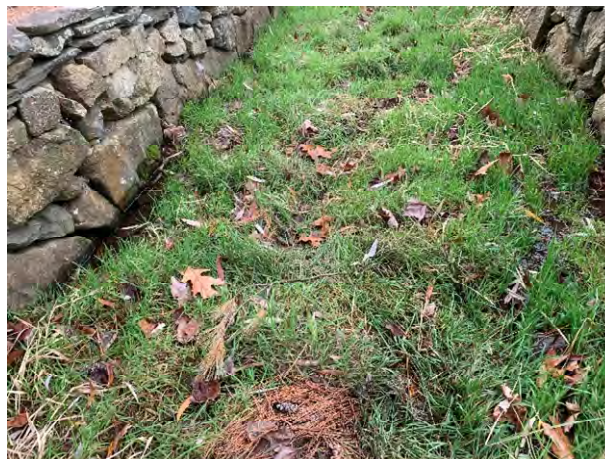
4 Brickyard Circle - 2 (Drainage Course)

pH: **7.5**

Observations/Notes: Standing water adjacent to east wall of raceway, approx. 2" deep. No visible flow.

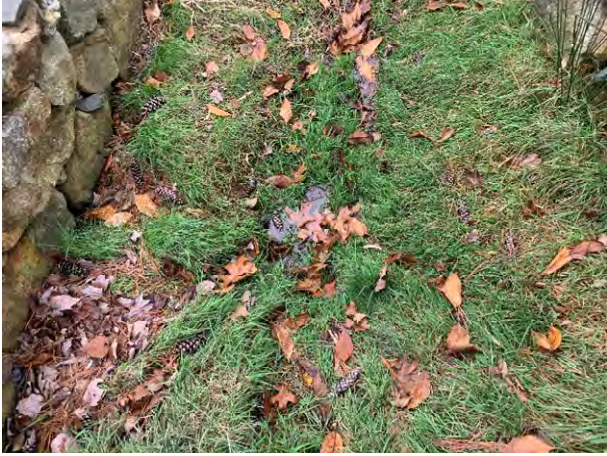
4 Brickyard Circle – 3 (Drainage Course)

pH: **7.4**

Observations/Notes: Small area of standing water in center of raceway, approx. 3" deep. No visible flow.
