### **CONSTRUCTION MONITORING REPORT**

Eversource Transmission Lines: F107

Eversource Seacoast Reliability Project

### Construction Monitoring Report #102

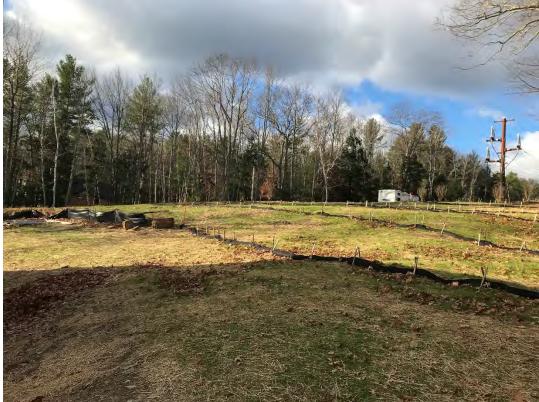
Fig 1: Slope above the cable house at the Eversource property/west side of the bay. Viewing southwest. (11-24-20)

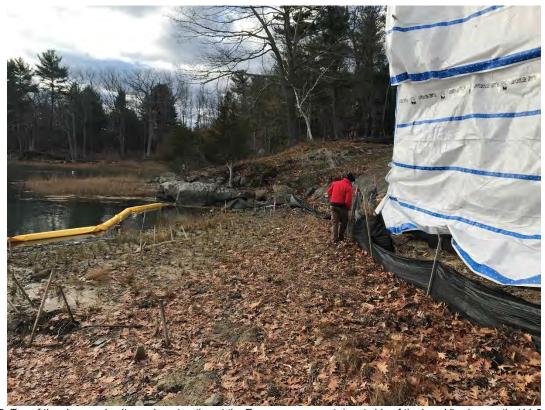
Fig 2: Toe of the slope and salt marsh restoration at the Eversource property/west side of the bay. Viewing south. (11-24-20)

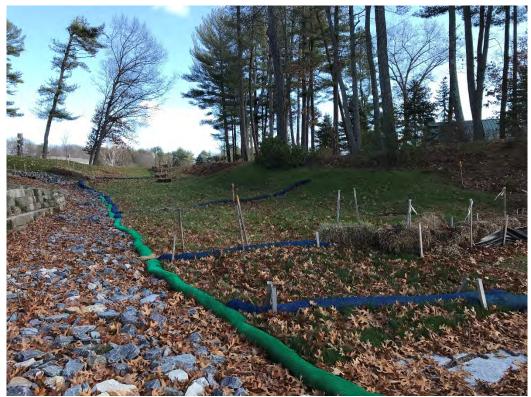
Fig 3: Slope above the manhole at Gundalow Landing/east side of the bay. Viewing east. (11-24-20)

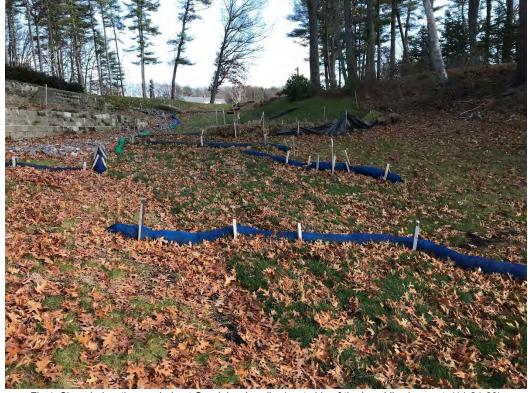
Fig 4: Slope below the manhole at Gundalow Landing/east side of the bay. Viewing east. (11-24-20)

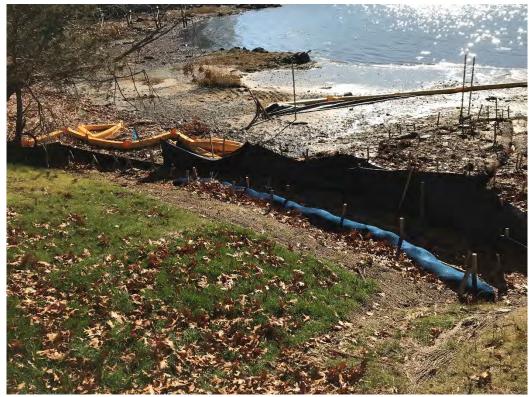
Fig 5: Toe of the slope at Gundalow Landing/east side of the bay. Viewing south. (11-24-20)

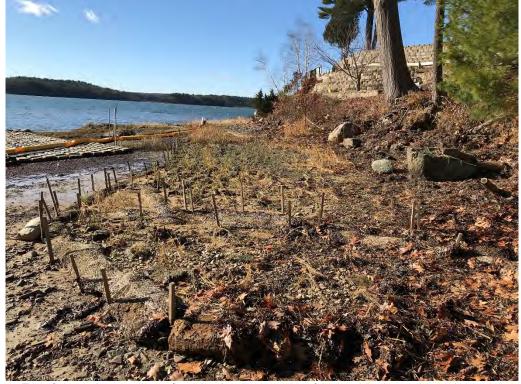
Fig 6: Salt marsh restoration at Gundalow Landing/east side of the bay. Viewing northwest. (11-24-20)

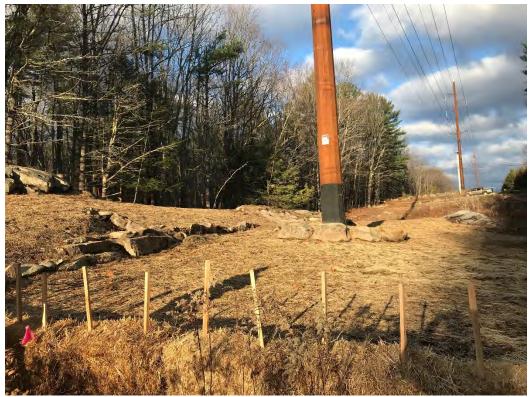
Fig 7: Str. 89 work area. Viewing northwest. (11-24-20)

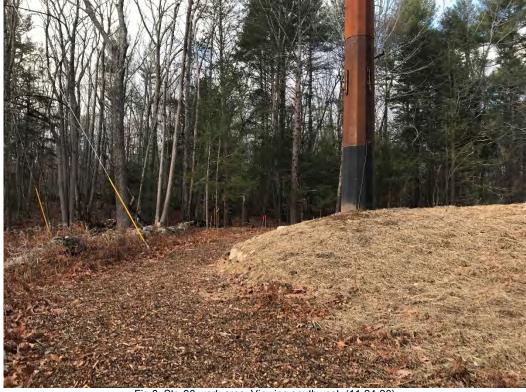
Fig 8: Str. 90 work area. Viewing southwest. (11-24-20)

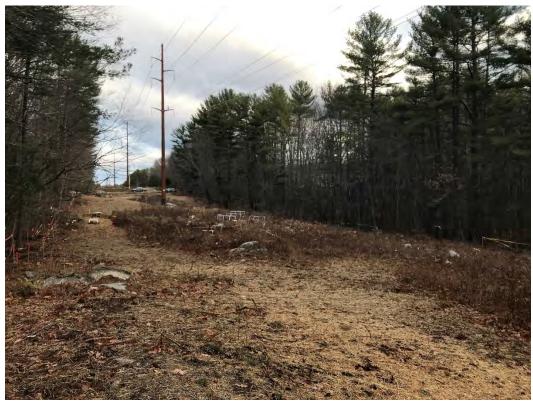
Fig 9: Access route between Strs. 90 and 89. Viewing northwest. (11-24-20)

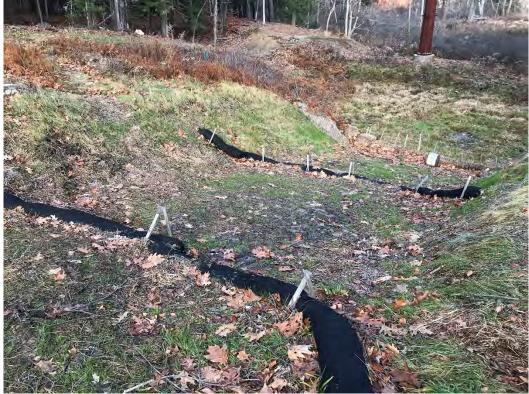
Fig 10: Slope between Strs. 28 and 29. Viewing north. (11-24-20)

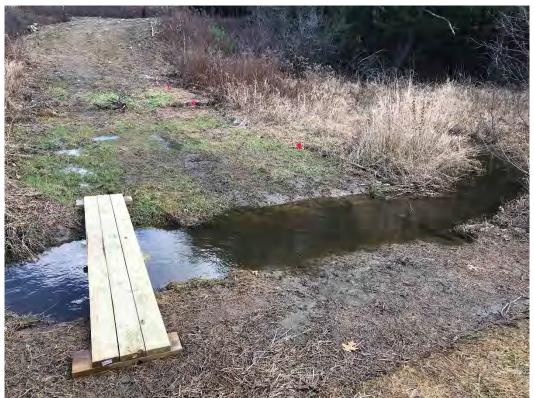
Fig 11: DS46 between Strs. 51 and 52. Footbridge installed by others. Viewing northeast. (11-24-20)

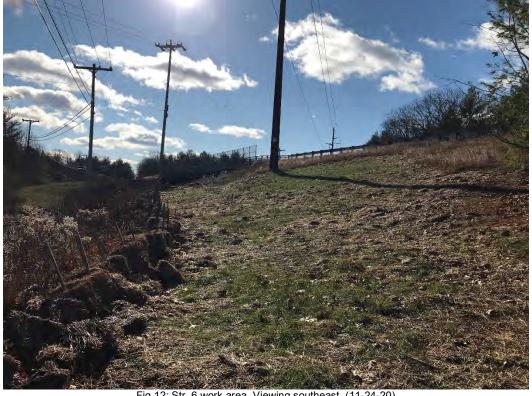
Fig 12: Str. 6 work area. Viewing southeast. (11-24-20)
