DRAINAGE MONITORING REPORT

F107 - Seacoast Reliability Project

Newington, New Hampshire

04.0190967.00

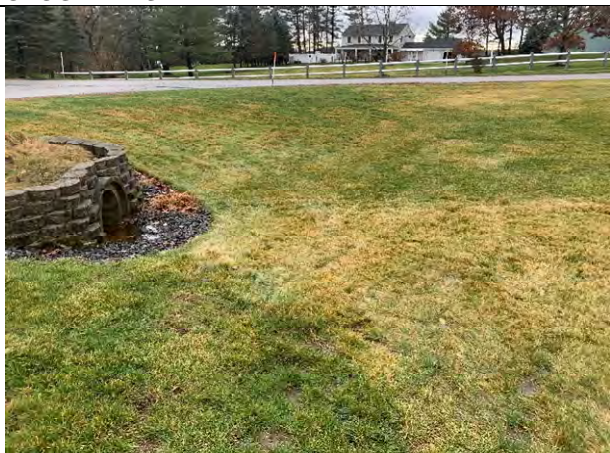
29 Gundalow - 1 (Drainage Area)

pH: **6.0**

Observations/Notes: Intermittent areas of standing water in grass, max depth approx. 0.5"

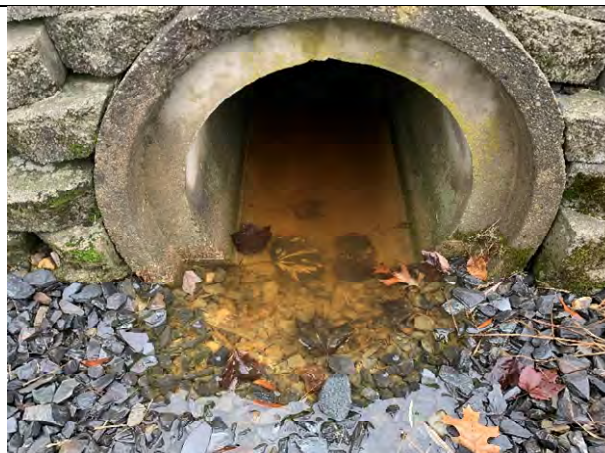
29 Gundalow - 2 (Culvert)

pH: **11.6**

Observations/Notes: Water extending approx. 12" beyond culvert inlet into stone area, approx. max depth 4". Flow visible through culvert. Precipitate observed on stone and leaf litter below water.

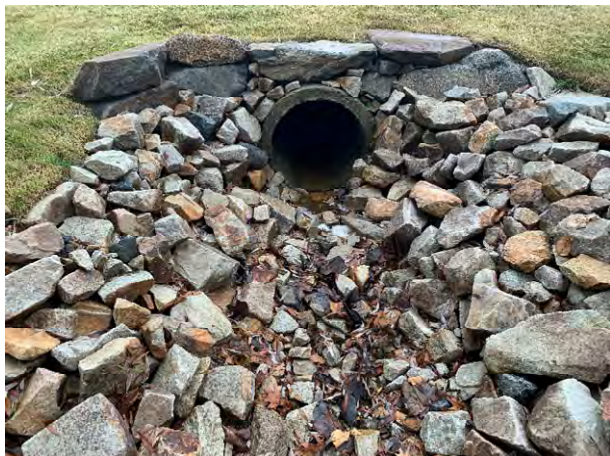
64 Gundalow - 1 (Drainage Course)

pH: **10.8**

Observations/Notes: Accessible flowing water extending approx. 8" from culvert outlet, approx. 1" deep.

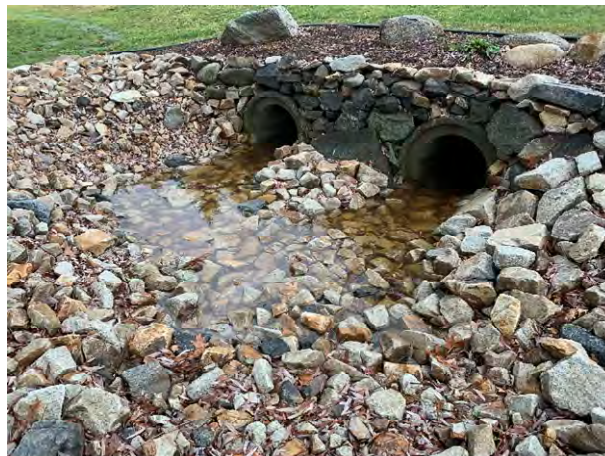
64 Gundalow - 2 (Drainage Course)

pH: **9.5**

Observations/Notes: Large area of pooled water extending approx. 6" from culvert inlets, max depth approx. 8". Visible flow through culverts.

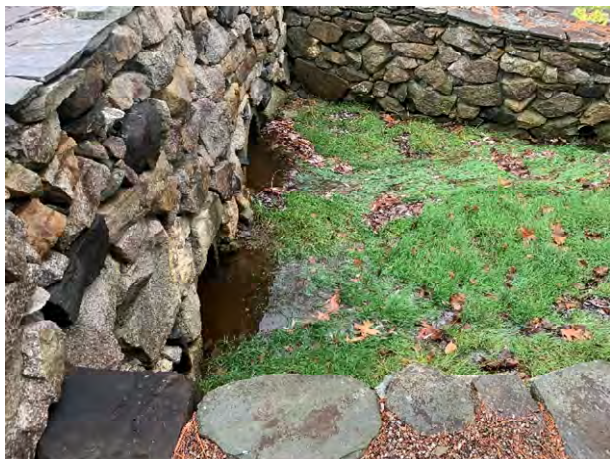
4 Brickyard Circle - 1 (Drainage Course)

pH: **9.0**

Observations/Notes: Water flowing through culvert with pools at outlet, max depth approx. 10". Visible flow through culvert and into raceway.

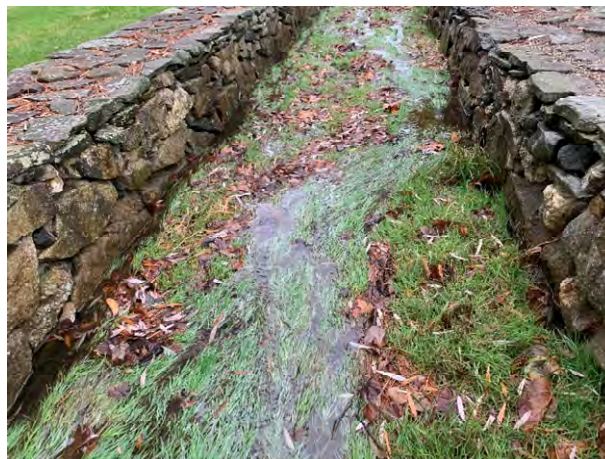
4 Brickyard Circle - 2 (Drainage Course)

pH: **7.6**

Observations/Notes: Water flowing through center and adjacent to east wall of raceway, approx. 4" deep.

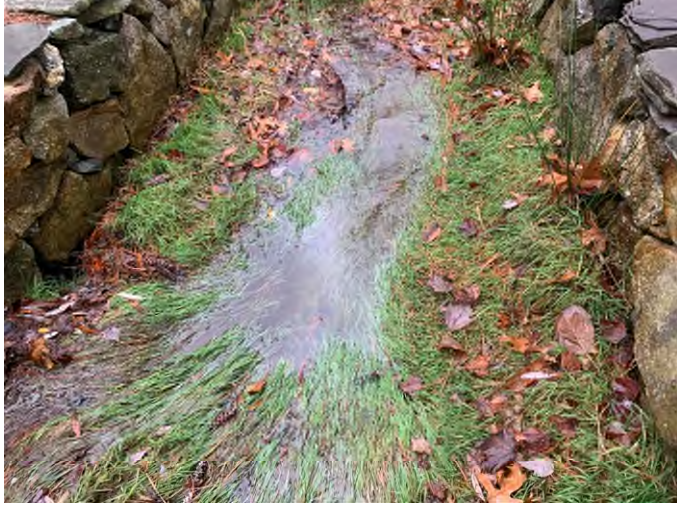
4 Brickyard Circle – 3 (Drainage Course)

pH: **7.2**

Observations/Notes: Water flowing with pooled area in center of raceway, max depth approx. 6".

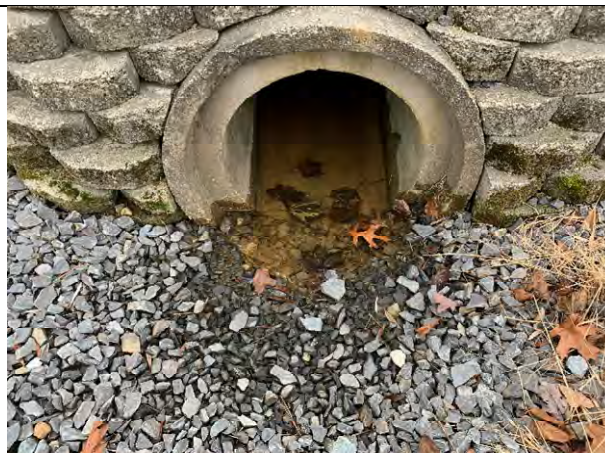
29 Gundalow - 2 (Culvert)

pH: 12.5

Observations/Notes: Water extending approx. 12" beyond culvert inlet into stone area, approx. max depth 4". Flow visible through culvert. Precipitate observed on stone and leaf litter below water.

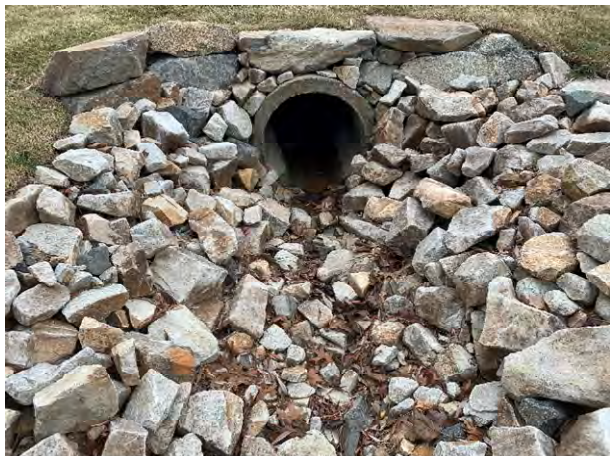
64 Gundalow - 1 (Drainage Course)

pH: 12.1

Observations/Notes: Accessible flowing water in rip rap extending approx. 8" from culvert outlet, approx. 1" deep.

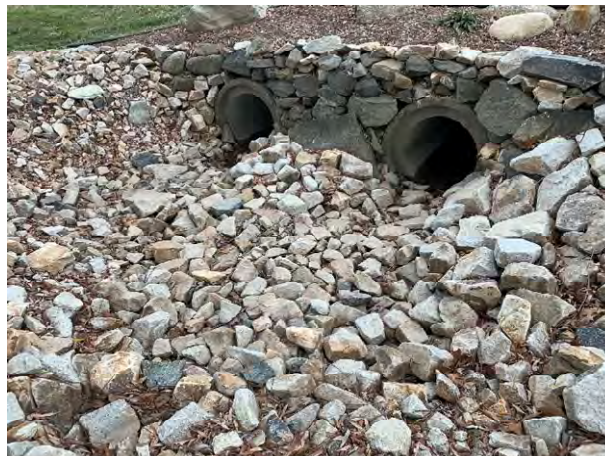
64 Gundalow - 2 (Drainage Course)

pH: 9.3

Observations/Notes: Small area of pooled water adjacent to culvert inlets, max depth approx. 4". Minor flow through culverts.

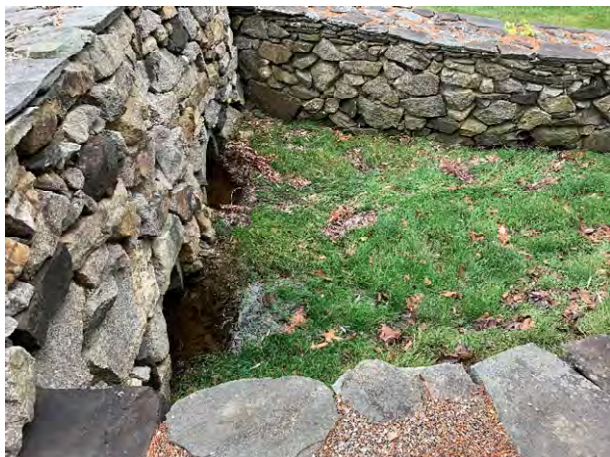
4 Brickyard Circle - 1 (Drainage Course)

pH: 7.4

Observations/Notes: Water extending approx. 14" beyond culvert outlet, max depth approx. 8". Minor flow through raceway.

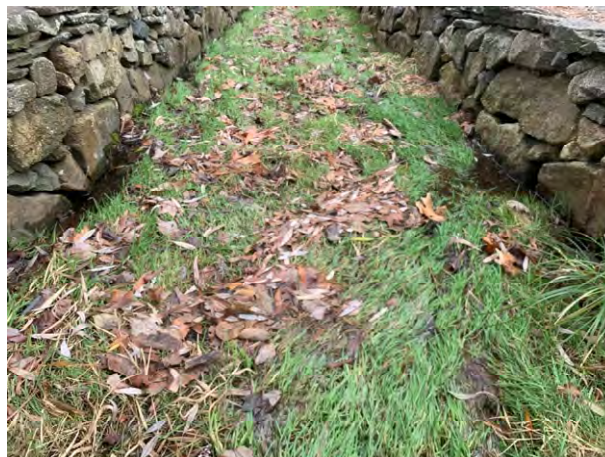
4 Brickyard Circle - 2 (Drainage Course)

pH: 7.5

Observations/Notes: Minor flow through center and adjacent to east wall of raceway, approx. 3" deep.

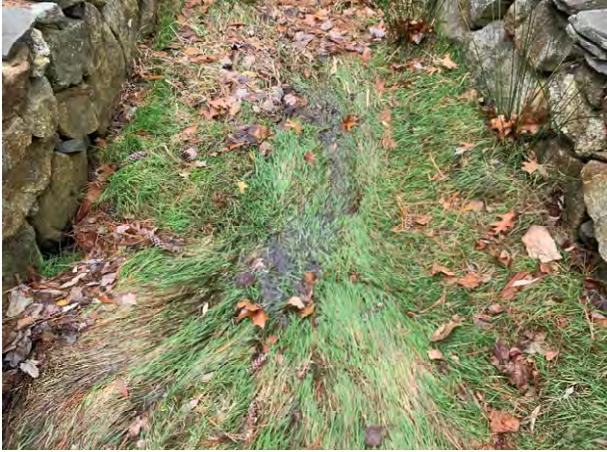
4 Brickyard Circle – 3 (Drainage Course)

pH: 7.4

Observations/Notes: Minor flow with pooled area in center of raceway, max depth approx. 4".

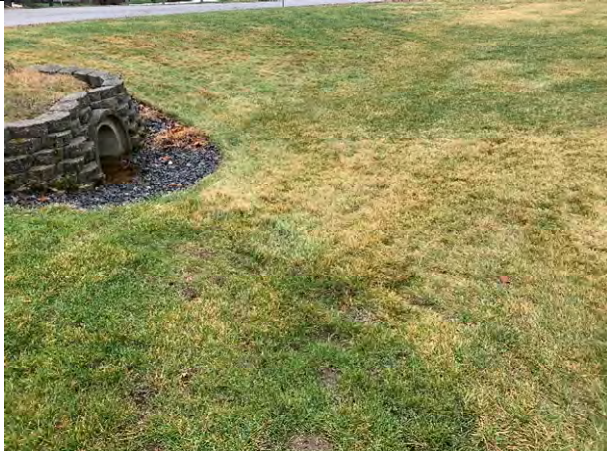
29 Gundalow - 1 (Drainage Area)

Observations/Notes: Saturated soil but no standing water

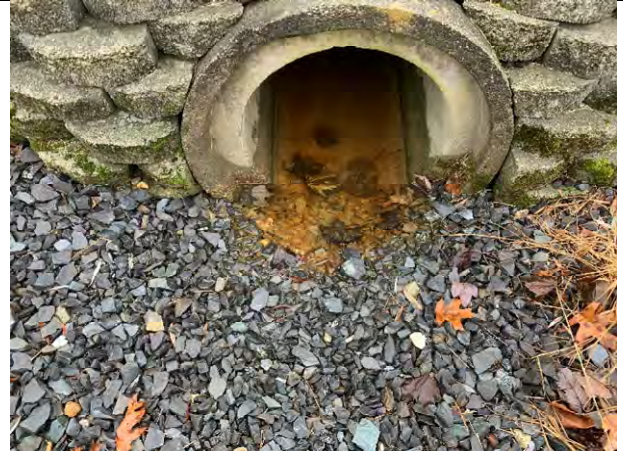
29 Gundalow - 2 (Culvert)

pH: 12.2

Observations/Notes: Water extending approx. 12" beyond culvert inlet into stone area, approx. max depth 4". Flow visible through culvert. Precipitate observed on stone and leaf litter below water.

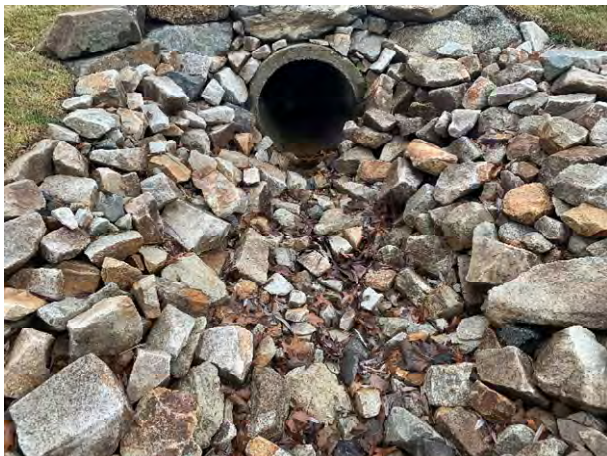
64 Gundalow - 1 (Drainage Course)

pH: 11.4

Observations/Notes: Accessible flowing water extending approx. 8" from culvert outlet, approx. 1" deep.

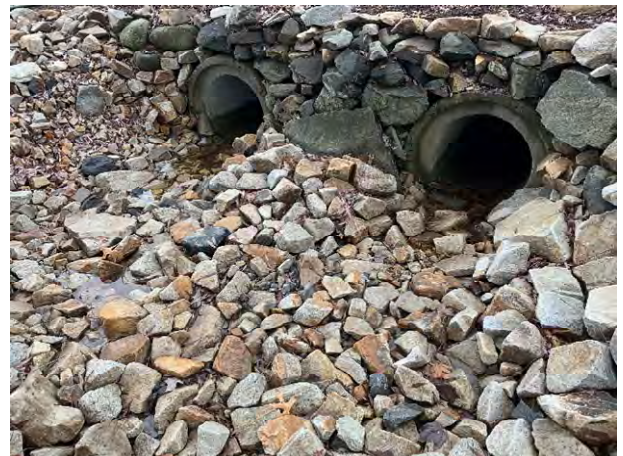
64 Gundalow - 2 (Drainage Course)

pH: 9.8

Observations/Notes: Area of pooled water adjacent to culvert inlets, max depth approx. 5". Visible flow through culverts.

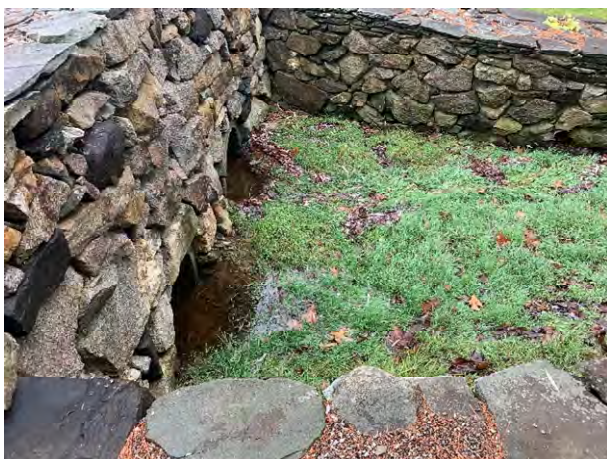
4 Brickyard Circle - 1 (Drainage Course)

pH: 9.4

Observations/Notes: Standing water extending approx. 14" beyond culvert outlet, max depth approx. 8". Visible flow into raceway.

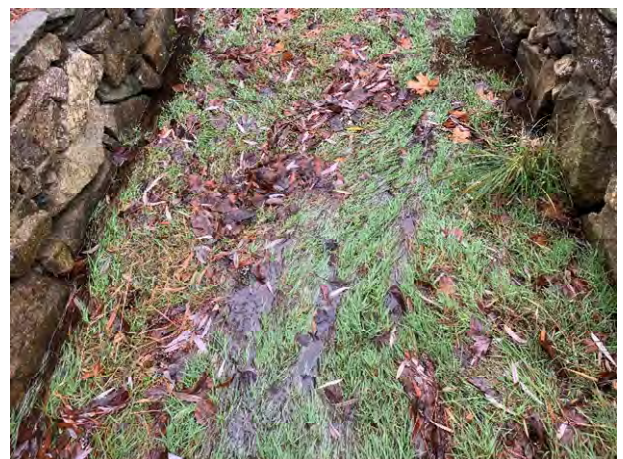
4 Brickyard Circle - 2 (Drainage Course)

pH: 7.8

Observations/Notes: Flow through center and adjacent to east wall of raceway, approx. 3" deep.

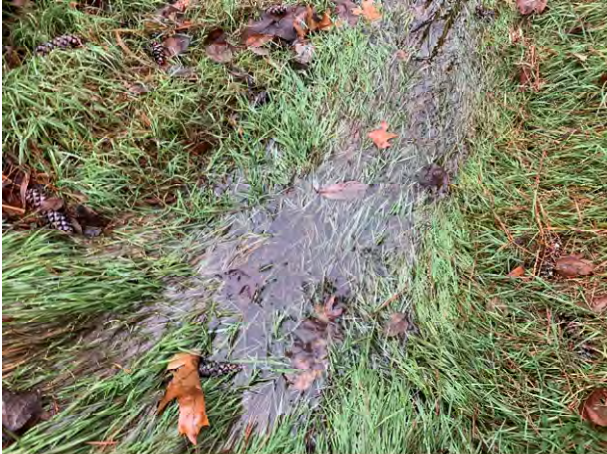
4 Brickyard Circle – 3 (Drainage Course)

pH: 7.4

Observations/Notes: Minor flow with pooled water in center of raceway, max depth approx. 4".
