#### CONSTRUCTION MONITORING REPORT

Eversource	Transmission	Lines:
	F10	7

NAI Project No: 23840.39

### Eversource Seacoast Reliability Project

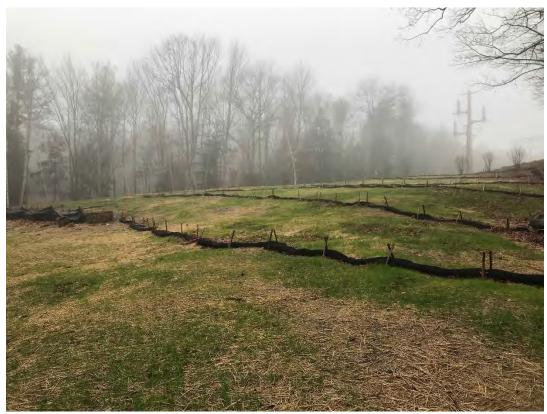
Fig 1: Slope above the cable house at the Eversource property/west side of the bay. Viewing southwest. (12-01-20)

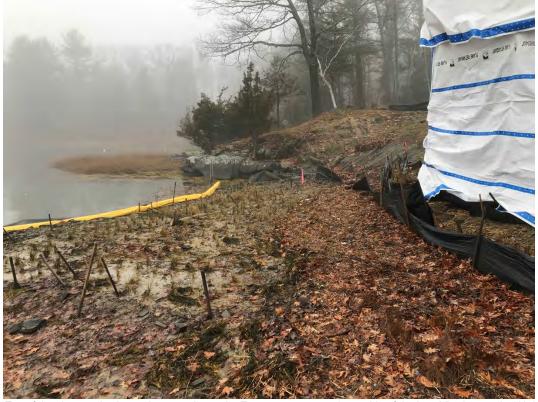
Fig 2: Toe of the slope and salt marsh restoration at the Eversource property/west side of the bay. Viewing south. (12-01-20)

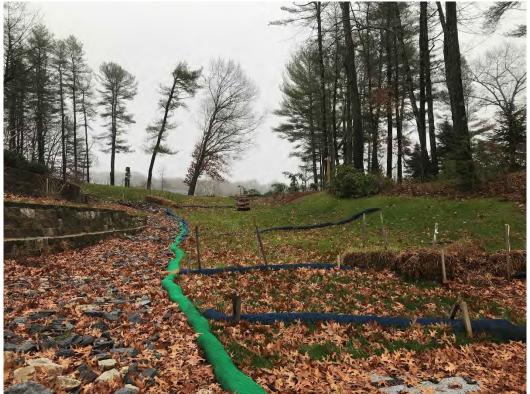
Fig 3: Slope above the manhole at Gundalow Landing/east side of the bay. Viewing east. (12-01-20)

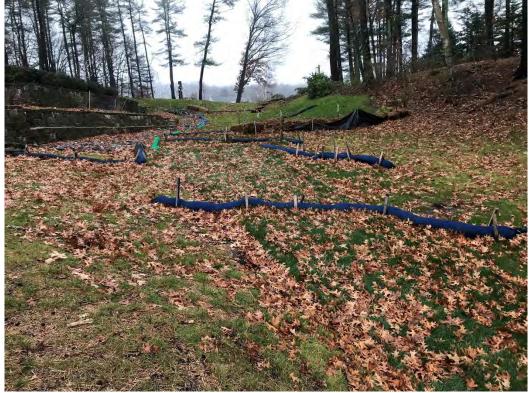
Fig 4: Slope below the manhole at Gundalow Landing/east side of the bay. Viewing east. (12-01-20)

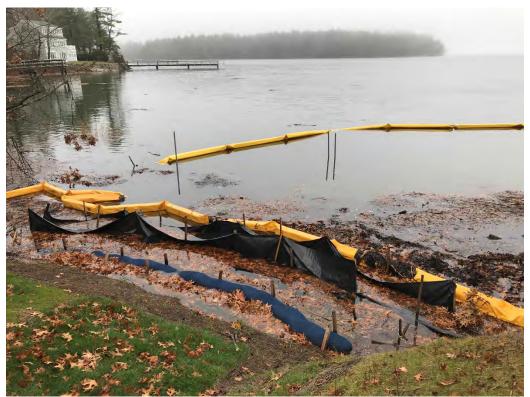
Fig 5: Toe of the slope at Gundalow Landing/east side of the bay. Viewing south. (12-01-20)

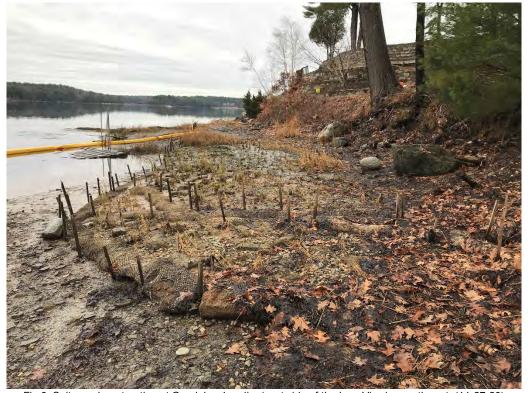
Fig 6: Salt marsh restoration at Gundalow Landing/east side of the bay. Viewing northwest. (11-27-20)

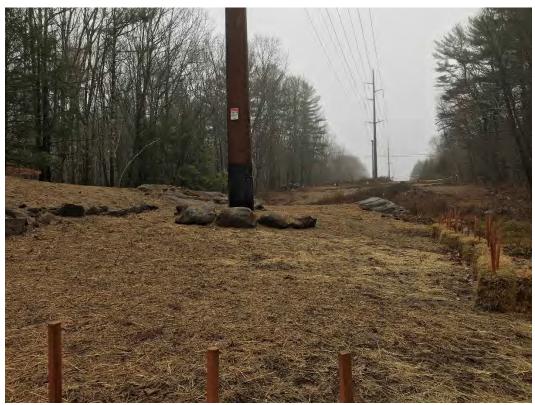
* Note: The permit differentiates between conditions requiring repairs and maintenance, and those requiring corrective action. Corrective actions are triggered only for specific, more serious conditions and require a corrective action form be filled out. Please refer to Part 5 of the CGP for additional information
PERMANENT EROSION AND SEDIMENTATION CONTROLS
Disturbed areas must have a uniform perennial vegetative cover with 85% density, or equivalent physical stabilization, to be considered permanently stabilized (per the SWPPP).
Installed and functioning per the SWPPP? XYESNON/A
If not, explain what was not performed correctly (construction/stabilization) for each of the following categories. Detail what/where needs to be corrected, and what has been corrected since the last monitoring inspection.  If so, what areas: N/A
Areas that have been restored and mulched, but have little germination: Hannah Ln, Eversource property/west side of bay, 89-90

Fig 7: Str. 89 work area. Viewing northwest. (12-01-20)

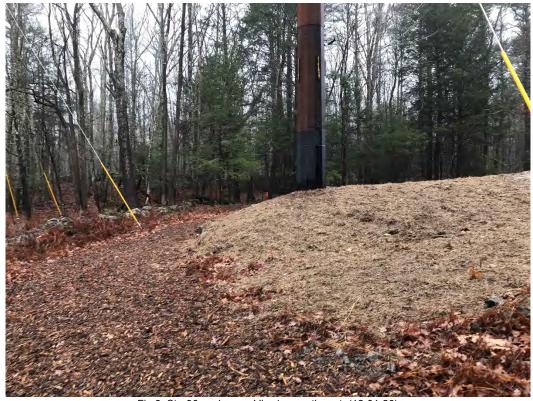
Fig 8: Str. 90 work area. Viewing southwest. (12-01-20)

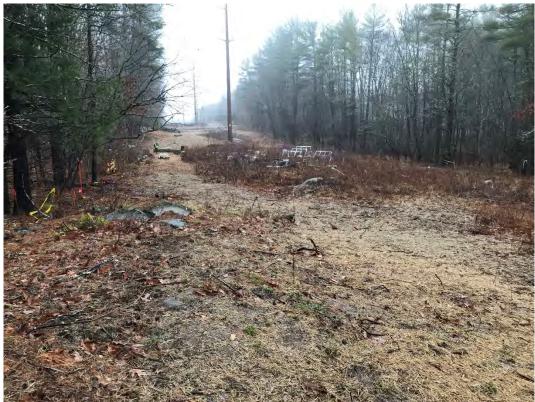
Fig 9: Access route between Strs. 90 and 89. Viewing northwest. (12-01-20)

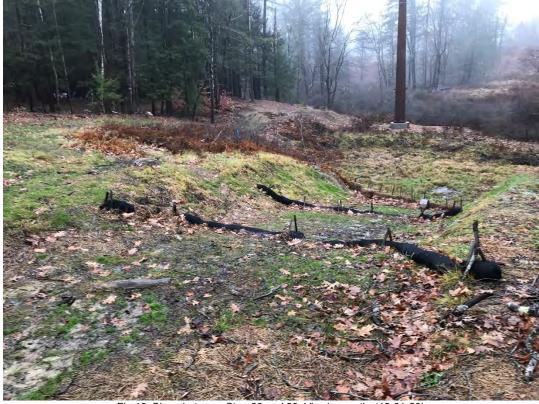
Fig 10: Slope between Strs. 28 and 29. Viewing north. (12-01-20)

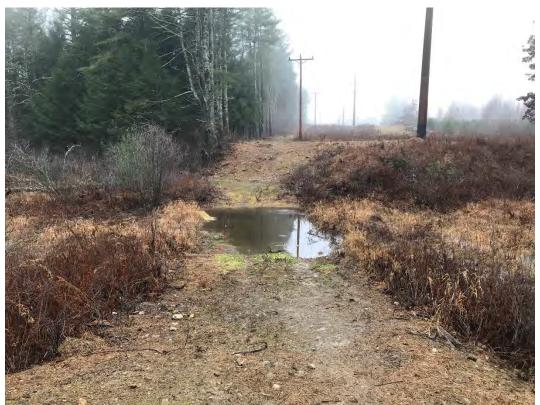
Fig 11: DS46 between Strs. 51 and 52. Viewing southwest. (12-01-20)

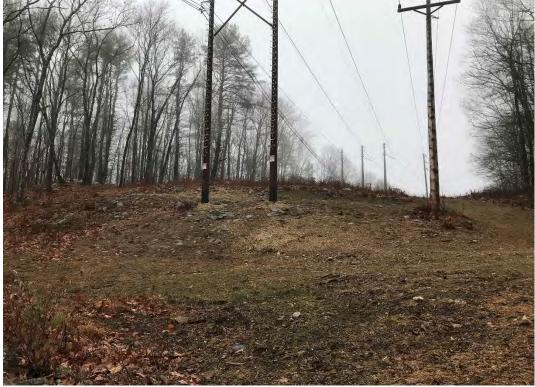
Fig 12: Str. 57 work area. Viewing northeast. (12-01-20)
