# DRAINAGE MONITORING REPORT

## F107 - Seacoast Reliability Project

### Newington, New Hampshire

**04.0190967.00**

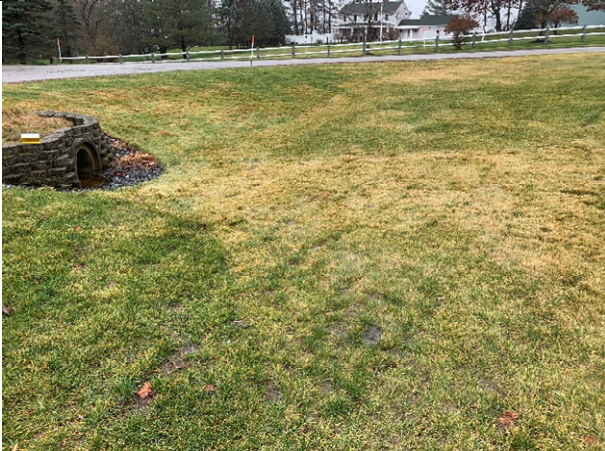
29 Gundalow - 1 (Drainage Area)

**Location: 29 Gundalow – 1 (Drainage Area)**

pH: **6.2**

Observations/Notes: Intermittent areas of standing water in grass, max depth approx. 0.5"

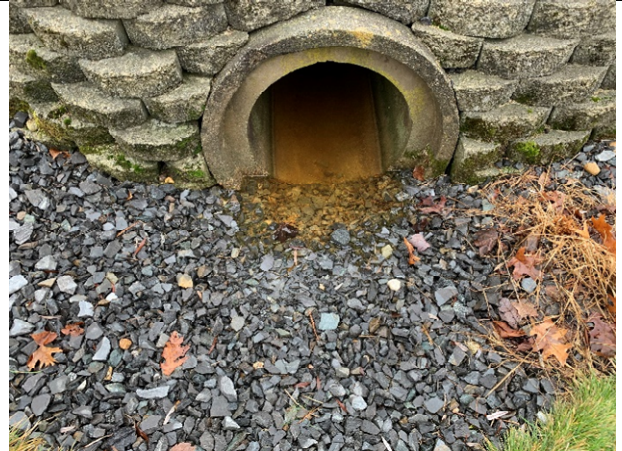
29 Gundalow - 2 (Culvert)

**Location: 29 Gundalow – 2 (Culvert)**

pH: **10.9**

Observations/Notes: Water extending approx. 12" beyond culvert inlet into stone area, approx. max depth 4". Flow visible through culvert. Precipitate observed on stone and leaf litter below water.

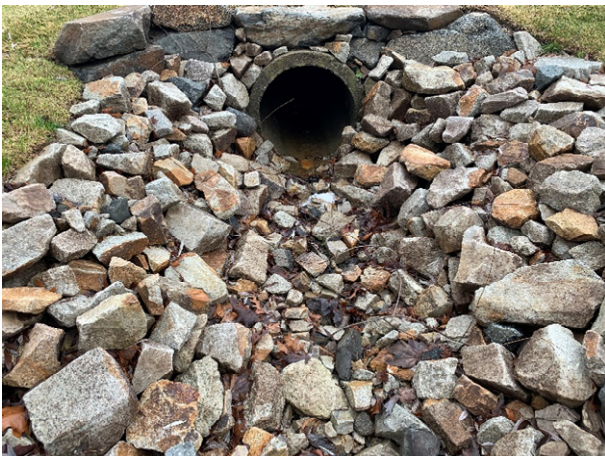
64 Gundalow - 1 (Drainage Course)

**Location: 64 Gundalow – 1 (Drainage Course)**

pH: **9.9**

Observations/Notes: Accessible flowing water extending approx. 8" from culvert outlet, approx. 1" deep.

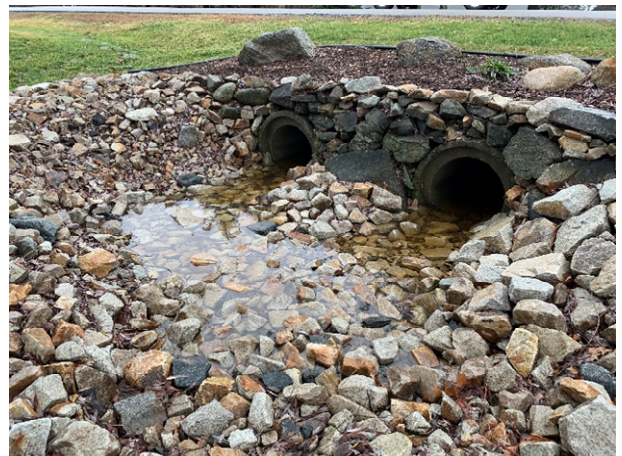
64 Gundalow - 2 (Drainage Course)

**Location: 64 Gundalow – 2 (Drainage Course)**

pH: **8.7**

Observations/Notes: Large area of pooled water extending approx. 5' from culvert inlets, max depth approx. 8". Visible flow through culverts.

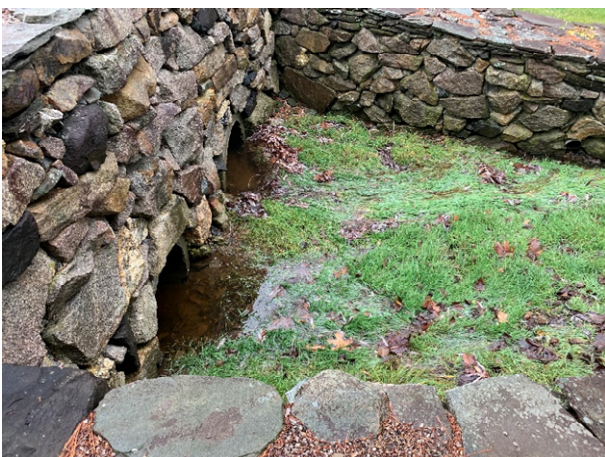
4 Brickyard Circle - 1 (Drainage Course)

**Location: 4 Brickyard Circle – 1 (Drainage Course)**

pH: **7.5**

Observations/Notes: Water flowing through culvert with pools at outlet, max depth approx. 10". Visible flow through culvert and into raceway.

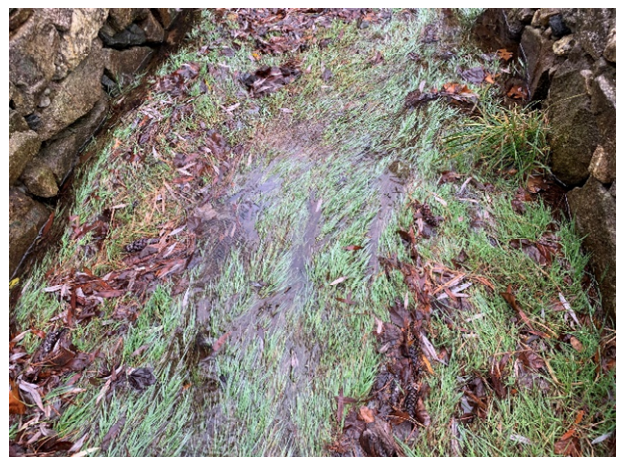
4 Brickyard Circle - 2 (Drainage Course)

**Location: 4 Brickyard Circle – 2 (Drainage Course)**

pH: **7.3**

Observations/Notes: Water flowing through center and adjacent to east wall of raceway, approx. 4" deep.

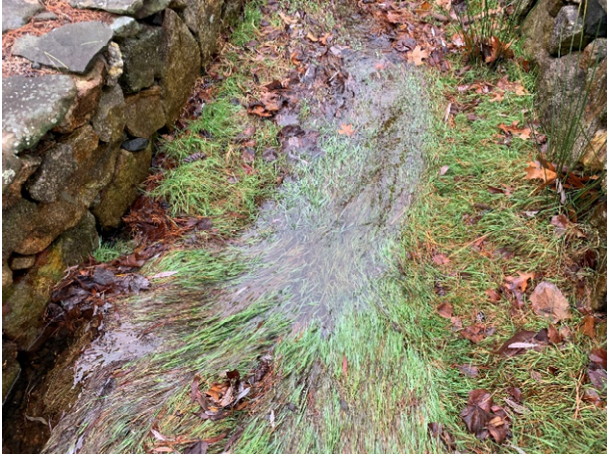
4 Brickyard Circle – 3 (Drainage Course)

**Location: 4 Brickyard Circle – 3 (Drainage Course)**

pH: **6.8**

Observations/Notes: Water flowing with pooled area in center of raceway, max depth approx. 6".

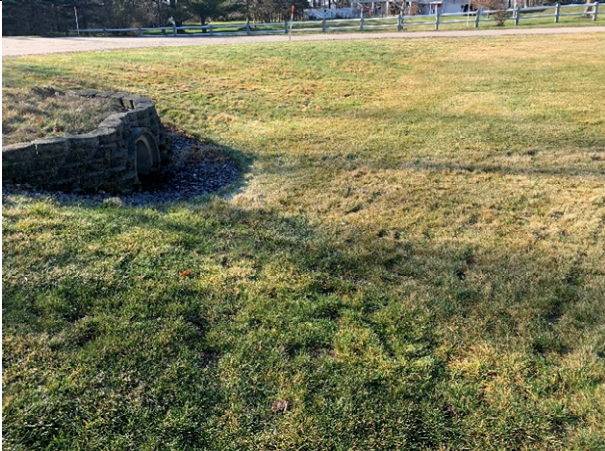
29 Gundalow - 1 (Drainage Area)

**Location: 29 Gundalow – 1 (Drainage Area)**

Observations/Notes: Saturated soil but no standing water.

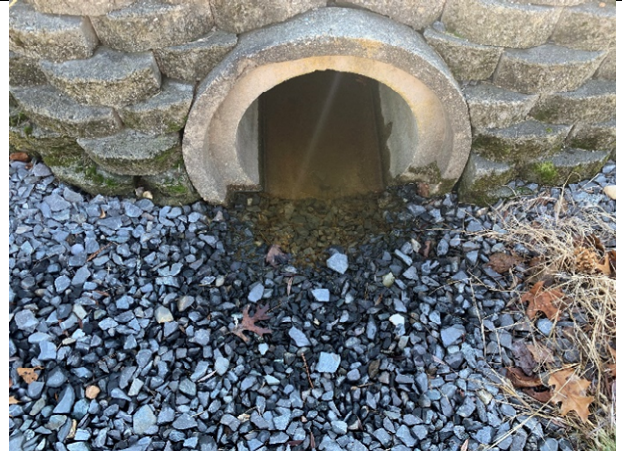
29 Gundalow - 2 (Culvert)

**Location: 29 Gundalow – 2 (Culvert)**

pH: 12.3

Observations/Notes: Water extending approx. 12" beyond culvert inlet into stone area, approx. max depth 4". Flow visible through culvert. Precipitate observed on stone and leaf litter below water.

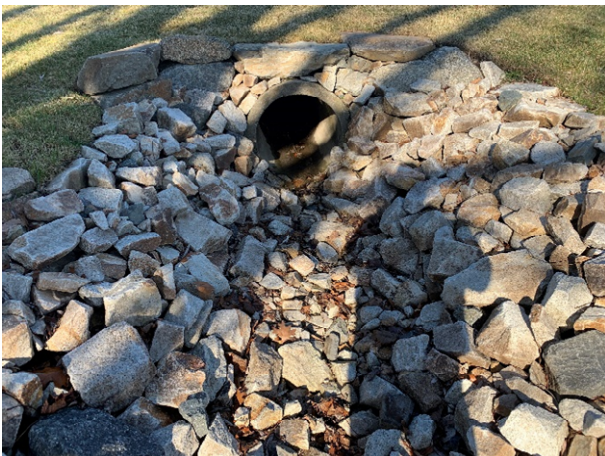
64 Gundalow - 1 (Drainage Course)

**Location: 64 Gundalow – 1 (Drainage Course)**

pH: 11.8

Observations/Notes: Accessible flowing water extending approx. 8" from culvert outlet, approx. 1" deep.

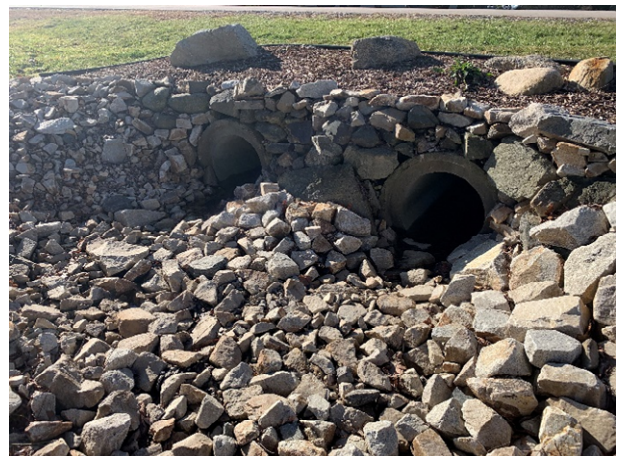
64 Gundalow - 2 (Drainage Course)

**Location: 64 Gundalow – 2 (Drainage Course)**

pH: 9.2

Observations/Notes: Standing water extending approx. 2' from culvert inlets, max depth approx. 4".

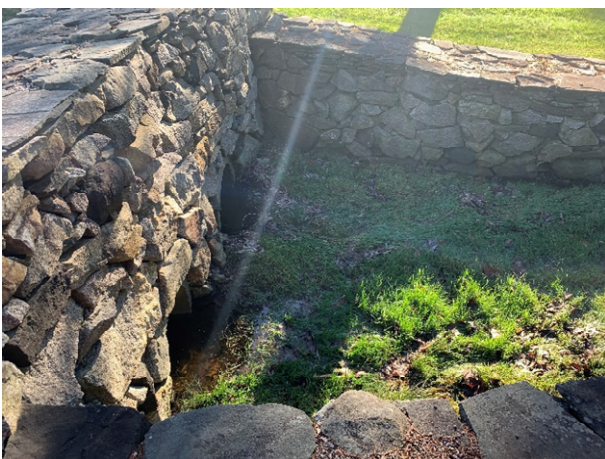
4 Brickyard Circle - 1 (Drainage Course)

**Location: 4 Brickyard Circle – 1 (Drainage Course)**

pH: 8.1

Observations/Notes: Standing water extending approx. 2.5' from outlet, max depth approx. 10".

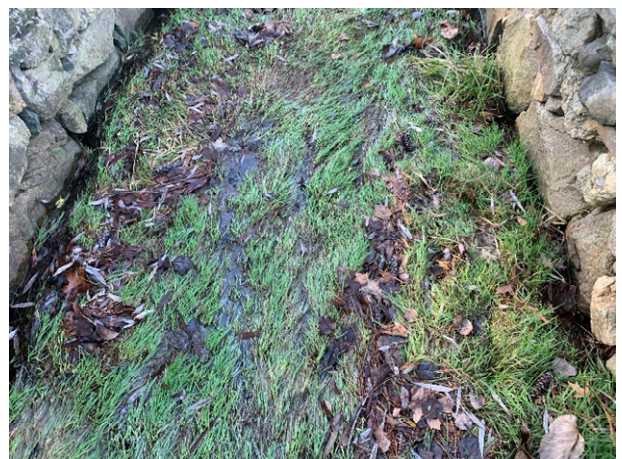
4 Brickyard Circle - 2 (Drainage Course)

**Location: 4 Brickyard Circle – 2 (Drainage Course)**

pH: 7.8

Observations/Notes: Water flowing through center and adjacent to east wall of raceway, approx. 3" deep.

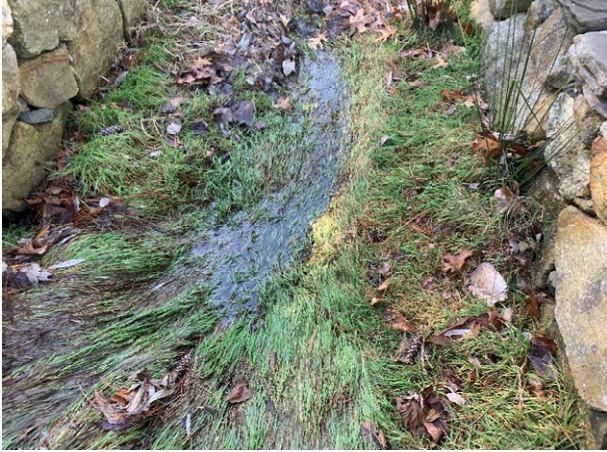
4 Brickyard Circle – 3 (Drainage Course)

**Location: 4 Brickyard Circle – 3 (Drainage Course)**

pH: 7.5

Observations/Notes: Pooled area in center of raceway, max depth approx. 5".
