CONSTRUCTION MONITORING REPORT

Eversource Transmission Lines:
F107

**Madbury, Durham,
Newington, Portsmouth, NH**

TYPE OF INSPECTION: Weekly Storm Event Incident Corrective Action

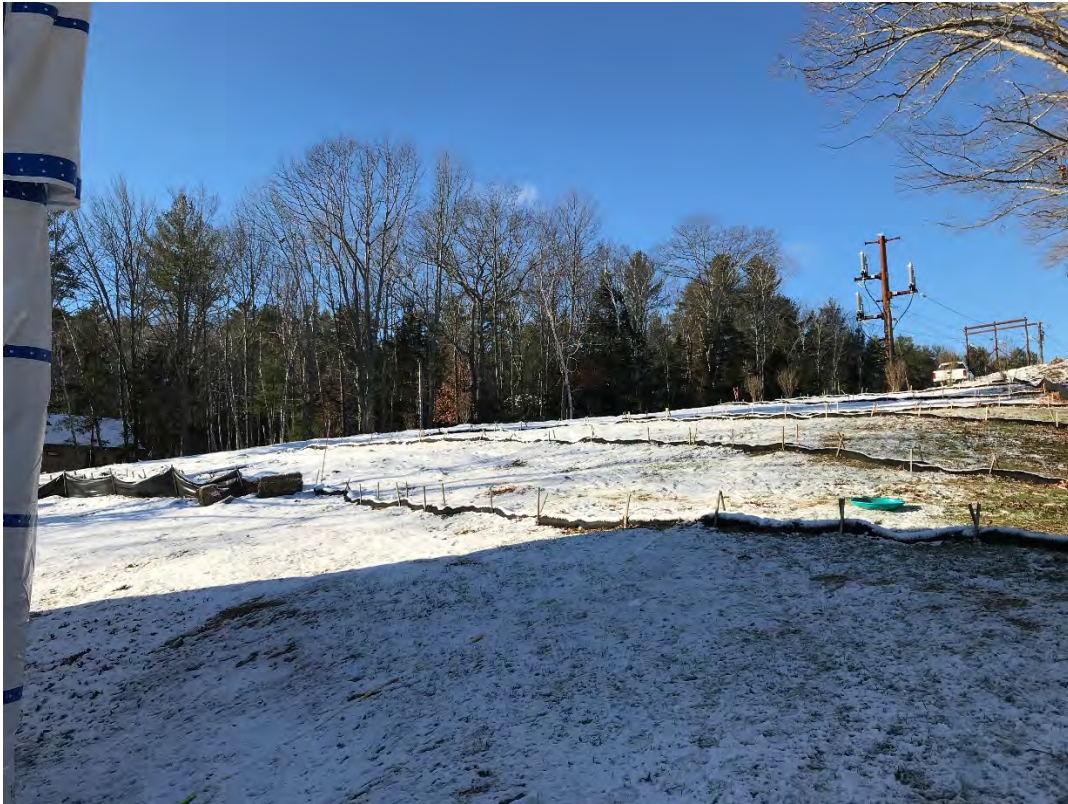
Areas that have been restored and mulched, but have little germination: Hannah Ln, Eversource property/west side of bay, 89-90

Fig 1: Slope above the cable house at the Eversource property/west side of the bay. Viewing southwest. (12-07-20)

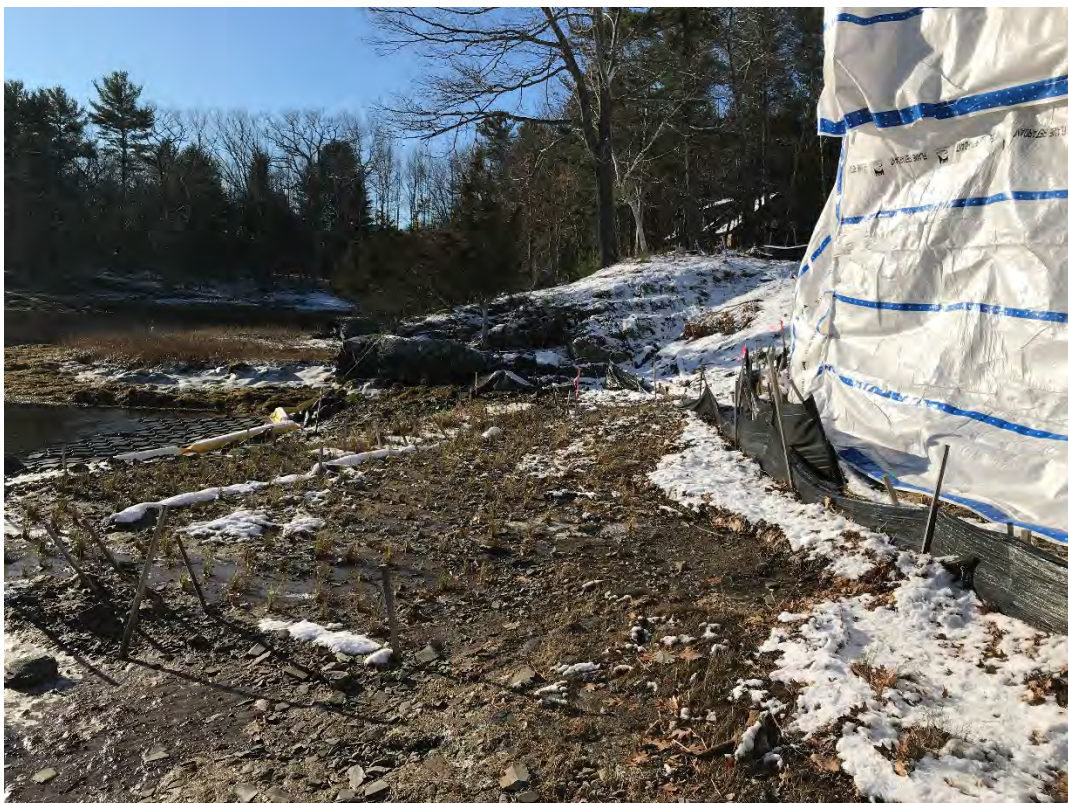
Fig 2: Toe of the slope and salt marsh restoration at the Eversource property/west side of the bay. Viewing south. (12-07-20)

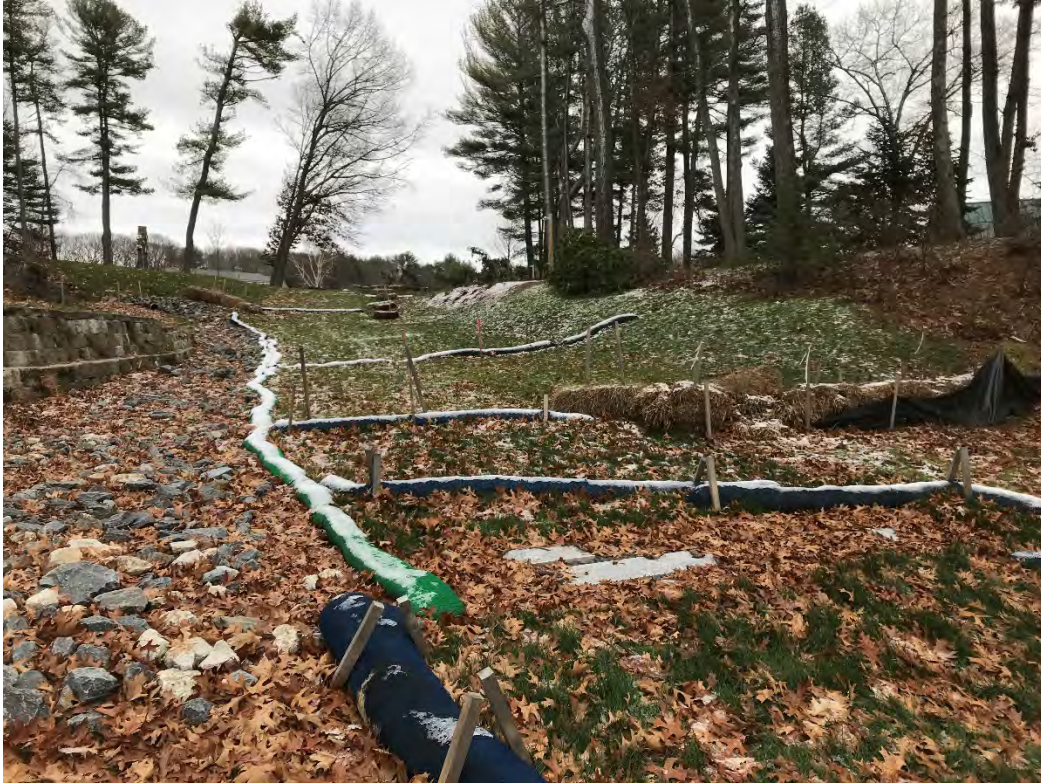
Moderate germination: Strs. 4-6, Strs. 7-21, 25-34, 36-88, 91-101, 107, 109-112, 122-127, 129-130, and Gundalow Landing/east side of bay.

Fig 3: Slope above the manhole at Gundalow Landing/east side of the bay. Viewing east. (12-07-20)

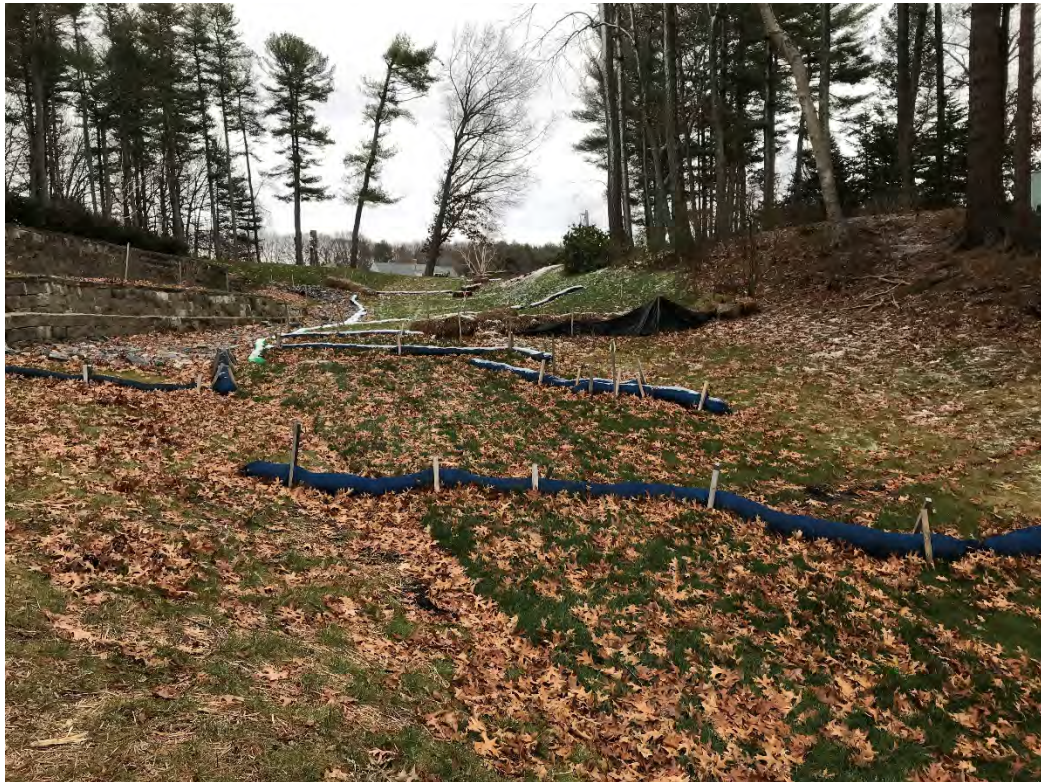
Fig 4: Slope below the manhole at Gundalow Landing/east side of the bay. Viewing east. (12-07-20)

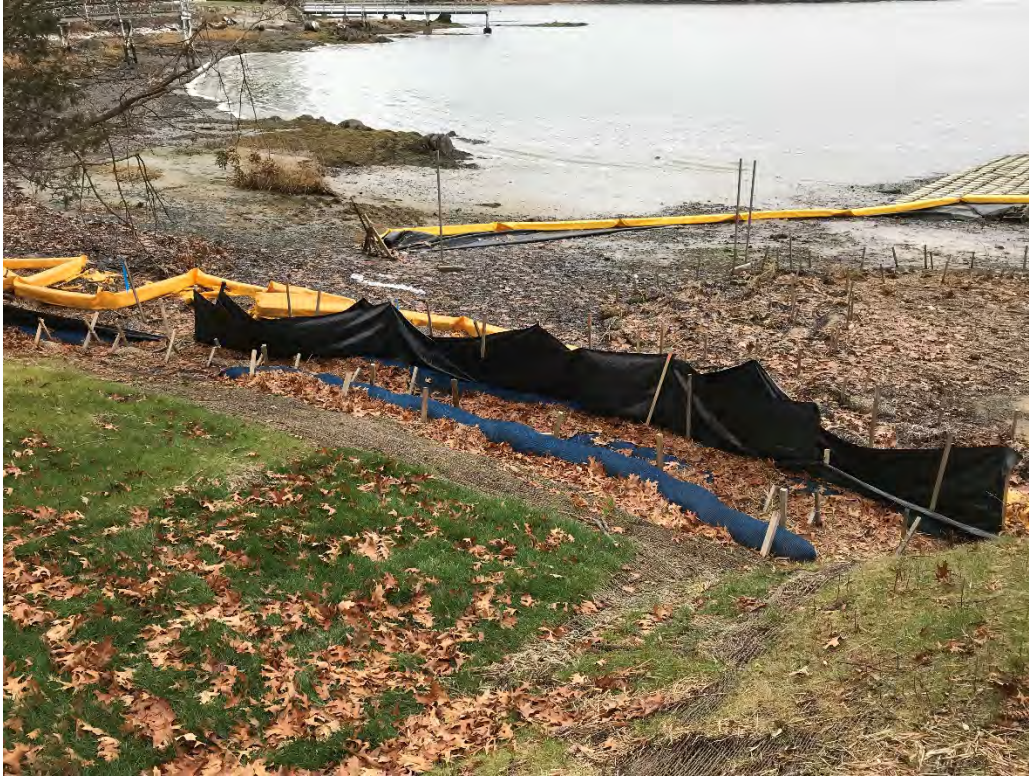
Fig 5: Toe of the slope at Gundalow Landing/east side of the bay. Viewing south. (12-07-20)

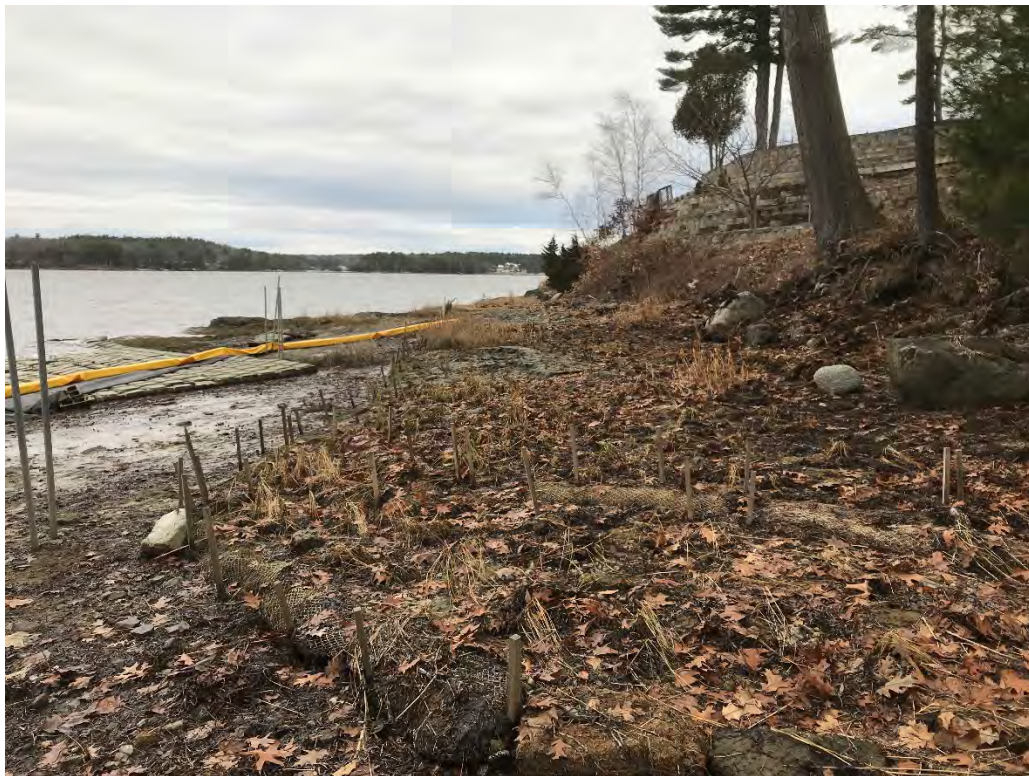
Fig 6: Salt marsh restoration at Gundalow Landing/east side of the bay. Viewing northwest. (12-07-20)

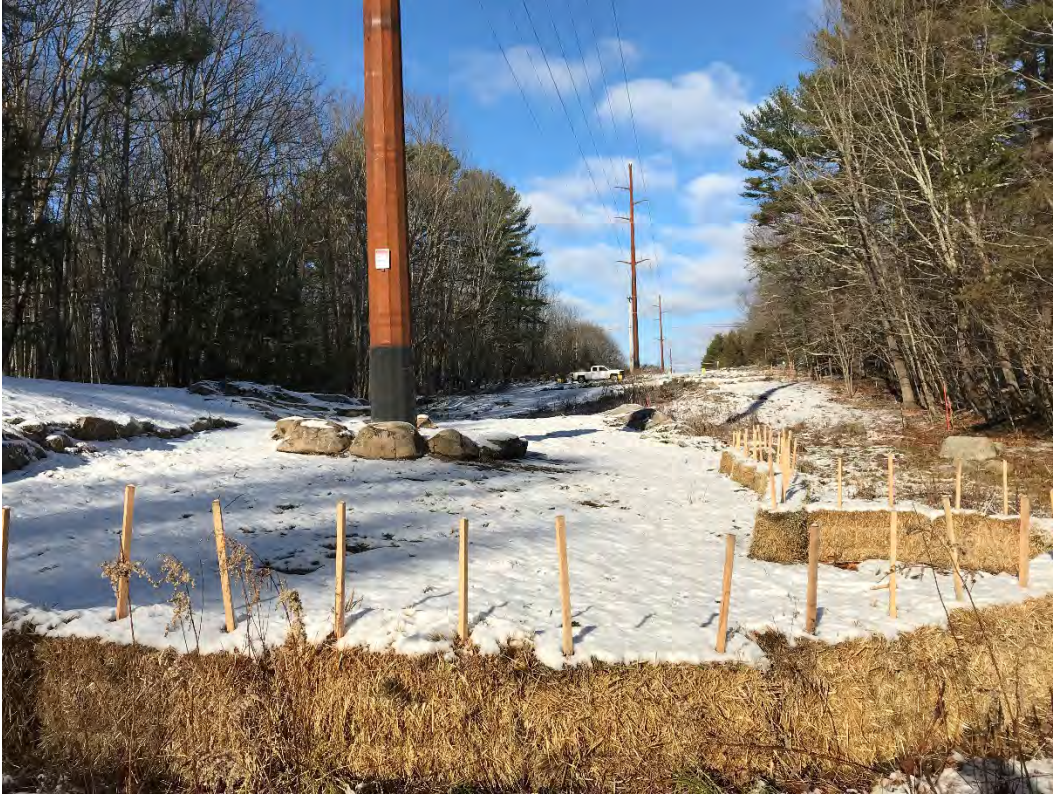
Fig 7: Str. 89 work area. Viewing northwest. (12-07-20)

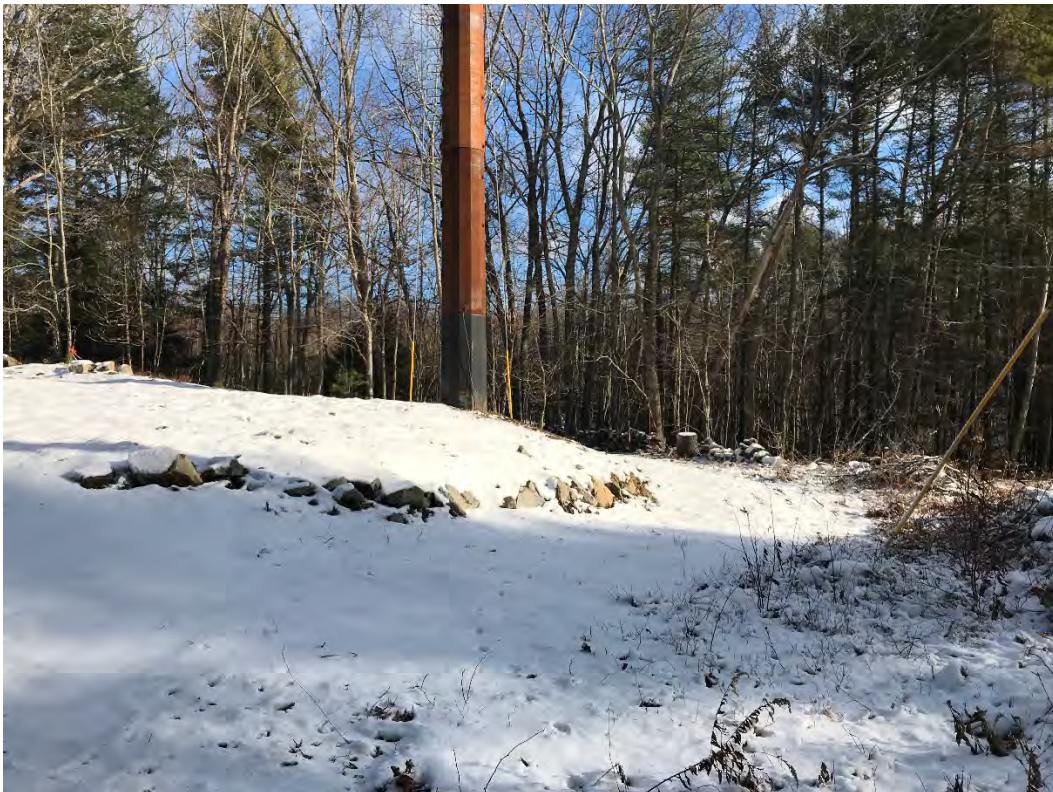
Fig 8: Str. 90 work area. Viewing northeast. (12-07-20)

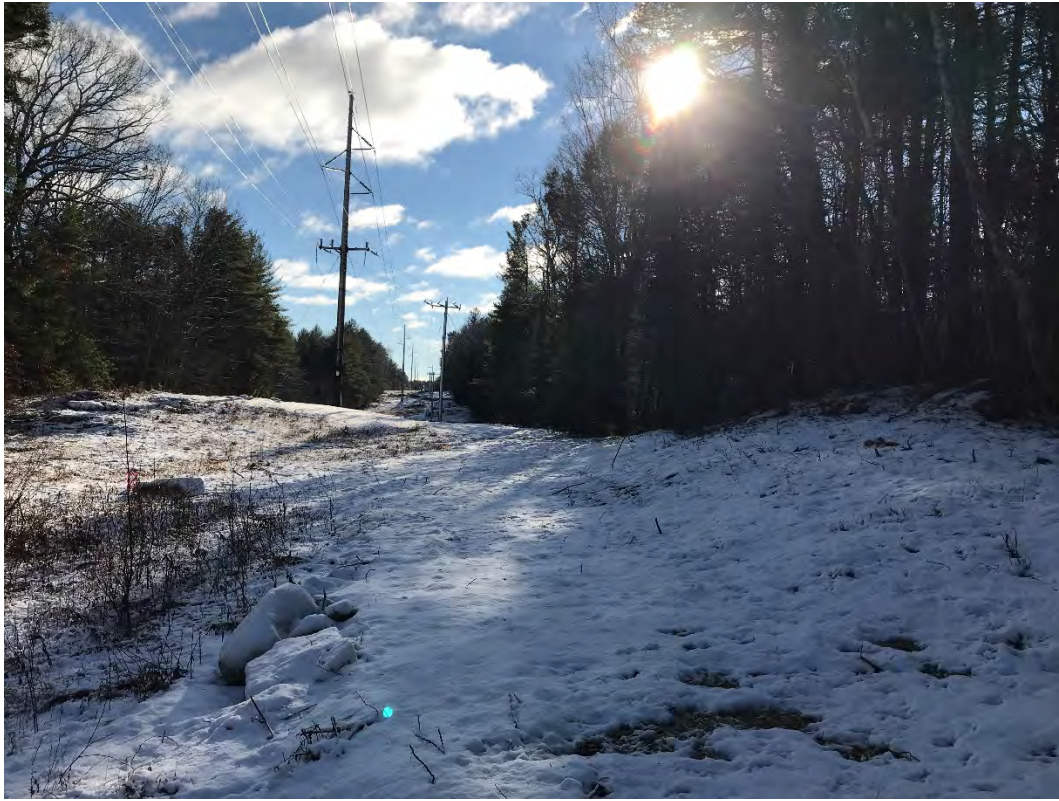
Fig 9: Access route between Strs. 90 and 89. Viewing southeast. (12-07-20)

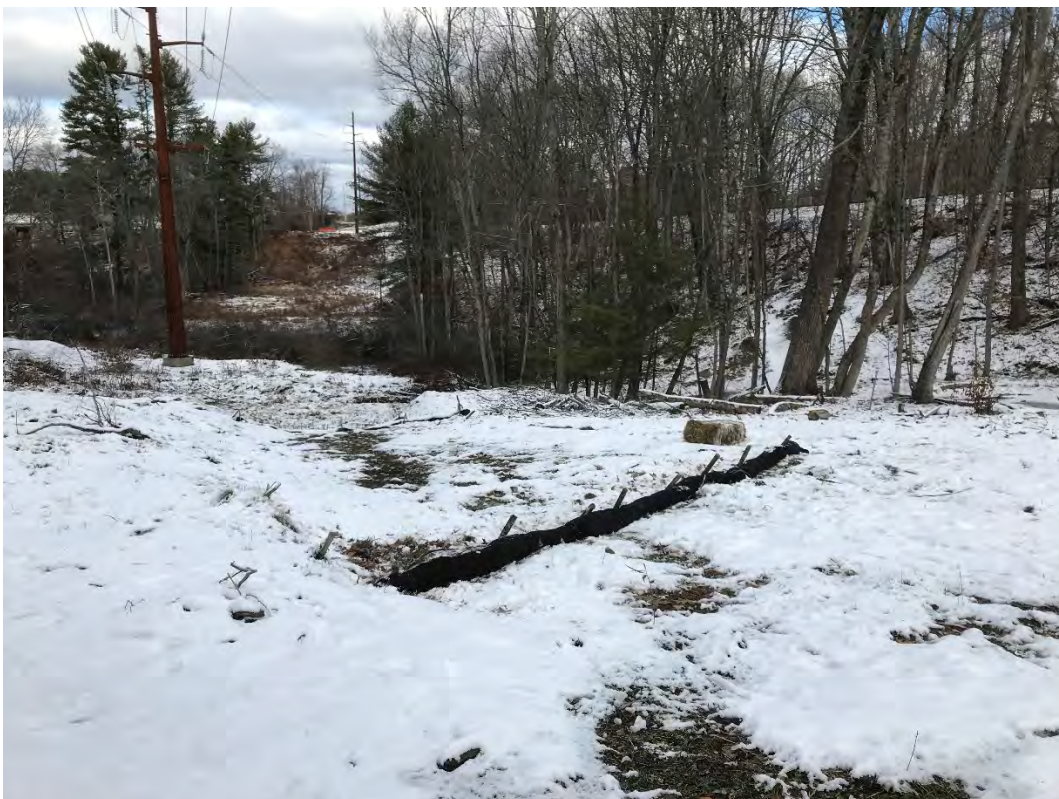
Fig 10: Additional line of silt socks installed on upper portion of slope between Strs. 28 and 29. Viewing northeast. (12-07-20)

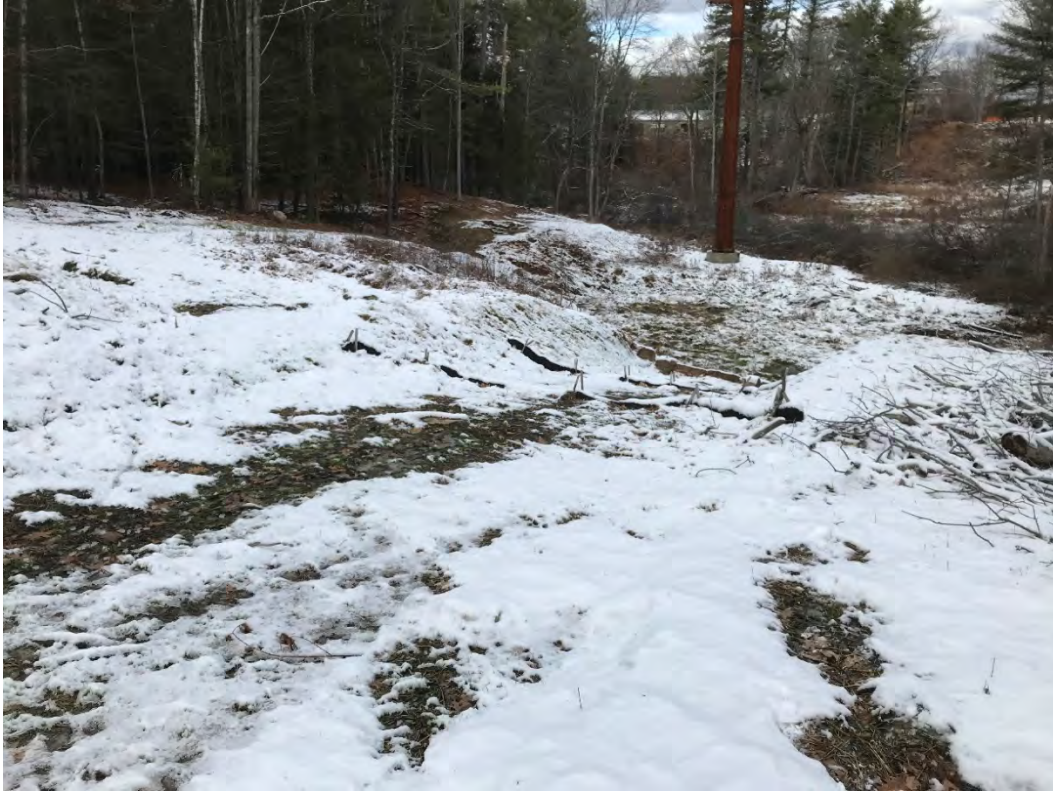
Fig 11: Lower portion of slope between Strs. 28 and 29. Viewing northwest. (12-07-20)

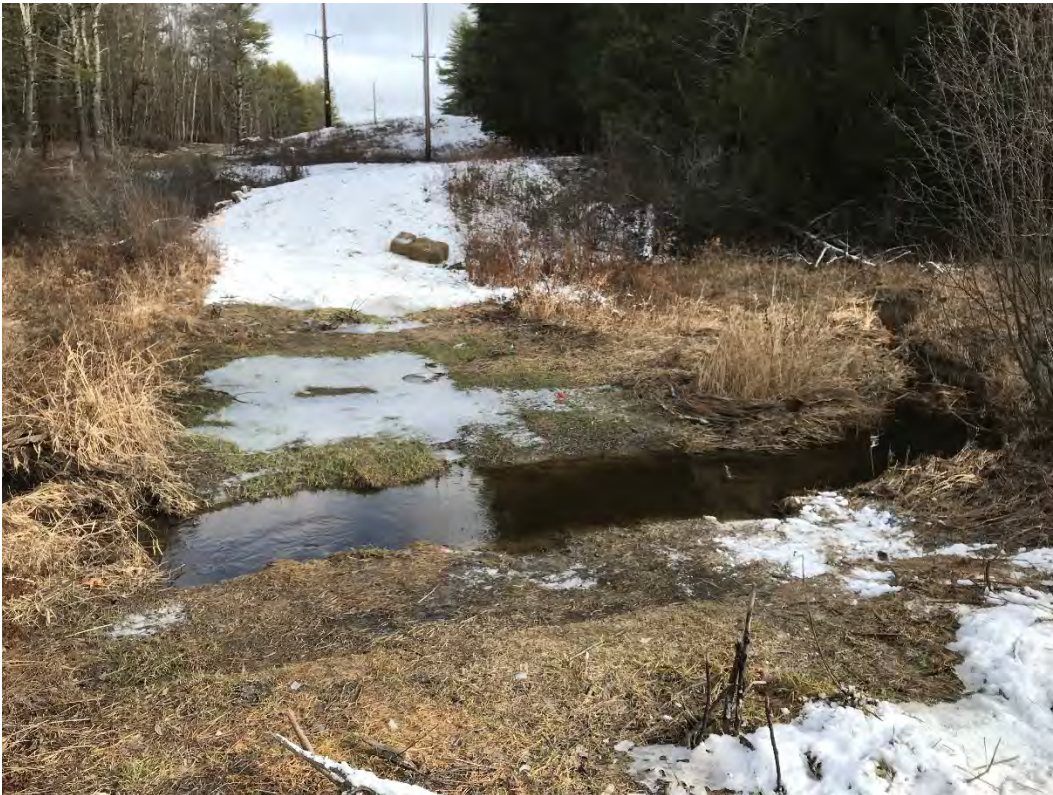
Fig 12: DS46 between Strs. 51 and 52. Viewing northeast. (12-07-20)

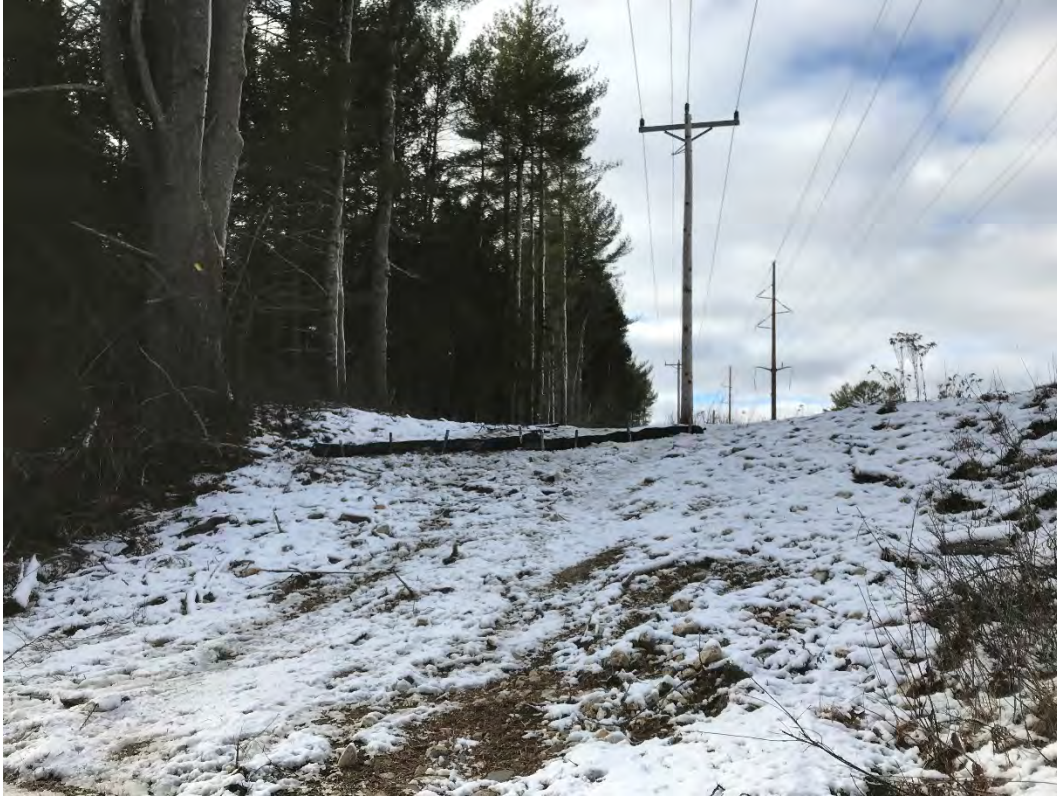
Fig 13: Line of silt sock installed on northeast facing slope above DS46 between Strs. 51 and 52. Viewing southwest. (12-07-20)
