DRAINAGE MONITORING REPORT

F107 - Seacoast Reliability Project

Newington, New Hampshire

04.0190967.00

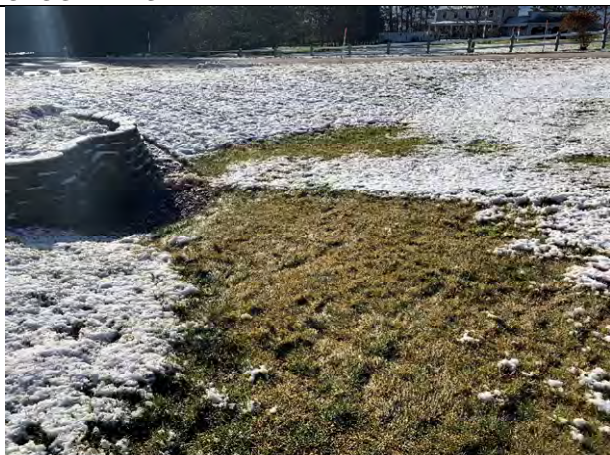
29 Gundalow - 1 (Drainage Area)

pH: **6.0**

Observations/Notes: Intermittent areas of standing water in grass, max depth approx. 1"

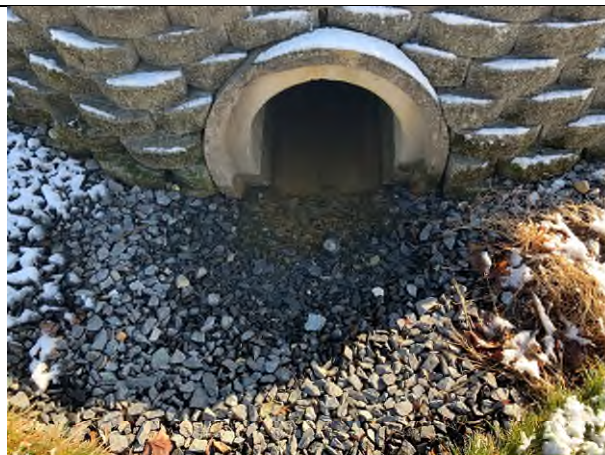
29 Gundalow - 2 (Culvert)

pH: **11.4**

Observations/Notes: Water extending approx. 18" beyond culvert inlet into stone area, approx. max depth 4". Flow visible through culvert.

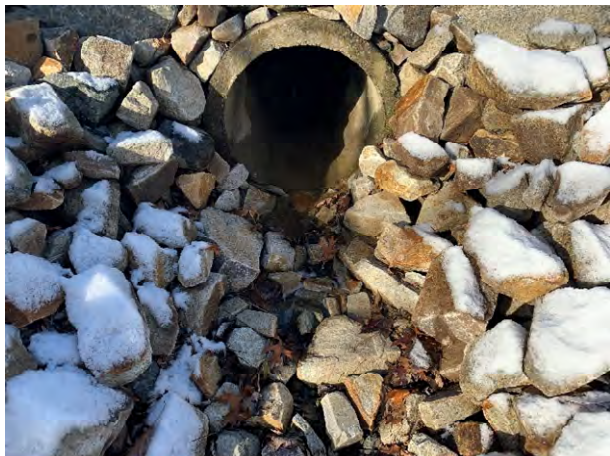
64 Gundalow - 1 (Drainage Course)

pH: **10.4**

Observations/Notes: Accessible flowing water extending approx. 16" from culvert outlet, approx. 2" deep.

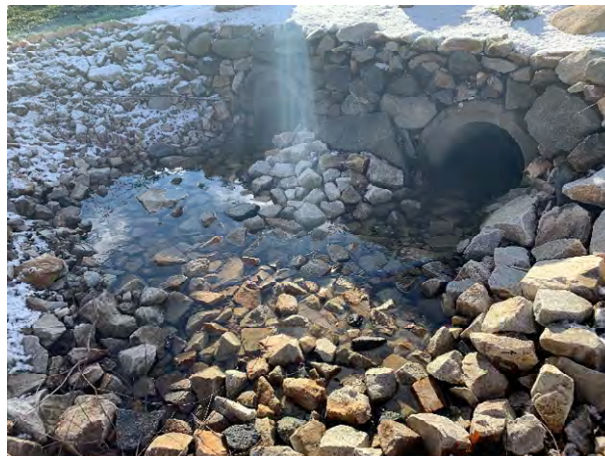
64 Gundalow - 2 (Drainage Course)

pH: **9.3**

Observations/Notes: Large area of pooled water extending approx. 5' from culvert inlets, max depth approx. 8". Visible flow through culverts.

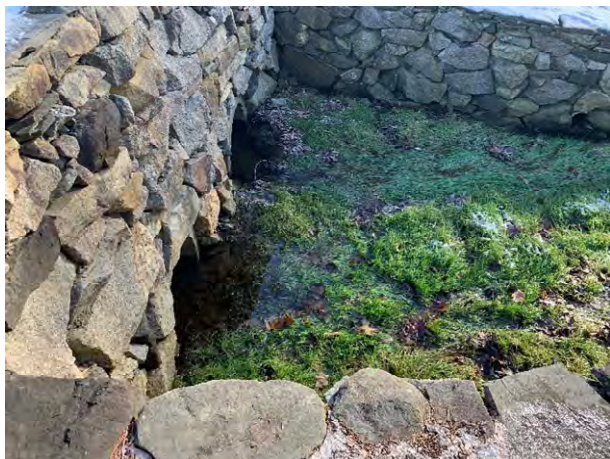
4 Brickyard Circle - 1 (Drainage Course)

pH: **8.6**

Observations/Notes: Water flowing through culvert with pools at outlet, max depth approx. 10". Visible flow through culvert and into raceway.

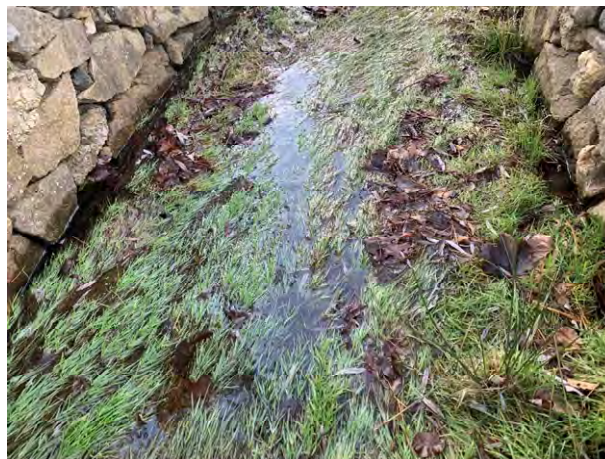
4 Brickyard Circle - 2 (Drainage Course)

pH: **7.7**

Observations/Notes: Water flowing through center and adjacent to east wall of raceway, approx. 4" deep.

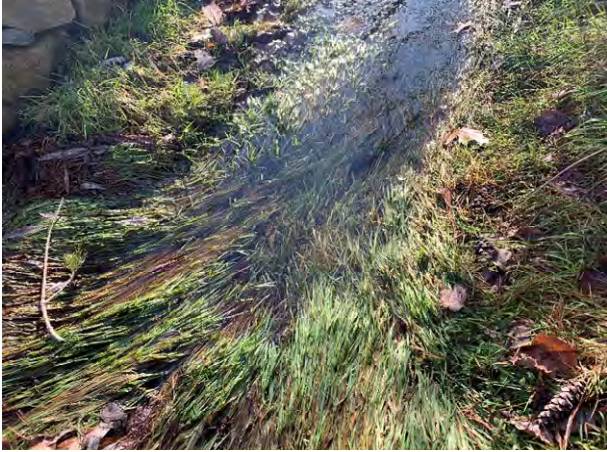
4 Brickyard Circle – 3 (Drainage Course)

pH: **7.5**

Observations/Notes: Water flowing with pooled area in center of raceway, max depth approx. 6".

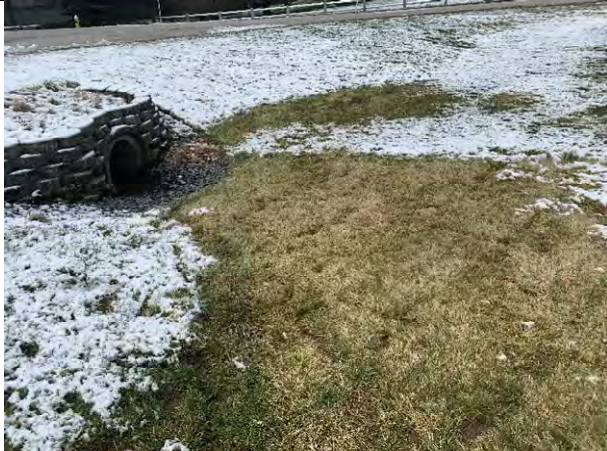
29 Gundalow - 1 (Drainage Area)

Observations/Notes: Saturated soil but no standing water.

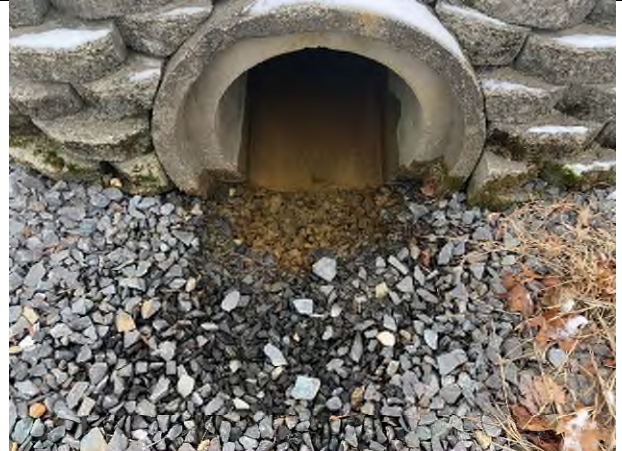
29 Gundalow - 2 (Culvert)

pH: 12.1

Observations/Notes: Water extending approx. 12" beyond culvert inlet into stone area, approx. max depth 4". Flow visible through culvert.

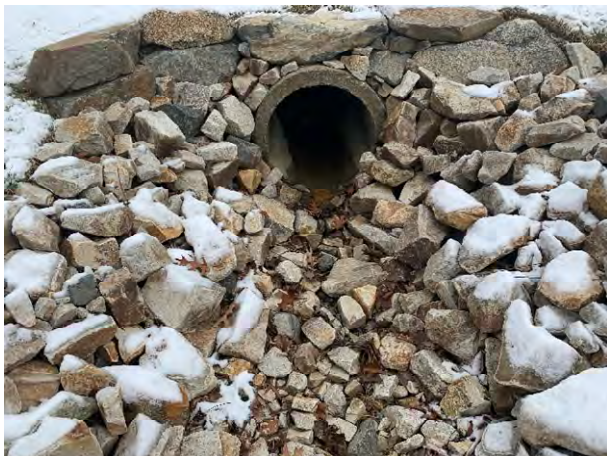
64 Gundalow - 1 (Drainage Course)

pH: 11.5

Observations/Notes: Accessible flowing water extending approx. 12" from culvert outlet, approx. 1" deep.

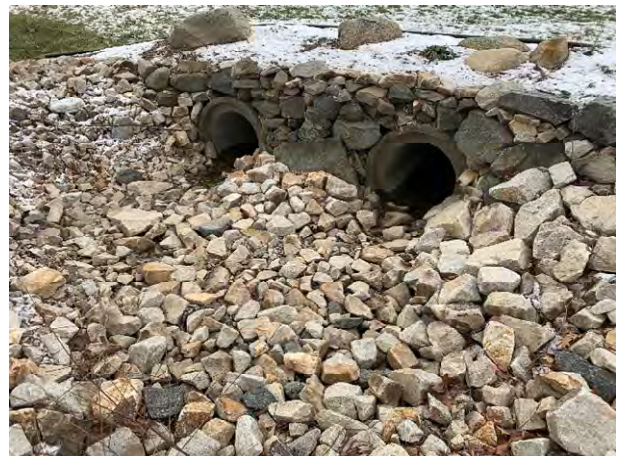
64 Gundalow - 2 (Drainage Course)

pH: 9.5

Observations/Notes: Standing water extending approx. 2' from culvert inlets, max depth approx. 3".

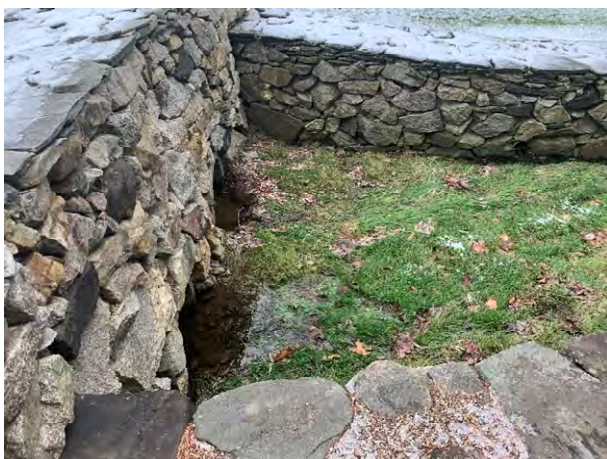
4 Brickyard Circle - 1 (Drainage Course)

pH: 9.2

Observations/Notes: Standing water extending approx. 2.5' from outlet, max depth approx. 10".

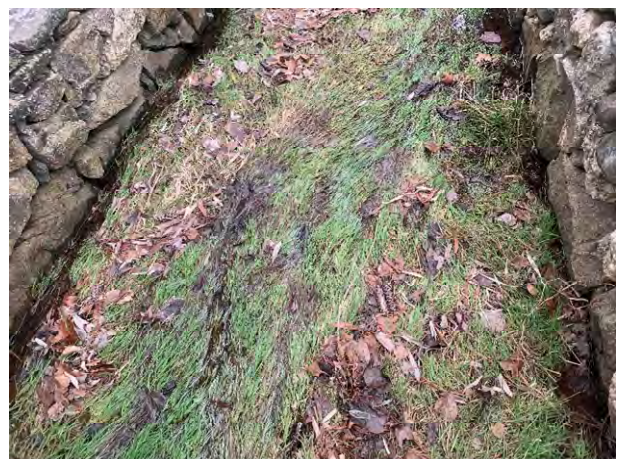
4 Brickyard Circle - 2 (Drainage Course)

pH: 7.9

Observations/Notes: Water flowing through center and adjacent to east wall of raceway, approx. 3" deep.

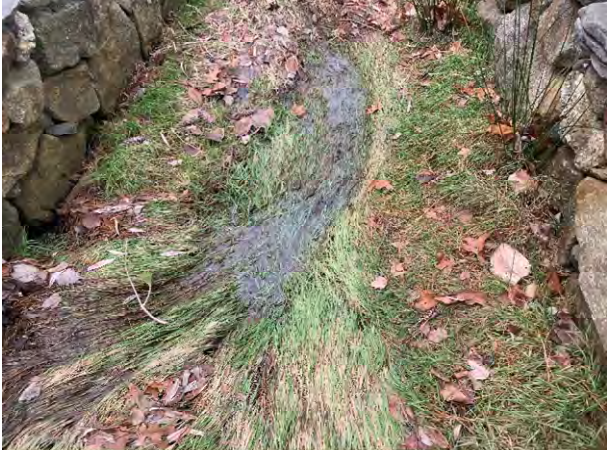
4 Brickyard Circle – 3 (Drainage Course)

pH: 7.6

Observations/Notes: Pooled area in center of raceway, max depth approx. 4".

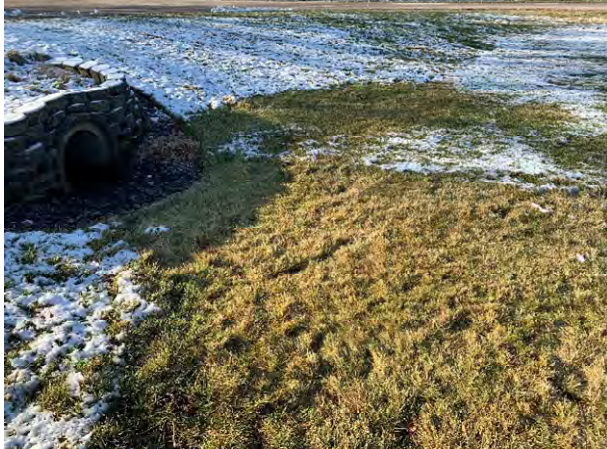
29 Gundalow - 1 (Drainage Area)

Observations/Notes: Saturated soil but no standing water.

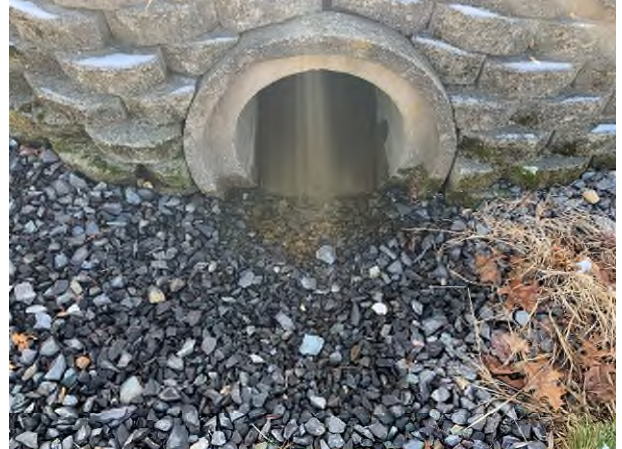
29 Gundalow - 2 (Culvert)

pH: 12.6

Observations/Notes: Water extending approx. 12" beyond culvert inlet into stone area, approx. max depth 4". Flow visible through culvert.

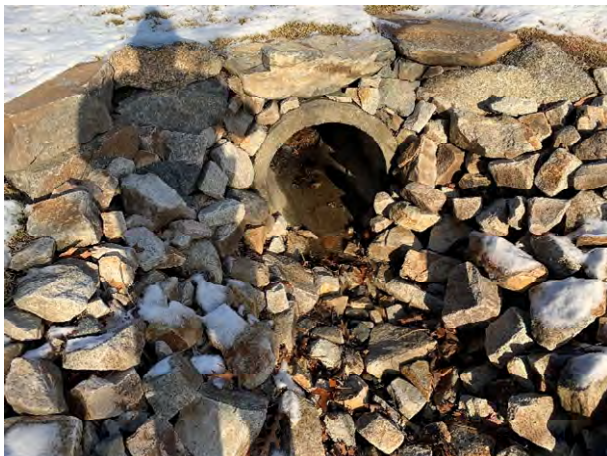
64 Gundalow - 1 (Drainage Course)

pH: 12.0

Observations/Notes: Accessible flowing water extending approx. 12" from culvert outlet, approx. 1" deep.

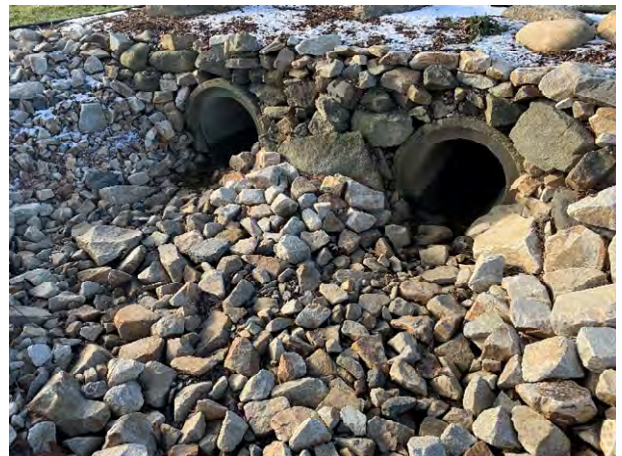
64 Gundalow - 2 (Drainage Course)

pH: 9.6

Observations/Notes: Standing water extending approx. 2' from culvert inlets, max depth approx. 2".

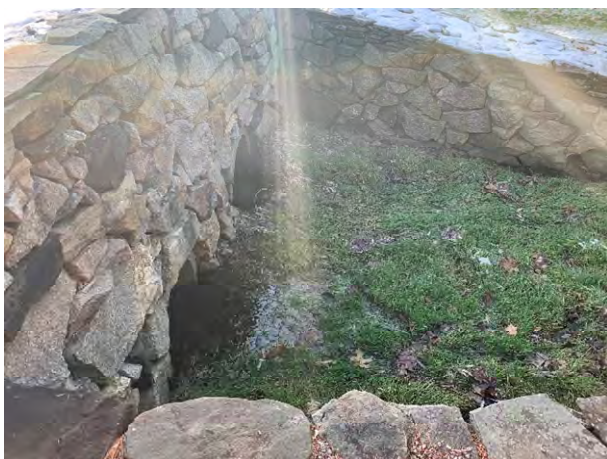
4 Brickyard Circle - 1 (Drainage Course)

pH: 9.3

Observations/Notes: Standing water extending approx. 2.5' from outlet, max depth approx. 10".

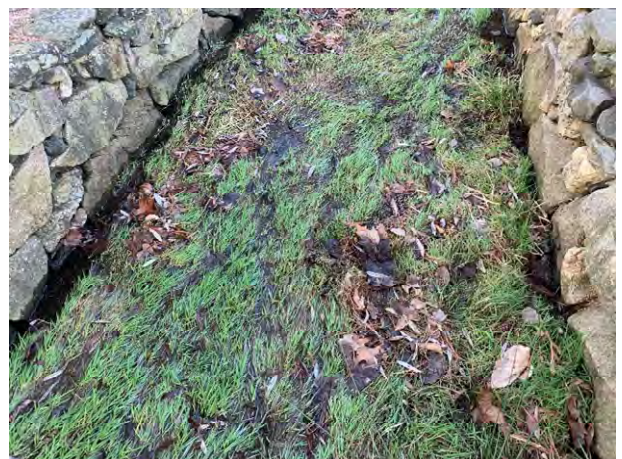
4 Brickyard Circle - 2 (Drainage Course)

pH: 7.7

Observations/Notes: Water flowing through center and adjacent to east wall of raceway, approx. 3" deep.

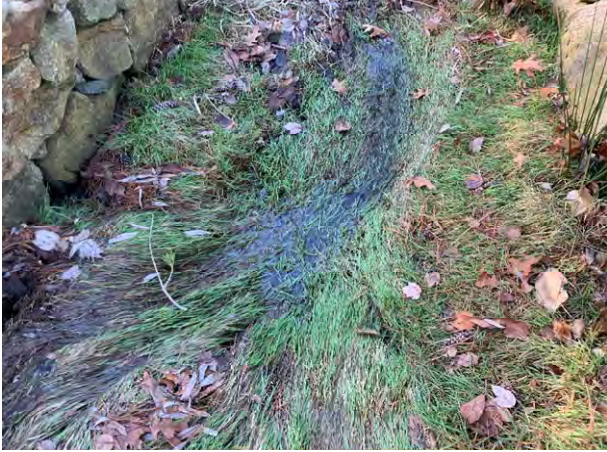
4 Brickyard Circle – 3 (Drainage Course)

pH: 7.6

Observations/Notes: Pooled area in center of raceway, max depth approx. 4".
