### CONSTRUCTION MONITORING REPORT

Eversource Transmission Lines:  
**F107**

**Madbury, Durham,  
Newington, Portsmouth, NH**

NAI Project No:  
**23840.39**

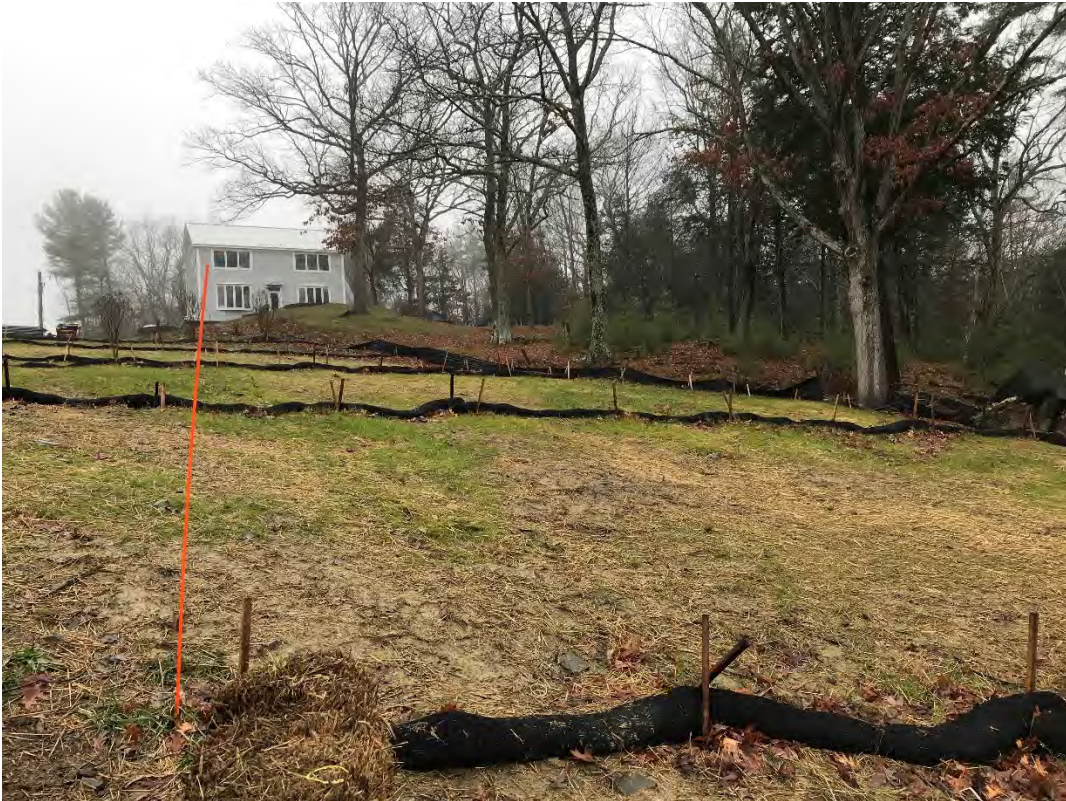
Fig 1: Slope above the cable house at the Eversource property/west side of the bay. Viewing northwest. (12-11-20)

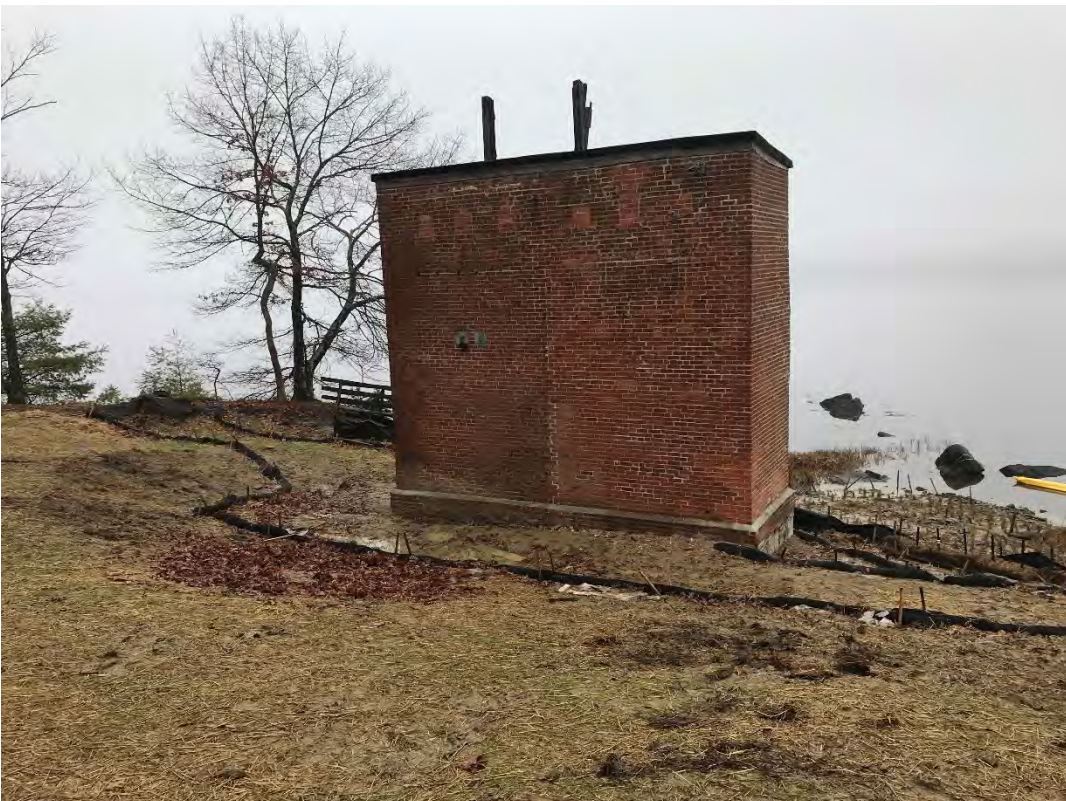
Fig 2: Slope leading down to cable house and salt marsh restoration at the Eversource property/west side of the bay. Viewing northeast. (12-13-20)

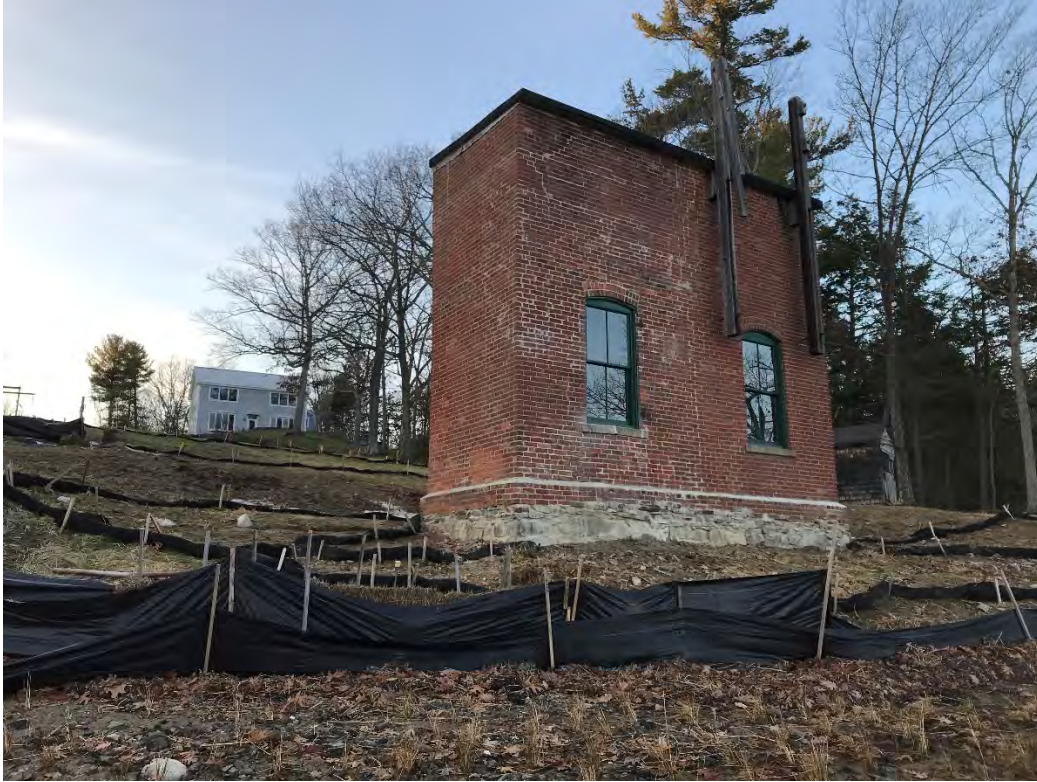
Fig 3: Cable house post-restoration and scaffolding removal at the Eversource property/west side of the bay. Viewing northwest. (12-11-20)

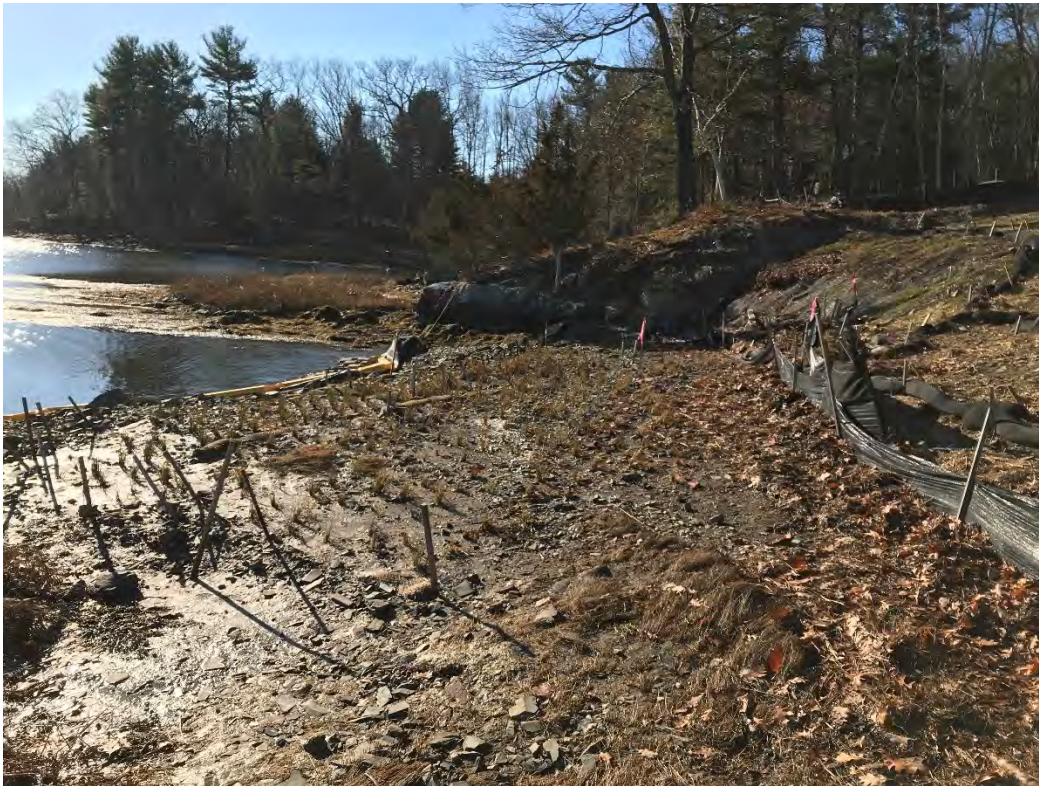
Fig 4: Toe of the slope and salt marsh restoration at the Eversource property/west side of the bay. Viewing south. (12-15-20)

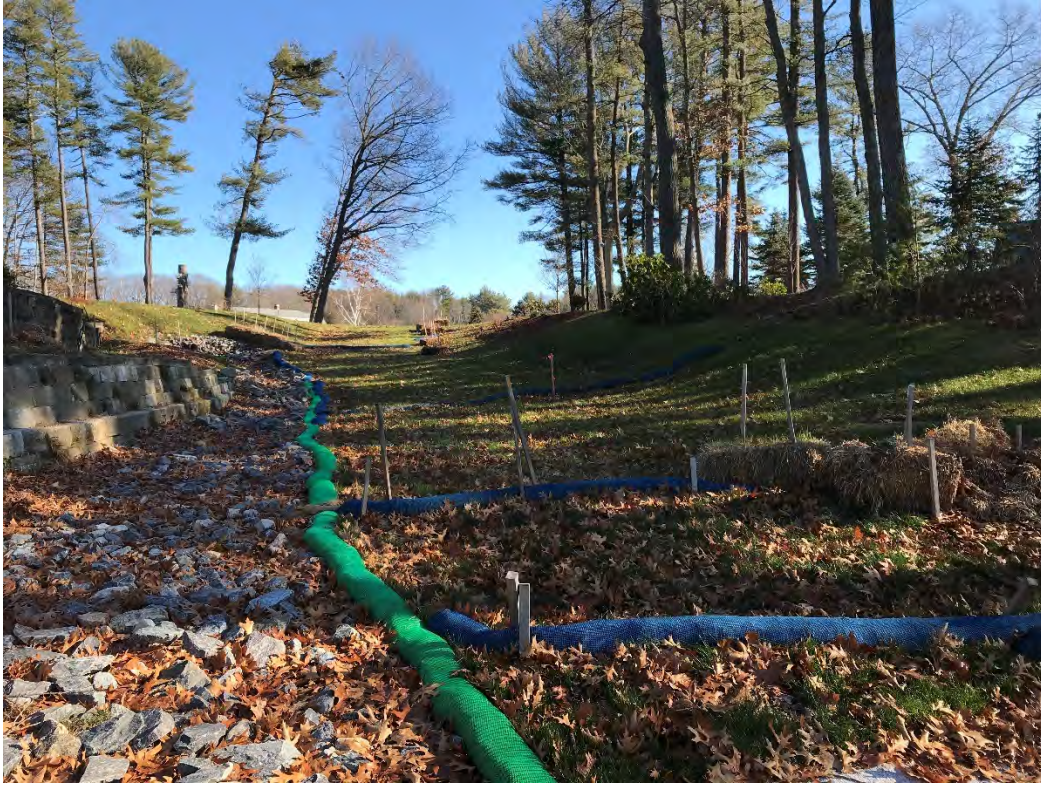
Fig 5: Slope above the manhole at Gundalow Landing/east side of the bay. Viewing east. (12-15-20)

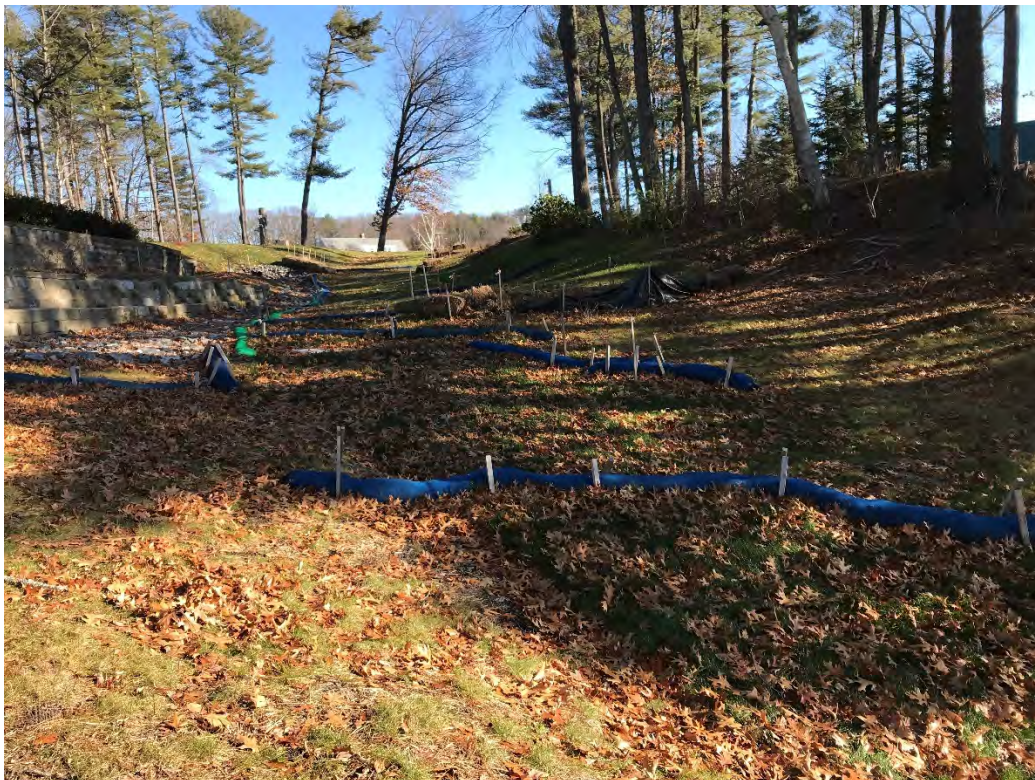
Fig 6: Slope below the manhole at Gundalow Landing/east side of the bay. Viewing east. (12-15-20)

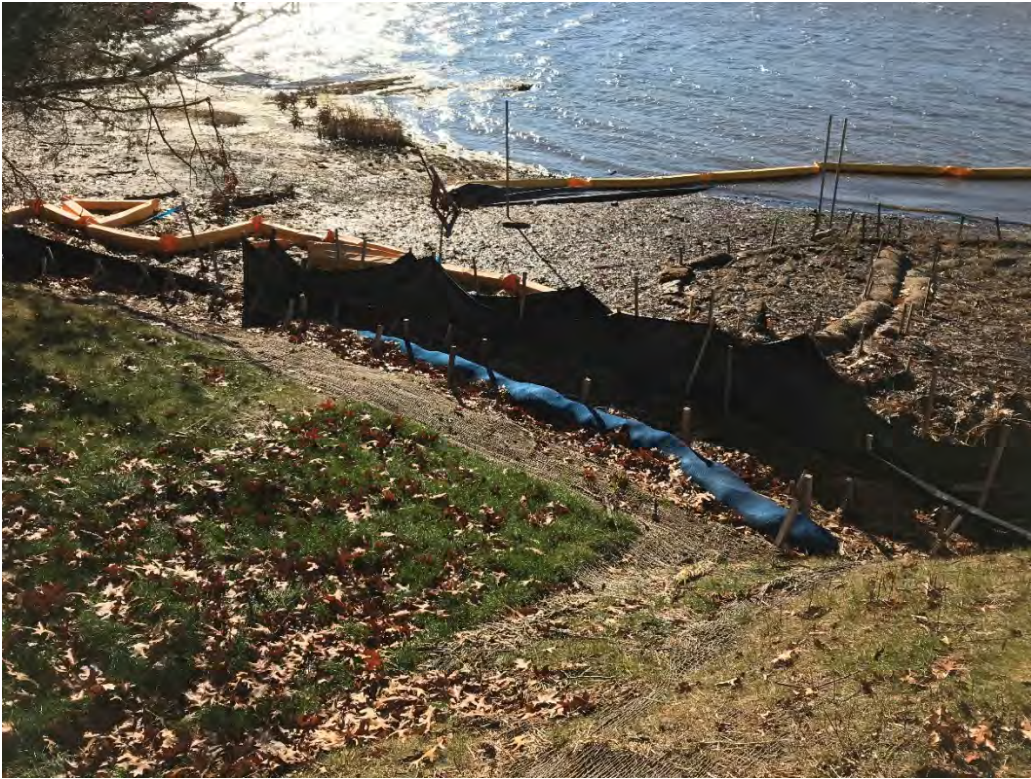
Fig 7: Toe of the slope at Gundalow Landing/east side of the bay. Viewing south. (12-15-20)

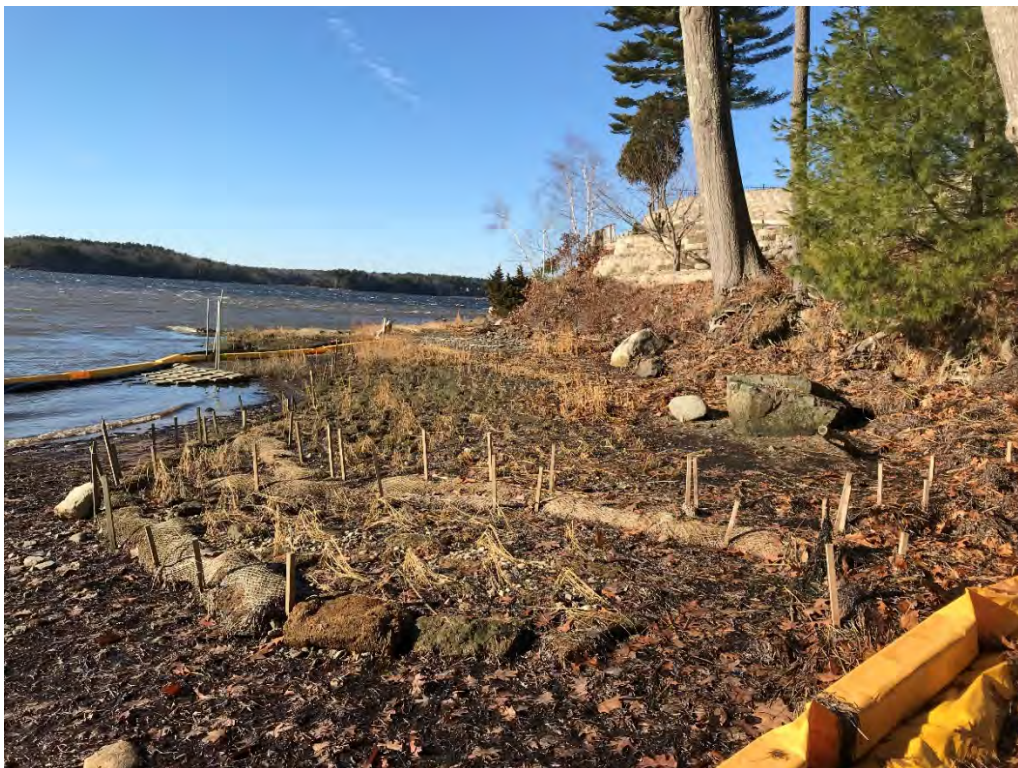
Fig 8: Salt marsh restoration at Gundalow Landing/east side of the bay. Viewing northwest. (12-15-20)

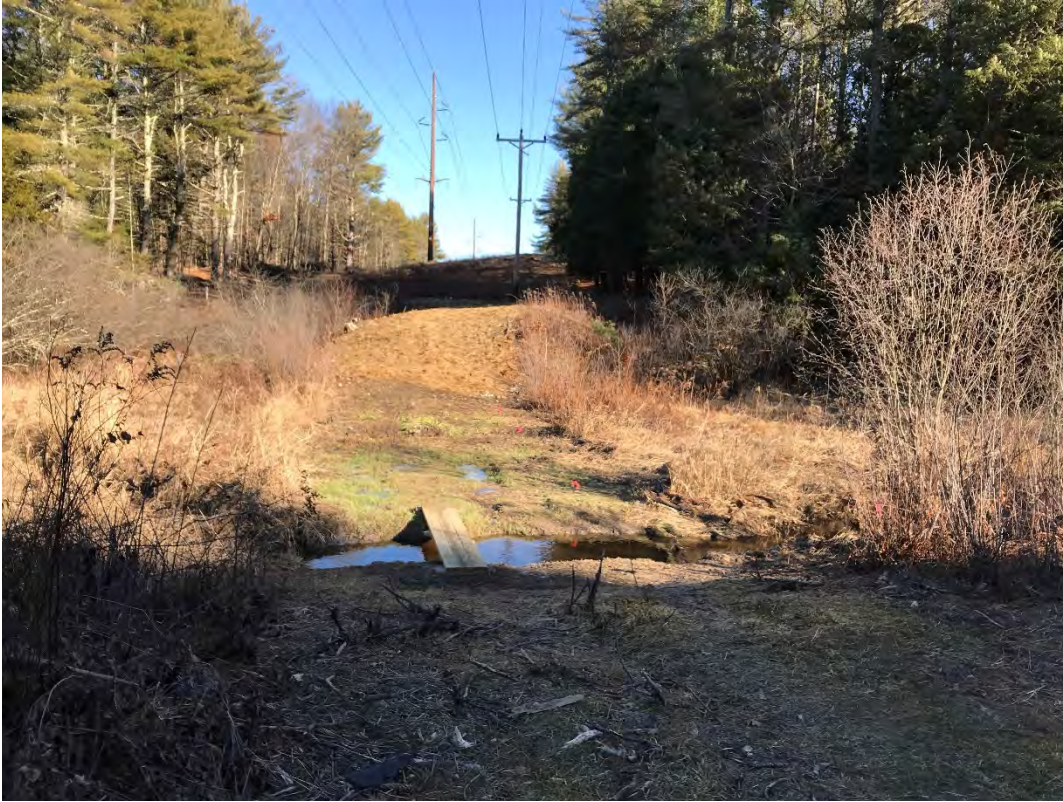
Fig 9: Stream DS46 between Strs. 51 and 52. Viewing northeast. (12-15-20)

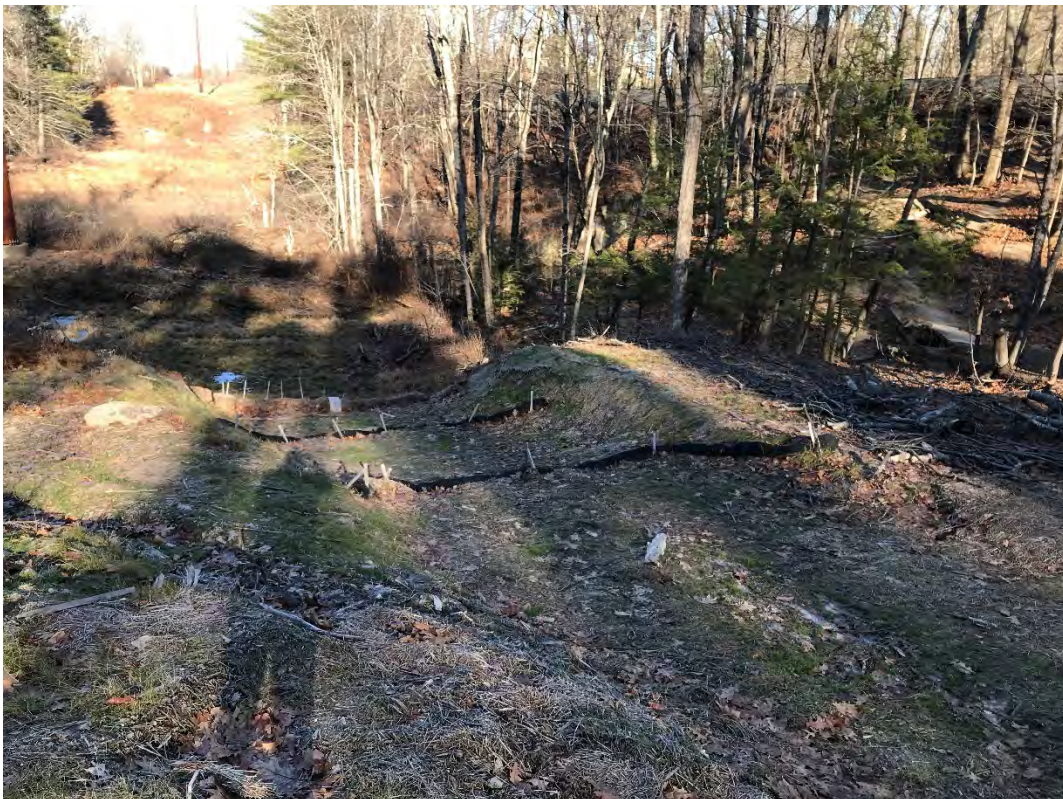
Fig 10: Lower portion of slope between Strs. 28 and 29. Viewing northeast. (12-15-20)

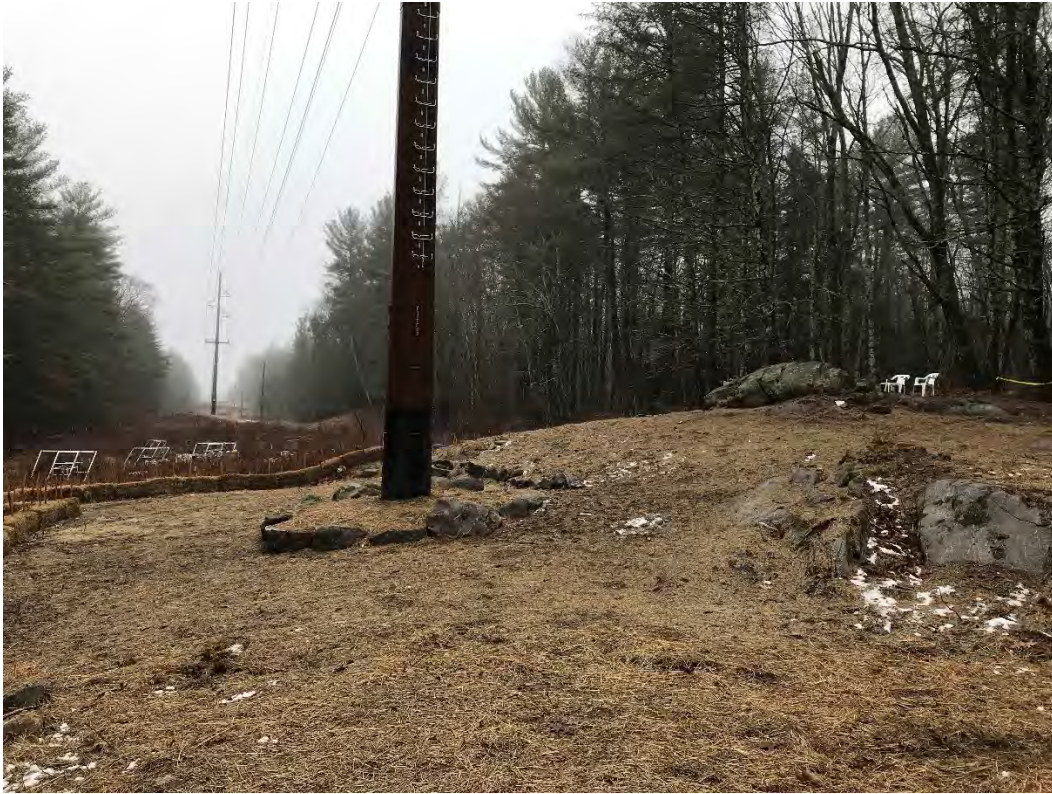
**Areas that have been restored and mulched, but have little germination:** Hannah Ln, Eversource property/west side of bay, 89-90

Fig 11: Str. 89 work area. Viewing southeast. (12-13-20)

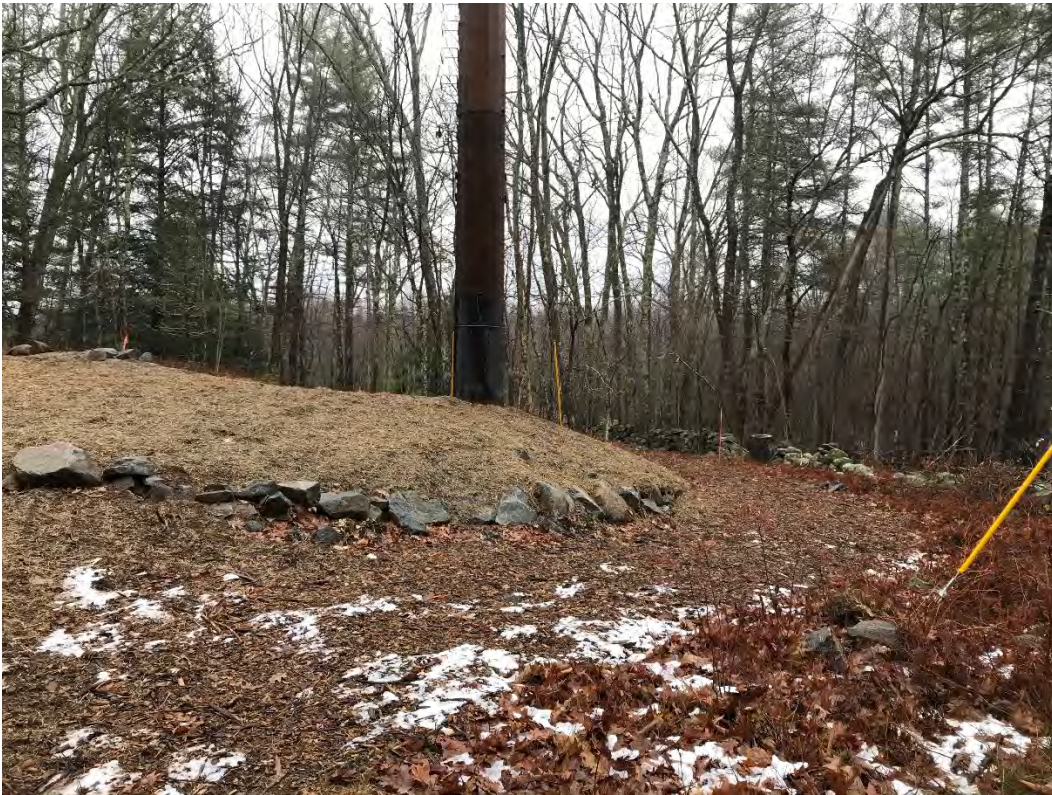
Fig 12: Str. 90 work area. Viewing northeast. (12-13-20)
