DRAINAGE MONITORING REPORT

F107 - Seacoast Reliability Project

Newington, New Hampshire

04.0190967.00

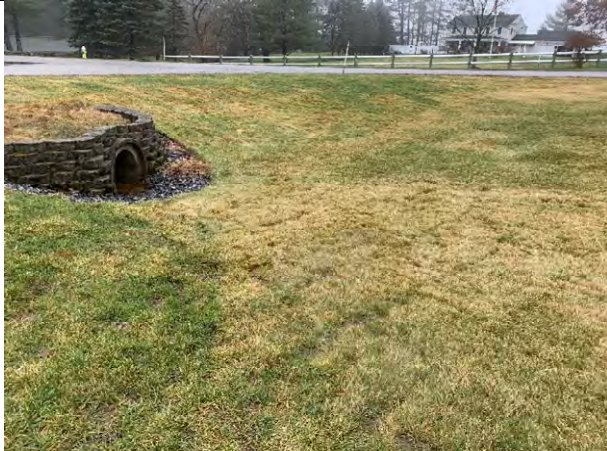
29 Gundalow - 1 (Drainage Area)

pH: **6.3**

Observations/Notes: Intermittent areas of standing water in grass, max depth approx. 1"

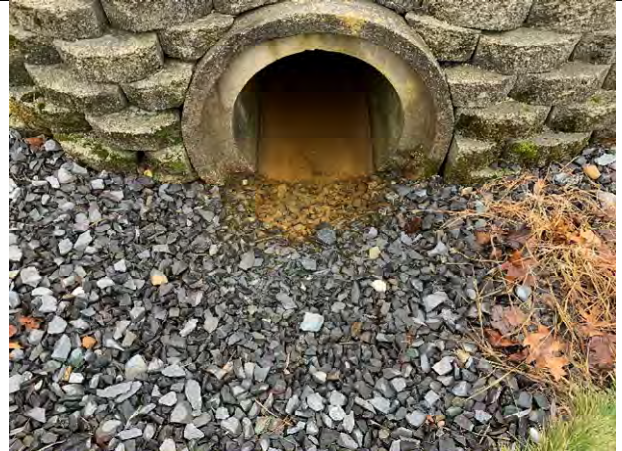
29 Gundalow - 2 (Culvert)

pH: **11.8**

Observations/Notes: Water extending approx. 18" beyond culvert inlet into stone area, approx. max depth 4". Flow visible through culvert.

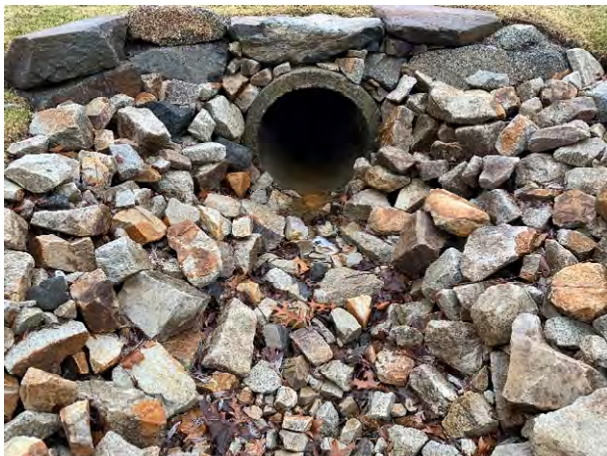
64 Gundalow - 1 (Drainage Course)

pH: **11.5**

Observations/Notes: Accessible flowing water extending approx. 16" from culvert outlet, approx. 2" deep.

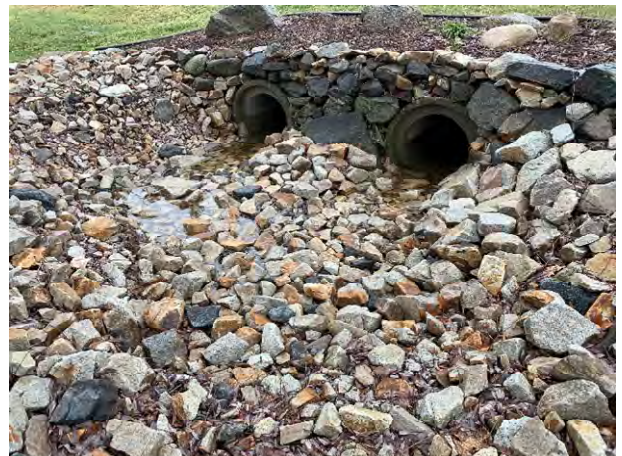
64 Gundalow - 2 (Drainage Course)

pH: **9.3**

Observations/Notes: Large area of pooled water extending approx. 5' from culvert inlets, max depth approx. 8". Visible flow through culverts.

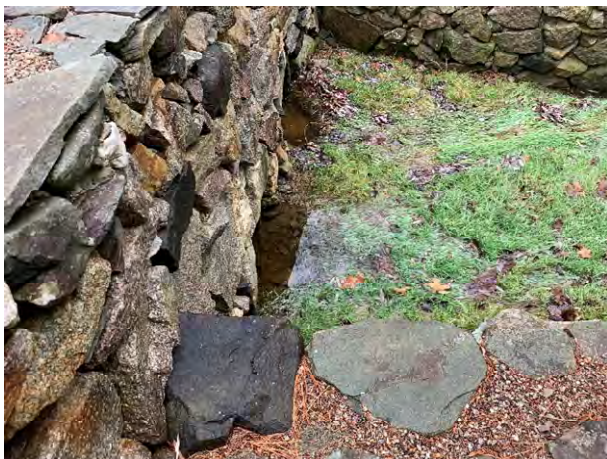
4 Brickyard Circle - 1 (Drainage Course)

pH: **8.3**

Observations/Notes: Water flowing through culvert with pools at outlet, max depth approx. 10". Visible flow through culvert and into raceway.

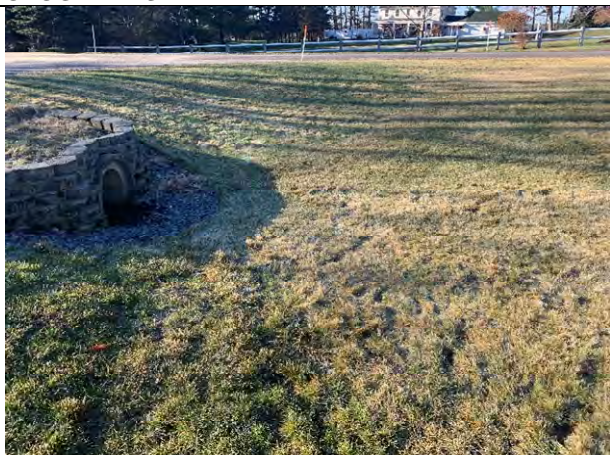
29 Gundalow - 1 (Drainage Area)

Observations/Notes: Saturated soil but no standing water.

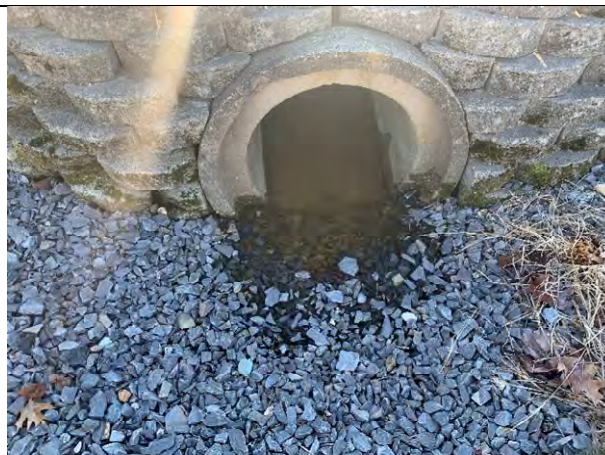
29 Gundalow - 2 (Culvert)

pH: 12.3

Observations/Notes: Water extending approx. 12" beyond culvert inlet into stone area, approx. max depth 4". Flow visible through culvert.

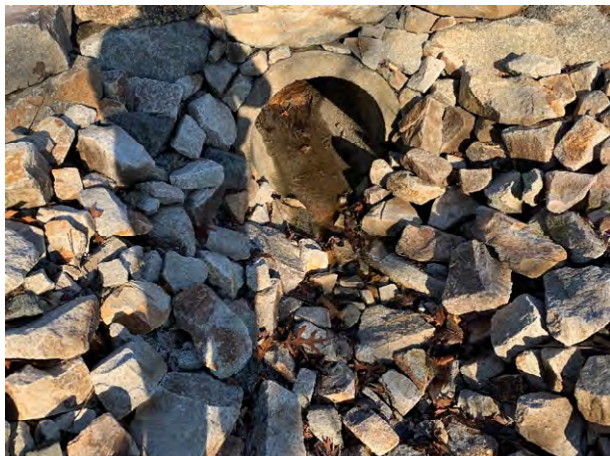
64 Gundalow - 1 (Drainage Course)

pH: 11.8

Observations/Notes: Accessible flowing water extending approx. 12" from culvert outlet, approx. 1" deep.

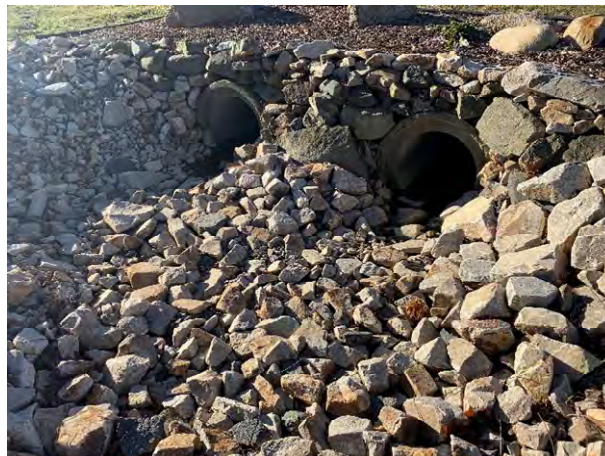
64 Gundalow - 2 (Drainage Course)

pH: 9.8

Observations/Notes: Standing water extending approx. 18" from culvert inlets, max depth approx. 2".

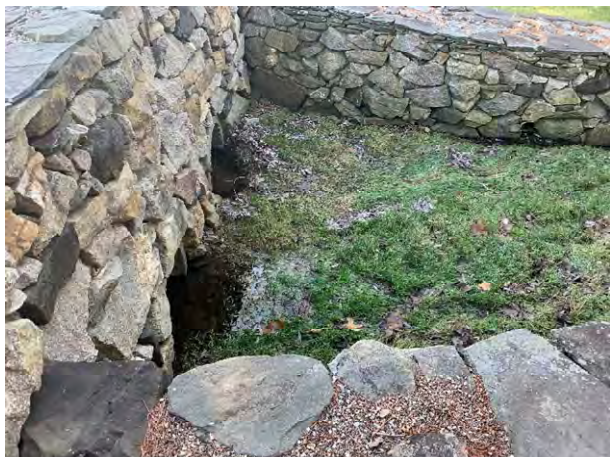
4 Brickyard Circle - 1 (Drainage Course)

pH: 9.5

Observations/Notes: Standing water extending approx. 2.5' from outlet, max depth approx. 10".

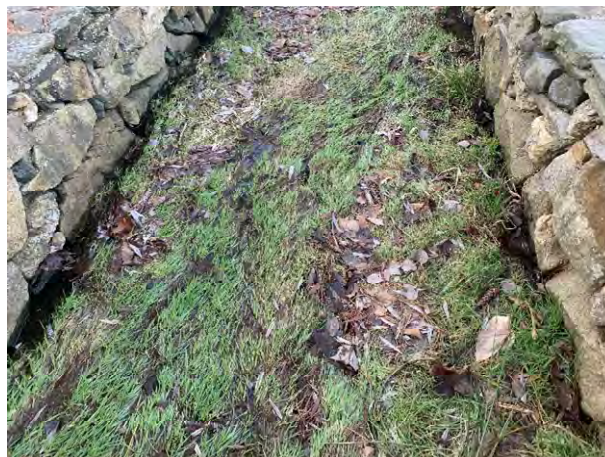
4 Brickyard Circle - 2 (Drainage Course)

pH: 7.9

Observations/Notes: Water flowing through center and adjacent to east wall of raceway, approx. 3" deep.

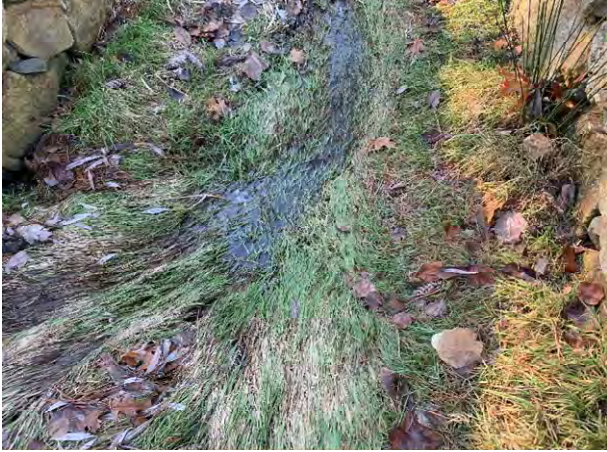
4 Brickyard Circle – 3 (Drainage Course)

pH: 7.6

Observations/Notes: Pooled area in center of raceway, max depth approx. 3".

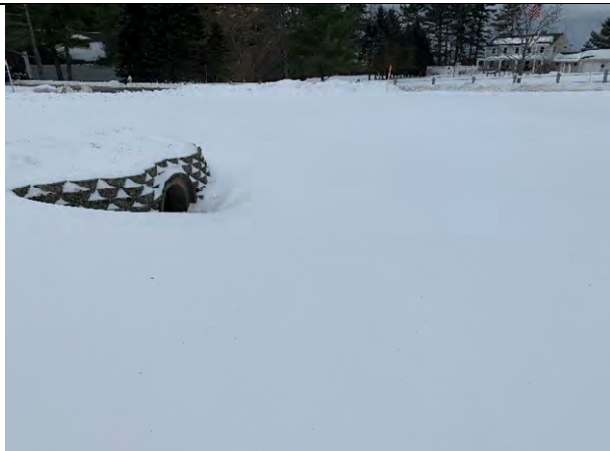
29 Gundalow - 1 (Drainage Area)

<p>OTHER COMMENTS AND OBSERVATIONS</p> <ul style="list-style-type: none">• Heavy snow cover over 29 Gundalow – 1, 64 Brickyard – 1, 64 Brickyard – 2, and 4 Brickyard – 3.

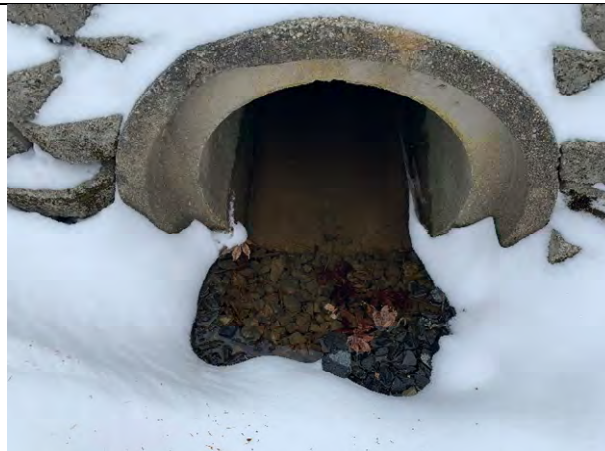
29 Gundalow - 2 (Culvert)

pH: 12.6

Observations/Notes: Water extending approx. 12" beyond culvert inlet into stone area, approx. max depth 4". Flow visible through culvert.

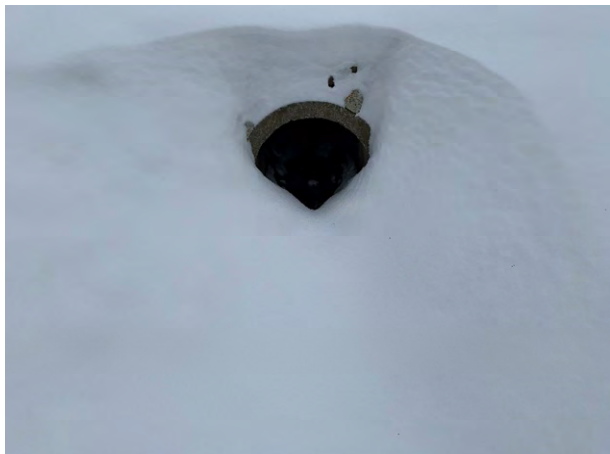
64 Gundalow - 1 (Drainage Course)

pH: **12.3

Observations/Notes: **Standing water in drainage course covered by snow/ice - pH measurement taken from standing water just inside culvert. Standing water approx. 1" deep.

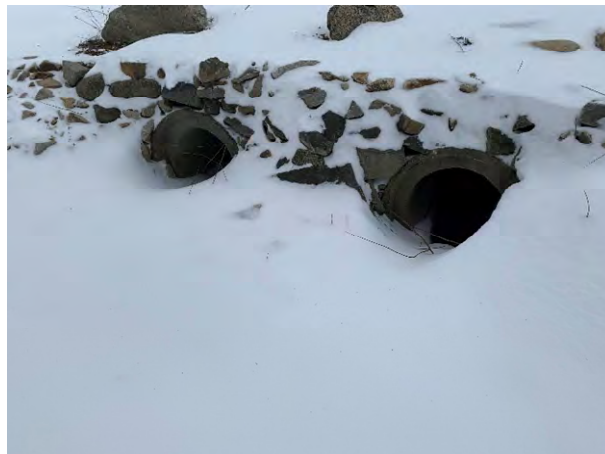
64 Gundalow - 2 (Drainage Course)

pH: **10.0

Observations/Notes: **Standing water in drainage course covered by snow/ice - pH measurement taken from standing water just inside culvert. Standing water approx. 1" deep.

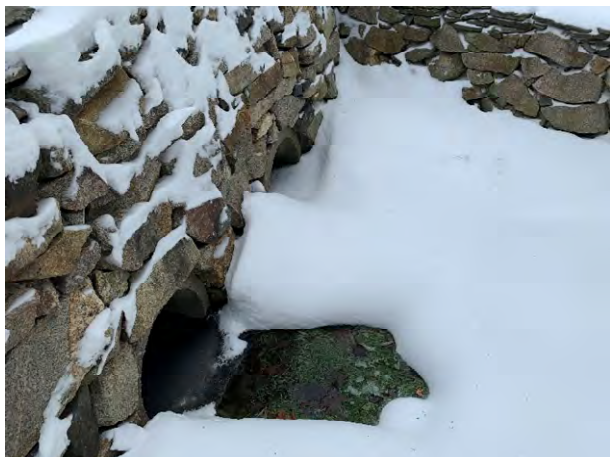
4 Brickyard Circle - 1 (Drainage Course)

pH: 9.3

Observations/Notes: Standing water extending approx. 2.5' from outlet, max depth approx. 10".

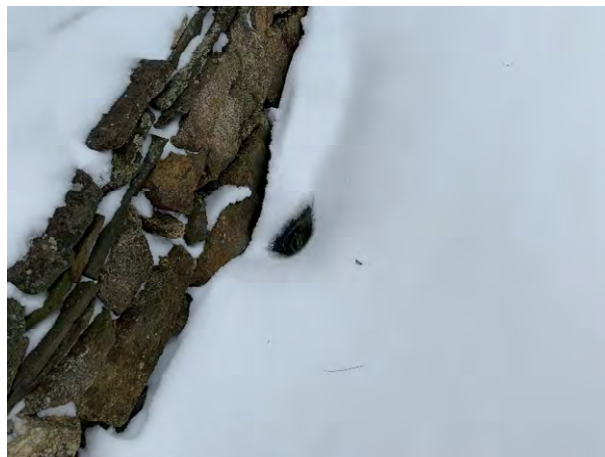
4 Brickyard Circle - 2 (Drainage Course)

pH: 7.6

Observations/Notes: Small area of accessible standing water adjacent to east wall of raceway, approx. 2" deep.

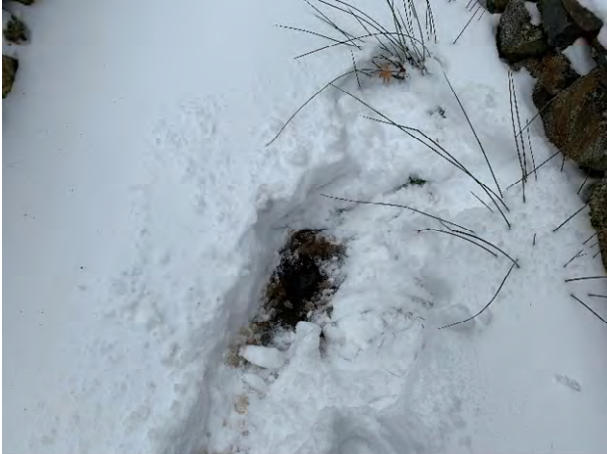
4 Brickyard Circle – 3 (Drainage Course)

pH: 7.5

Observations/Notes: Snow manually removed to access flowing water. Waited until flow resumed to take pH measurement.
