DRAINAGE MONITORING REPORT

F107 - Seacoast Reliability Project

Newington, New Hampshire

04.0190967.00

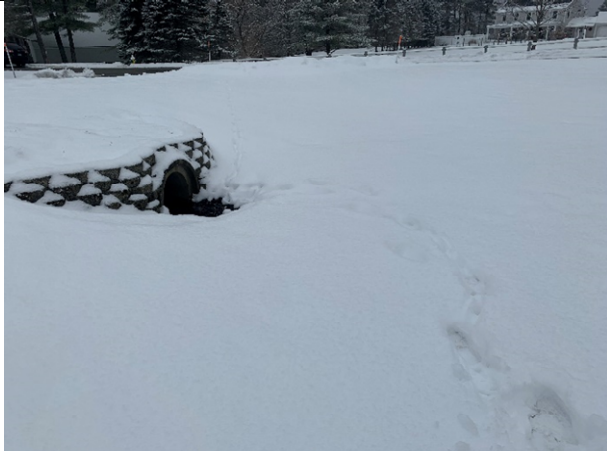
29 Gundalow - 1 (Drainage Area)

<p>OTHER COMMENTS AND OBSERVATIONS</p> <ul style="list-style-type: none">• Heavy snow cover over 29 Gundalow – 1, 64 Brickyard – 1, 64 Brickyard – 2, and 4 Brickyard – 3.

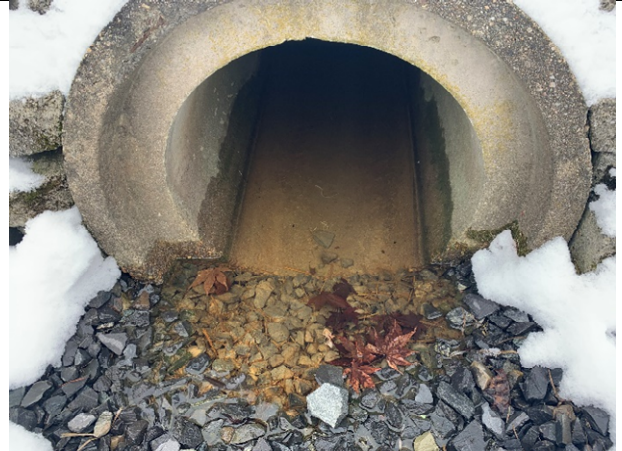
29 Gundalow - 2 (Culvert)

pH: 12.5

Observations/Notes: Water extending approx. 12" beyond culvert inlet into stone area, approx. max depth 4". Flow visible through culvert.

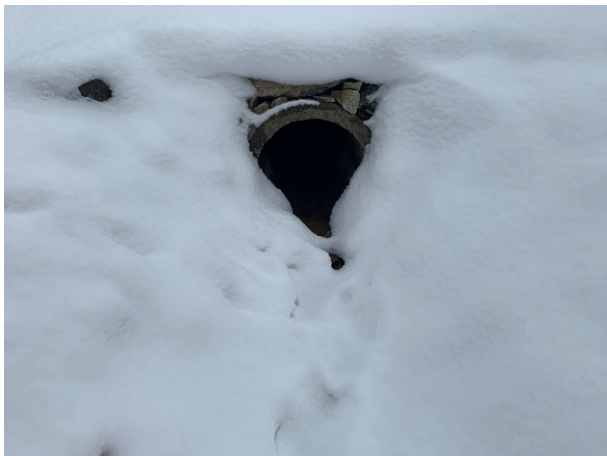
64 Gundalow - 1 (Drainage Course)

pH: 11.9

Observations/Notes: Flowing water extending approx. 8" beyond culvert outlet, approx. 1" deep.

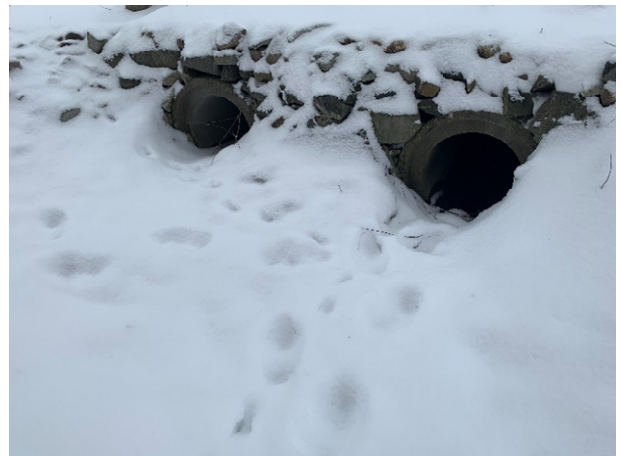
64 Gundalow - 2 (Drainage Course)

pH: 9.9

Observations/Notes: Flowing water extending approx. 8" beyond culvert inlet, approx. 1" deep.

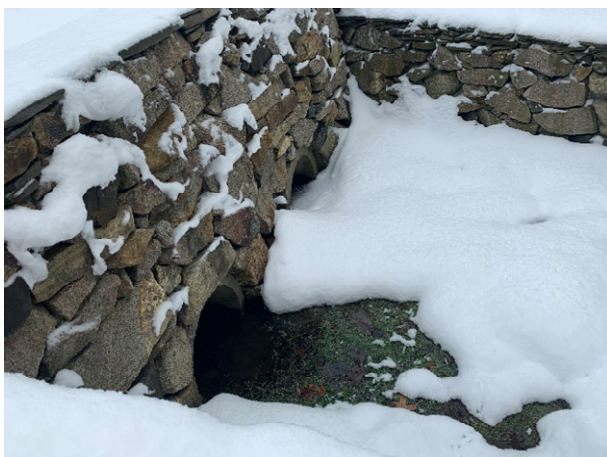
4 Brickyard Circle - 1 (Drainage Course)

pH: 9.6

Observations/Notes: Standing water extending approx. 2.5' from outlet, max depth approx. 8".

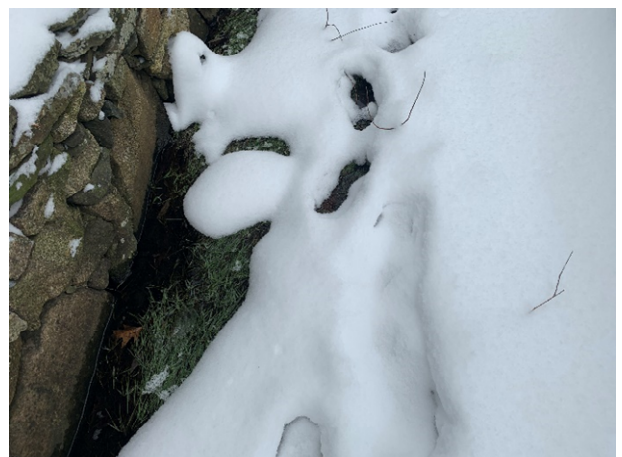
4 Brickyard Circle - 2 (Drainage Course)

pH: 7.8

Observations/Notes: Flowing water adjacent to east wall of raceway, approx. 2" deep.

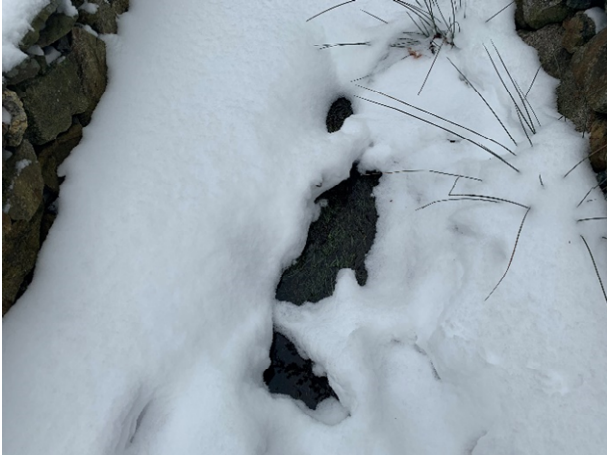
4 Brickyard Circle – 3 (Drainage Course)

pH: 7.5

Observations/Notes: Flowing water in center of raceway, approx. 2" deep.

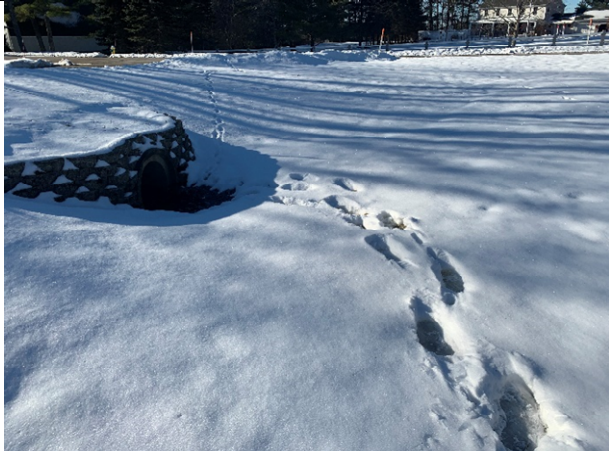
29 Gundalow - 1 (Drainage Area)

Observations/Notes: Ice at ground surface.

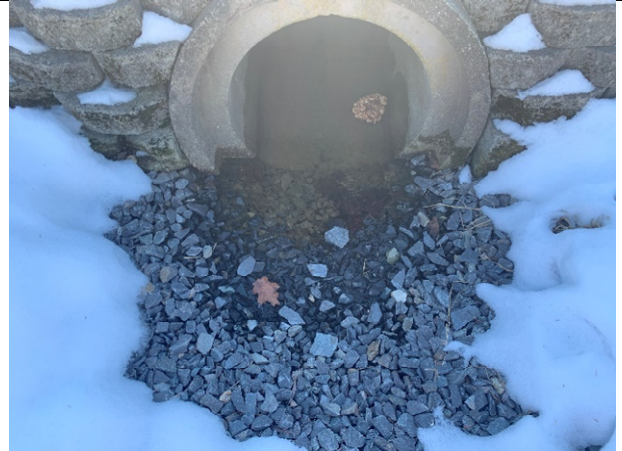
29 Gundalow - 2 (Culvert)

pH: 12.6

Observations/Notes: Water extending approx. 12" beyond culvert inlet into stone area, approx. max depth 4". Flow visible through culvert.

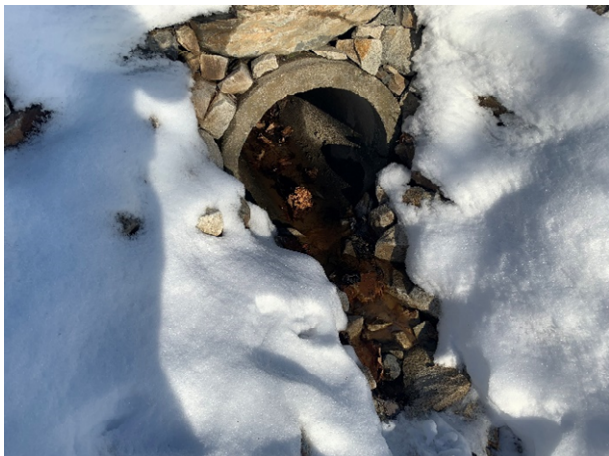
64 Gundalow - 1 (Drainage Course)

pH: 12.2

Observations/Notes: Flowing water extending approx. 16" beyond culvert outlet, approx. 1" deep.

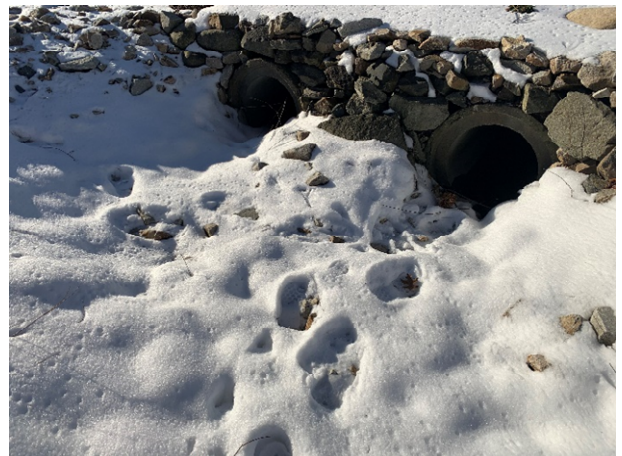
64 Gundalow - 2 (Drainage Course)

pH: 9.9

Observations/Notes: Flowing water extending approx. 8" beyond culvert inlet, approx. 1" deep.

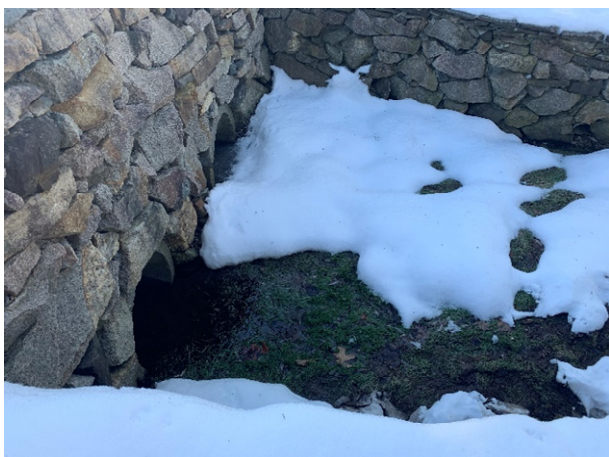
4 Brickyard Circle - 1 (Drainage Course)

pH: 9.7

Observations/Notes: Standing water extending approx. 2.5' from outlet, max depth approx. 8".

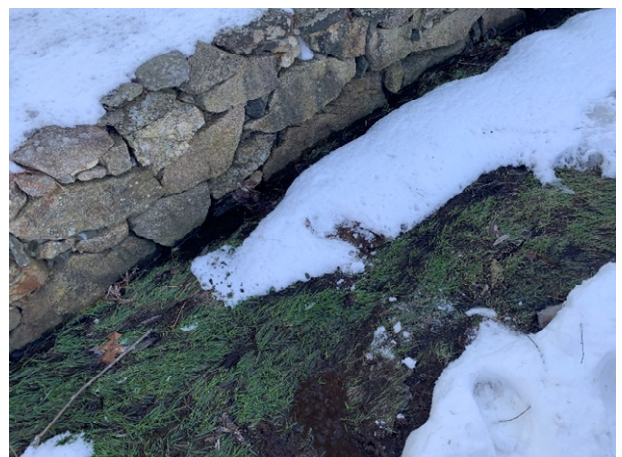
4 Brickyard Circle - 2 (Drainage Course)

pH: 7.7

Observations/Notes: Flowing water adjacent to east wall of raceway, approx. 2" deep.

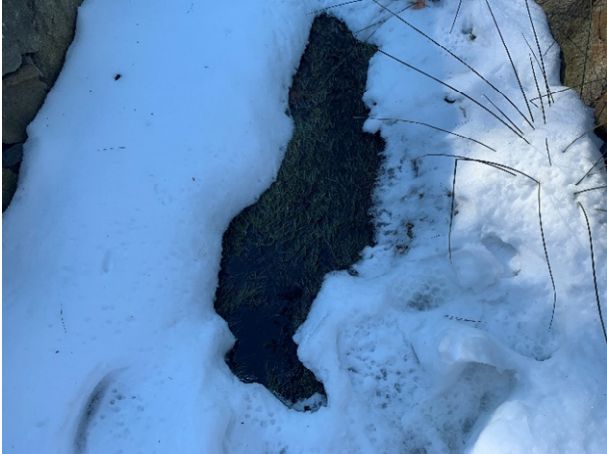
4 Brickyard Circle – 3 (Drainage Course)

pH: 7.5

Observations/Notes: Flowing water in center of raceway, approx. 2" deep.
