#### CONSTRUCTION MONITORING REPORT

Eversource Transmission Lines: F107

Eversource Seacoast Reliability Project

#### Construction Monitoring Report #108

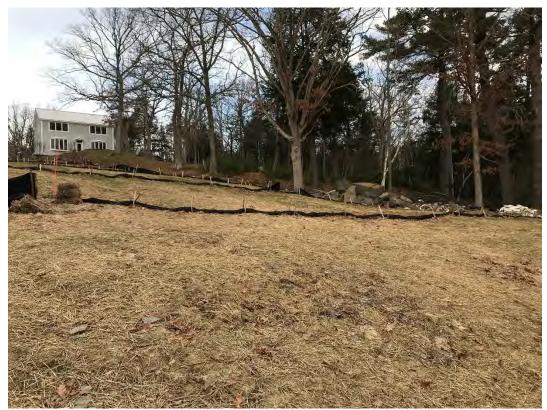
Fig 1: Slope above the cable house at the Eversource property/west side of the bay. Viewing northwest. (12-30-20)

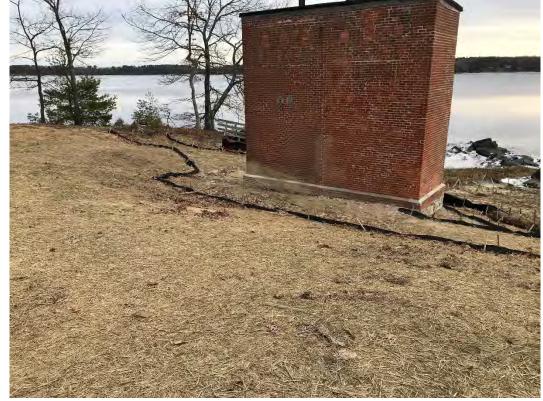
Fig 2: Slope leading down to cable house and salt marsh restoration at the Eversource property/west side of the bay. Viewing northeast. (12-30-20)

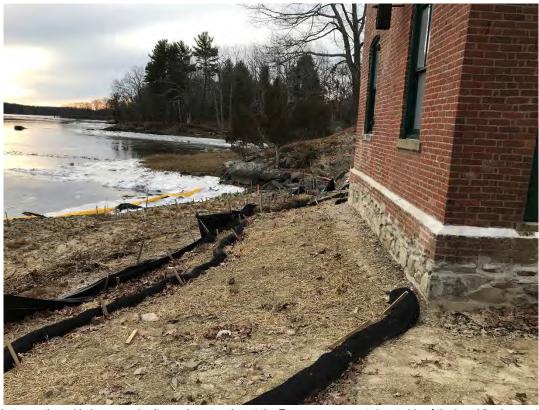
Fig 3: Slope between the cable house and salt marsh restoration at the Eversource property/west side of the bay. Viewing south. (12-30-20)

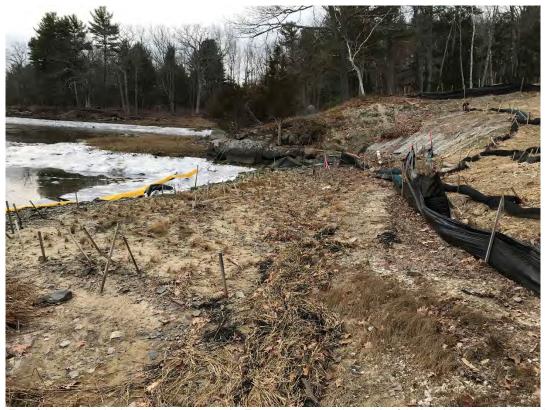
Fig 4: Toe of the slope and salt marsh restoration at the Eversource property/west side of the bay. Viewing south. (12-30-20)

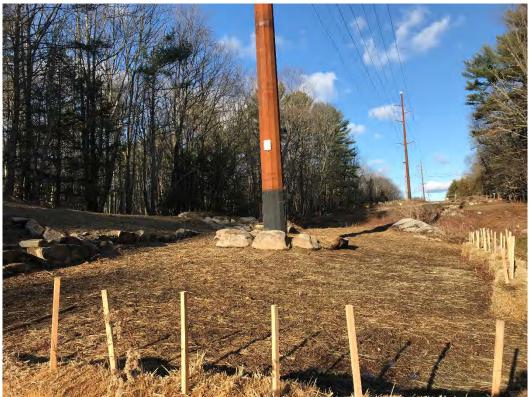
Fig 5: Str. 89 work area. Viewing northwest. (12-26-20)

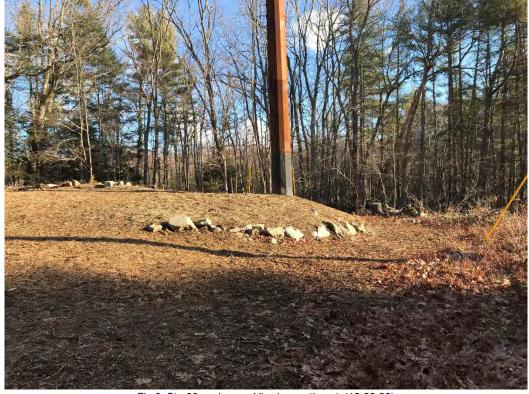
Fig 6: Str. 90 work area. Viewing northeast. (12-26-20)

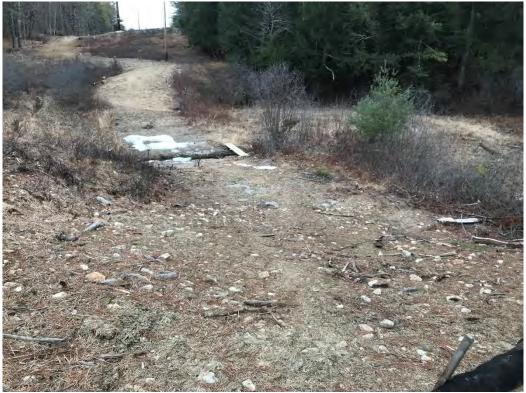
Fig 7: Stream DS46 between Strs. 51 and 52. Viewing northeast. (12-30-20)

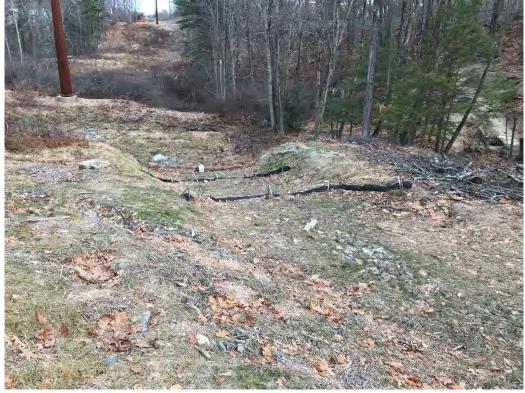
Fig 8: Lower portion of slope between Strs. 28 and 29. Viewing northeast. (12-30-20)

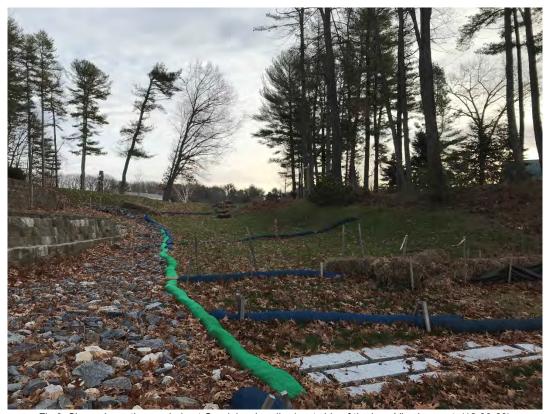
Fig 9: Slope above the manhole at Gundalow Landing/east side of the bay. Viewing east. (12-30-20)

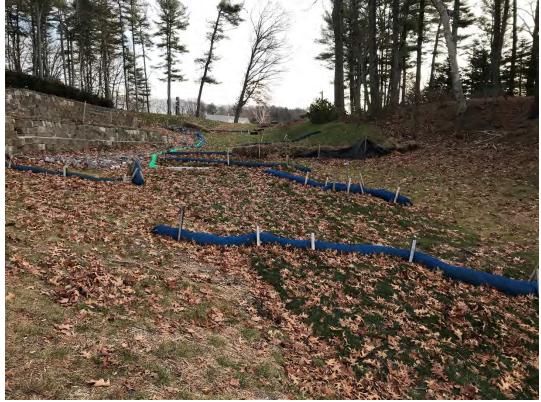
Fig 10: Slope below the manhole at Gundalow Landing/east side of the bay. Viewing east. (12-30-20)

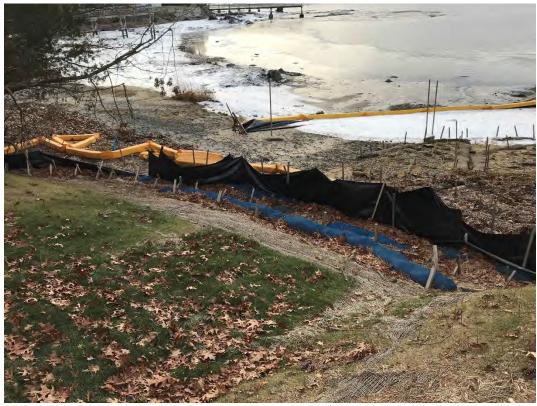
Fig 11: Toe of the slope at Gundalow Landing/east side of the bay. Viewing south. (12-30-20)

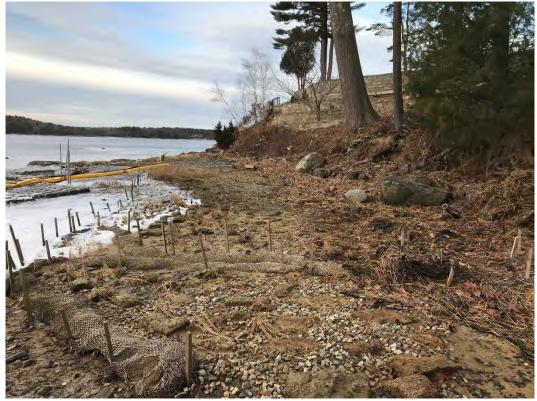
Fig 12: Salt marsh restoration at Gundalow Landing/east side of the bay. Viewing northwest. (12-30-20)
