# DRAINAGE MONITORING REPORT

## F107 - Seacoast Reliability Project

### Newington, New Hampshire

04.0190967.00

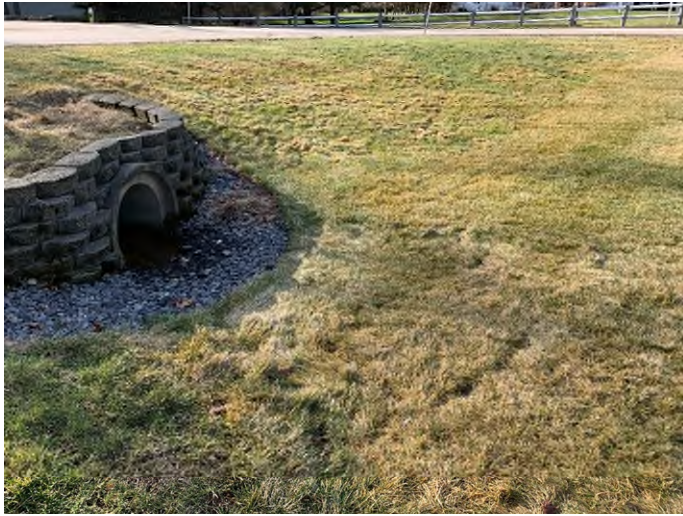
29 Gundalow - 1 (Drainage Area)

pH: **8.6**

Observations/Notes: Soil saturated. Very shallow pockets of water in depressions.

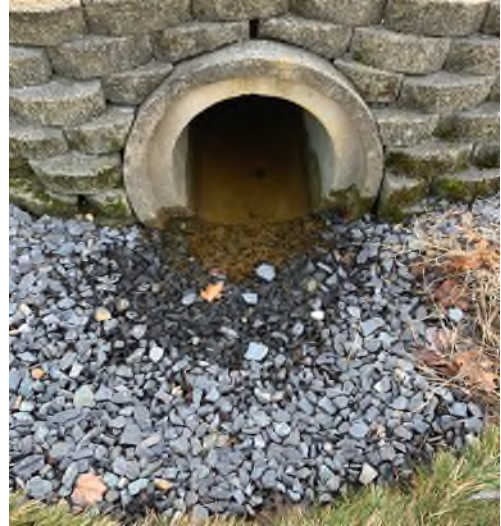
29 Gundalow - 2 (Culvert)

pH: **11.3**

Observations/Notes: Water extending approx. 12" beyond culvert inlet into stone area, approx. max depth 3". Flow visible through culvert.

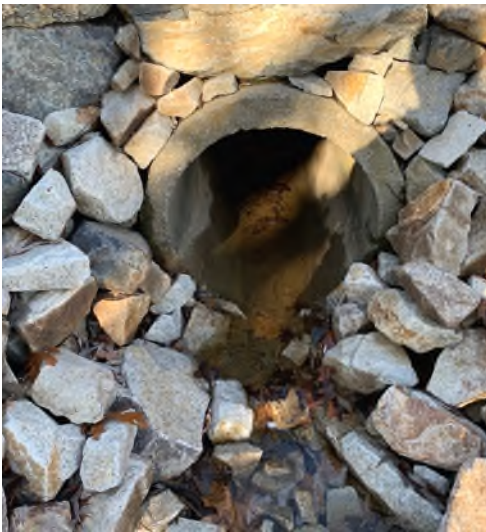
64 Gundalow - 1 (Drainage Course)

pH: **11.1**

Observations/Notes: Flowing water observed beyond culvert outlet within rip-rap.

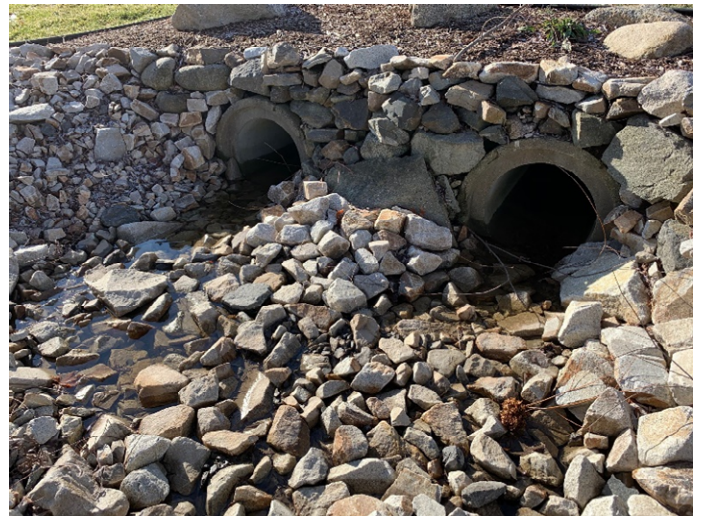
64 Gundalow - 2 (Drainage Course)

pH: **9.2**

Observations/Notes: Flowing water observed in rip-rap swale into culvert with pools of water in front of culverts.

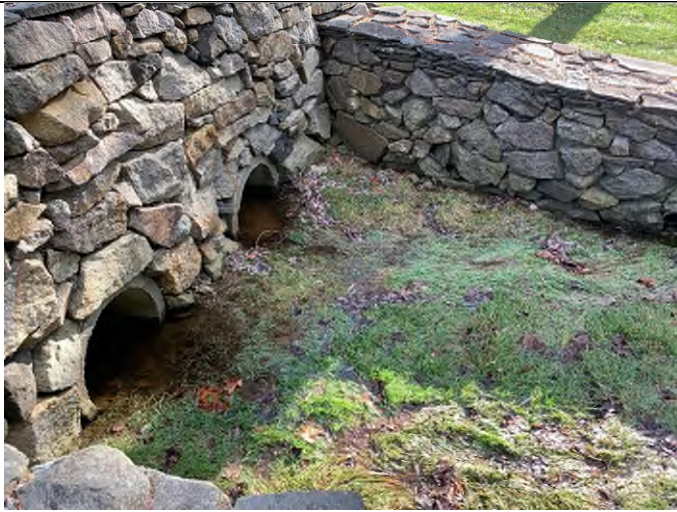
4 Brickyard Circle – 1 (Drainage Course)

pH: **9.0**

Observations/Notes: Slow flowing water observed across drainage course in grass, up to 2" deep at culvert exit.

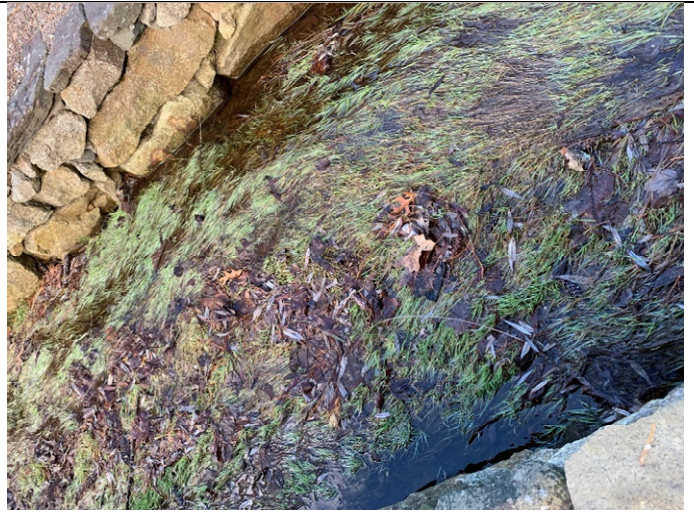
4 Brickyard Circle – 2 (Drainage Course)

pH: **8.1**

Observations/Notes: Slow flowing water observed across drainage course in grass, approx. 1" to 3" deep.

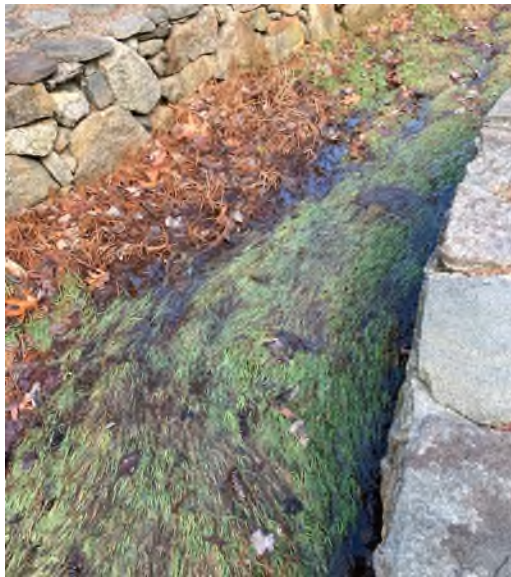
4 Brickyard Circle – 3 (Drainage Course)

pH: **7.8**

Observations/Notes: Paths of flowing water observed within drainage course, approx. 2" deep.

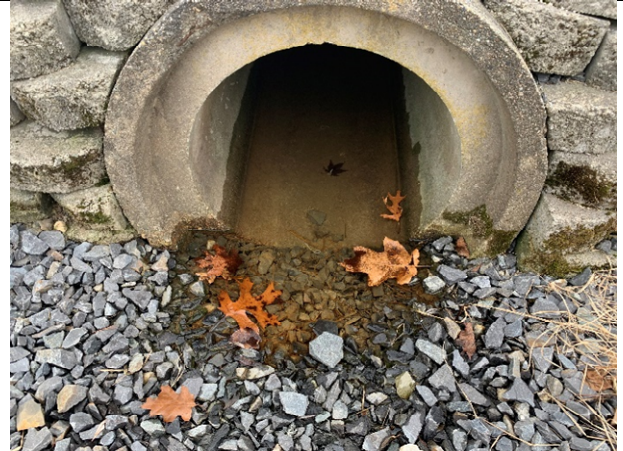
29 Gundalow - 2 (Culvert)

pH: 12.7

Observations/Notes: Water extending approx. 12" beyond culvert inlet into stone area, approx. max depth 4". Flow visible through culvert.

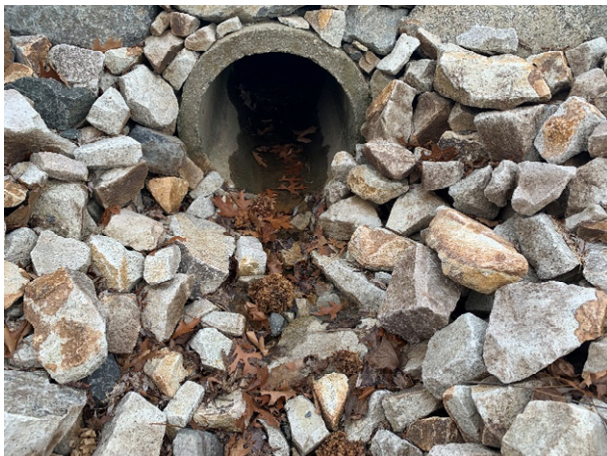
64 Gundalow - 1 (Drainage Course)

pH: 12.1

Observations/Notes: Flowing water extending approx. 8" beyond culvert outlet, approx. 1" deep.

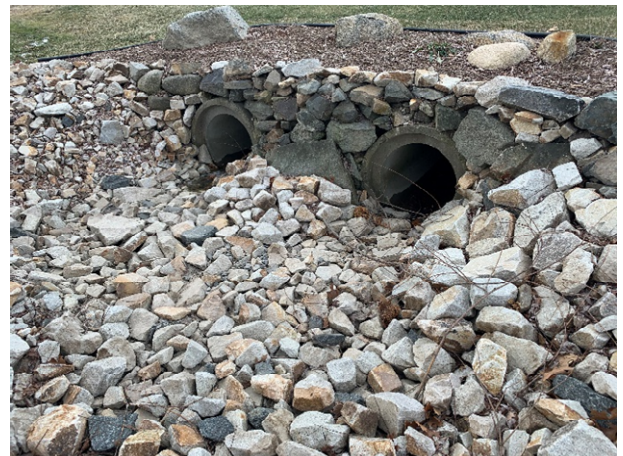
64 Gundalow - 2 (Drainage Course)

pH: 10.0

Observations/Notes: Flowing water extending approx. 8" beyond culvert inlet, approx. 1" deep.

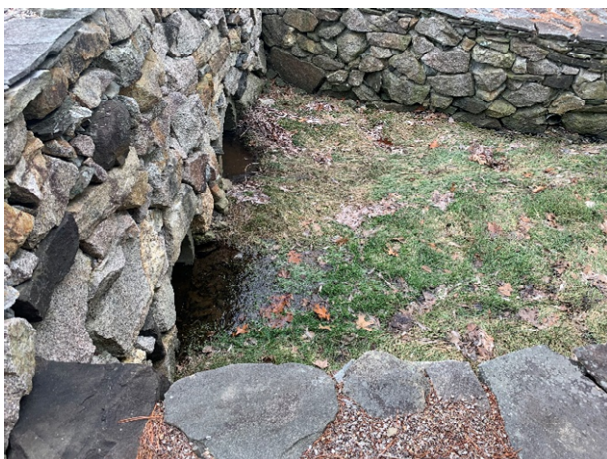
4 Brickyard Circle - 1 (Drainage Course)

pH: 9.3

Observations/Notes: Standing water extending approx. 18" from outlet, max depth approx. 8".

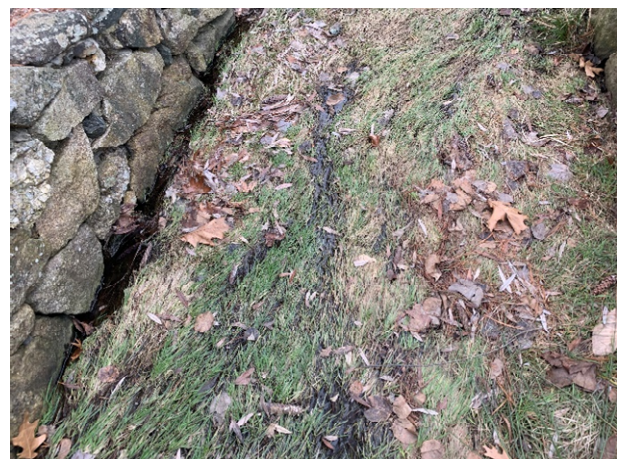
4 Brickyard Circle - 2 (Drainage Course)

pH: 7.8

Observations/Notes: Flowing water adjacent to east wall of raceway, approx. 1" deep.

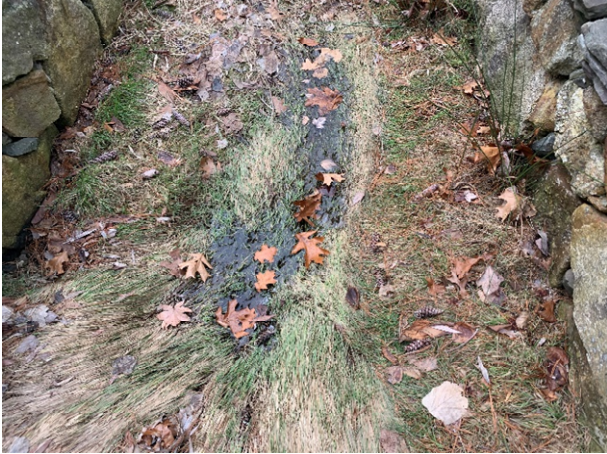
4 Brickyard Circle – 3 (Drainage Course)

pH: 7.5

Observations/Notes: Flowing water in center of raceway, approx. 2" deep.
