CONSTRUCTION MONITORING REPORT

Eversource Transmission Lines:
F107

**Madbury, Durham,
Newington, Portsmouth, NH**

NAI Project No:
23840.39

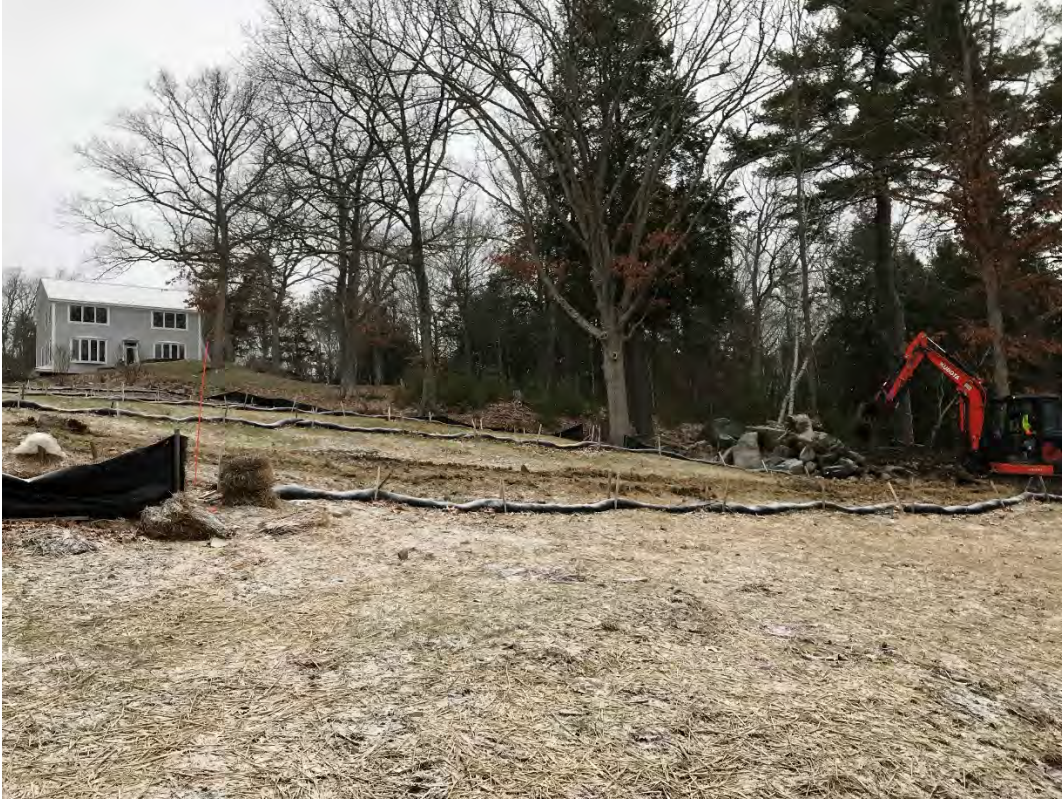
Fig 1: Removal of debris from pile on the slope above the cable house at the Eversource property/west side of the bay. Viewing northwest. (01-05-21)

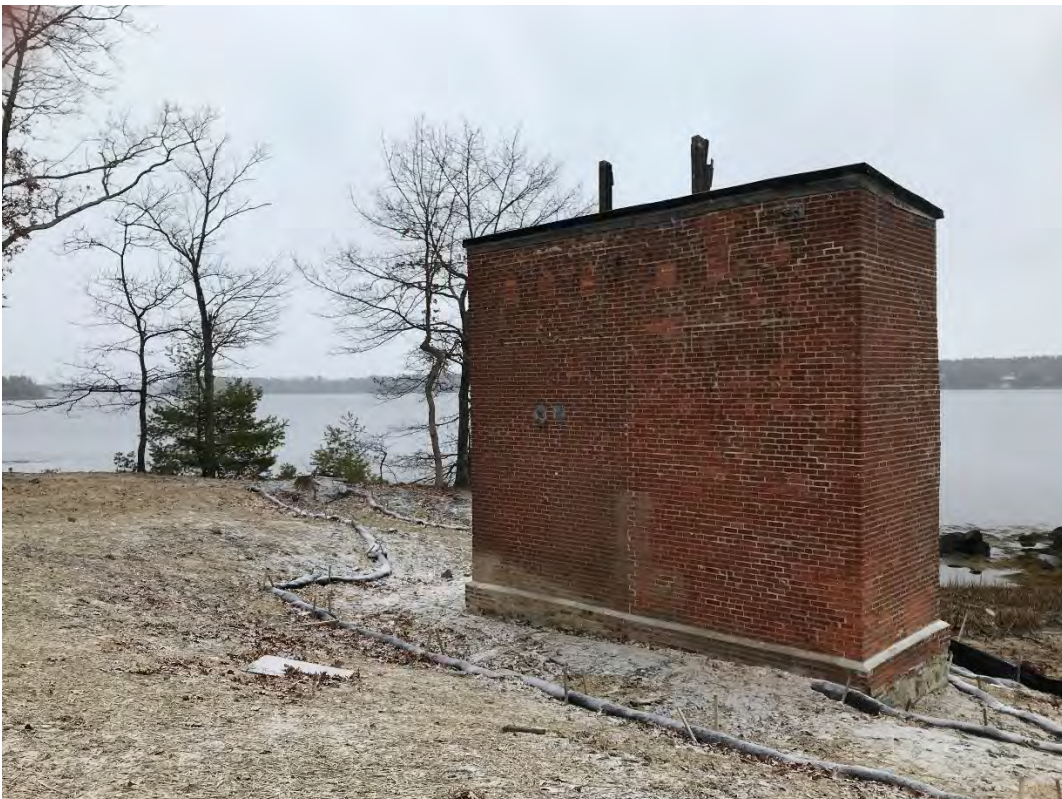
Fig 2: Slope leading down to cable house and salt marsh restoration at the Eversource property/west side of the bay. Viewing northeast. (01-05-21)

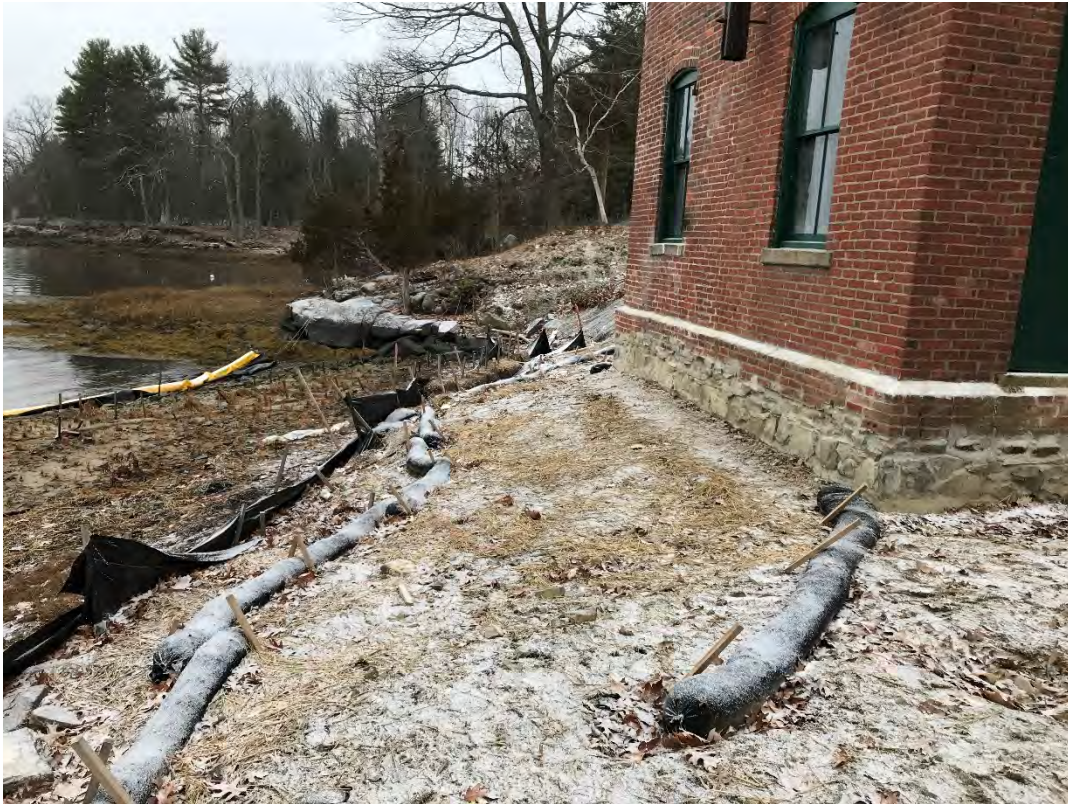
Fig 3: Slope between the cable house and salt marsh restoration at the Eversource property/west side of the bay. Viewing south. (01-05-21)

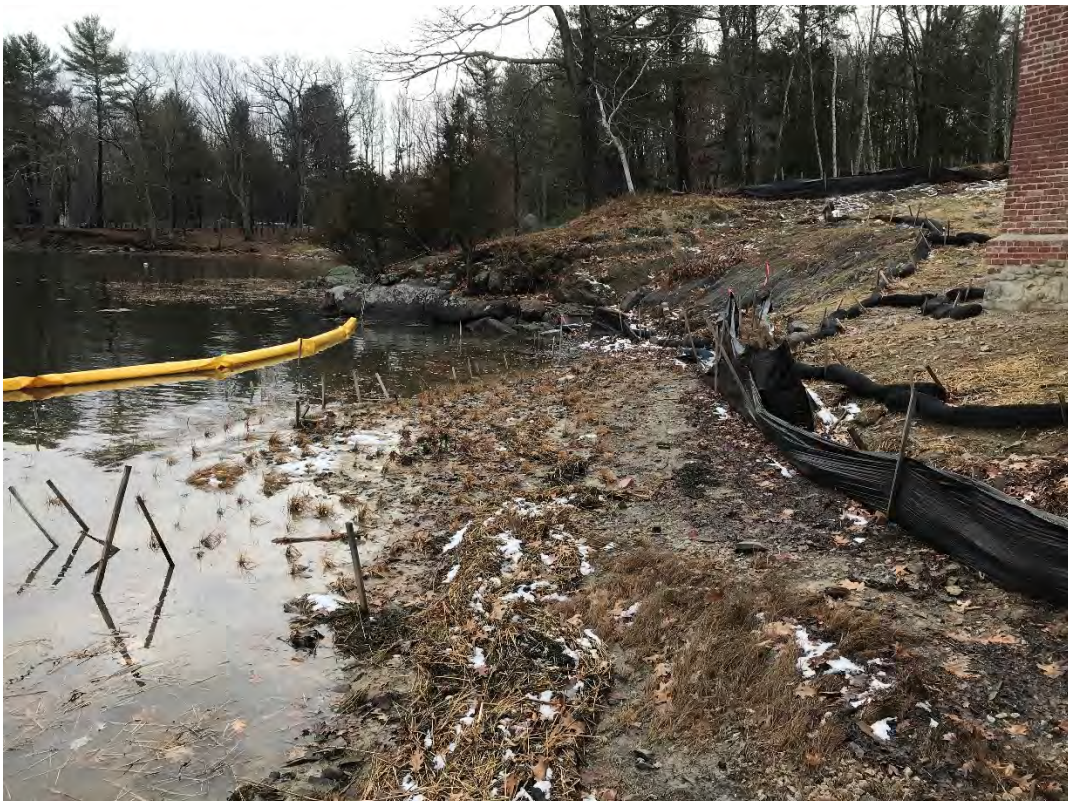
Fig 4: Toe of the slope and salt marsh restoration at the Eversource property/west side of the bay. Viewing south. (01-02-21)

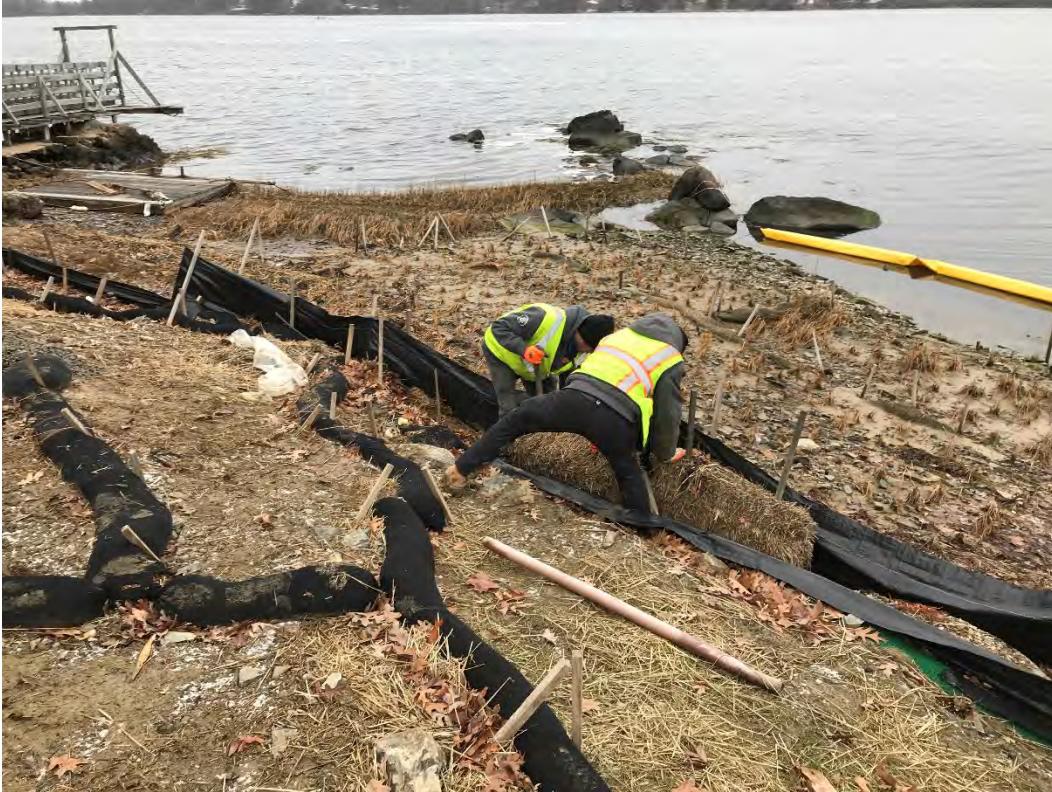
Fig 5: Restoration of the toe of slope below the cable house at the Eversource property/west side of the bay. Viewing east. (01-05-21)

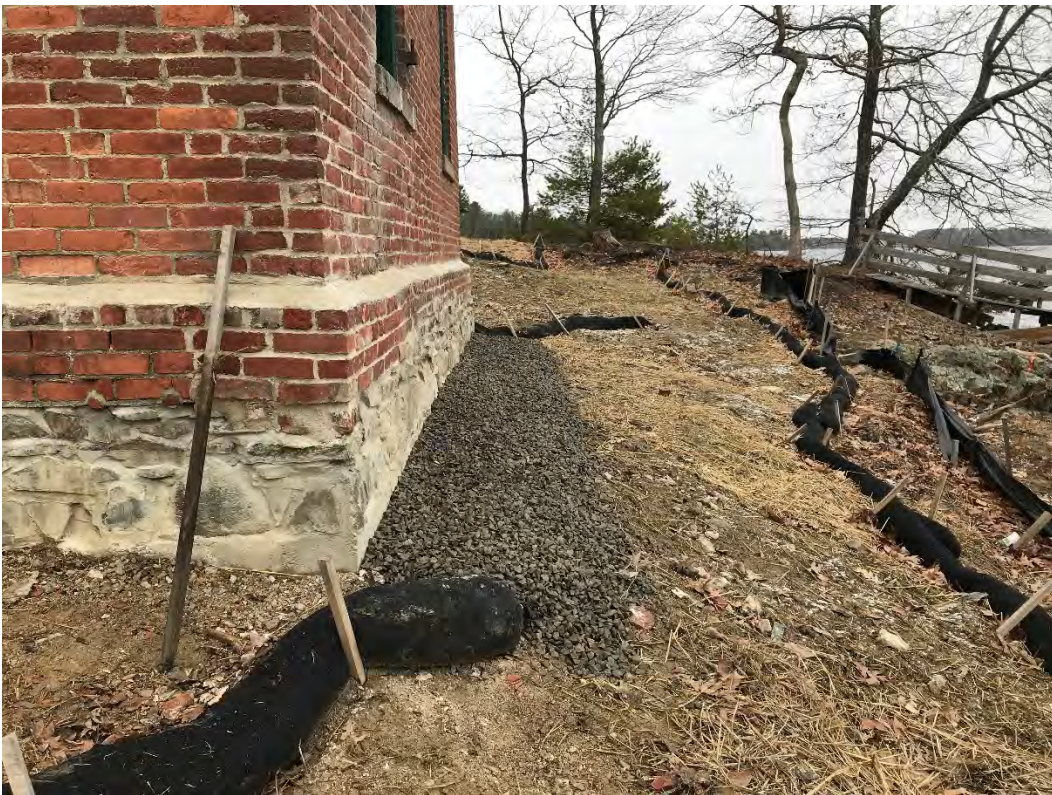
Fig 6: Gravel drip line installed along eastern side of the cable house at Eversource property/west side of the bay. Viewing north. (01-05-21)

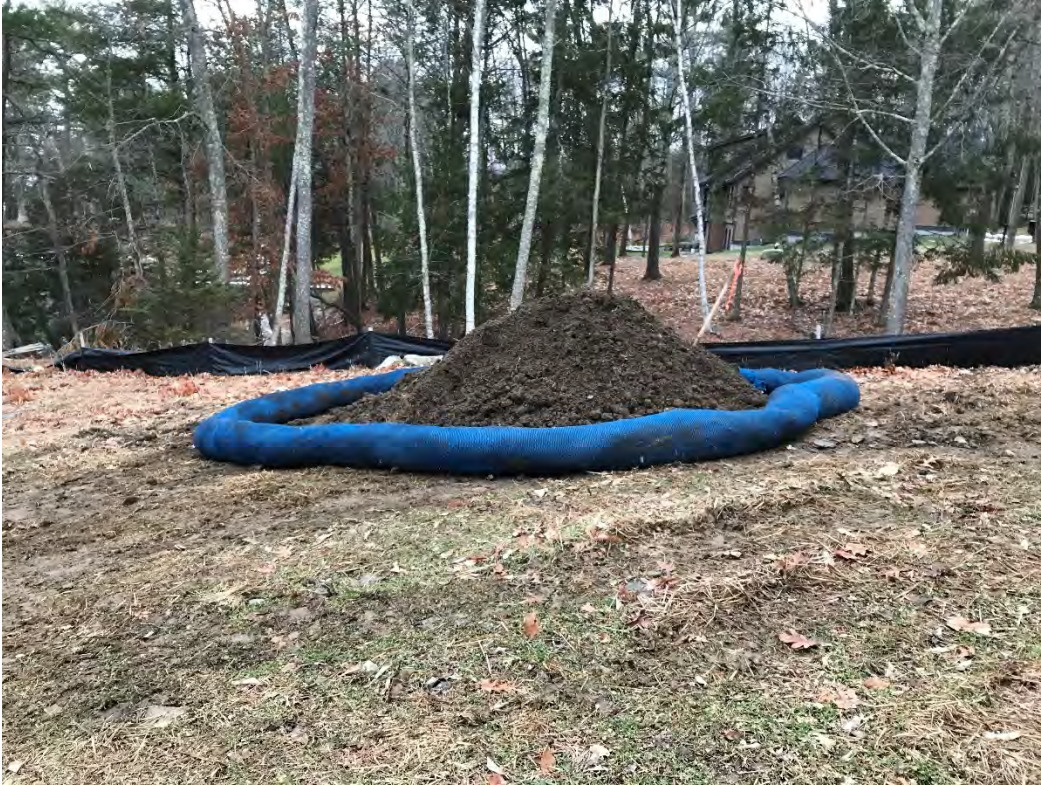
Fig 7: Temporary loam stockpile at the Eversource property/west side of the bay. Viewing south. (01-05-21)

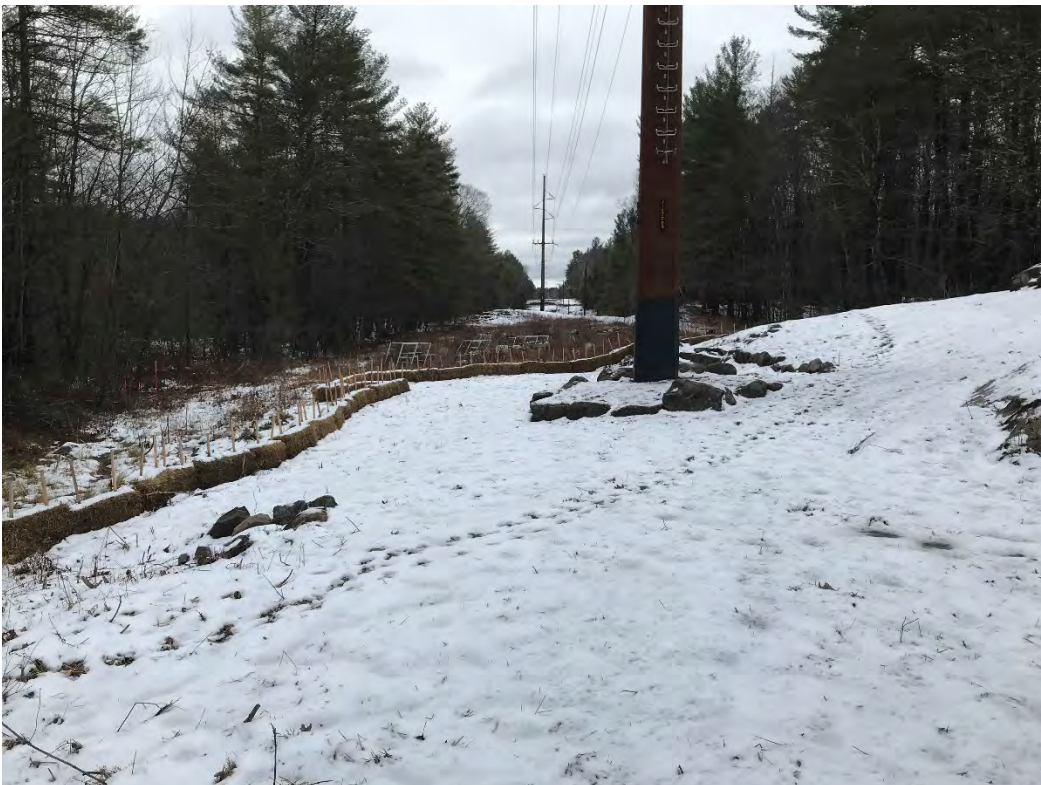
Areas that have been restored and mulched, but have little germination: Hannah Ln, Eversource property/west side of bay, Strs. 89-90

Fig 8: Str. 89 work area. Viewing southeast. (01-02-21)

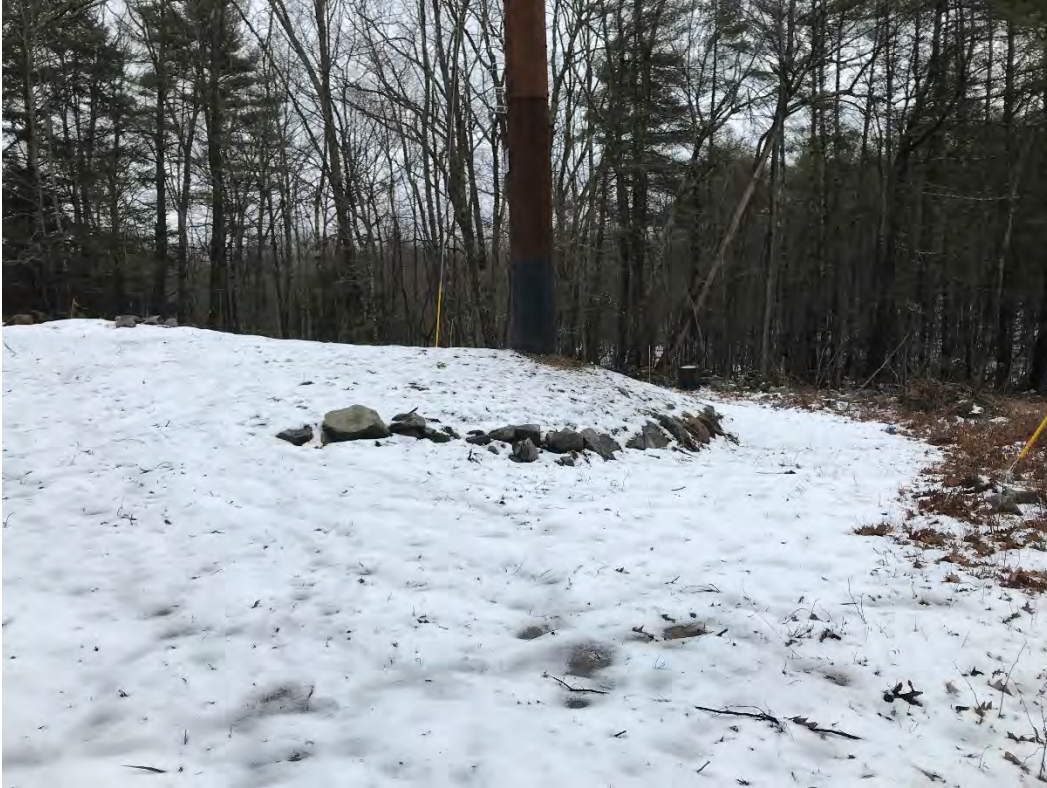
Fig 9: Str. 90 work area. Viewing northeast. (01-02-21)

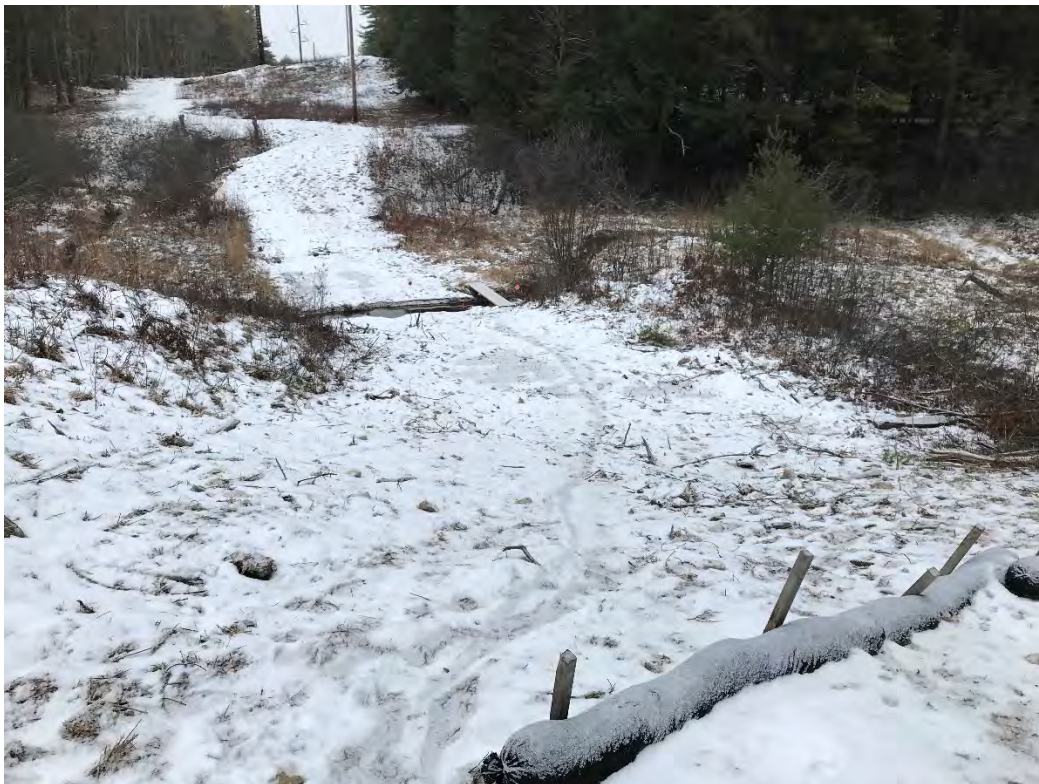
Fig 10: Stream DS46 between Strs. 51 and 52. Viewing northeast. (01-05-21)

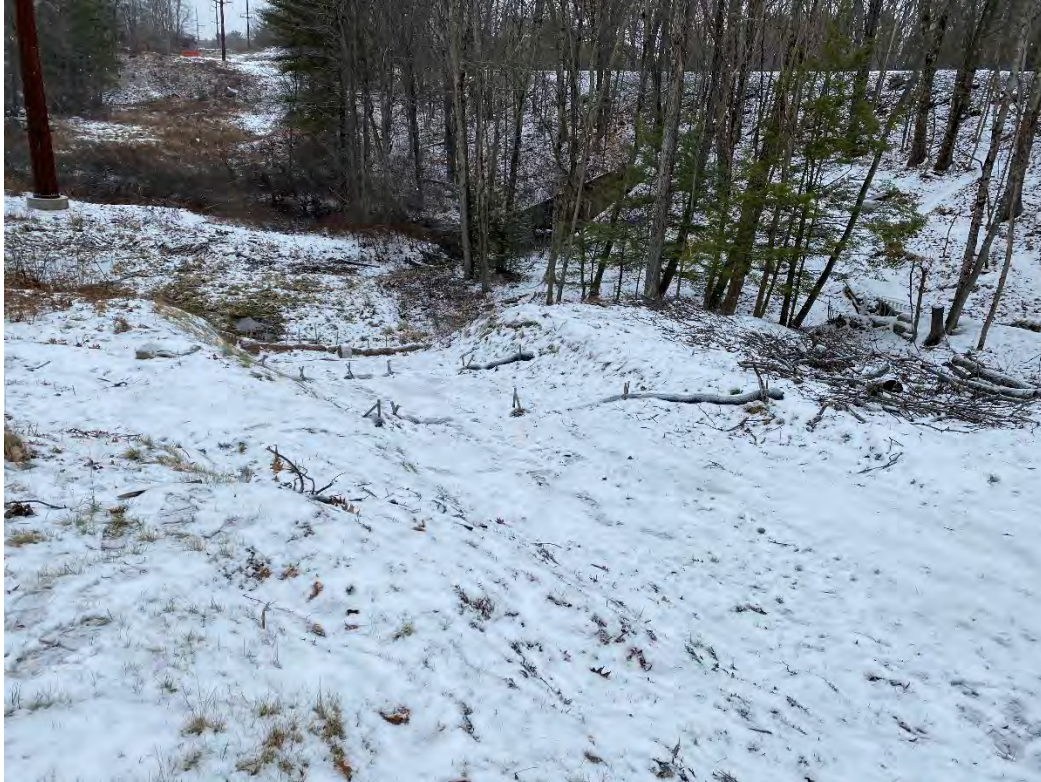
Fig 11: Lower portion of slope between Strs. 28 and 29. Viewing northeast. (01-05-21)

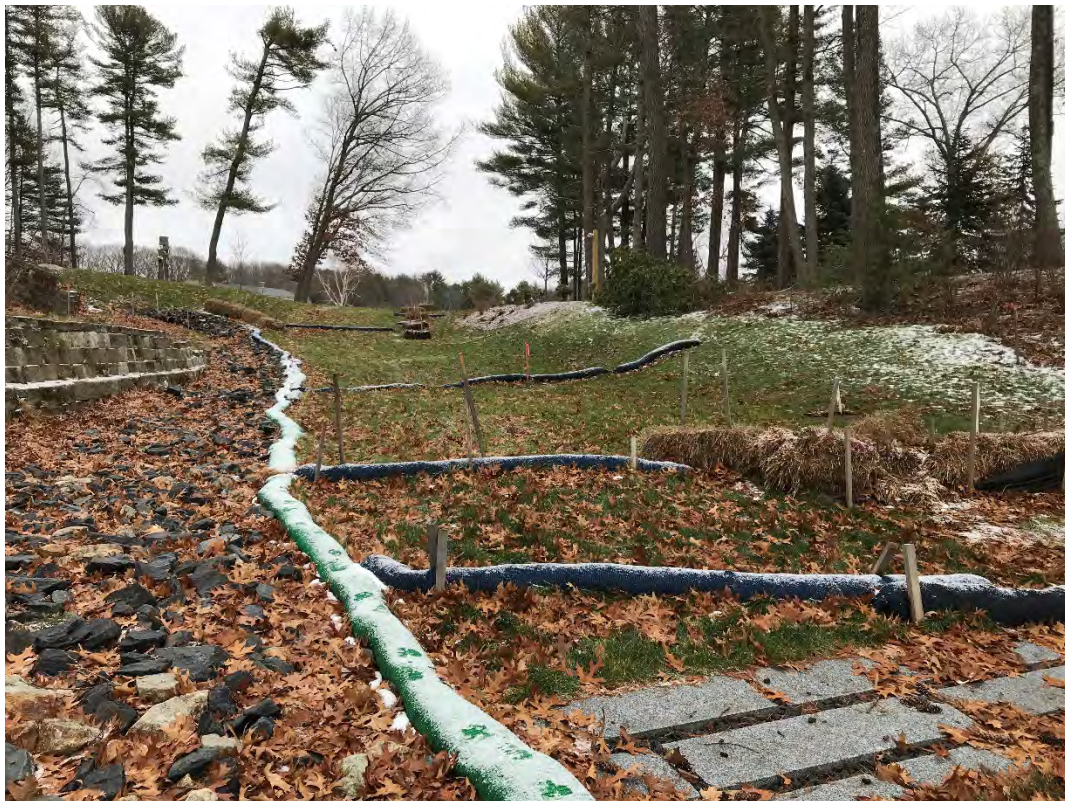
Fig 12: Slope above the manhole at Gundalow Landing/east side of the bay. Viewing east. (01-05-21)

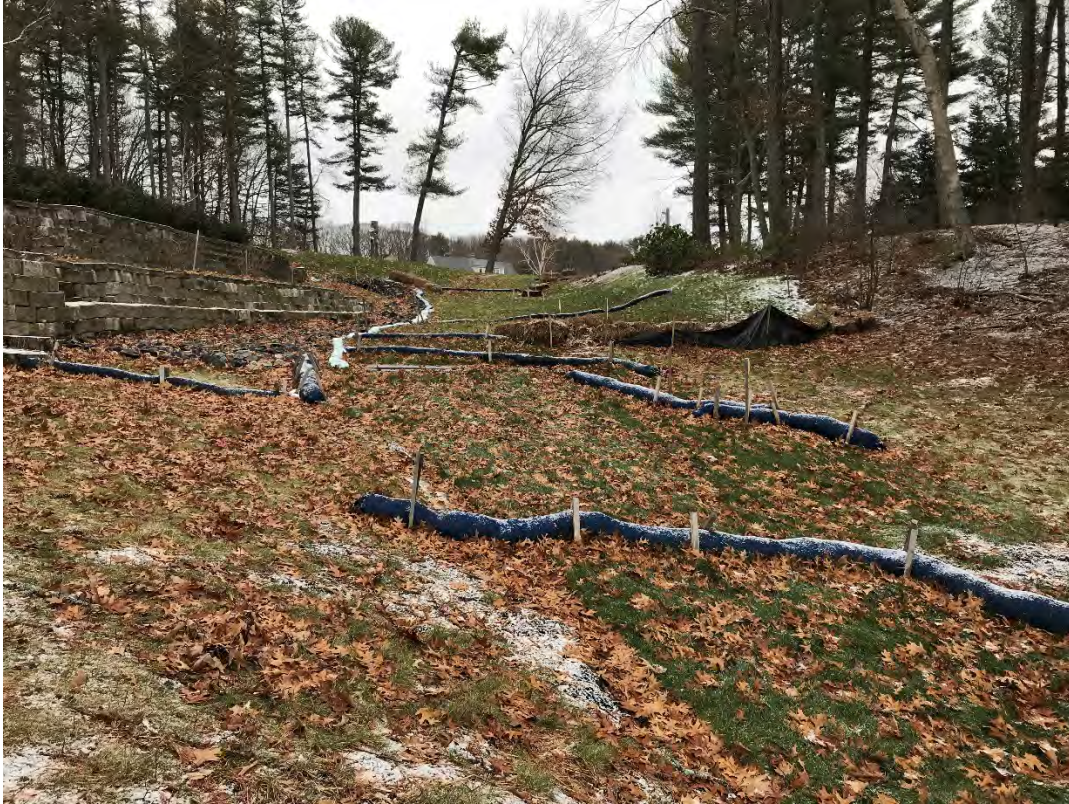
Fig 13: Slope below the manhole at Gundalow Landing/east side of the bay. Viewing east. (01-05-21)

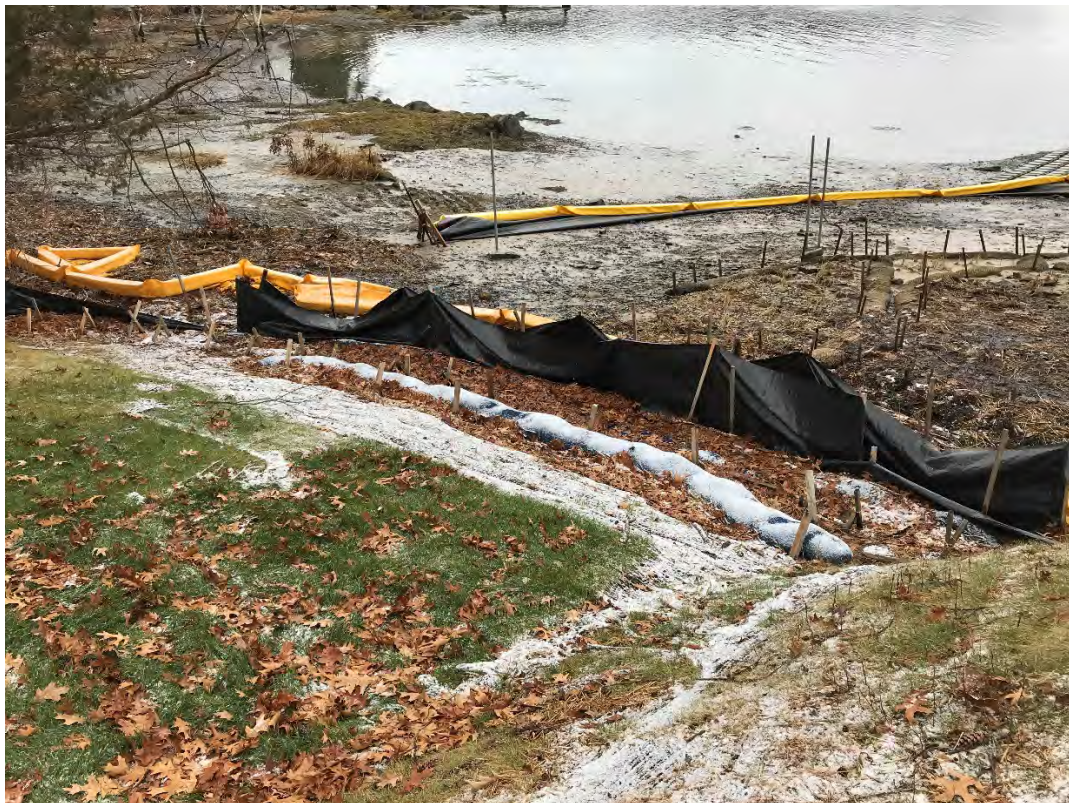
Fig 14: Toe of the slope at Gundalow Landing/east side of the bay. Viewing south. (01-05-21)

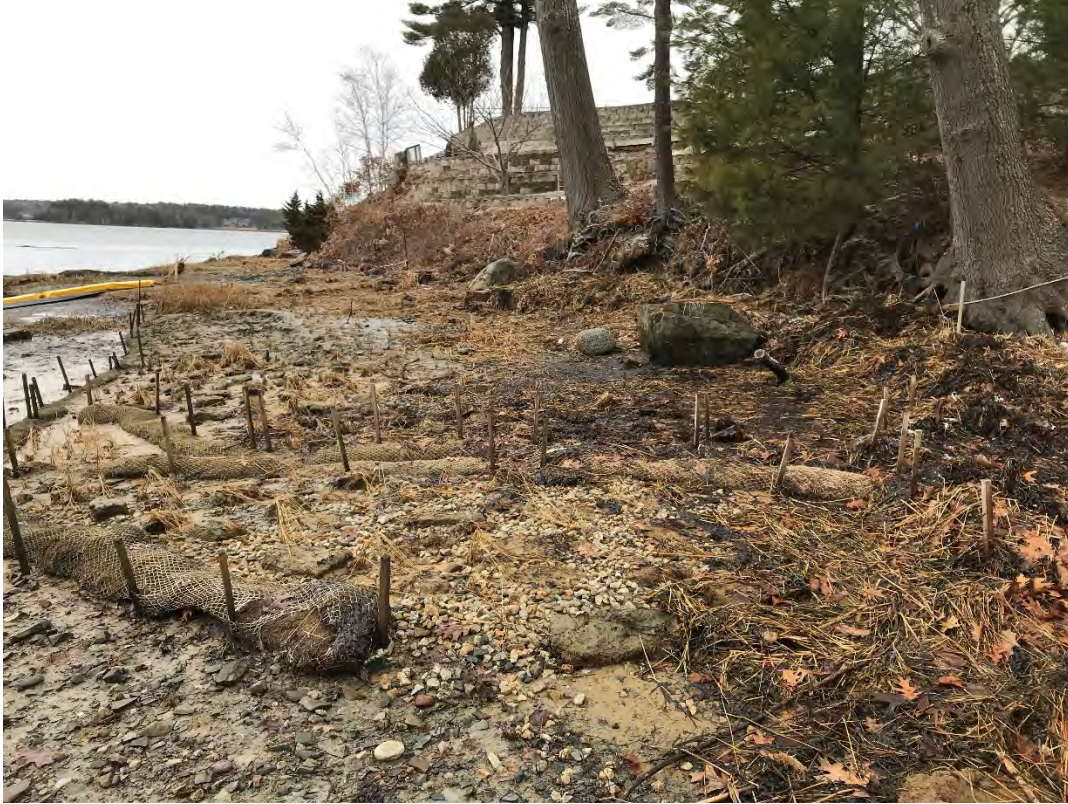
Fig 15: Salt marsh restoration at Gundalow Landing/east side of the bay. Viewing northwest. (01-05-21)
