### CONSTRUCTION MONITORING REPORT

Eversource Transmission Lines:  
**F107**

**Madbury, Durham,  
Newington, Portsmouth, NH**

NAI Project No:  
**23840.39**

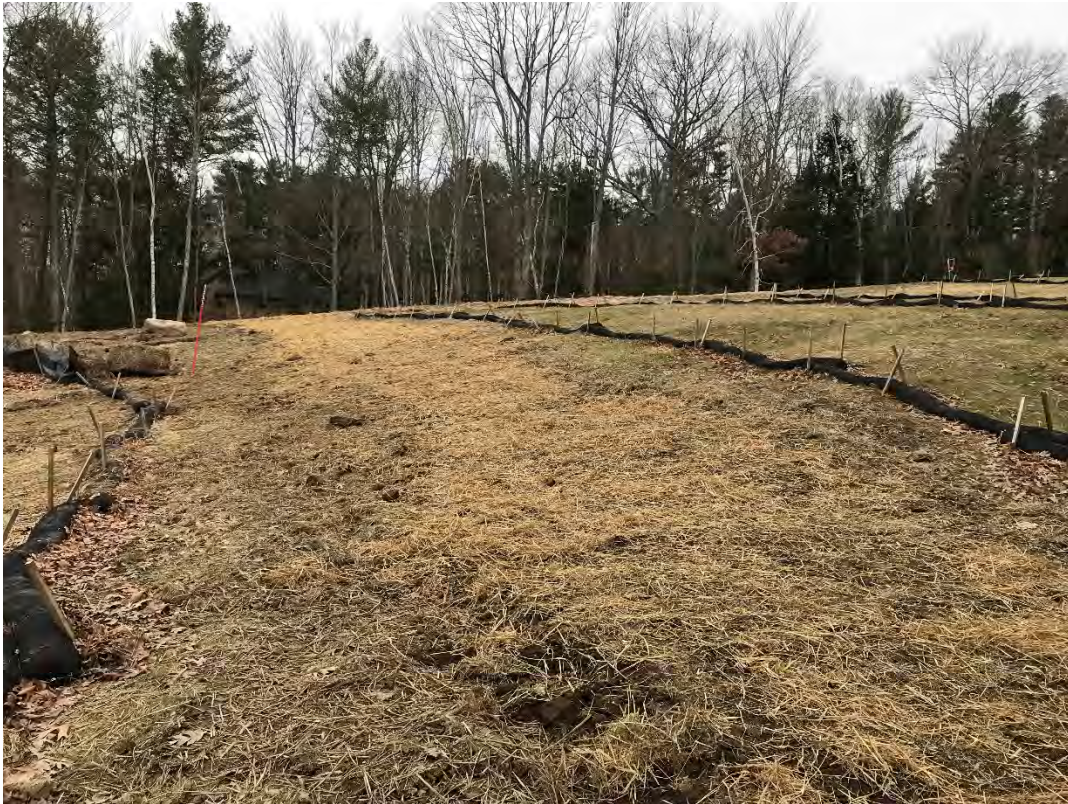
Fig 1: Stabilized access across the slope above the cable house at the Eversource property/west side of the bay. Viewing southwest. (01-11-21)

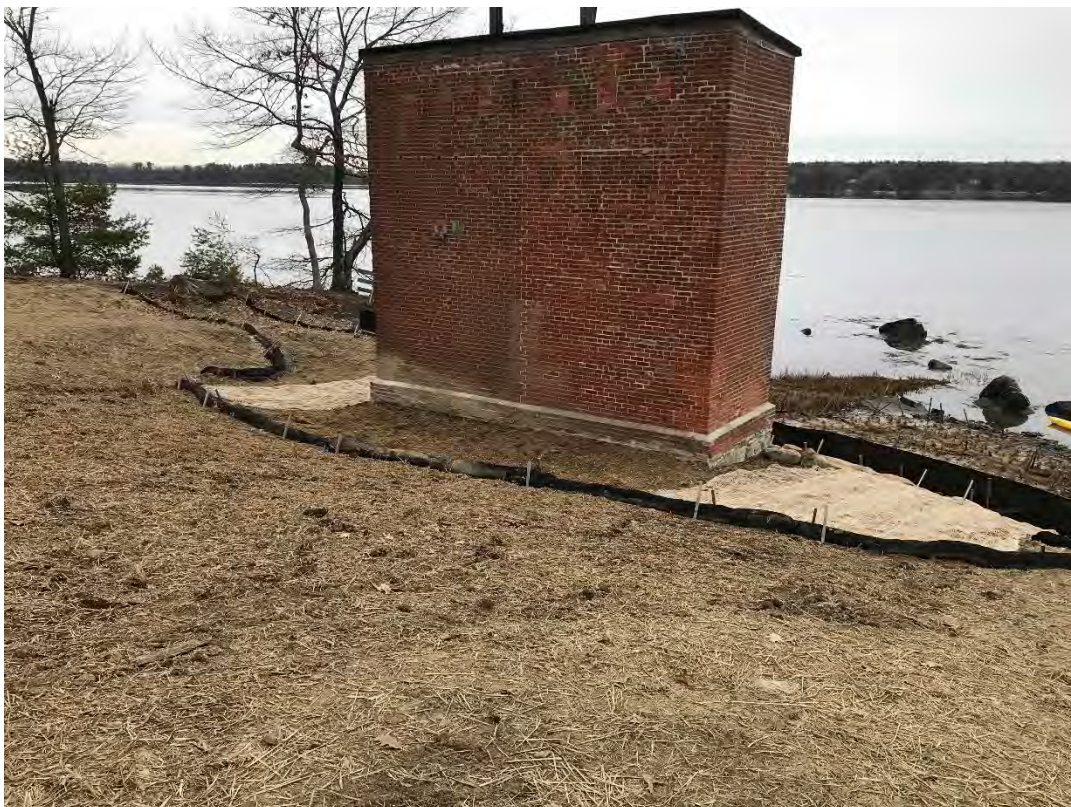
Fig 2: Slope leading down to cable house and salt marsh restoration at the Eversource property/west side of the bay. Viewing northeast. (01-11-21)

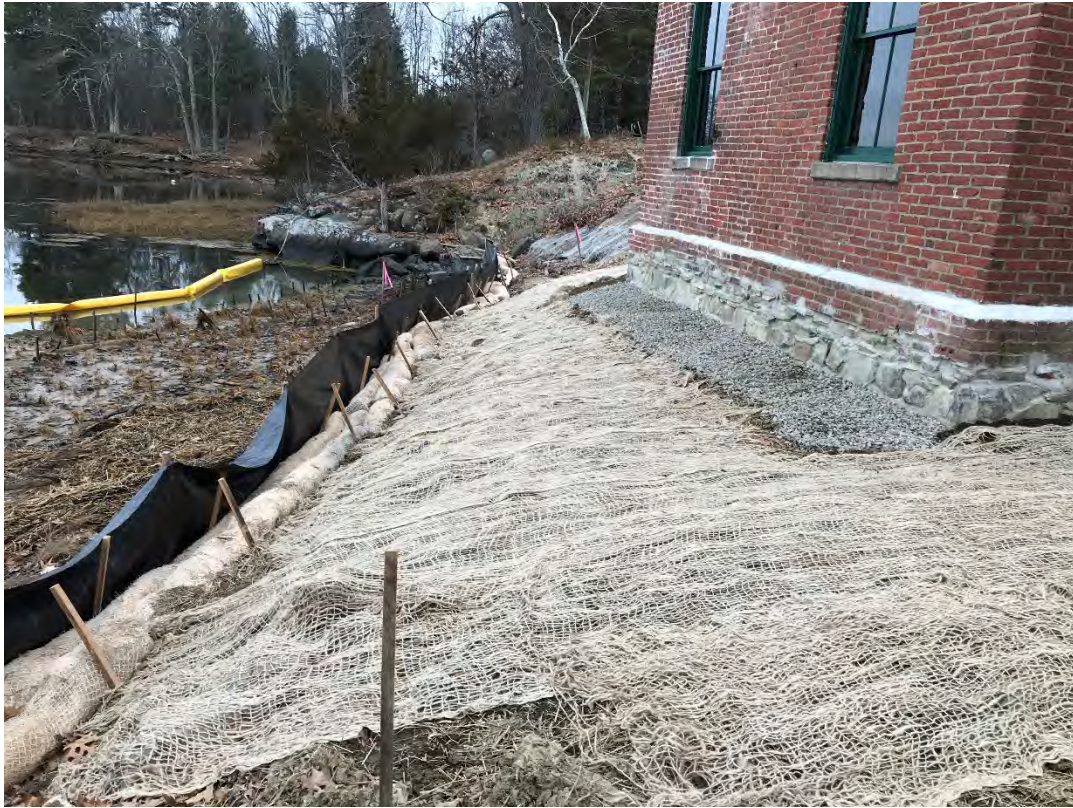
Fig 3: Stabilized slope between the cable house and salt marsh restoration at the Eversource property/west side of the bay. Viewing south. (01-11-21)

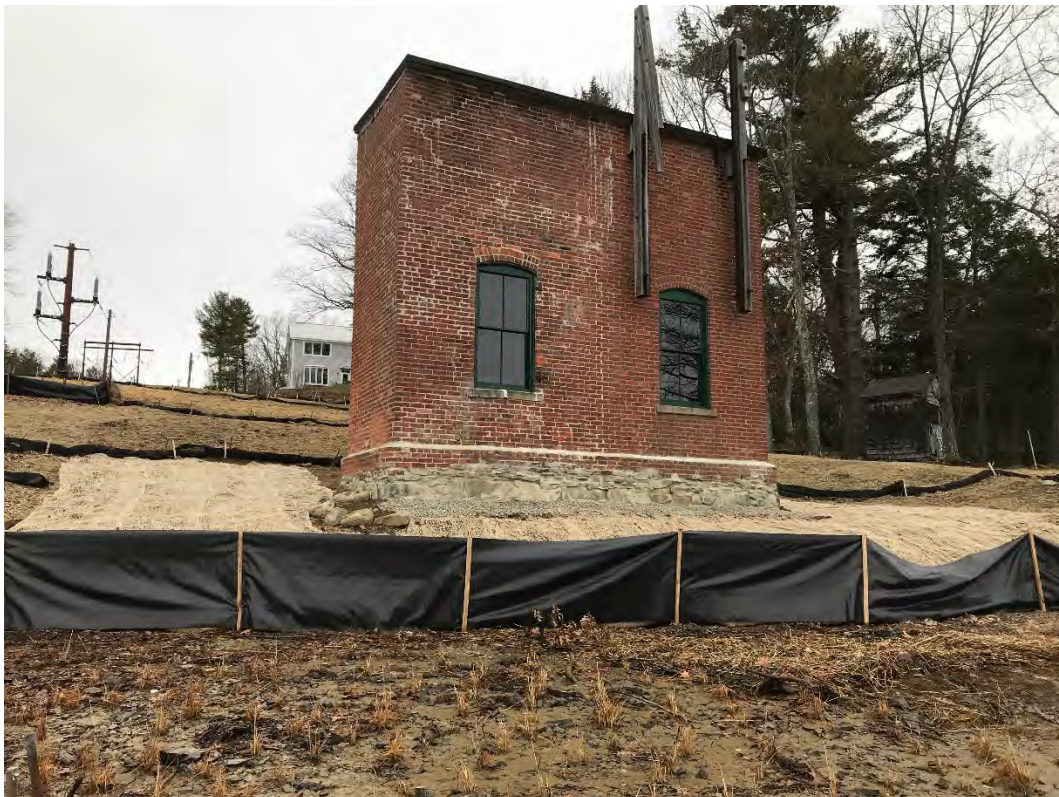
Fig 4: Stabilized slope around the cable house at the Eversource property/west side of the bay. Viewing west. (01-11-21)

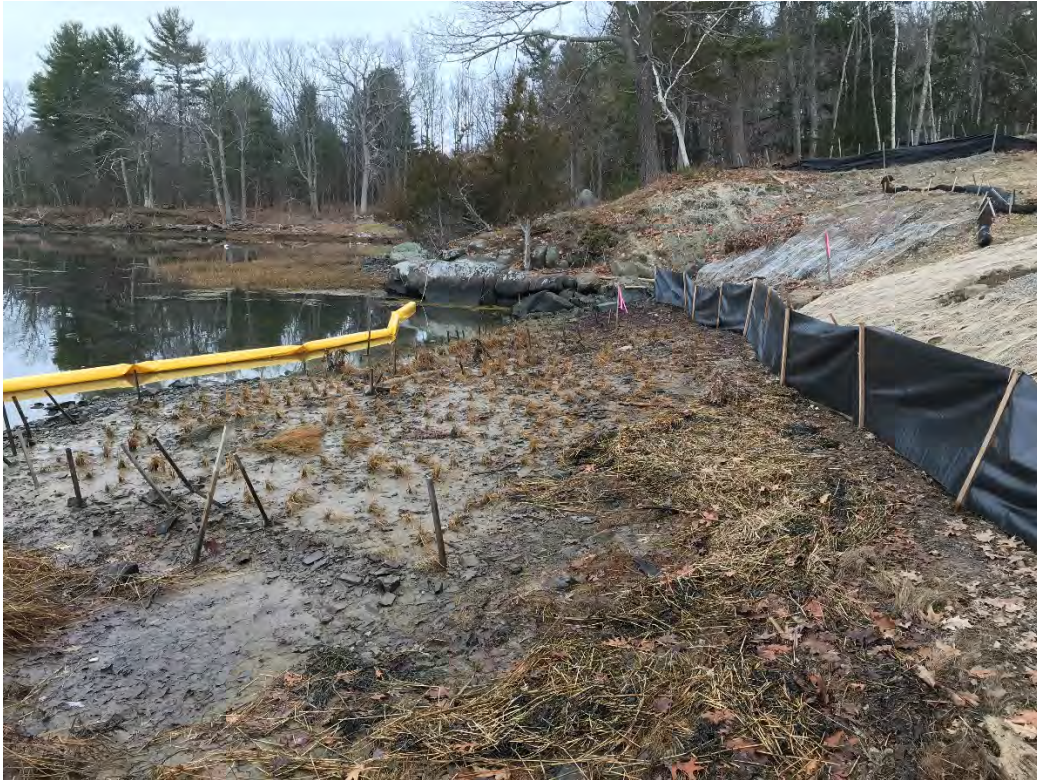
Fig 5: Toe of the slope and salt marsh restoration at the Eversource property/west side of the bay. Viewing south. (01-11-21)

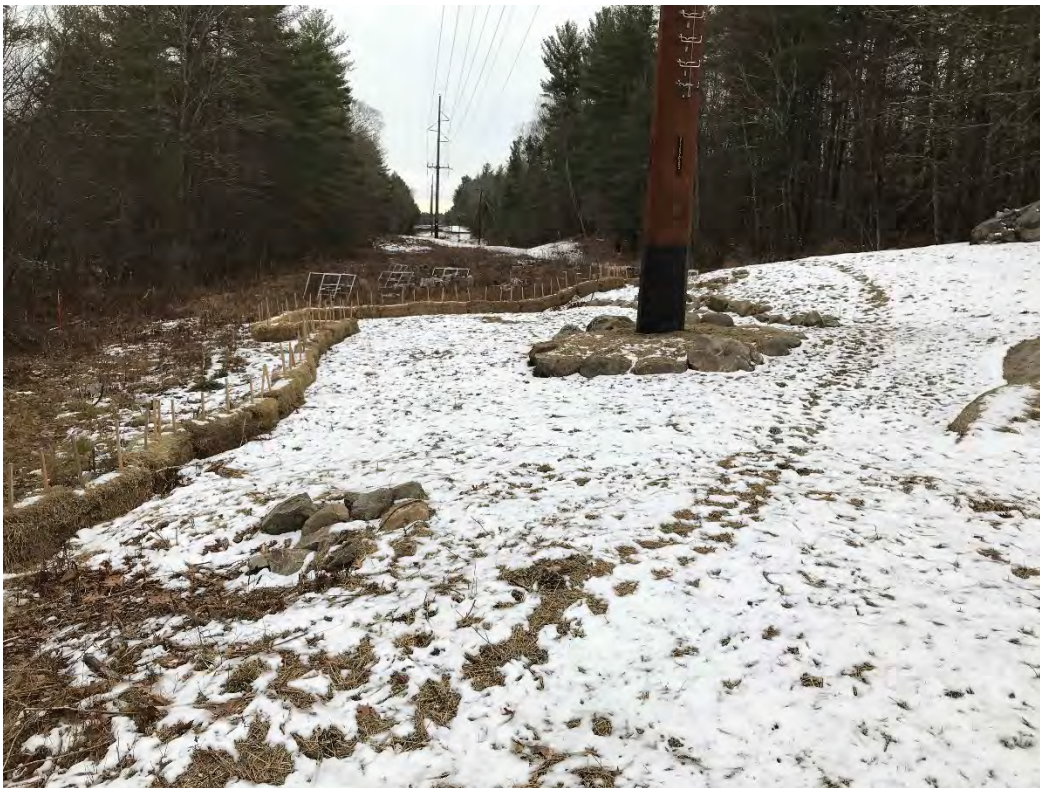
**Areas that have been restored and mulched, but have little germination:** Hannah Ln, Eversource property/west side of bay, Strs. 89-90  
**Moderate germination:** Strs. 4-6, Strs. 7-21, 25-34, 36-88, 91-101, 107, 109-112, 122-127, 129-130, and Gundalow Landing/east side of bay.  
**Stabilized (85%+ germination):** Strs. 1-3, 22-24, 35, 67, 102-106 (including Frink farm), 108, 113-121, 128, 131-144, UNH UG.

Fig 6: Str. 89 work area. Viewing southeast. (01-11-21)

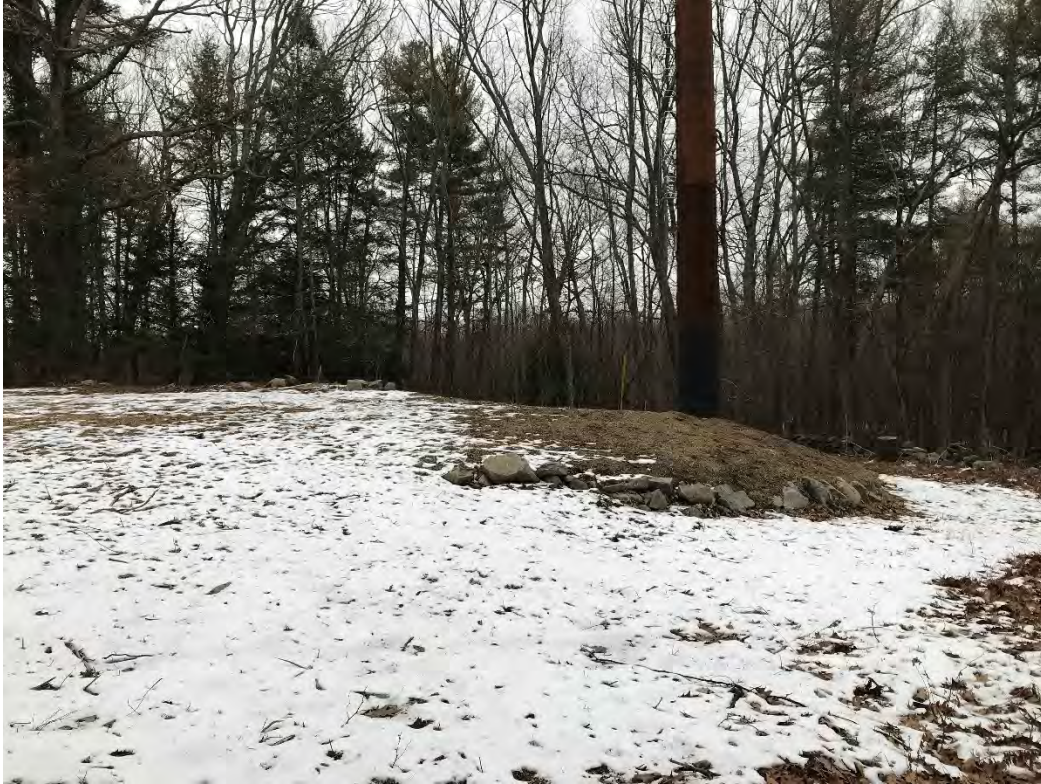
Fig 7: Str. 90 work area. Viewing northeast. (01-11-21)

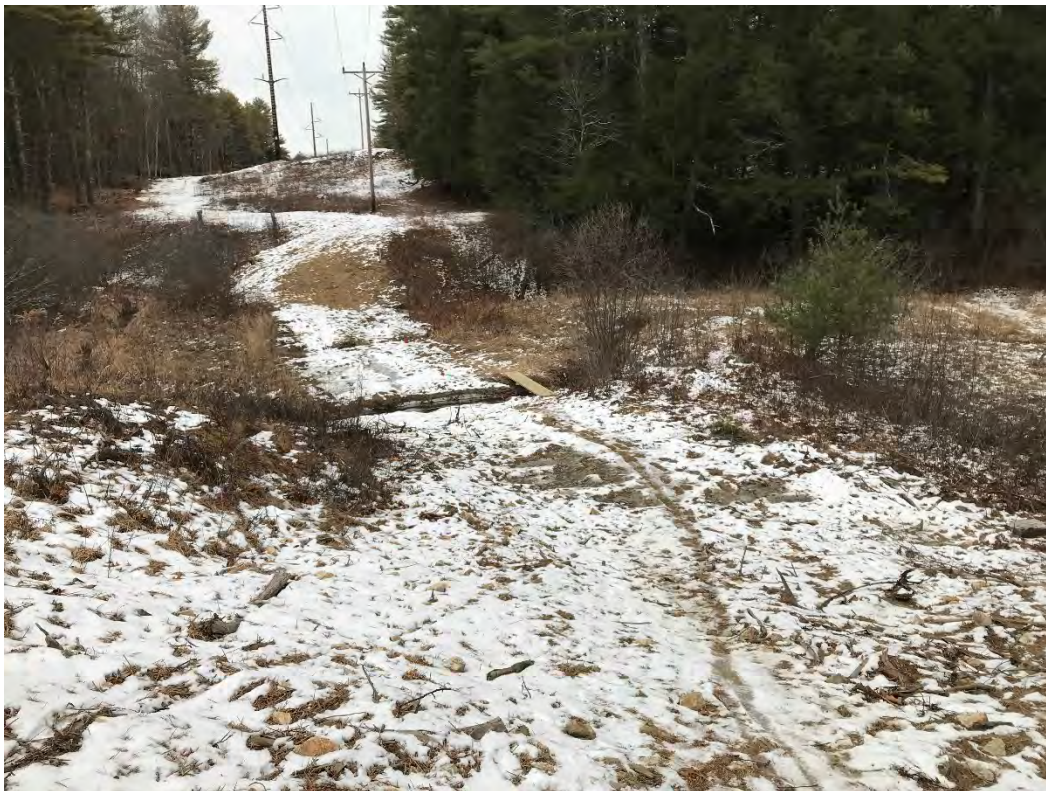
Fig 8: Stream DS46 between Strs. 51 and 52. Viewing northeast. (01-11-21)

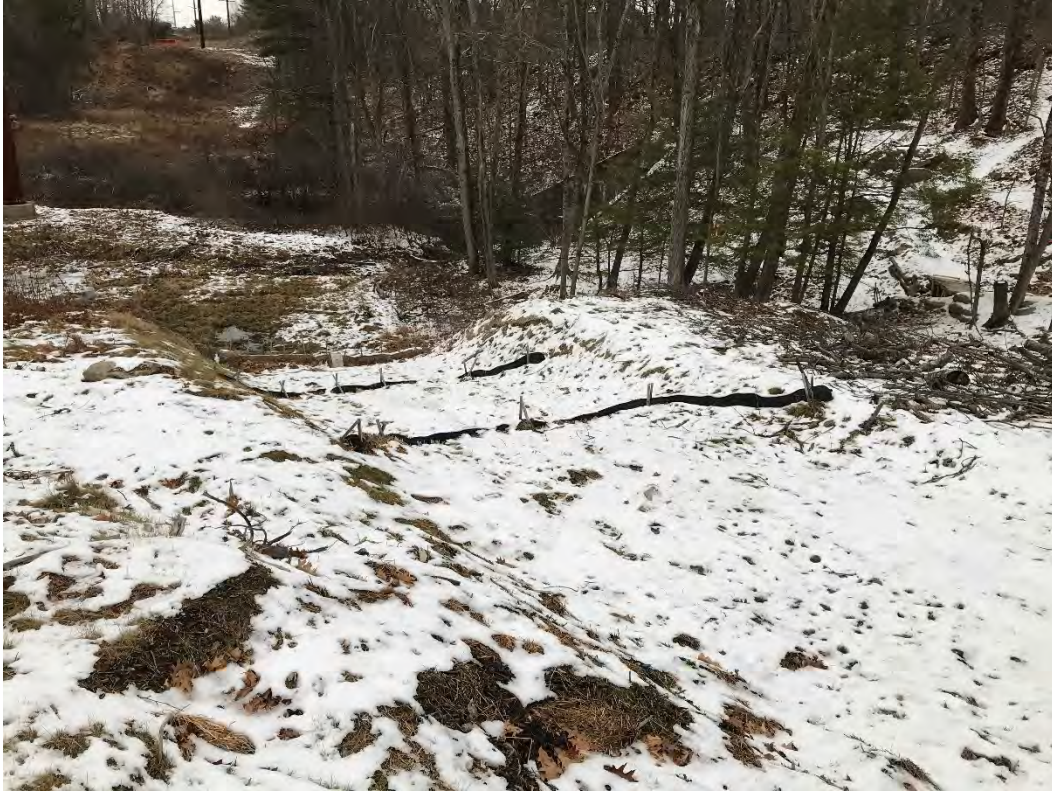
Fig 9: Lower portion of slope between Strs. 28 and 29. Viewing northeast. (01-11-21)

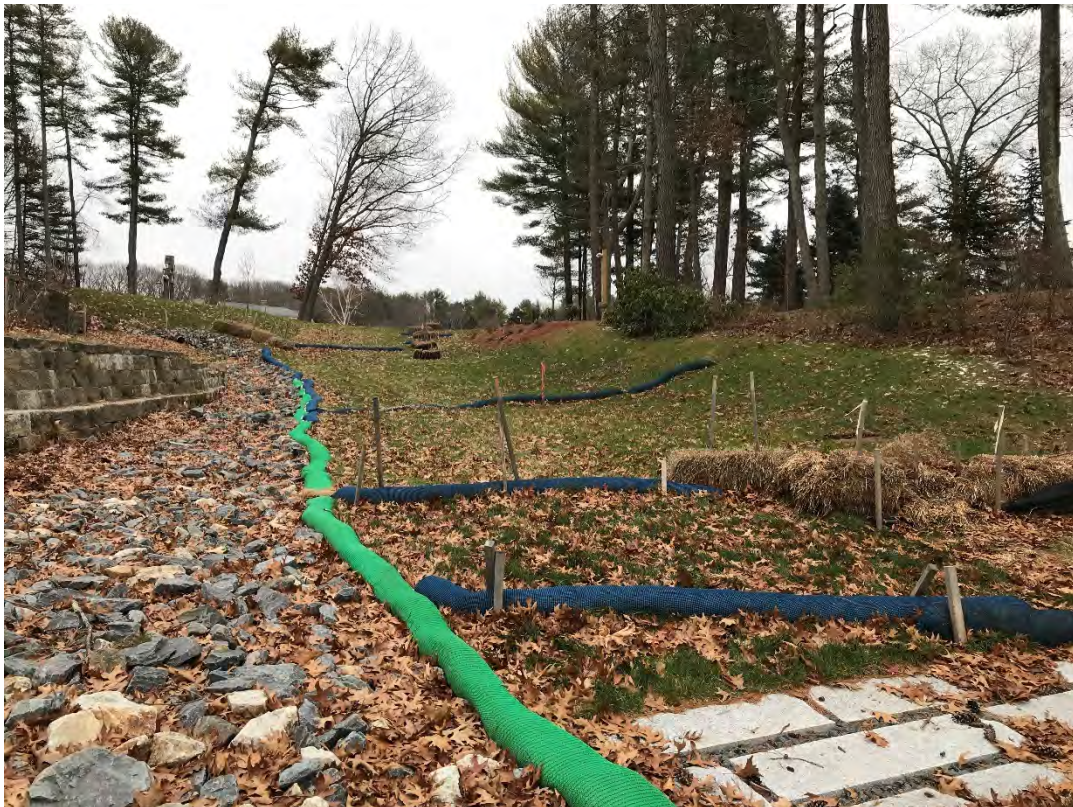
Fig 10: Slope above the manhole at Gundalow Landing/east side of the bay. Viewing east. (01-11-21)

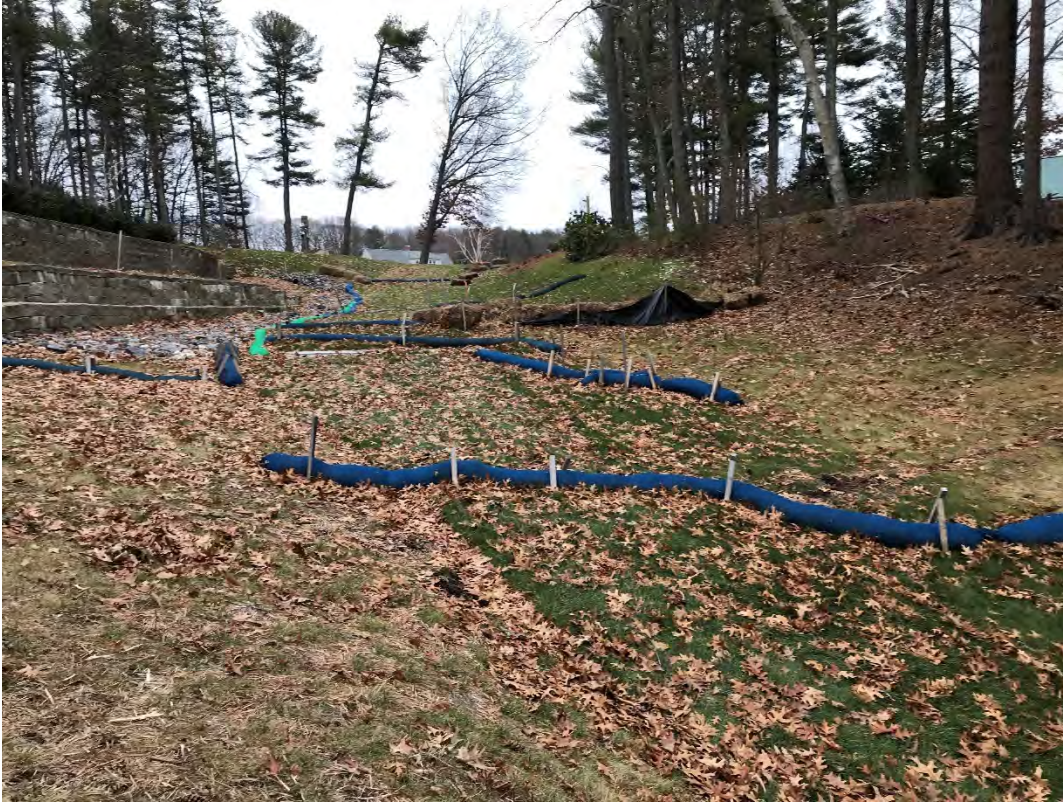
Fig 11: Slope below the manhole at Gundalow Landing/east side of the bay. Viewing east. (01-11-21)

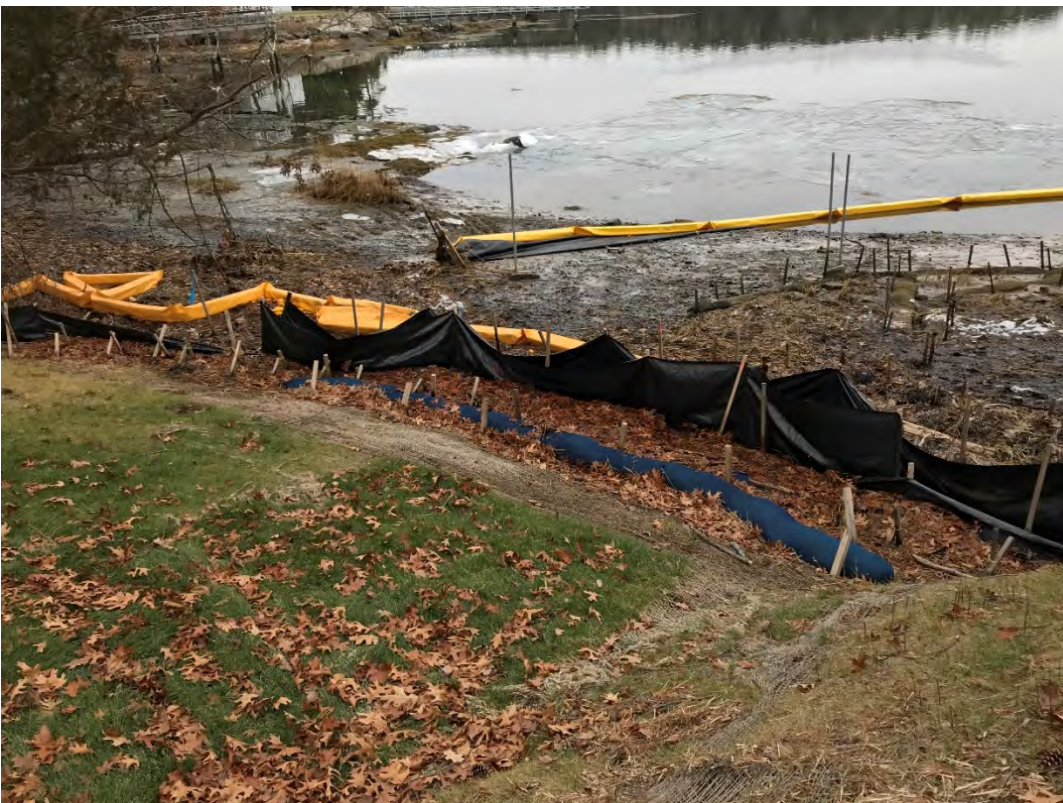
Fig 12: Toe of the slope at Gundalow Landing/east side of the bay. Viewing south. (01-11-21)

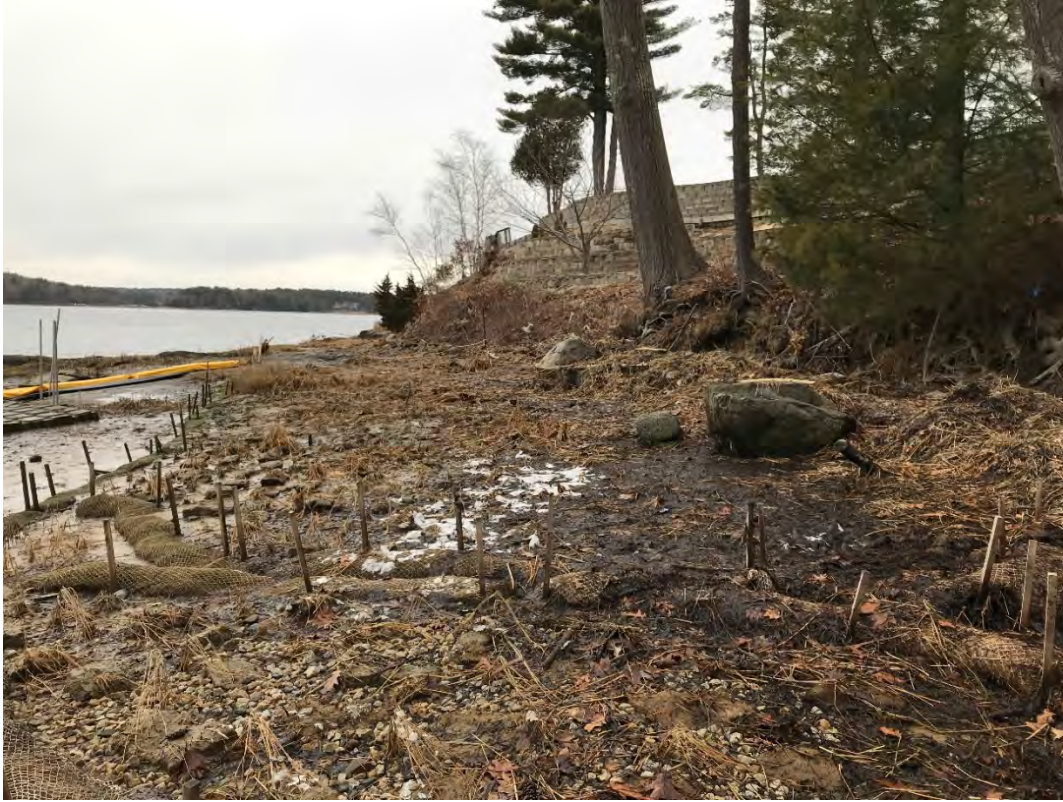
Fig 13: Salt marsh restoration at Gundalow Landing/east side of the bay. Viewing northwest. (01-11-21)
