# DRAINAGE MONITORING REPORT

## F107 - Seacoast Reliability Project

### Newington, New Hampshire

Date: **01/12/2021** Time: **0910** <sup>+</sup>Was this inspection triggered by a 0.25" storm event?  Yes  No

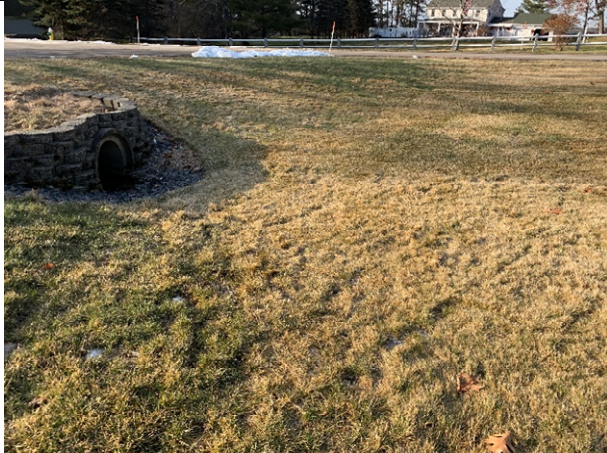
29 Gundalow - 1 (Drainage Area)

**Location: 29 Gundalow – 1 (Drainage Area)**

Observations/Notes: Ground surface frozen

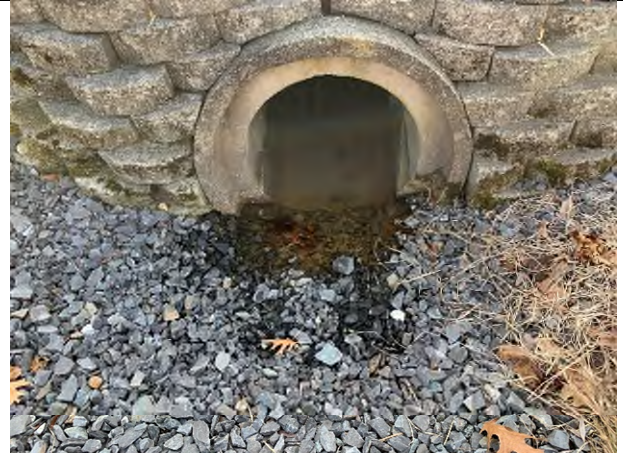
**Location: 29 Gundalow – 2 (Culvert)**

pH: 12.6

Observations/Notes: Water extending approx. 12" beyond culvert inlet into stone area, approx. max depth 4". Surface iced over.

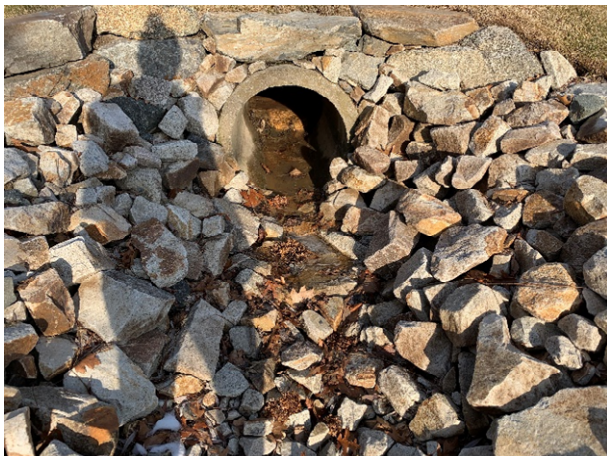
64 Gundalow - 1 (Drainage Course)

**Location: 64 Gundalow – 1 (Drainage Course)**

pH: 12.1

Observations/Notes: Flowing water extending approx. 18" beyond culvert outlet, approx. 1" deep. Surface iced over.

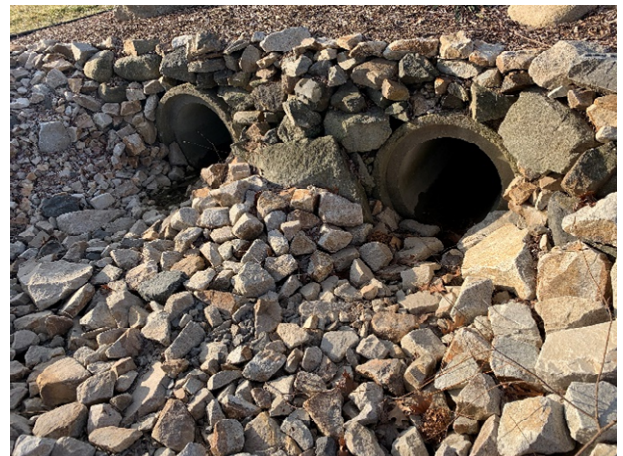
64 Gundalow - 2 (Drainage Course)

**Location: 64 Gundalow – 2 (Drainage Course)**

pH: 10.6

Observations/Notes: Flowing water extending approx. 6" beyond culvert inlet, approx. 1" deep.

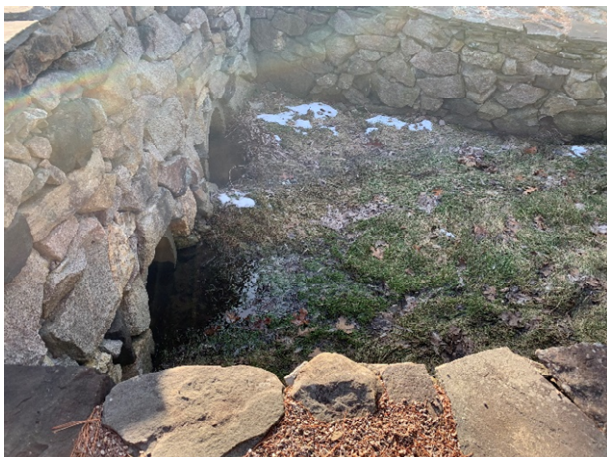
4 Brickyard Circle - 1 (Drainage Course)

**Location: 4 Brickyard Circle – 1 (Drainage Course)**

pH: 9.2

Observations/Notes: Standing water extending approx. 18" from outlet, max depth approx. 8".

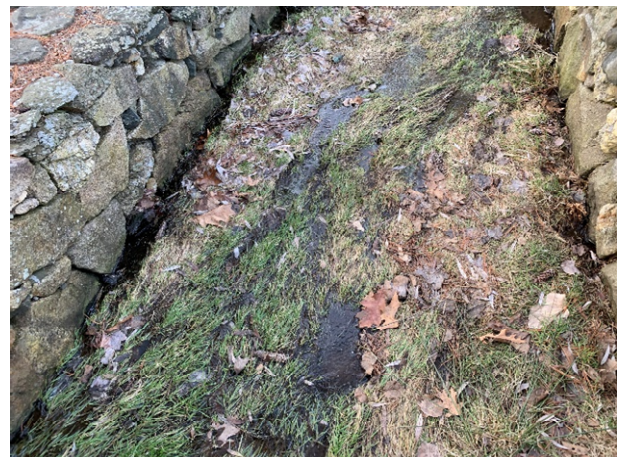
4 Brickyard Circle - 2 (Drainage Course)

**Location: 4 Brickyard Circle – 2 (Drainage Course)**

pH: 7.6

Observations/Notes: Flowing water adjacent to east wall of raceway, approx. 1" deep. Surface iced over.

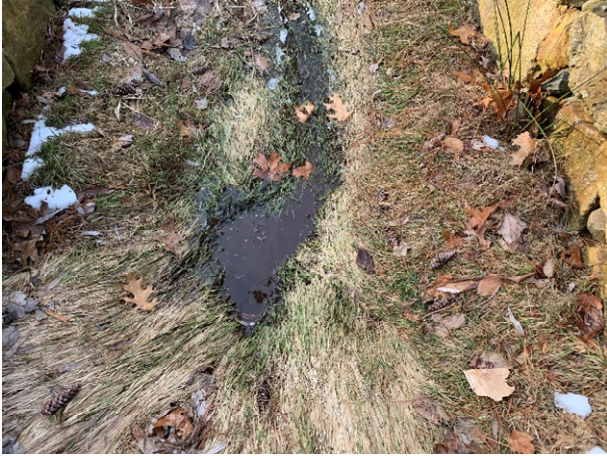
4 Brickyard Circle – 3 (Drainage Course)

**Location: 4 Brickyard Circle – 3 (Drainage Course)**

pH: 7.4

Observations/Notes: Flowing water in center of raceway, approx. 2" deep. Surface iced over.
