CONSTRUCTION MONITORING REPORT

Eversource Transmission Lines:
F107

**Madbury, Durham,
Newington, Portsmouth, NH**

NAI Project No:
23840.39

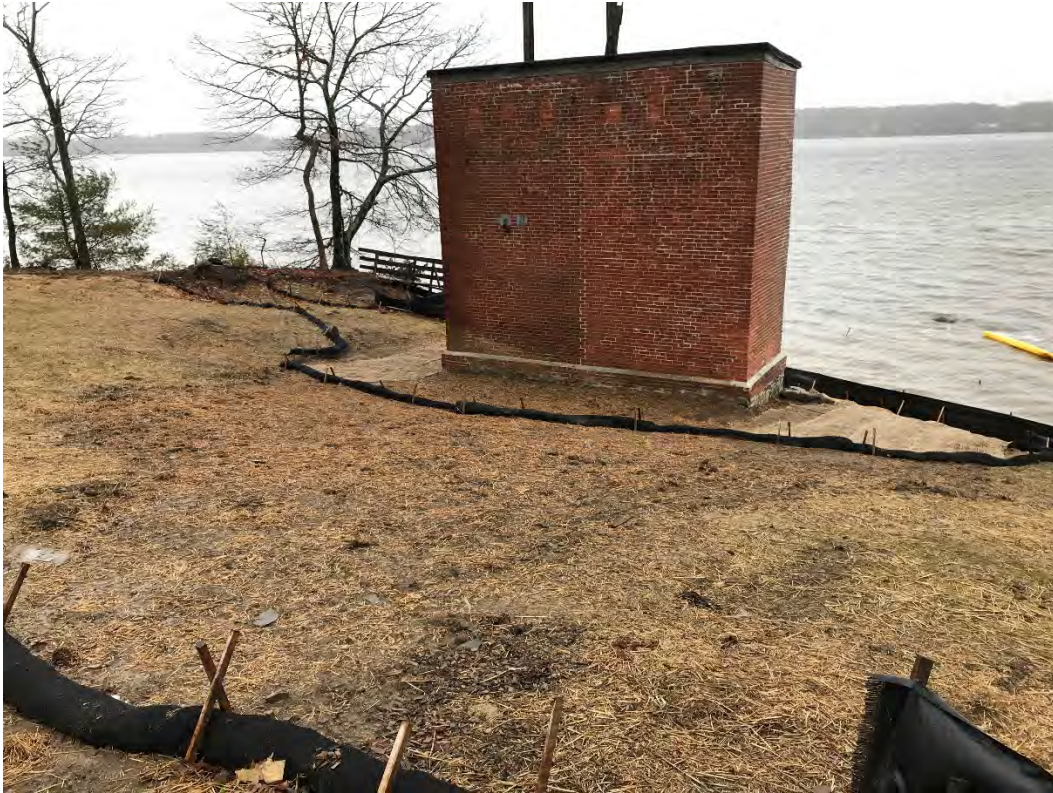
Fig 1: Slope leading down to cable house and salt marsh restoration at the Eversource property/west side of the bay. Viewing northeast. (01-16-21)

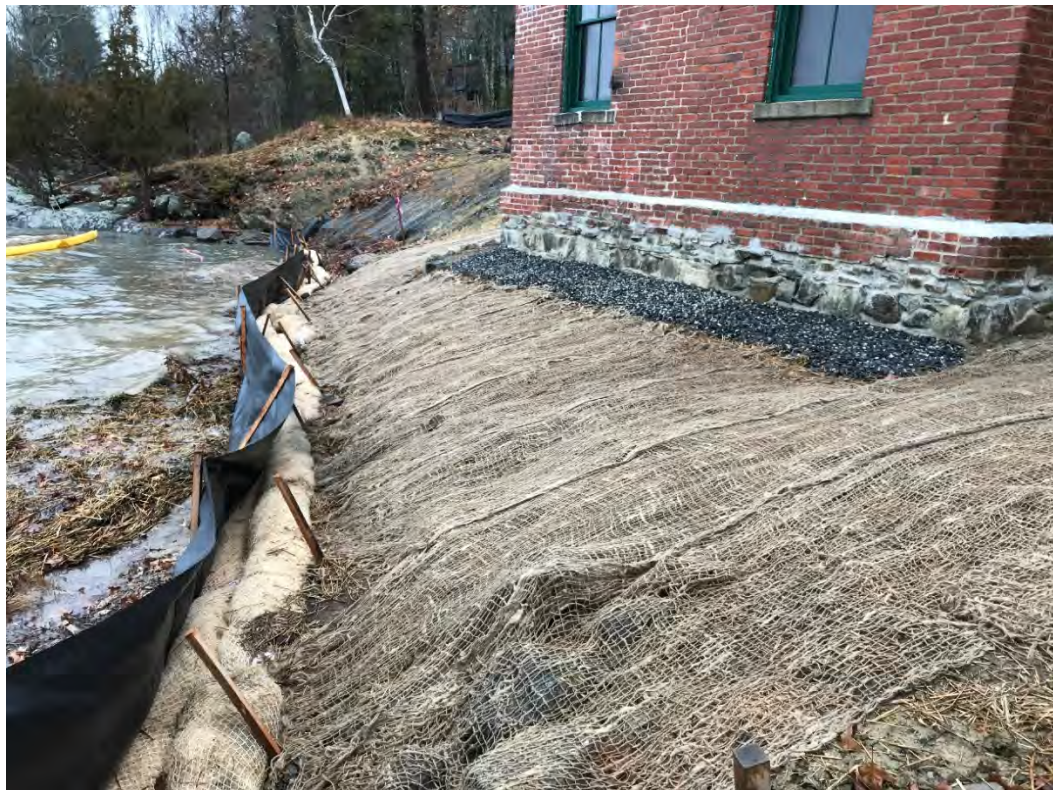
Fig 2: Stabilized slope between the cable house and salt marsh restoration at the Eversource property/west side of the bay. Viewing south. (01-16-21)

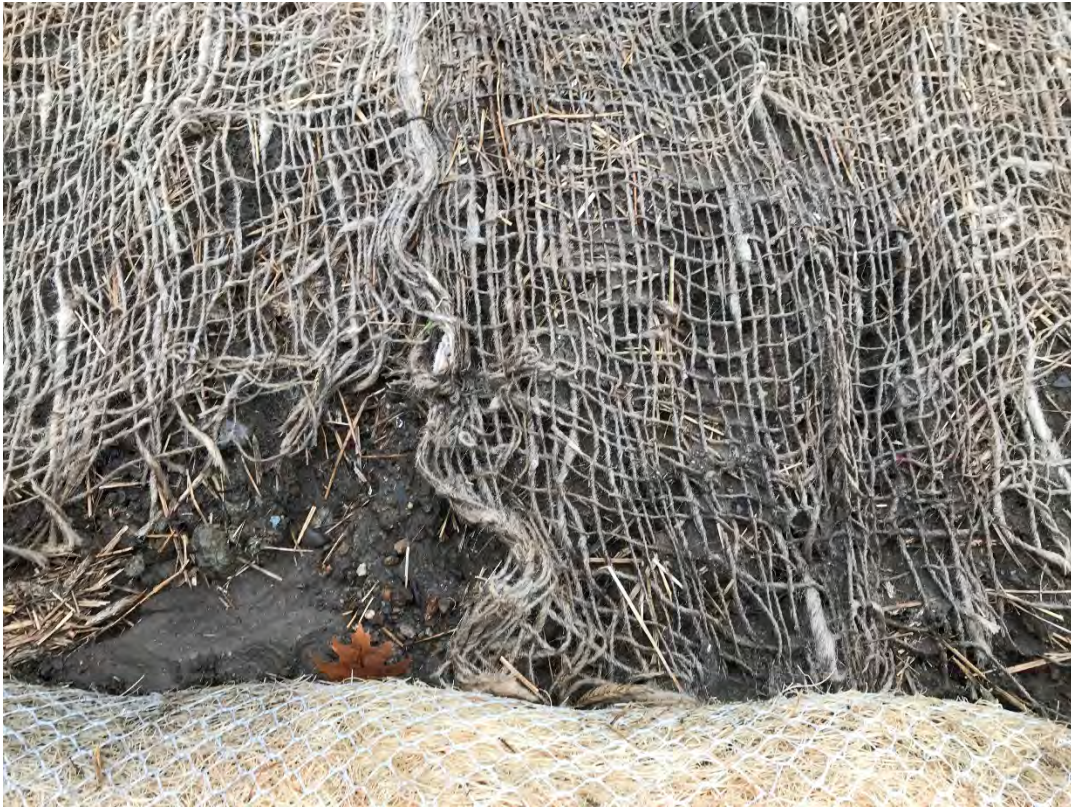
- **BMPs**
 - All remaining BMPs should be left in place until the sites are determined to be stabilized by the environmental monitor.
 - Development of minor rills and buildup of sediment noted on the toe of the slope at the Eversource property/west side of the bay. (See Photo 3)
 - Development of minor rills on the slope between Strs. 28 and 29. (See Photo 8).
 - Assessment of repair of rills and any necessary adjustment of erosion and sedimentation controls will occur over the next few days.

Fig 3: Minor rills and sedimentation on the slope above the salt marsh at the Eversource property/west side of the bay. Viewing west. (01-16-21)

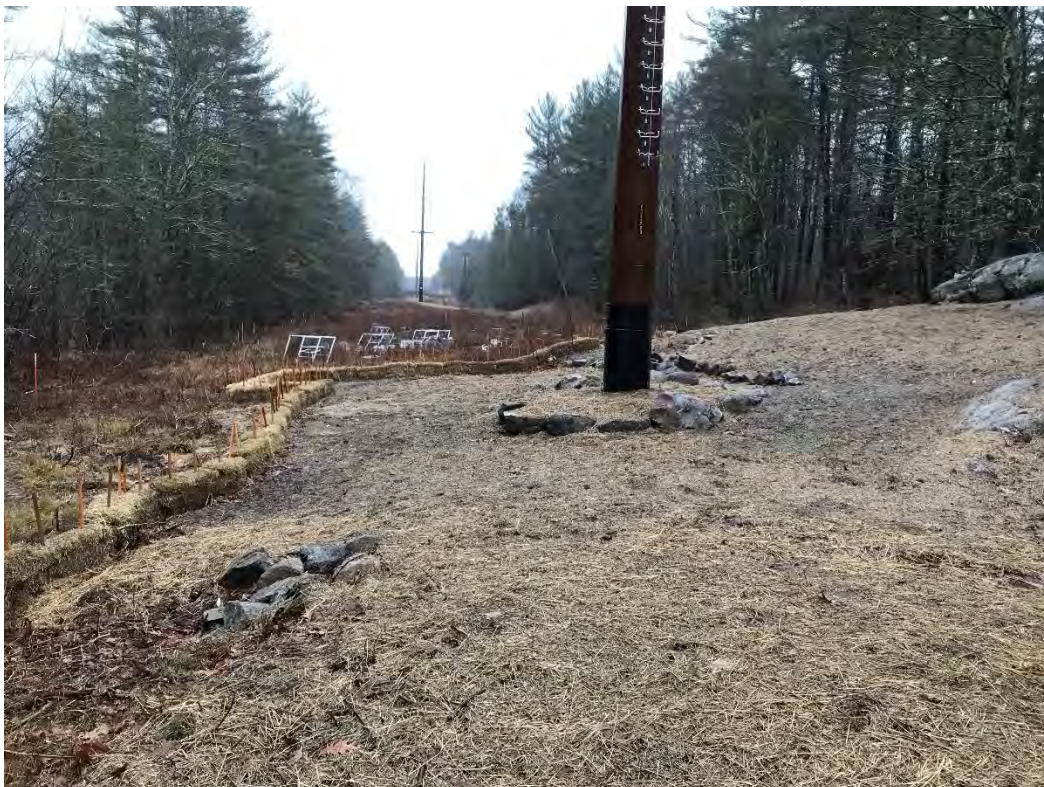
Areas that have been restored and mulched, but have little germination: Hannah Ln, Eversource property/west side of bay, Strs. 89-90

Fig 4: Str. 89 work area. Viewing southeast. (01-16-21)

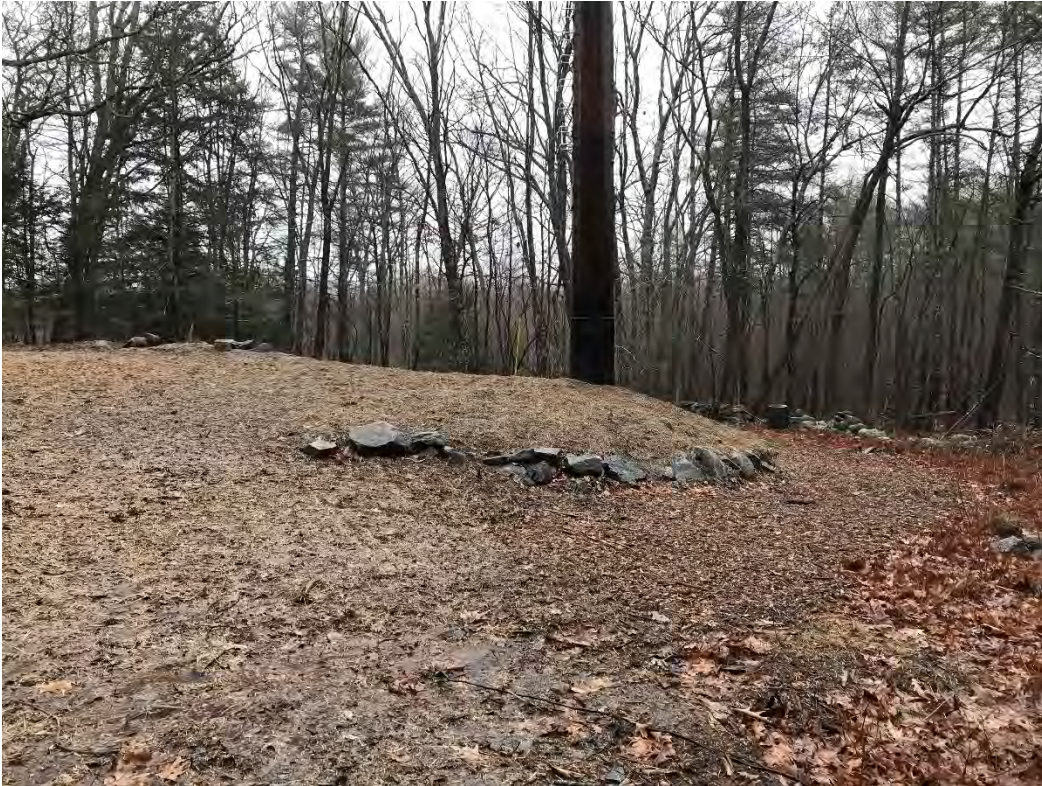
Fig 5: Str. 90 work area. Viewing northeast. (01-16-21)

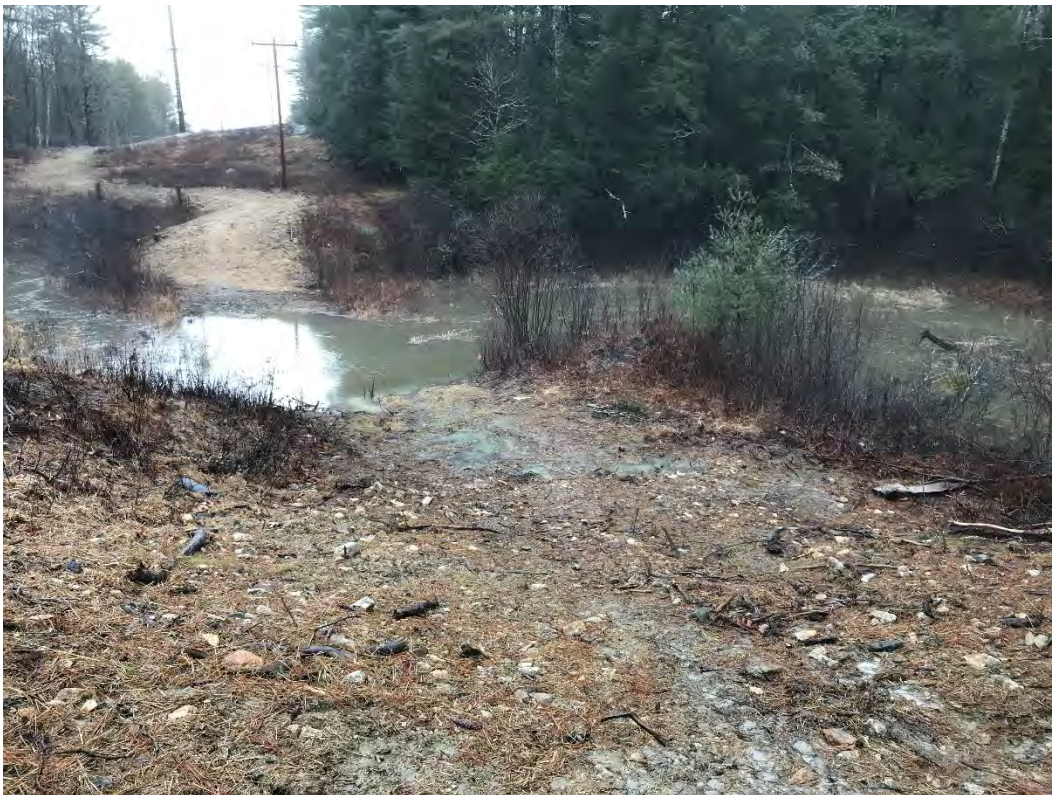
Fig 6: Stream DS46 between Strs. 51 and 52. Viewing northeast. (01-16-21)

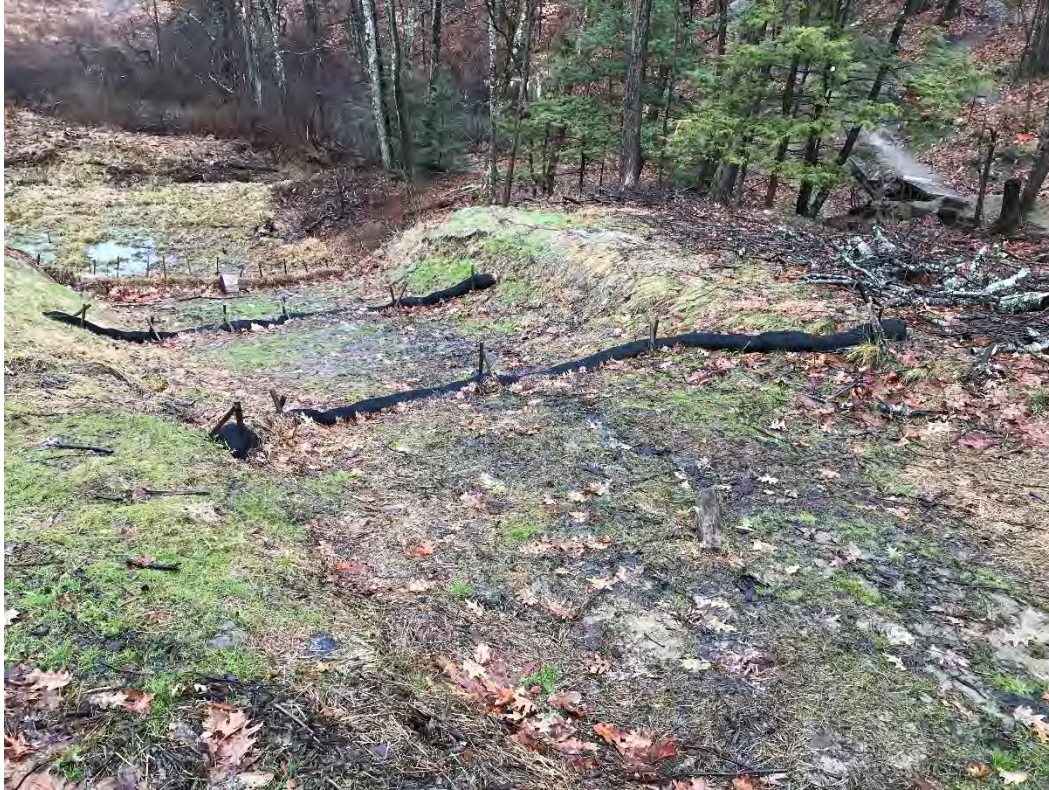
Fig 7: Lower portion of slope between Strs. 28 and 29. Viewing northeast. (01-16-21)

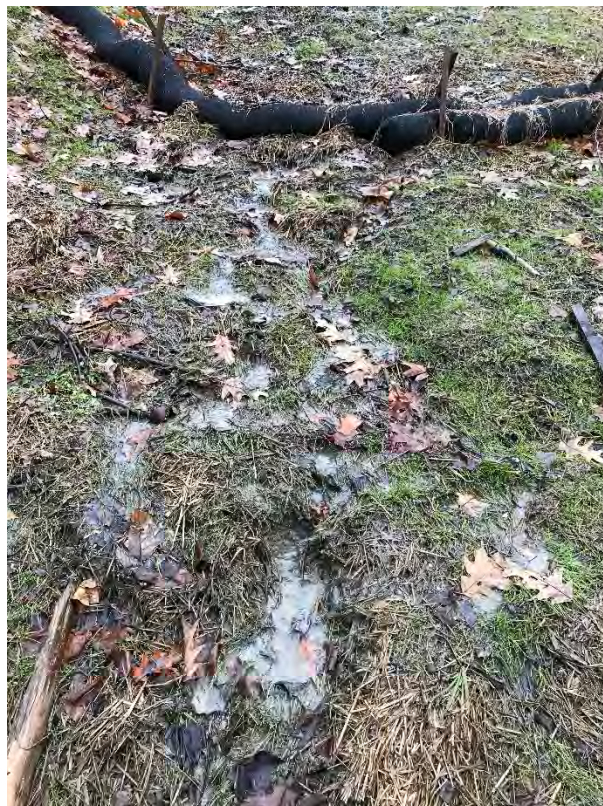
Fig 8: Minor rill and preferential flow path development on lower portion of slope between Strs. 28 and 29. Viewing south. (01-16-21)

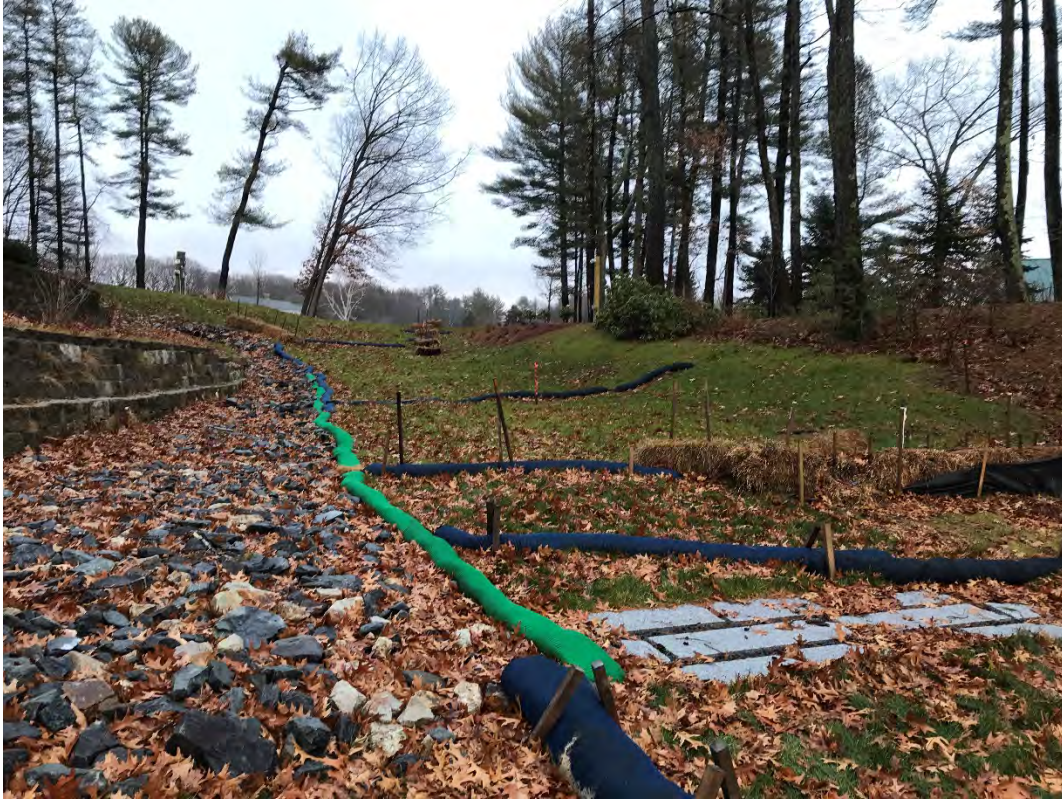
Fig 9: Slope above the manhole at Gundalow Landing/east side of the bay. Viewing east. (01-16-21)

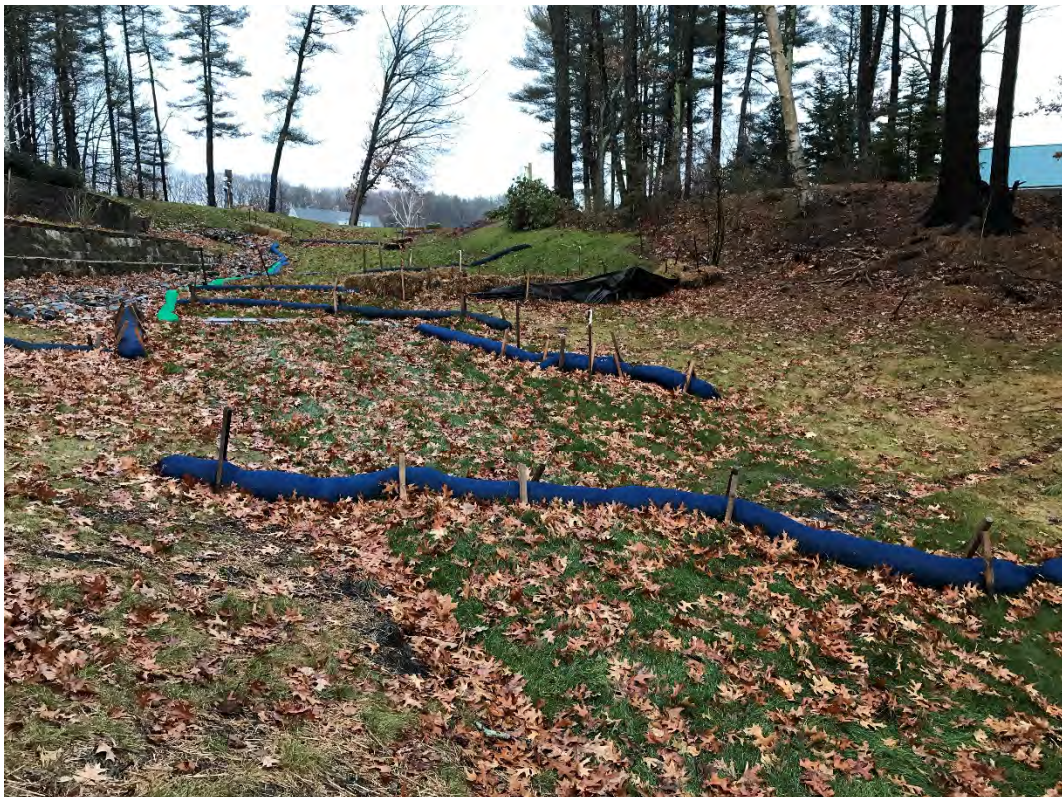
Fig 10: Slope below the manhole at Gundalow Landing/east side of the bay. Viewing east. (01-16-21)

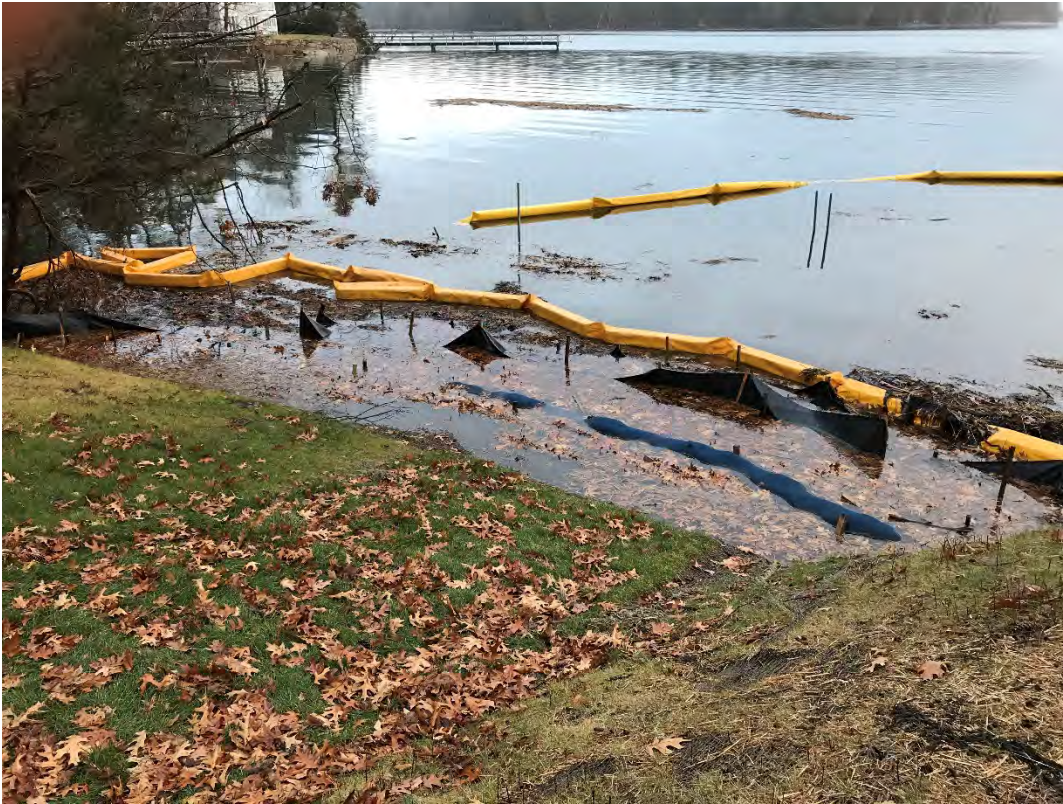
Fig 11: Toe of the slope at Gundalow Landing/east side of the bay. Viewing south. (01-16-21)
