# DRAINAGE MONITORING REPORT

## F107 - Seacoast Reliability Project

### Newington, New Hampshire

04.0190967.00

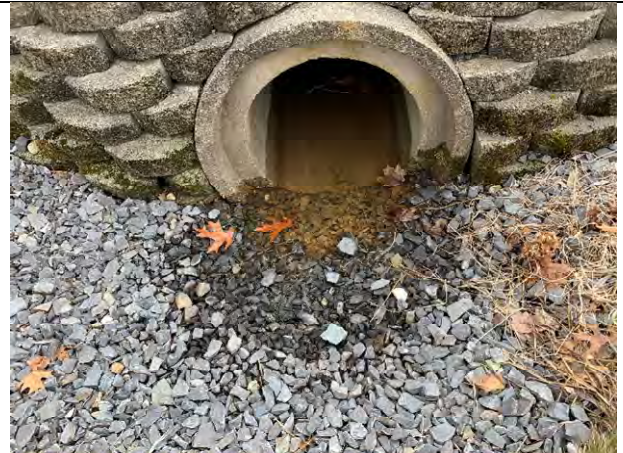
29 Gundalow - 2 (Culvert)

pH: 12.0

Observations/Notes: Water extending approx. 12" beyond culvert inlet into stone area, approx. max depth 4".

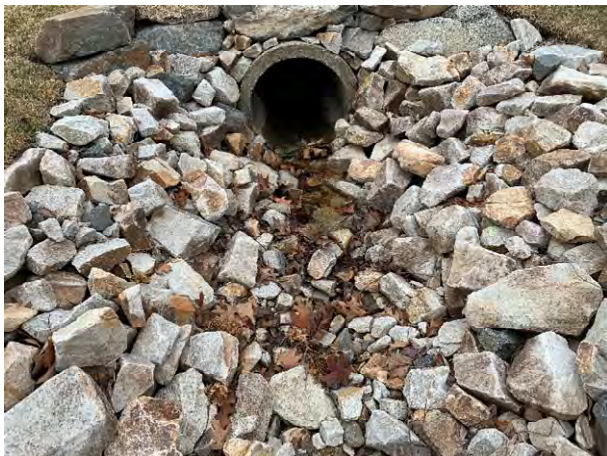
64 Gundalow - 1 (Drainage Course)

pH: 11.5

Observations/Notes: Flowing water extending approx. 18" beyond culvert outlet, approx. 1" deep.

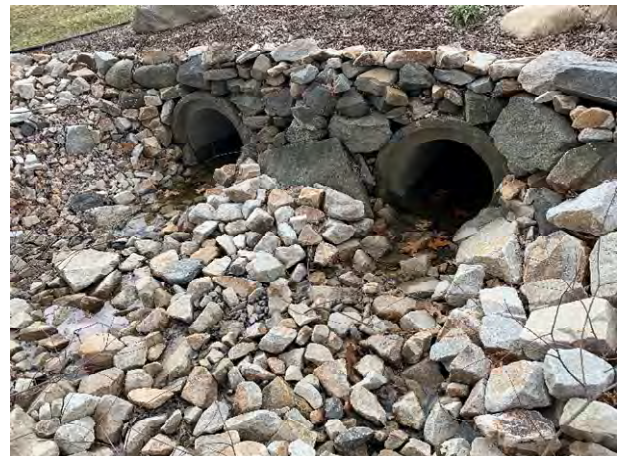
64 Gundalow - 2 (Drainage Course)

pH: 10.3

Observations/Notes: Flowing water extending approx. 2' beyond culvert inlet, approx. 2" deep.

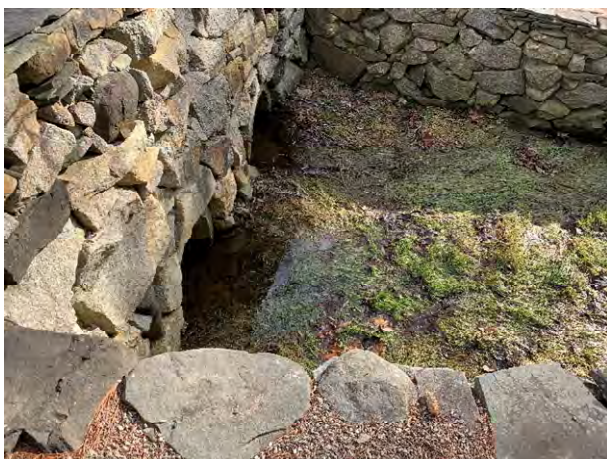
4 Brickyard Circle - 1 (Drainage Course)

pH: 10.0

Observations/Notes: Large pool of standing water extending from outlet, max depth approx. 8".

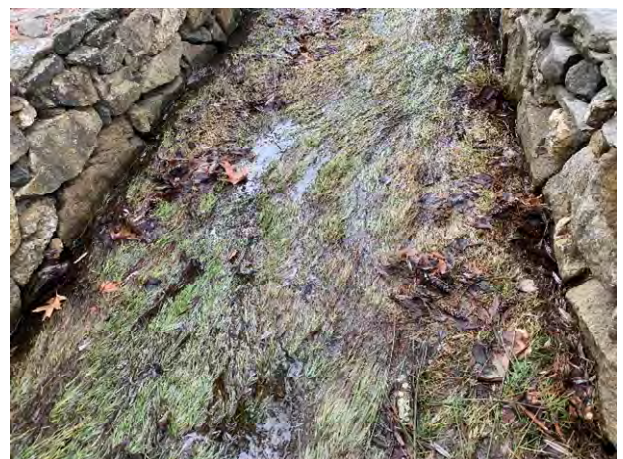
4 Brickyard Circle - 2 (Drainage Course)

pH: 7.8

Observations/Notes: Flowing water in raceway, approx. 2" deep.

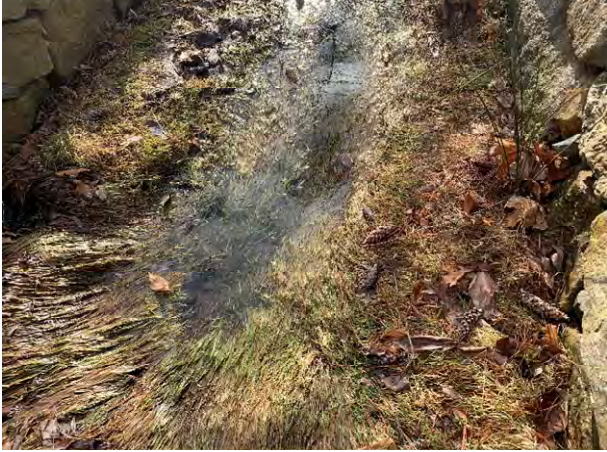
4 Brickyard Circle – 3 (Drainage Course)

pH: 7.5

Observations/Notes: Flowing water in center of raceway, approx. 3" deep.

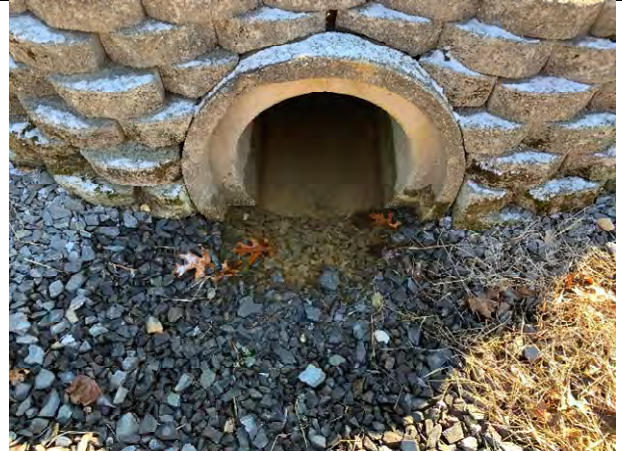
29 Gundalow - 2 (Culvert)

pH: 12.6

Observations/Notes: Water extending approx. 12" beyond culvert inlet into stone area, approx. max depth 4". Crystallized precipitate observed on submerged stone.

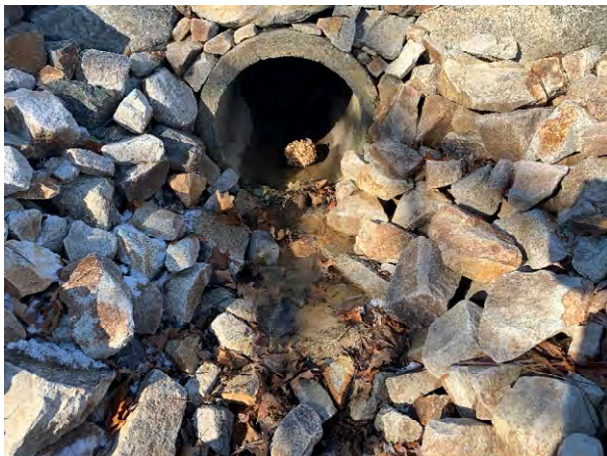
64 Gundalow - 1 (Drainage Course)

pH: 12.2

Observations/Notes: Flowing water extending approx. 18" beyond culvert outlet, approx. 1" deep. Crystallized precipitate observed on submerged stone and leaf litter, gray film on water surface.

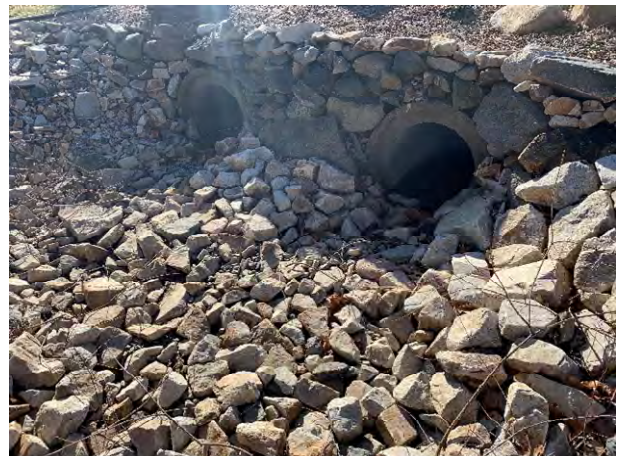
64 Gundalow - 2 (Drainage Course)

pH: 10.5

Observations/Notes: Flowing water extending approx. 6" beyond culvert inlet, approx. 1" deep.

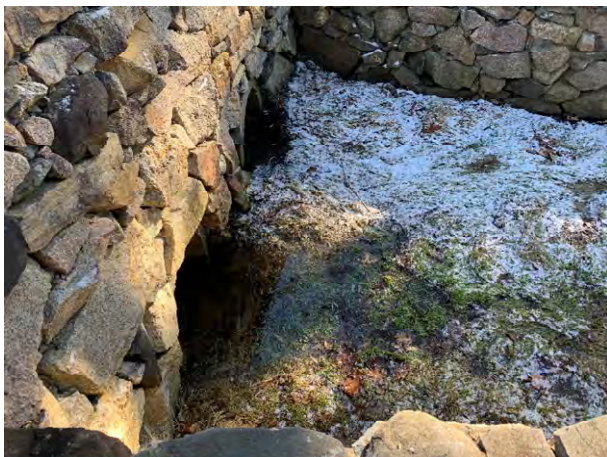
4 Brickyard Circle - 1 (Drainage Course)

pH: 10.2

Observations/Notes: Standing water extending approx. 2' from outlet, max depth approx. 8".

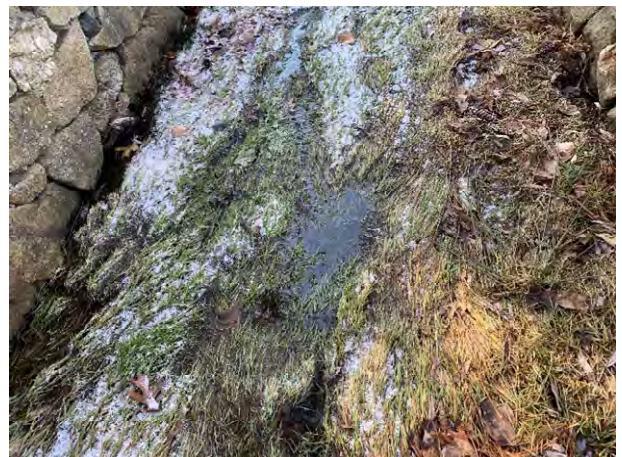
4 Brickyard Circle - 2 (Drainage Course)

pH: 7.8

Observations/Notes: Flowing water adjacent to east wall of raceway, approx. 2" deep.

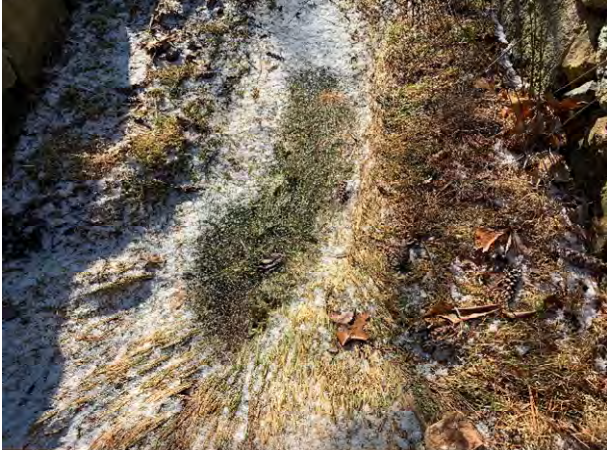
4 Brickyard Circle – 3 (Drainage Course)

pH: 7.6

Observations/Notes: Flowing water in center of raceway, approx. 3" deep. Surface iced over.
