CONSTRUCTION MONITORING REPORT

Eversource	Transmission	Lines:
	F107	<u>7</u>

Eversource Seacoast Reliability Project

Construction Monitoring Report #112

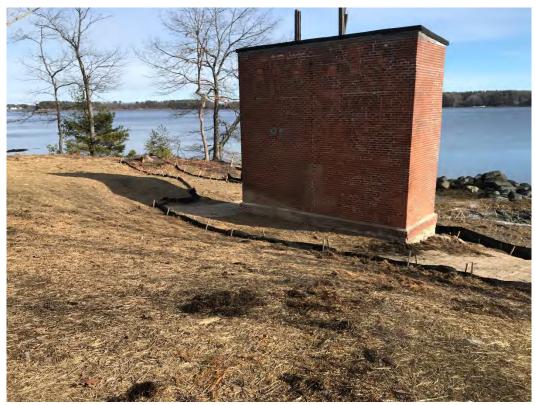
Fig 1: Slope leading down to cable house and salt marsh restoration at the Eversource property/west side of the bay. Viewing northeast. (01-19-21)

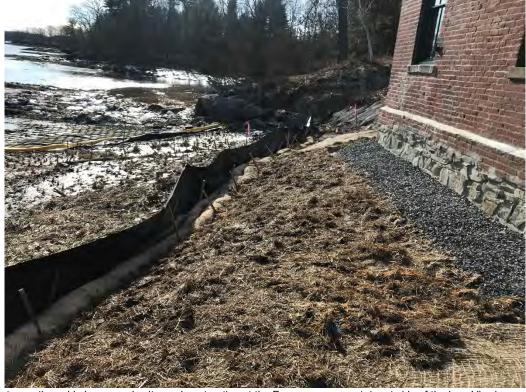
Fig 2: Slope between the cable house and salt marsh restoration at the Eversource property/west side of the bay. Viewing south. (01-19-21)

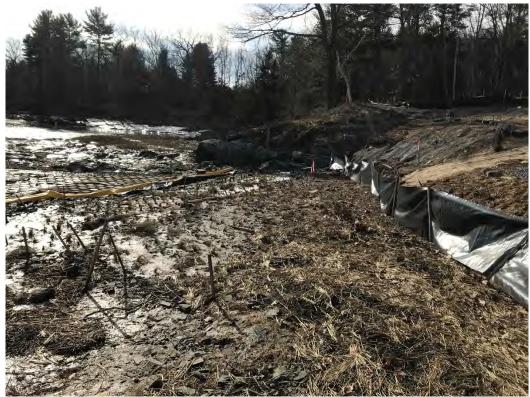
Fig 3: Toe of the slope and salt marsh restoration at the Eversource property/west side of the bay. Viewing south. (01-19-21)

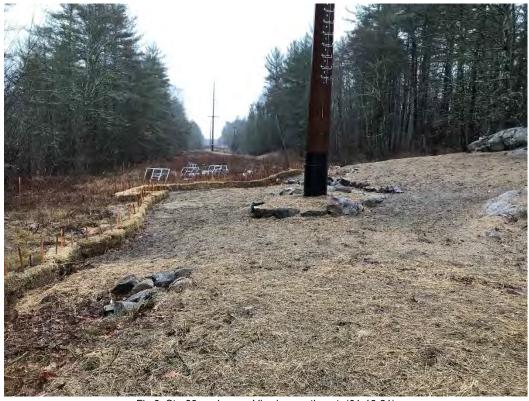
Fig 3: Str. 89 work area. Viewing southeast. (01-16-21)

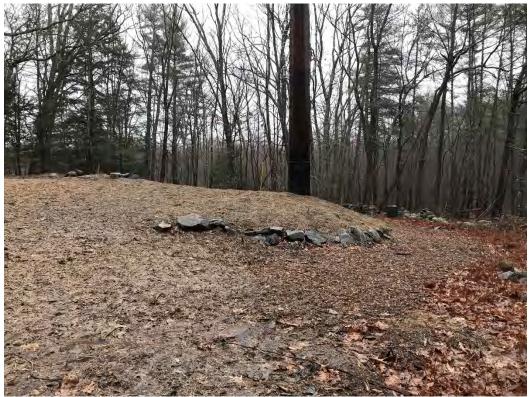
Fig 4: Str. 90 work area. Viewing northeast. (01-16-21)

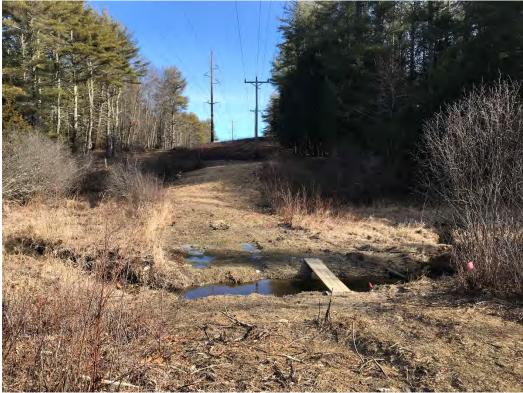
Fig 5: Stream DS46 between Strs. 51 and 52. Viewing northeast. (01-19-21)

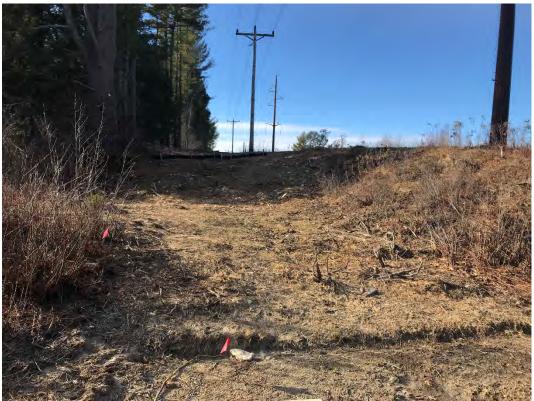
Fig 6: Northeast facing slope above stream DS46 between Strs. 51 and 52. Viewing southwest. (01-19-21)

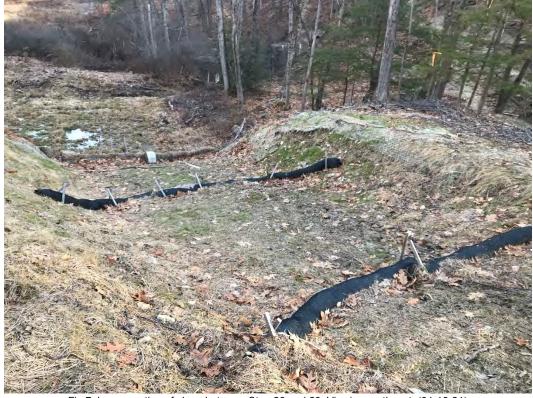
Fig 7: Lower portion of slope between Strs. 28 and 29. Viewing northeast. (01-19-21)

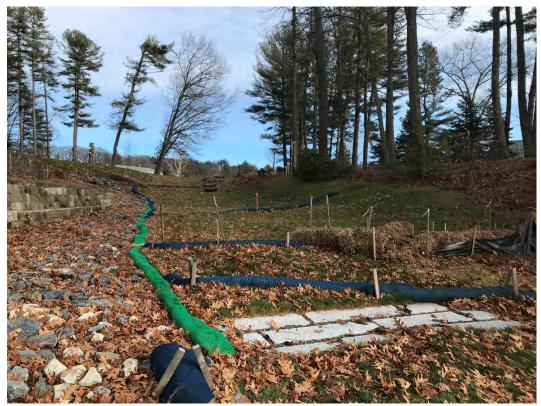
Fig 8: Slope above the manhole at Gundalow Landing/east side of the bay. Viewing east. (01-19-21)

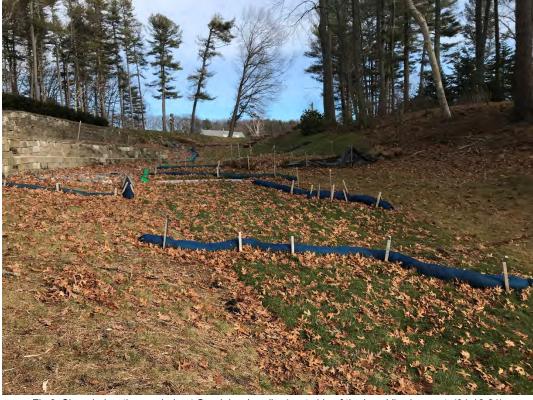
Fig 9: Slope below the manhole at Gundalow Landing/east side of the bay. Viewing east. (01-16-21)

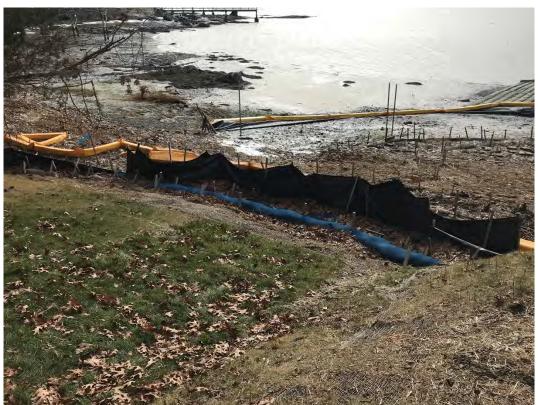
Fig 10: Toe of the slope at Gundalow Landing/east side of the bay. Viewing south. (01-19-21)

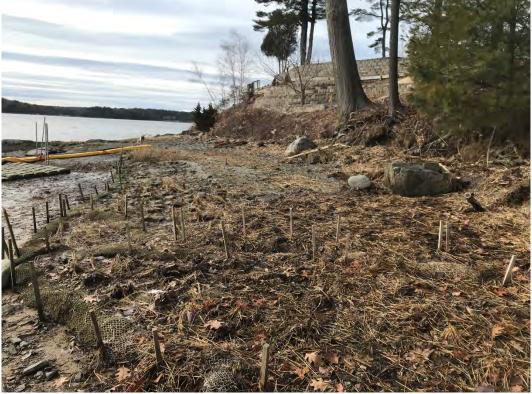
Fig 11: Salt marsh restoration at Gundalow Landing/east side of the bay. Viewing northwest. (01-19-21)
