CONSTRUCTION MONITORING REPORT

Date of inspection: 01/26/21 Start Time: 10:00am Previous inspection: 01/19/21

Eversource Transmission Lines:

Eversource Seacoast Reliability Project

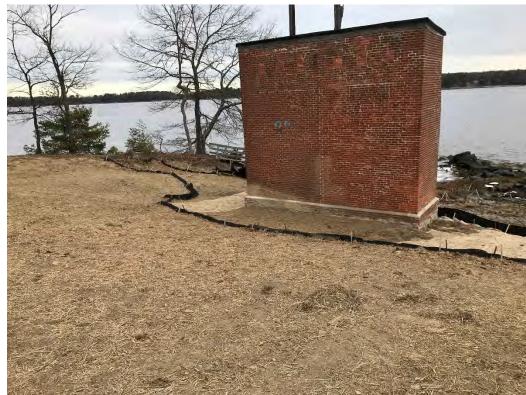
Fig 1: Slope leading down to cable house and salt marsh restoration at the Eversource property/west side of the bay. Viewing northeast. (01-26-21)

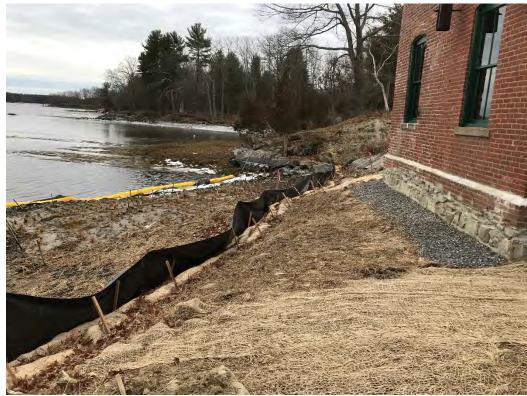
Fig 2: Slope between the cable house and salt marsh restoration at the Eversource property/west side of the bay. Viewing south. (01-26-21)

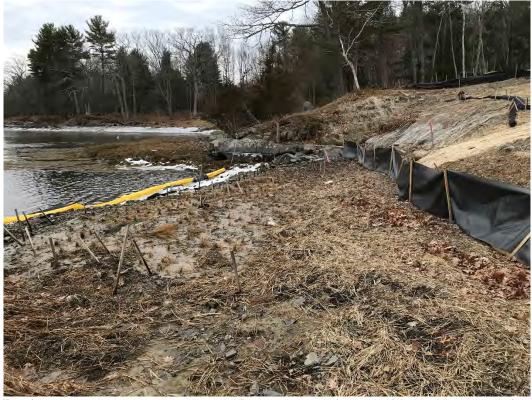
Fig 3: Toe of the slope and salt marsh restoration at the Eversource property/west side of the bay. Viewing south. (01-26-21)

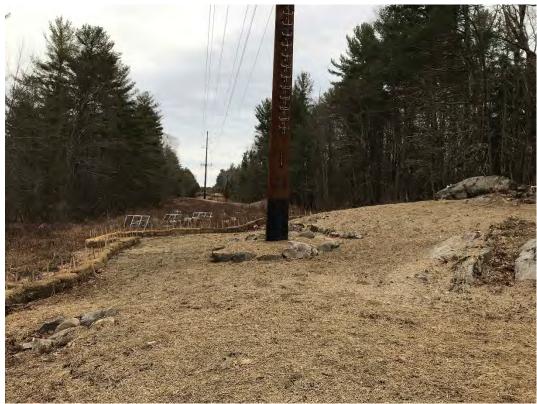
Fig 4: Str. 89 work area. Viewing southeast. (01-26-21)

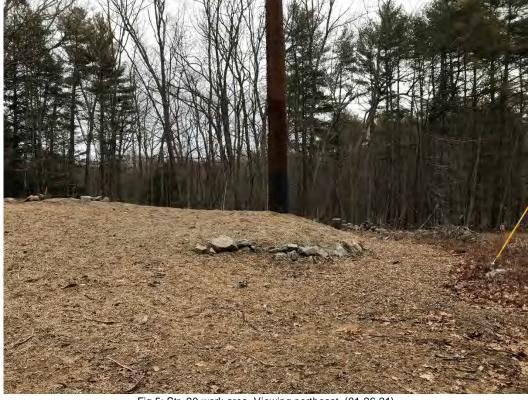
Fig 5: Str. 90 work area. Viewing northeast. (01-26-21)

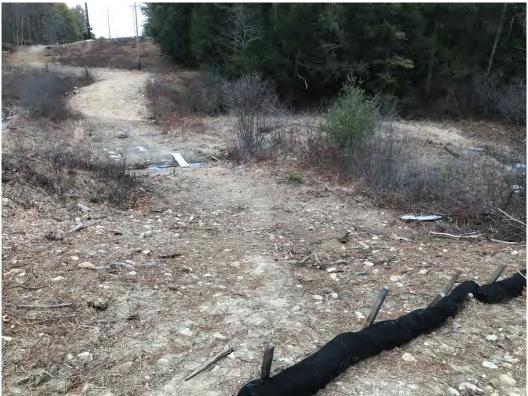
Fig 6: Stream DS46 between Strs. 51 and 52. Viewing northeast. (01-26-21)

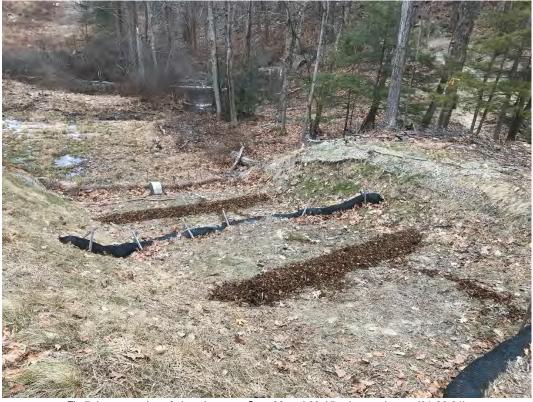
Fig 7: Lower portion of slope between Strs. 28 and 29. Viewing northeast. (01-26-21)

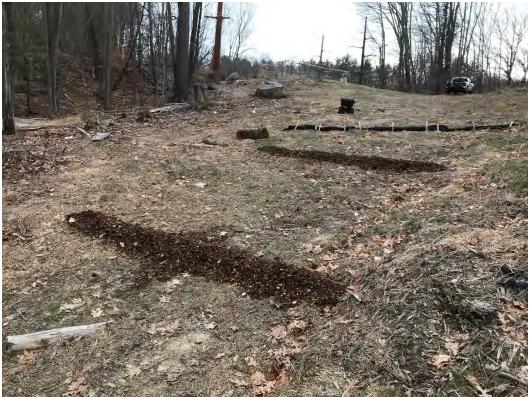
Fig 8: Upper portion of slope between Strs. 28 and 29. Viewing southeast. (01-26-21)

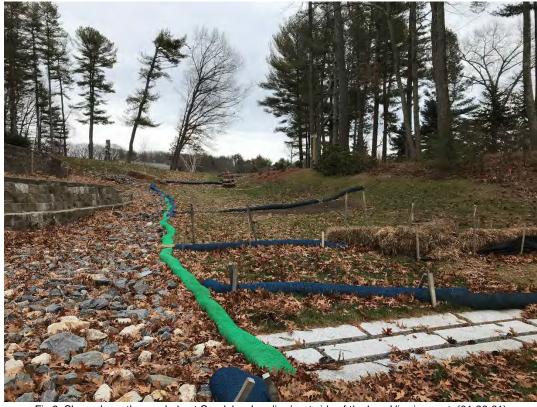
Fig 9: Slope above the manhole at Gundalow Landing/east side of the bay. Viewing east. (01-26-21)

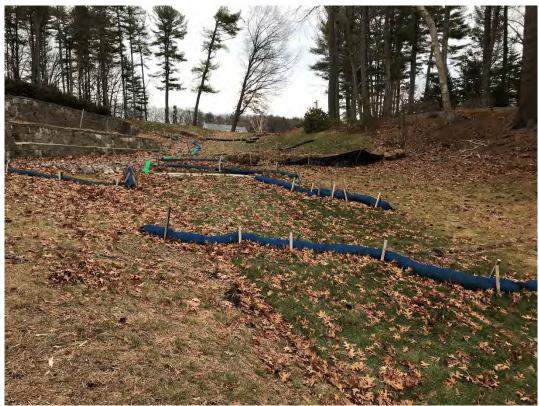
Fig 10: Slope below the manhole at Gundalow Landing/east side of the bay. Viewing east. (01-26-21)

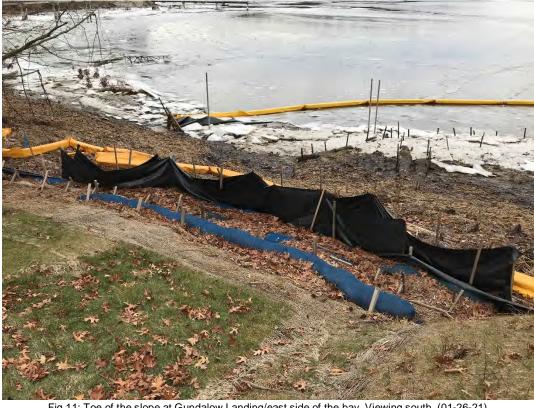
Fig 11: Toe of the slope at Gundalow Landing/east side of the bay. Viewing south. (01-26-21)

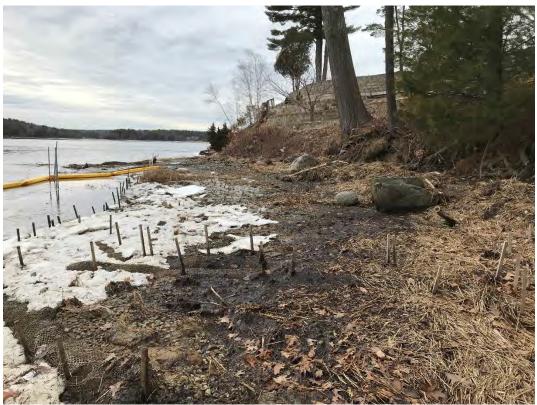
Fig 12: Salt marsh restoration at Gundalow Landing/east side of the bay. Viewing northwest. (01-26-21)
