CONSTRUCTION MONITORING REPORT

Eversource Transmission Lines:
F107

TYPE OF INSPECTION: Weekly Storm Event Incident Corrective Action

Date of inspection: **02/10/21** Start Time: **1:30pm** Previous inspection: **02/03/21**

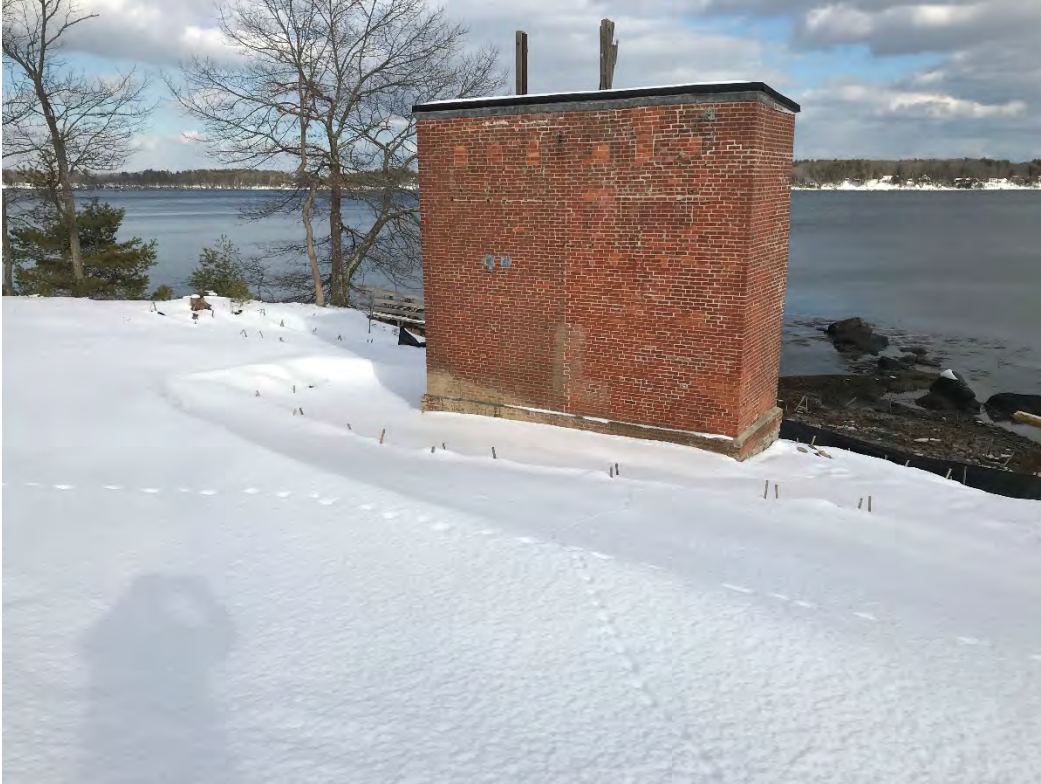
Areas that have been restored and mulched, but have little germination: Hannah Ln, Eversource property/west side of bay, Strs. 89-90

Fig 1: Slope leading down to cable house and salt marsh restoration at the Eversource property/west side of the bay. Viewing northeast. (02-10-21)

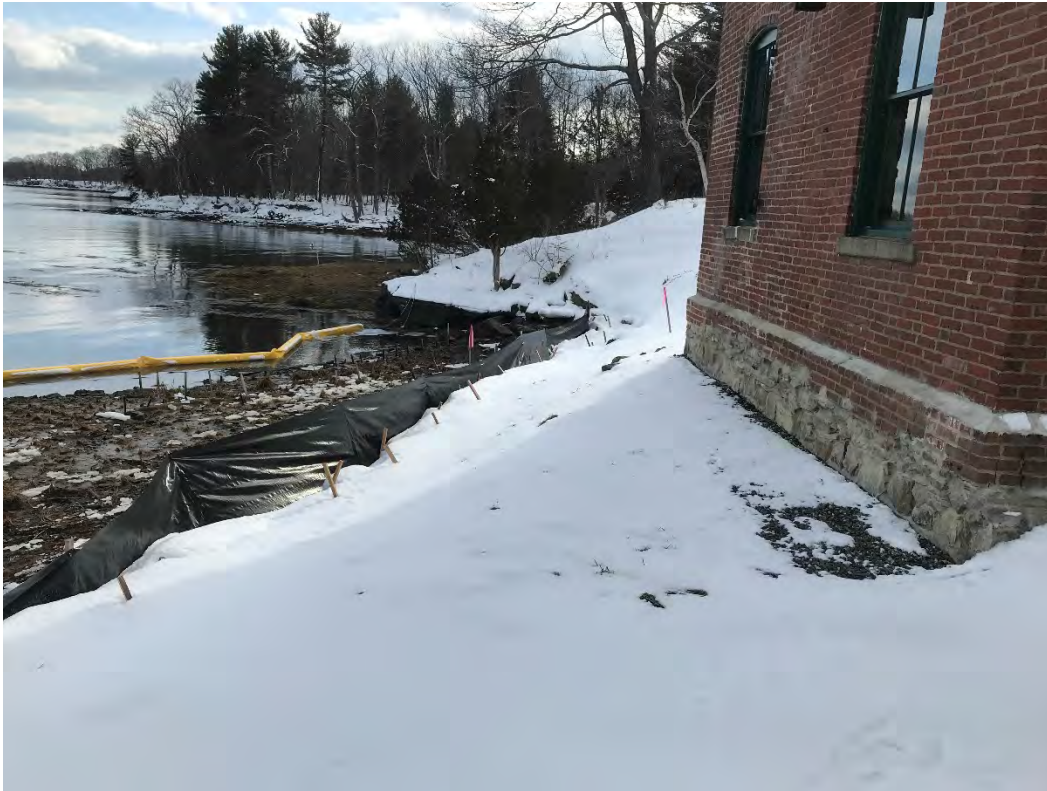
Fig 2: Slope between the cable house and salt marsh restoration at the Eversource property/west side of the bay. Viewing south. (02-10-21)

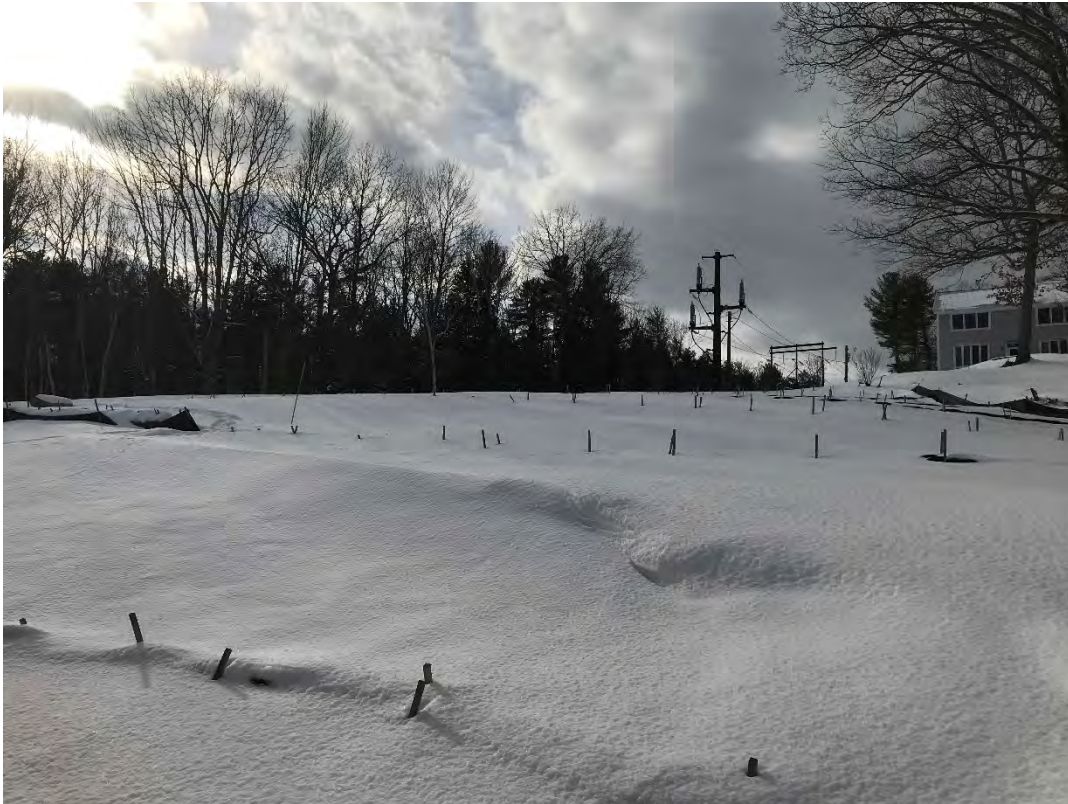
Fig 3: Slope above the cable house at the Eversource property/west side of the bay. Viewing southwest. (02-10-21)

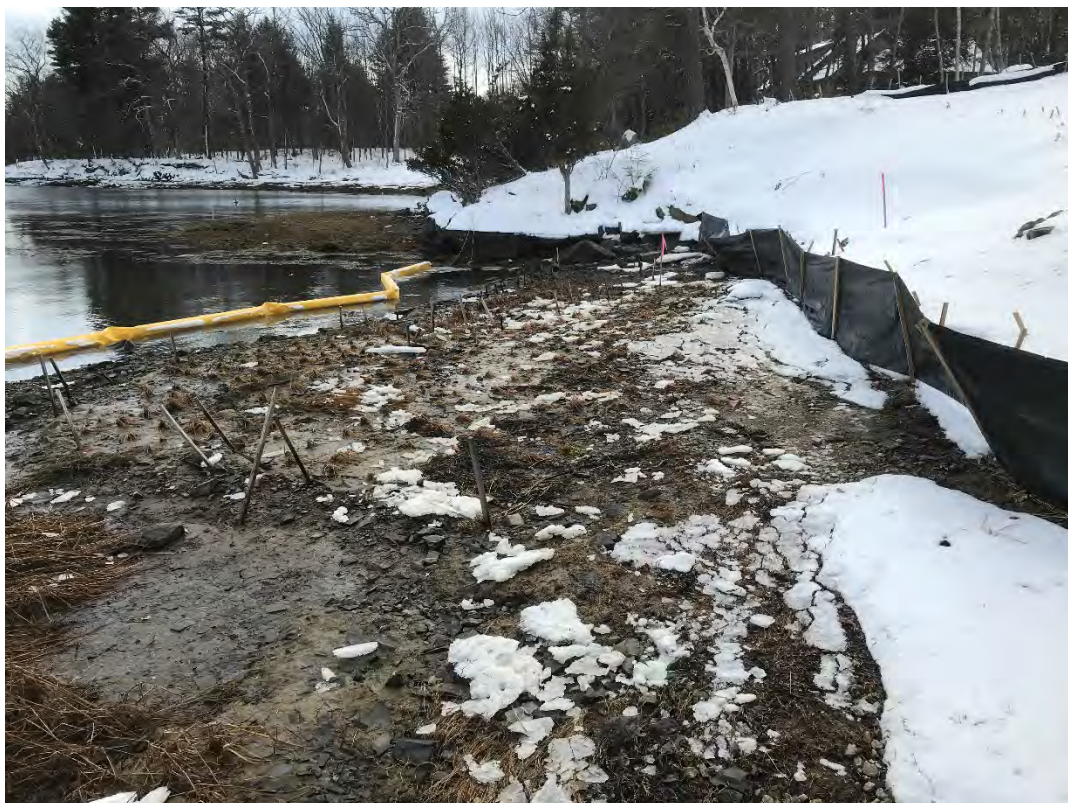
Fig 4: Toe of the slope and salt marsh restoration at the Eversource property/west side of the bay. Viewing south. (02-10-21)

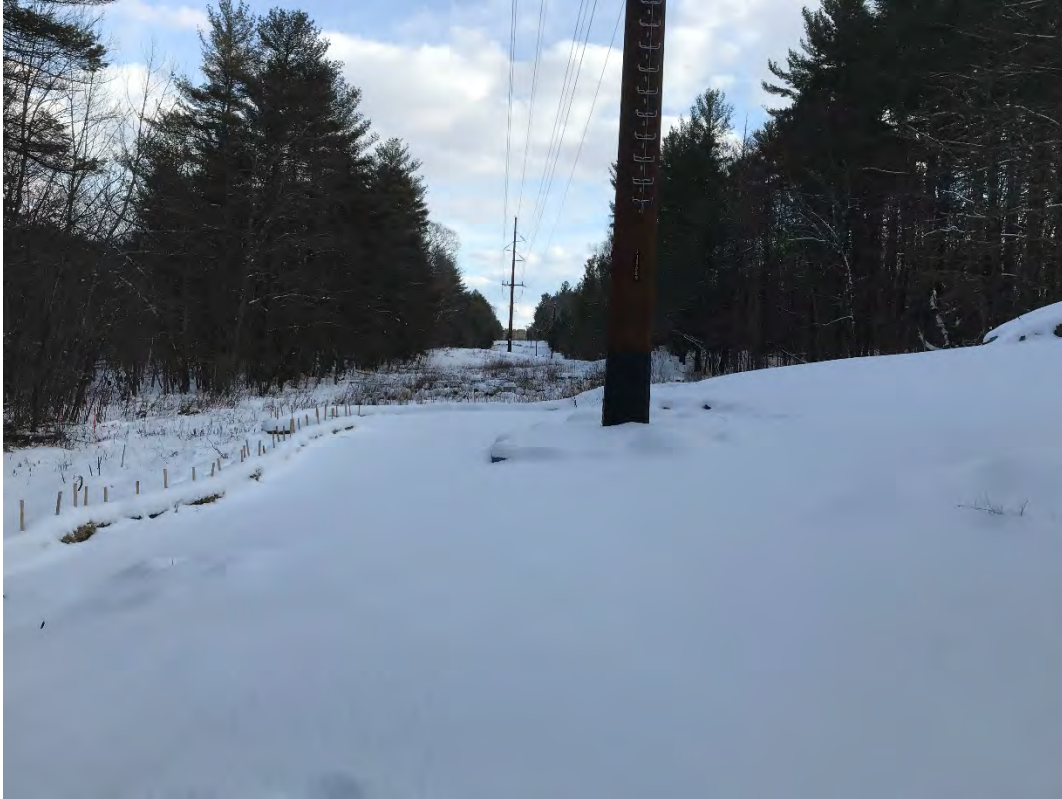
Fig 5: Str. 89 work area. Viewing southeast. (02-10-21)

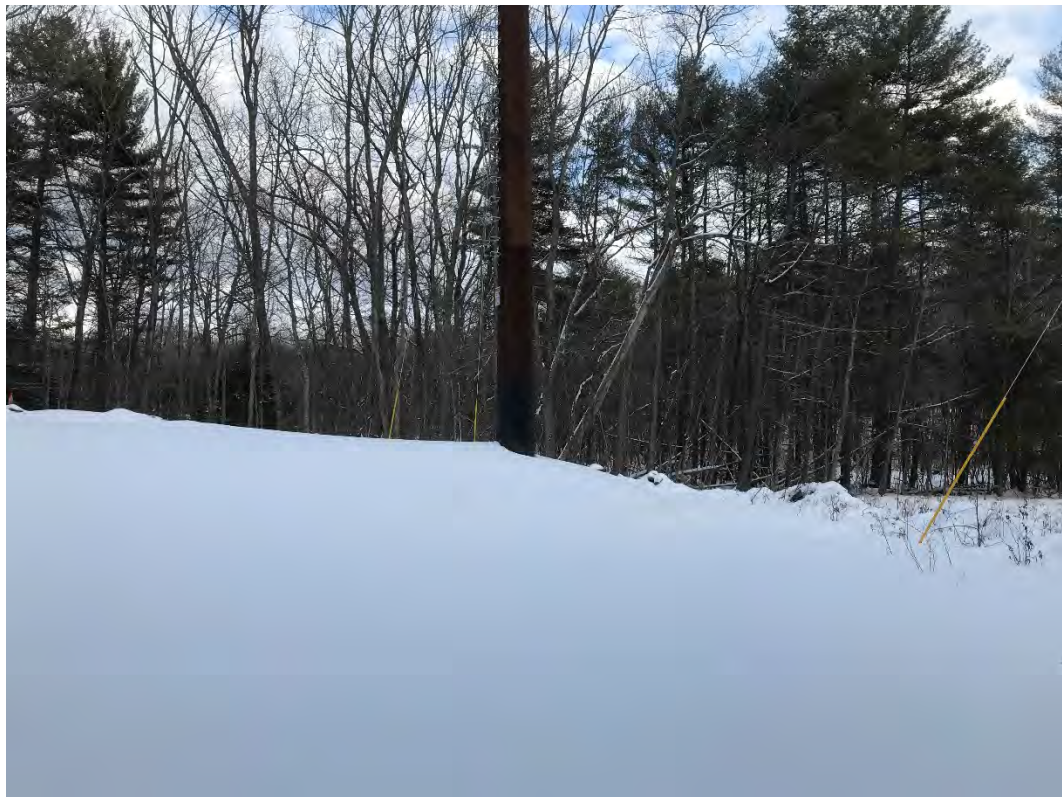
Fig 6: Str. 90 work area. Viewing northeast. (02-10-21)

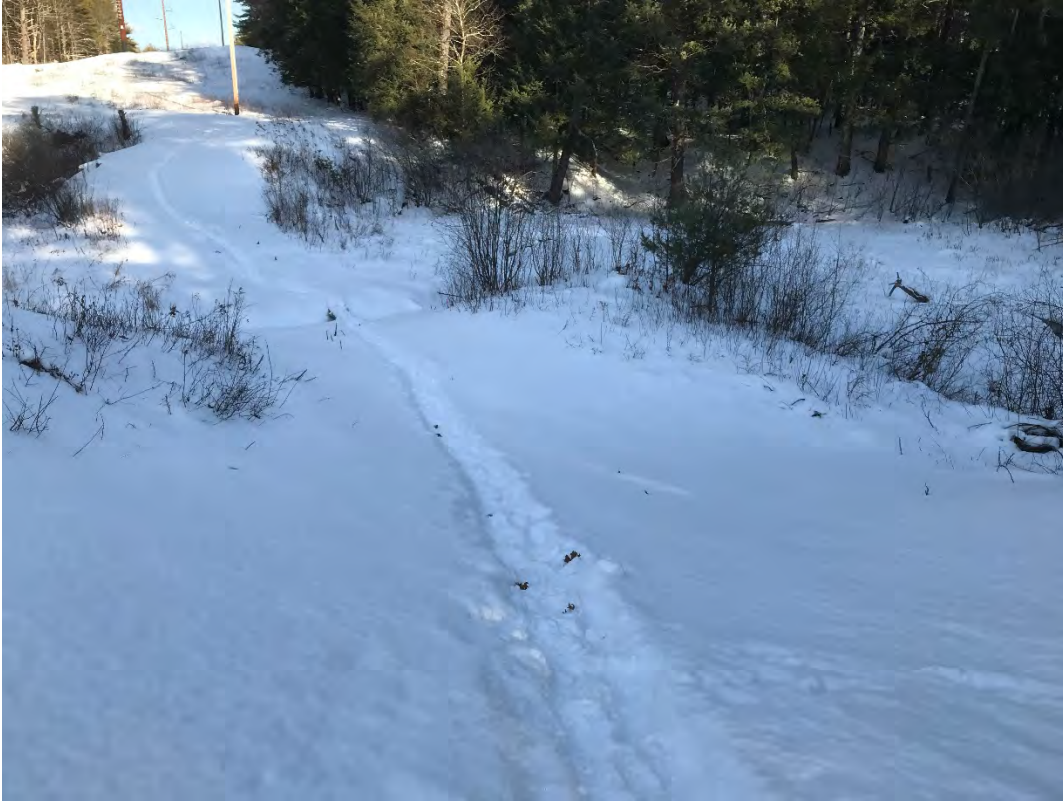
Fig 7: Stream DS46 between Strs. 51 and 52. Viewing northeast. (02-10-21)

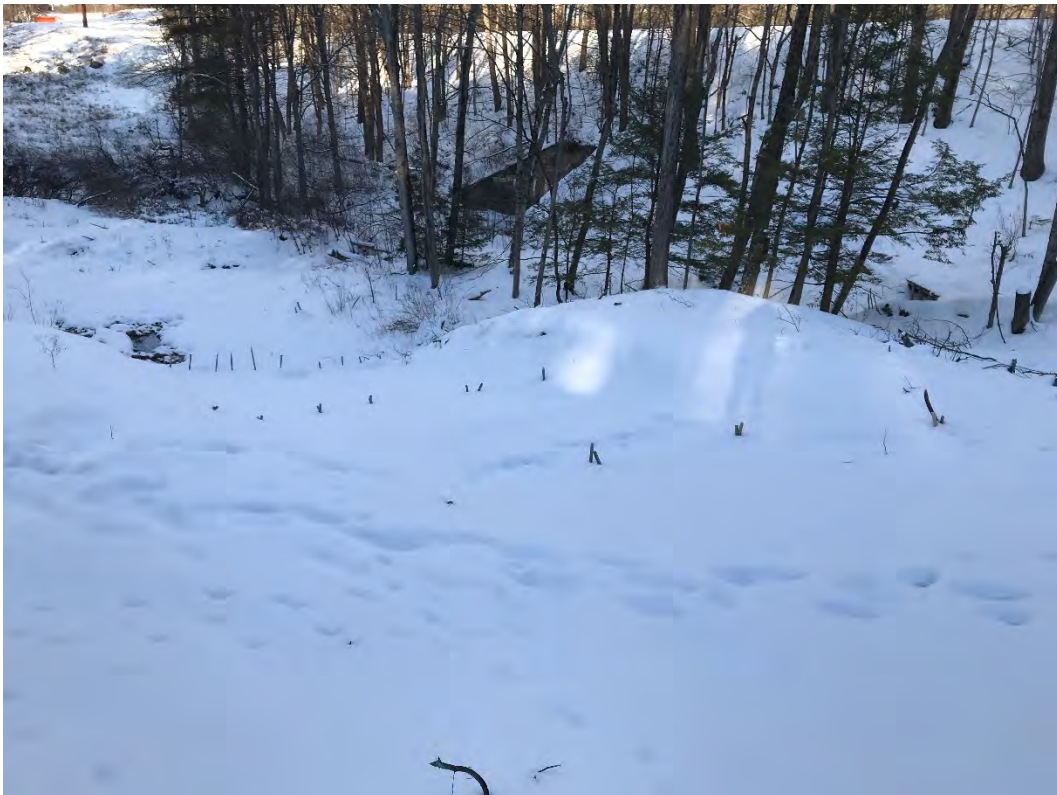
Fig 8: Lower portion of slope between Strs. 28 and 29. Viewing northeast. (02-10-21)

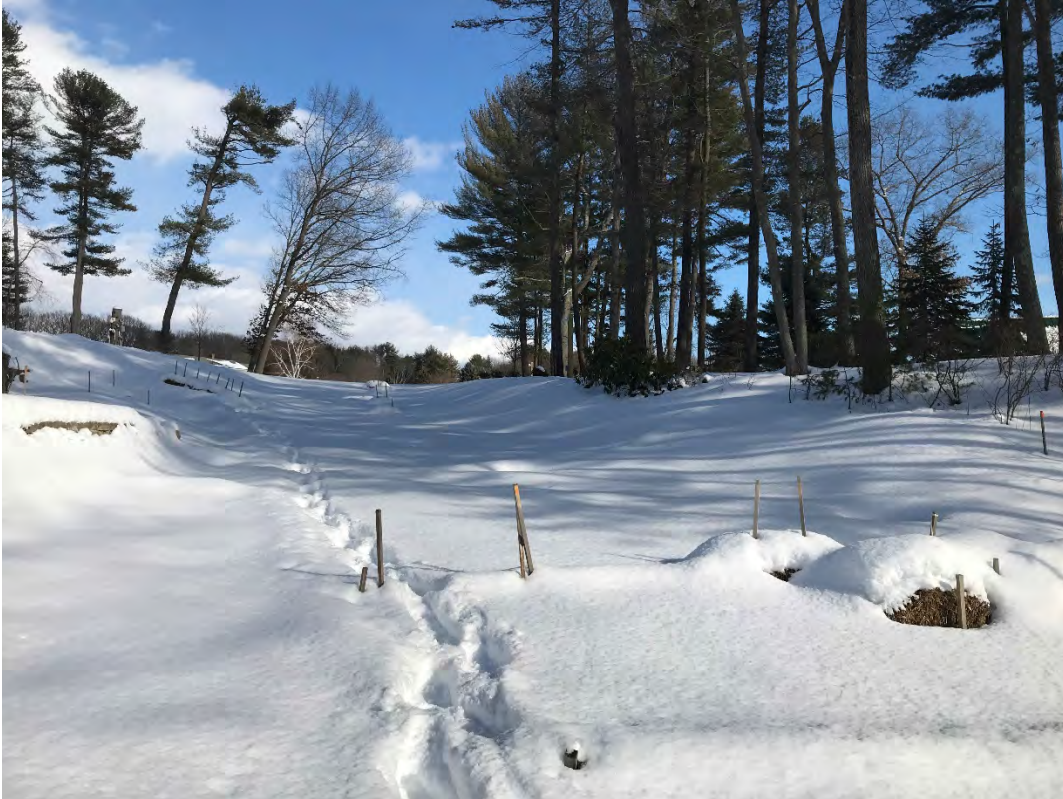
Fig 9: Slope above the manhole at Gundalow Landing/east side of the bay. Viewing east. (02-10-21)

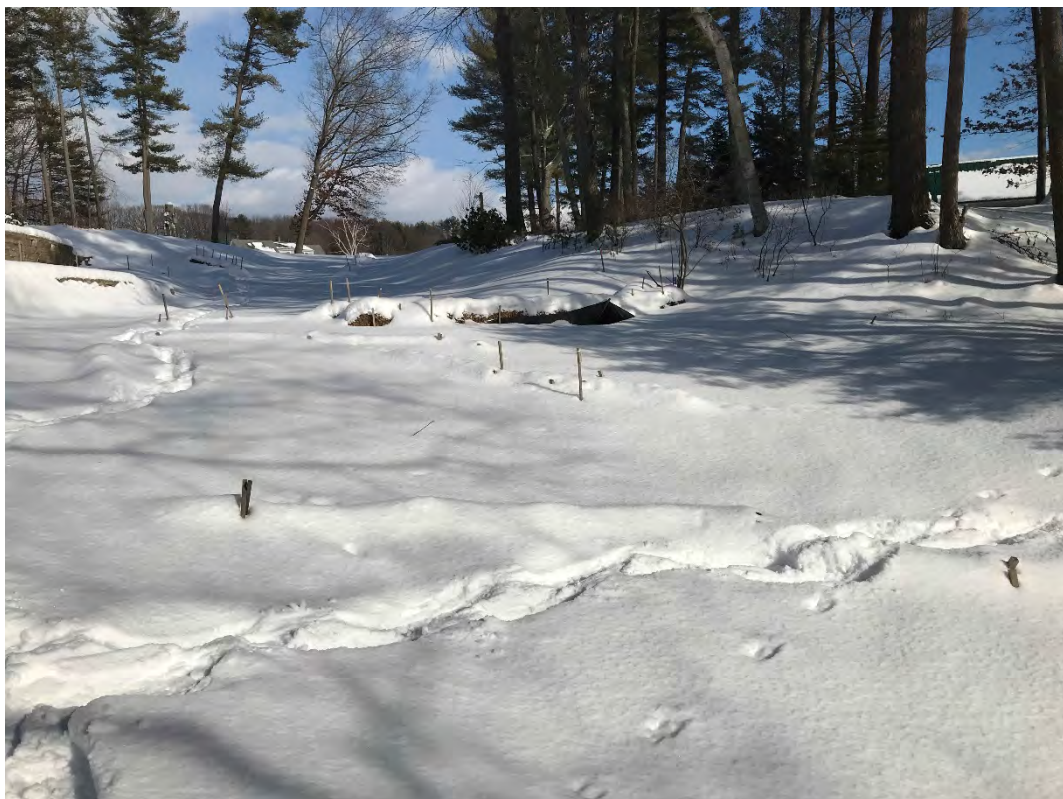
Fig 10: Slope below the manhole at Gundalow Landing/east side of the bay. Viewing east. (02-10-21)

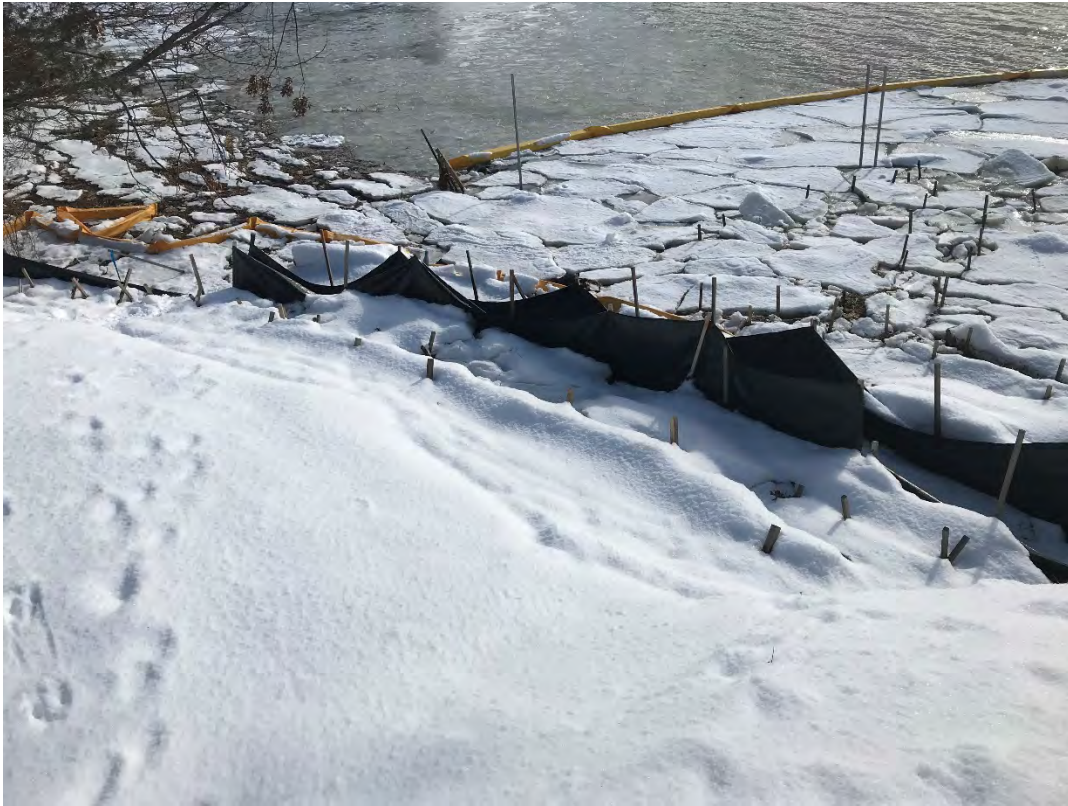
Fig 11: Toe of the slope at Gundalow Landing/east side of the bay. Viewing south. (02-10-21)

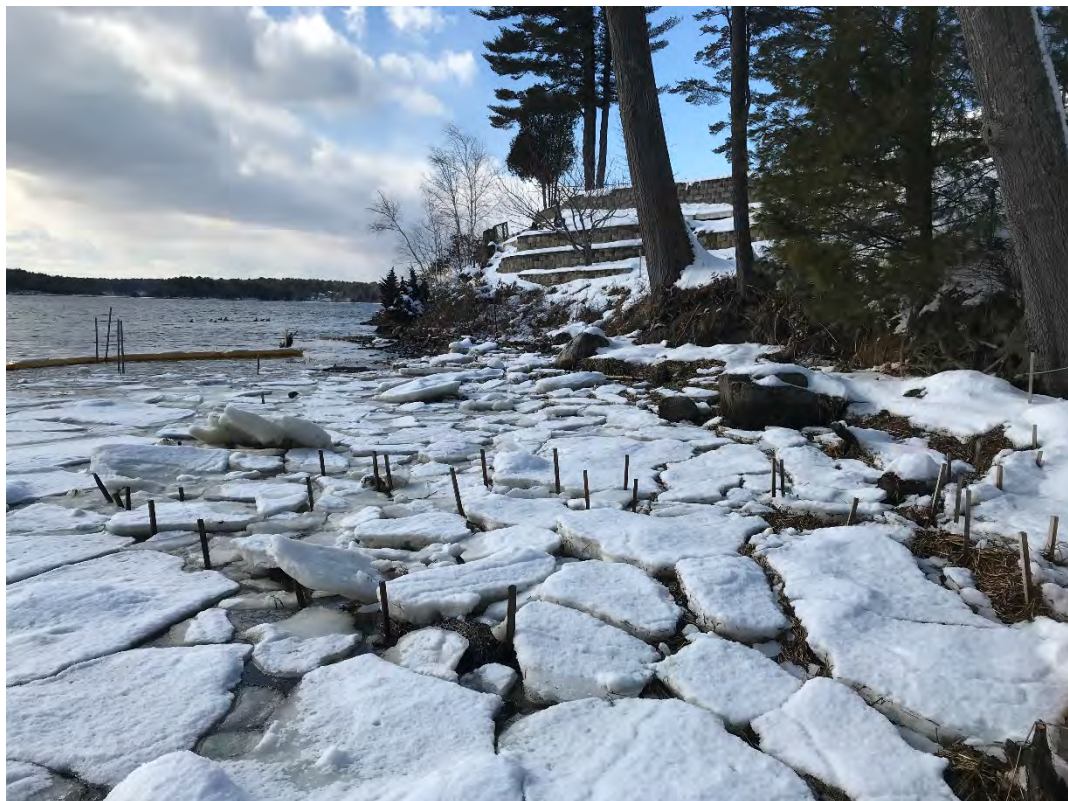
Fig 12: Salt marsh restoration at Gundalow Landing/east side of the bay. Viewing northwest. (02-10-21)
