CONSTRUCTION MONITORING REPORT

Eversource Transmission Lines:
F107

TYPE OF INSPECTION: Weekly Storm Event Incident Corrective Action

Date of inspection: **02/17/21** Start Time: **1:06pm** Previous inspection: **02/10/21**

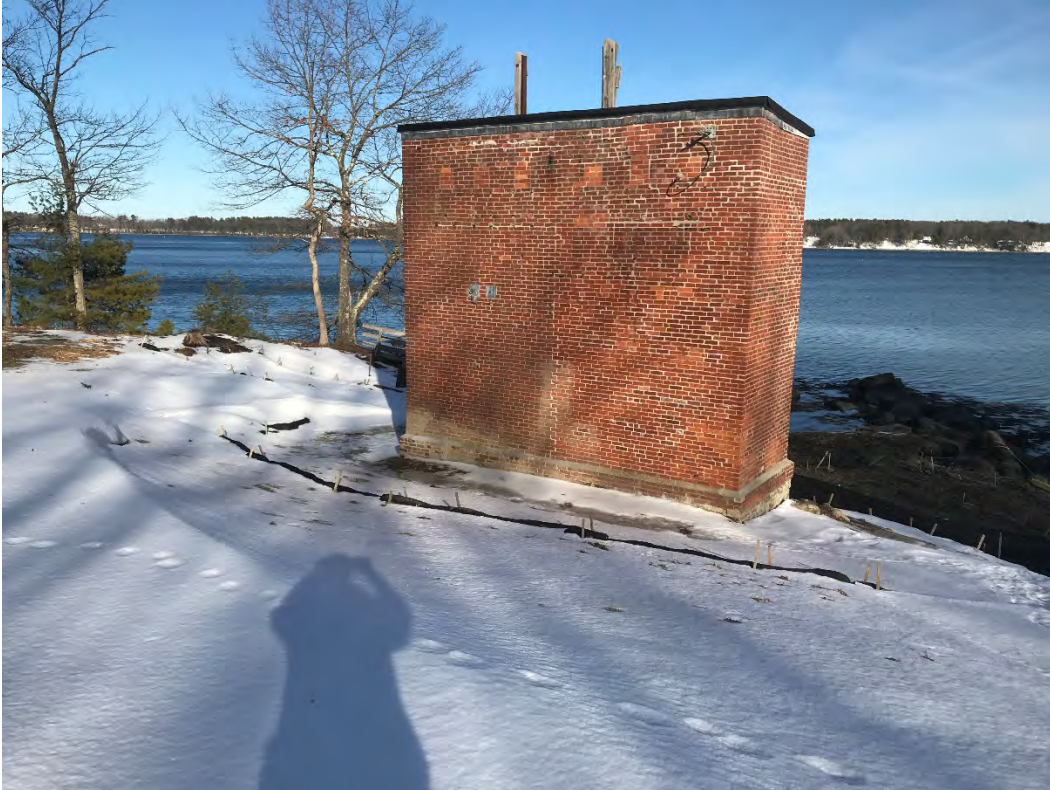
Fig 1: Slope leading down to cable house and salt marsh restoration at the Eversource property/west side of the bay. Viewing northeast. (02-17-21)

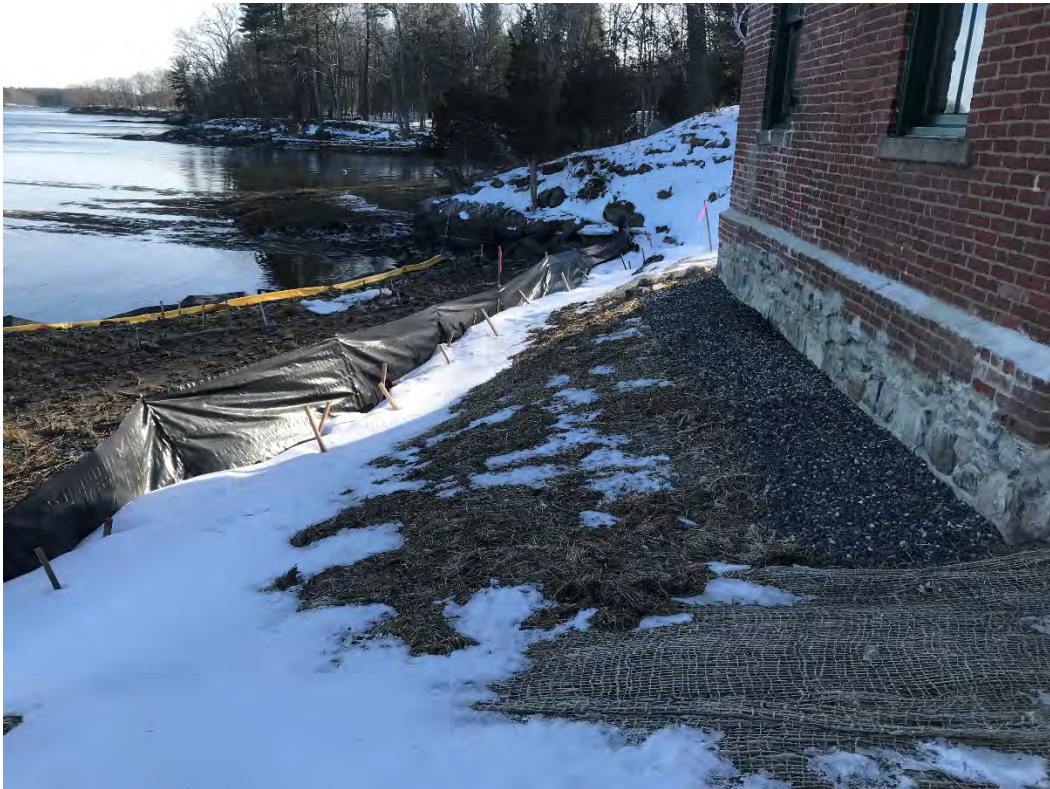
Fig 2: Slope between the cable house and salt marsh restoration at the Eversource property/west side of the bay. Viewing south. (02-17-21)

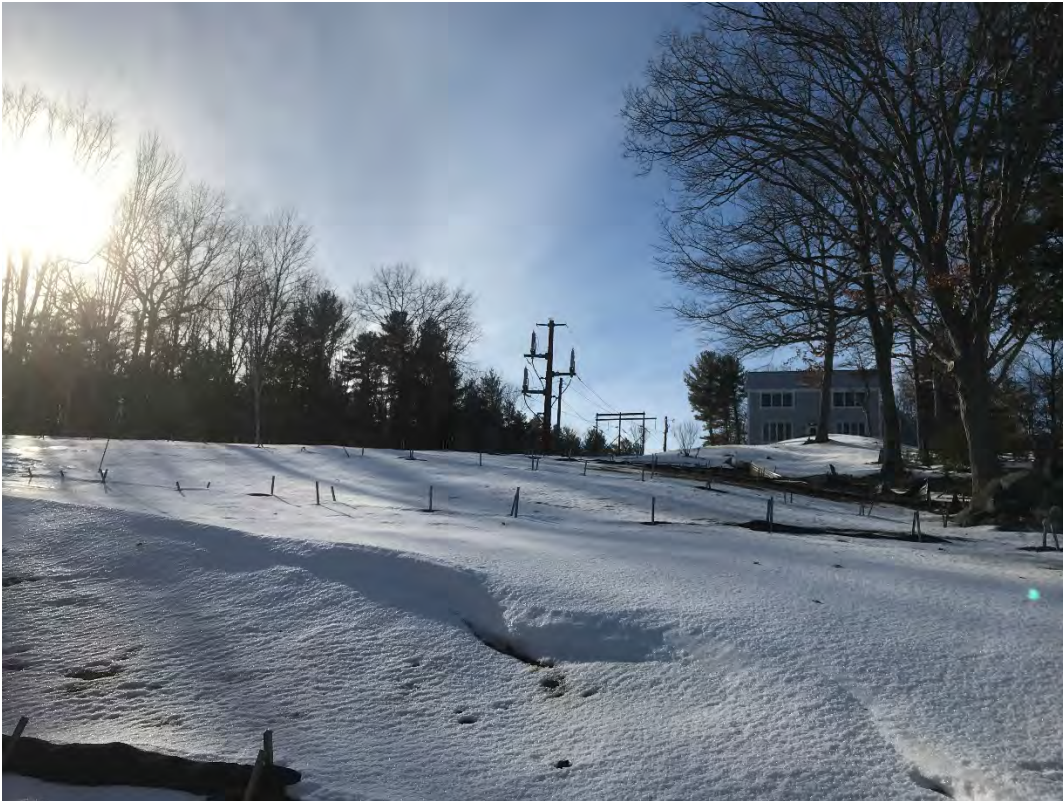
Fig 3: Slope above the cable house at the Eversource property/west side of the bay. Viewing southwest. (02-17-21)

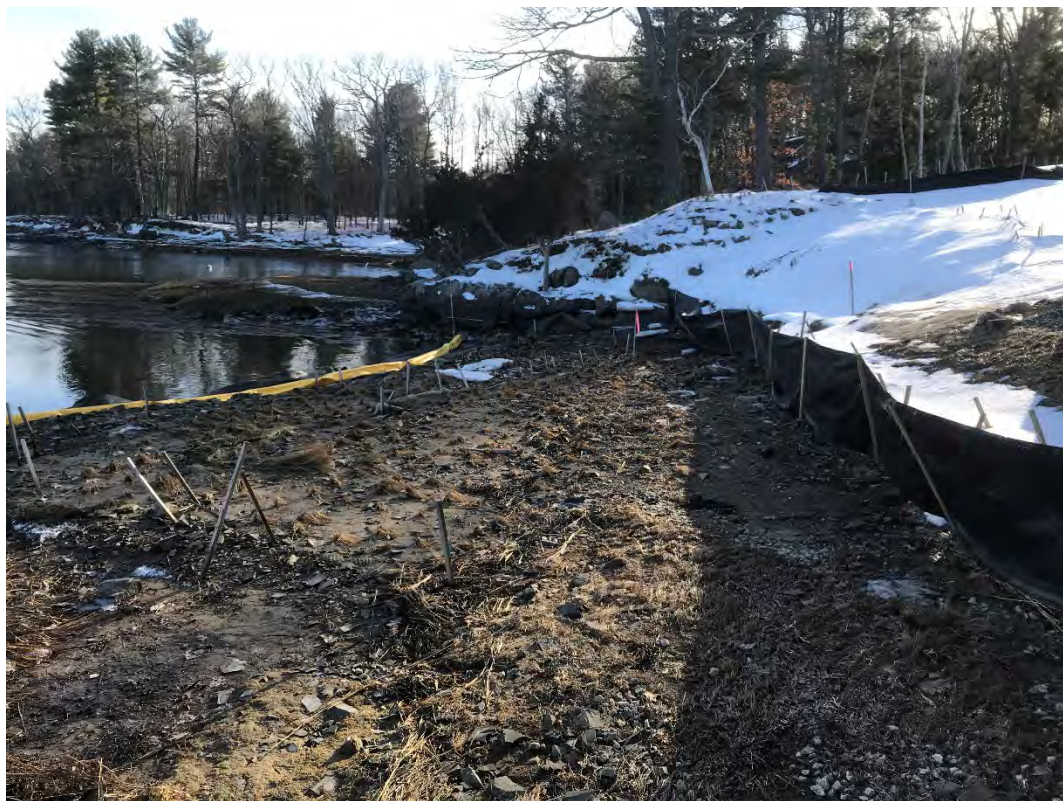
Fig 4: Toe of the slope and salt marsh restoration at the Eversource property/west side of the bay. Viewing south. (02-17-21)

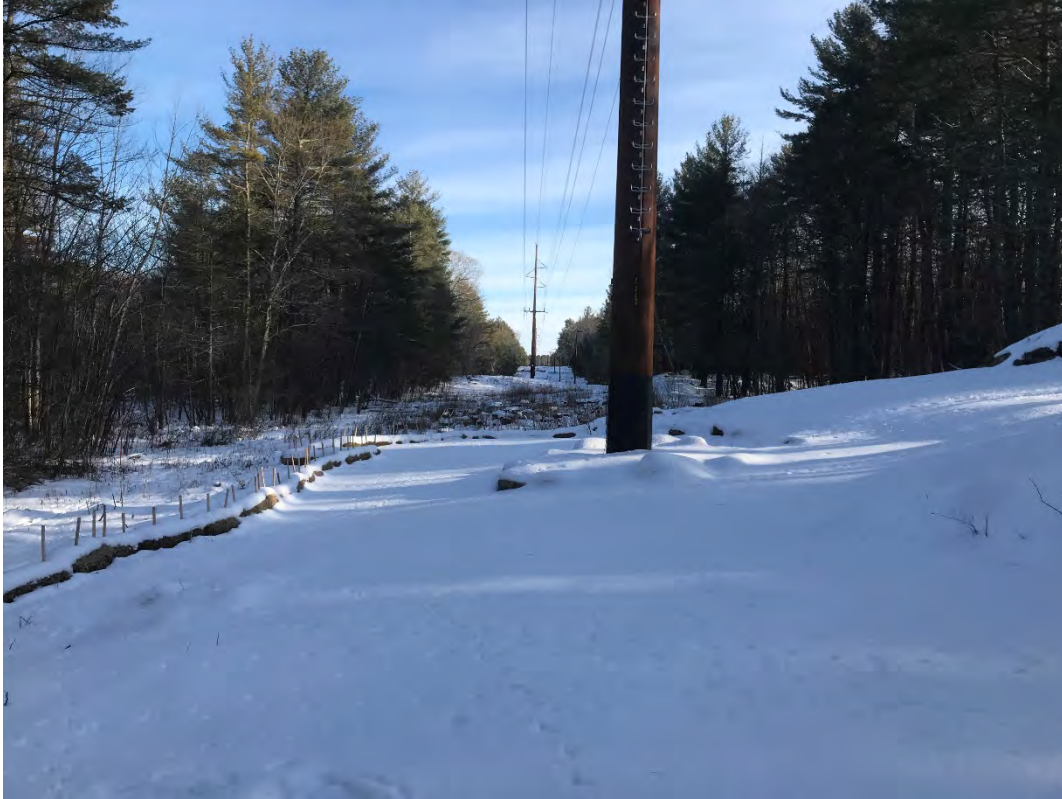
Fig 5: Str. 89 work area. Viewing southeast. (02-17-21)

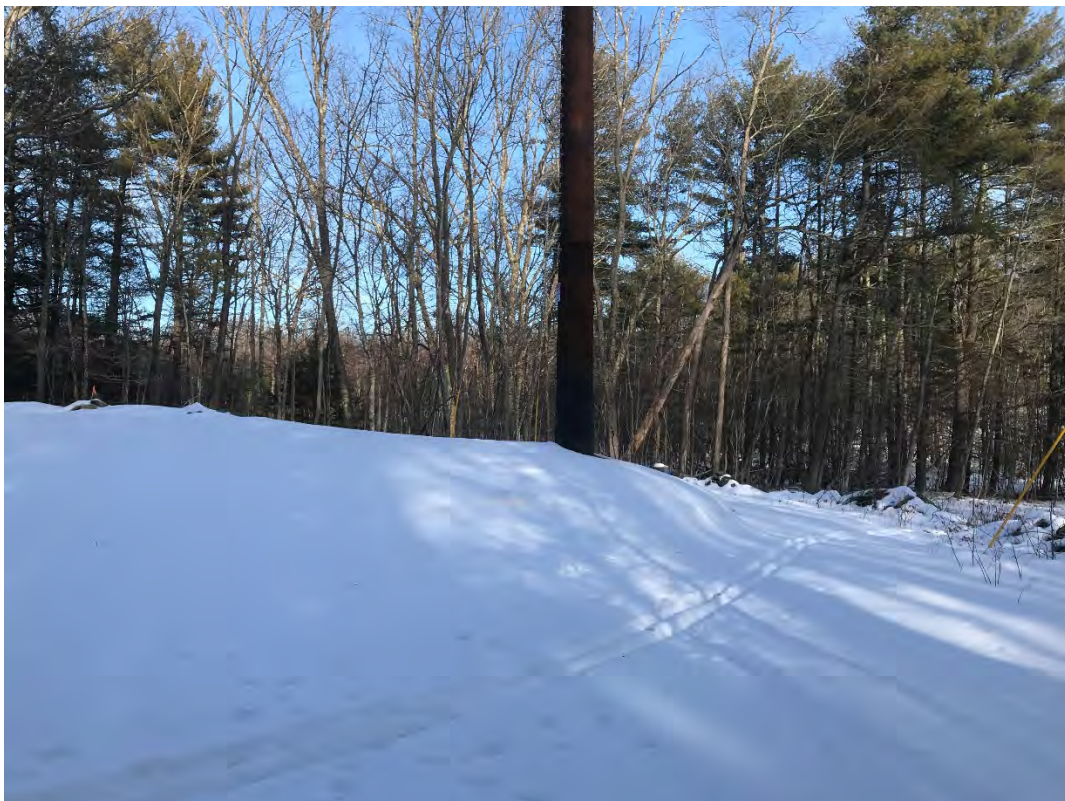
Fig 6: Str. 90 work area. Viewing northeast. (02-17-21)

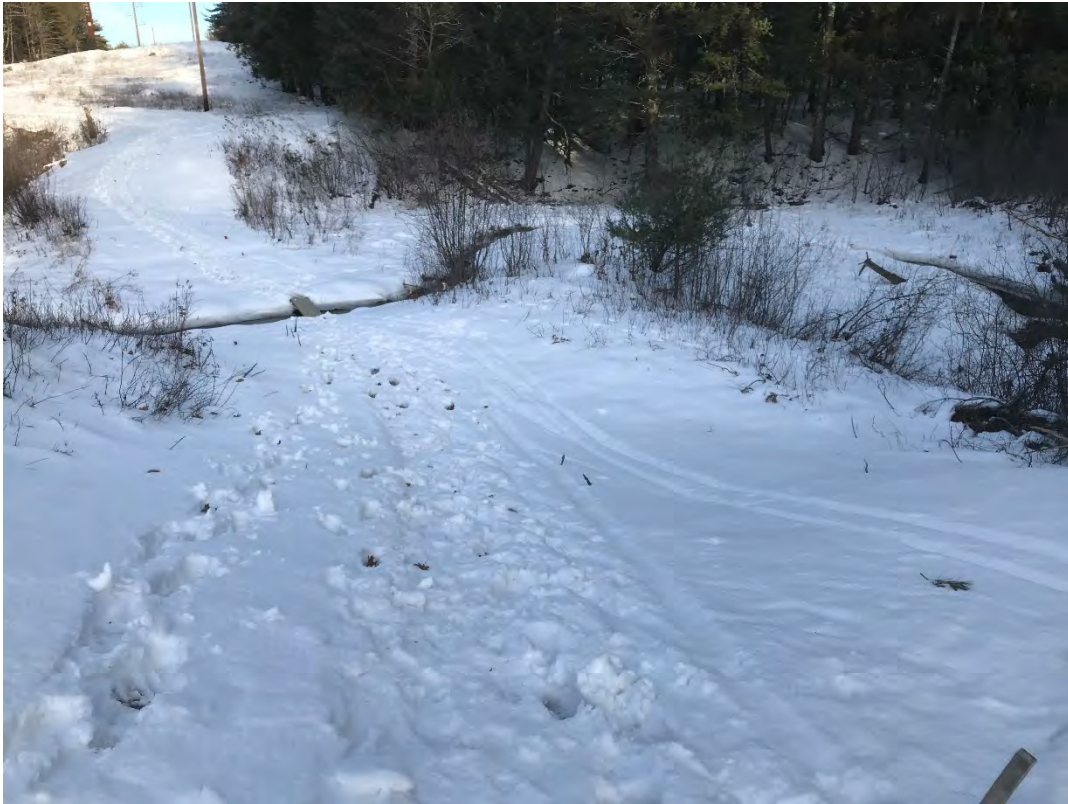
Fig 7: Stream DS46 between Strs. 51 and 52. Viewing northeast. (02-17-21)

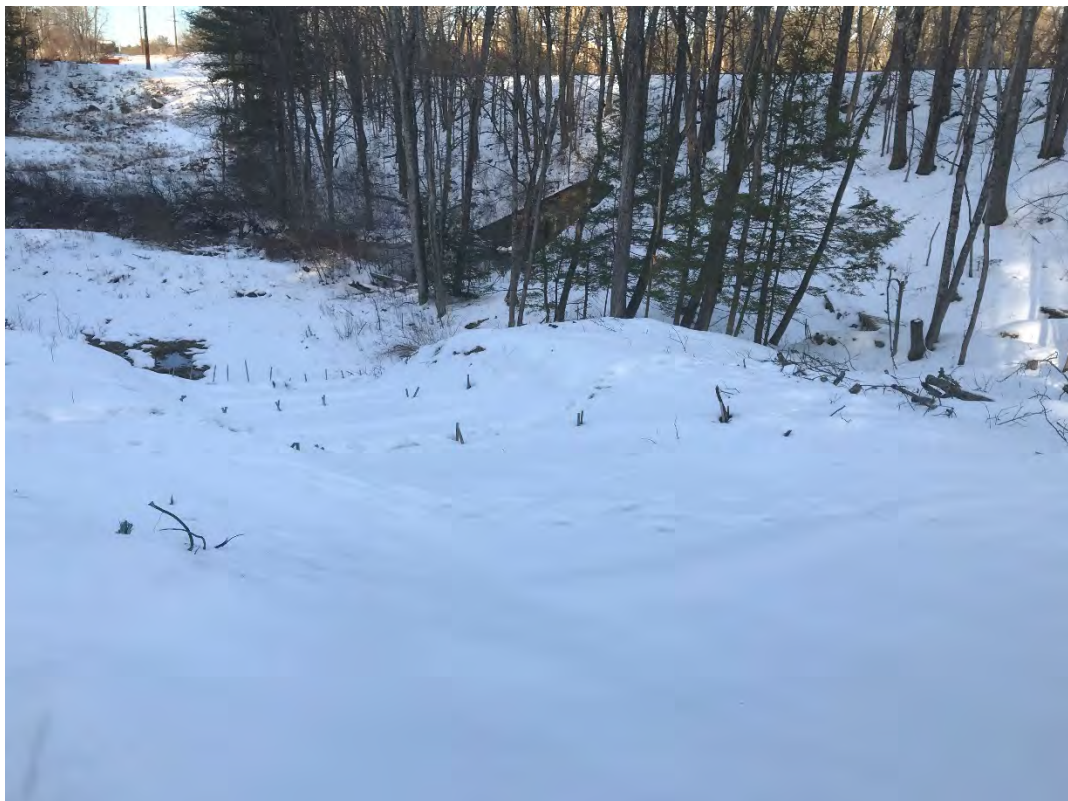
Fig 8: Lower portion of slope between Strs. 28 and 29. Viewing northeast. (02-17-21)

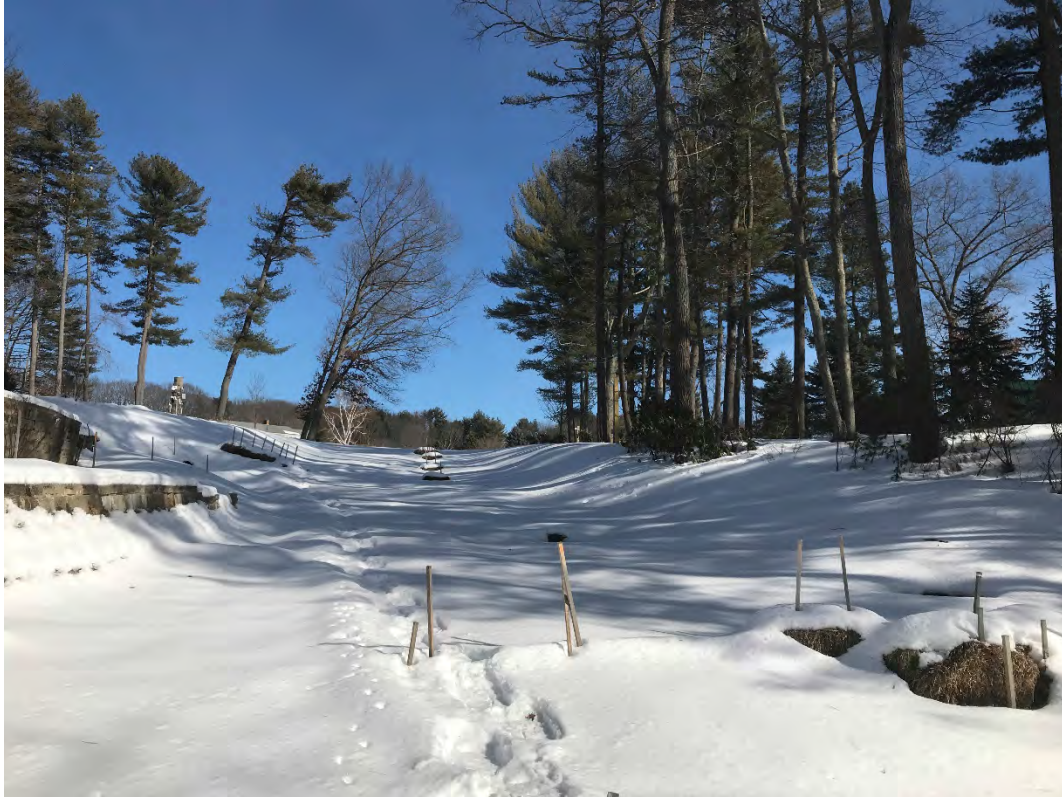
Fig 9: Slope above the manhole at Gundalow Landing/east side of the bay. Viewing east. (02-17-21)

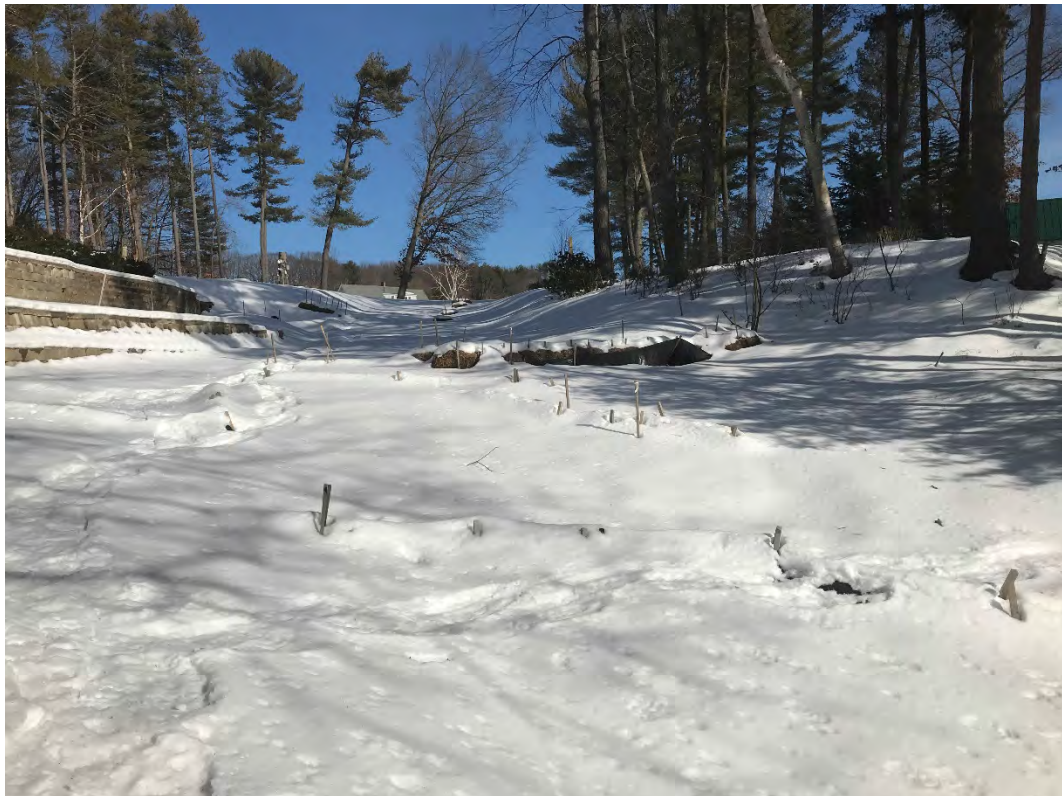
Fig 10: Slope below the manhole at Gundalow Landing/east side of the bay. Viewing east. (02-17-21)

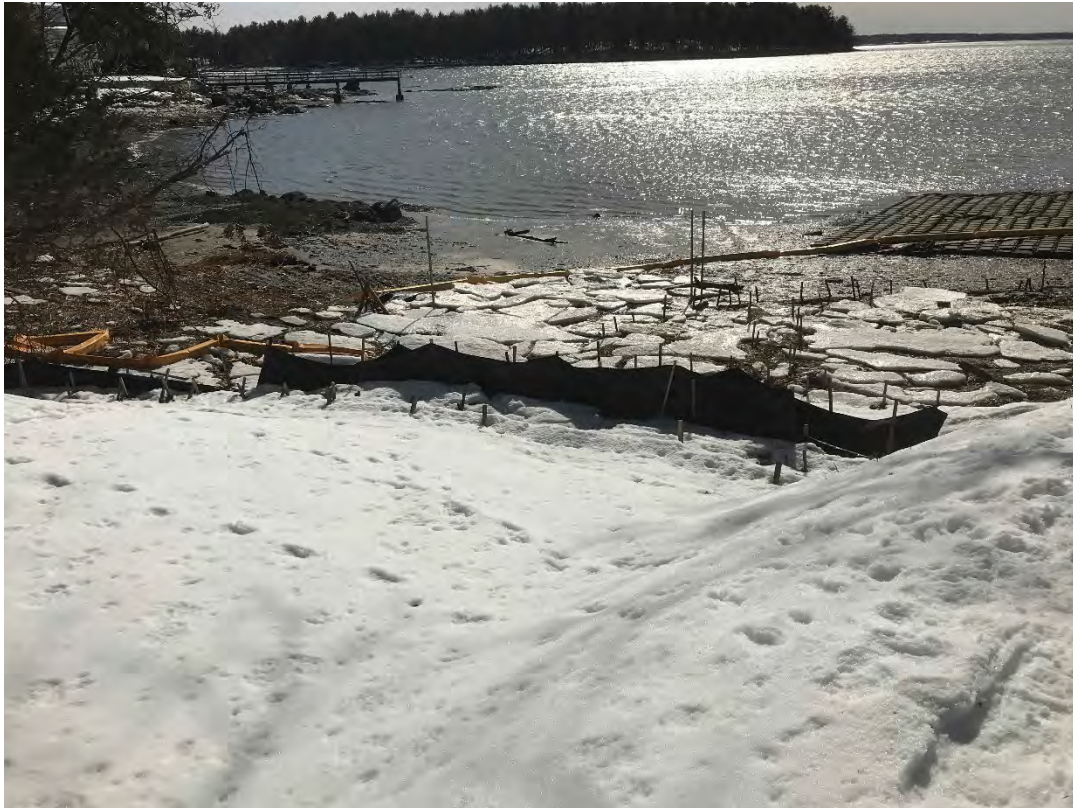
Fig 11: Toe of the slope at Gundalow Landing/east side of the bay. Viewing south. (02-17-21)

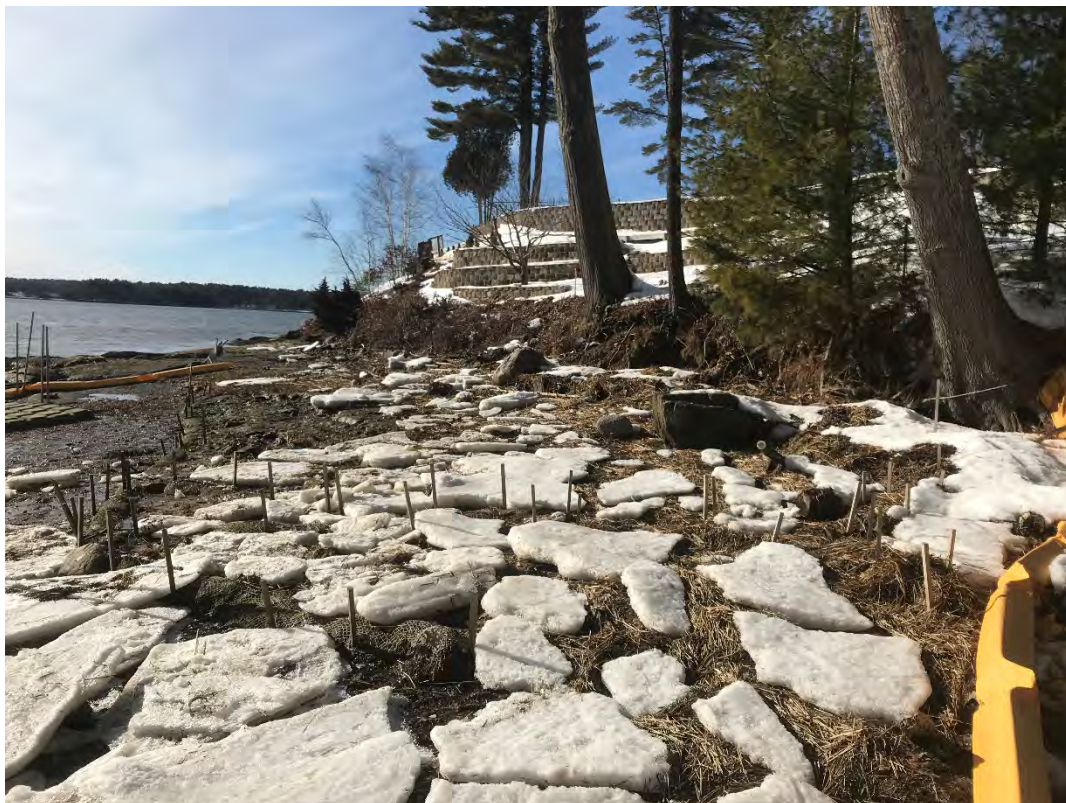
Fig 12: Salt marsh restoration at Gundalow Landing/east side of the bay. Viewing northwest. (02-17-21)
