CONSTRUCTION MONITORING REPORT

NAI Project No: 23840.39

Eversource Seacoast Reliability Project

Construction Monitoring Report #117

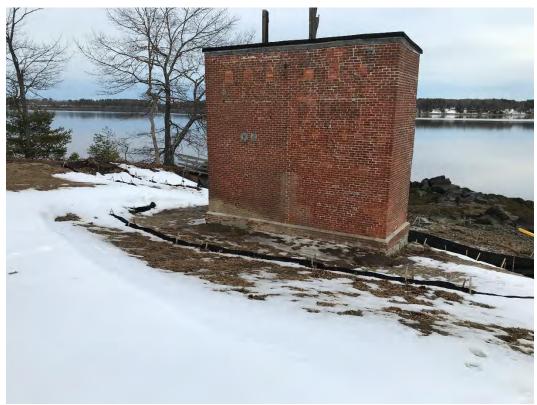
Fig 1: Slope leading down to cable house and salt marsh restoration at the Eversource property/west side of the bay. Viewing northeast. (02-24-21)

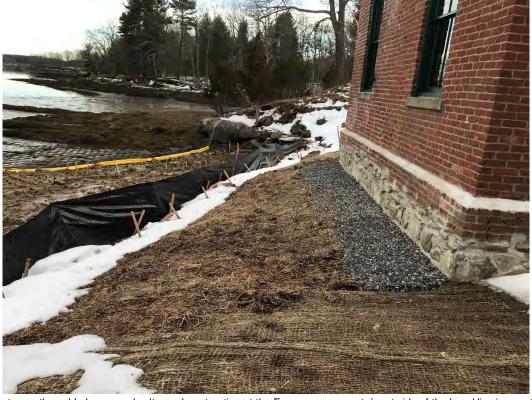
Fig 2: Slope between the cable house and salt marsh restoration at the Eversource property/west side of the bay. Viewing south. (02-24-21)

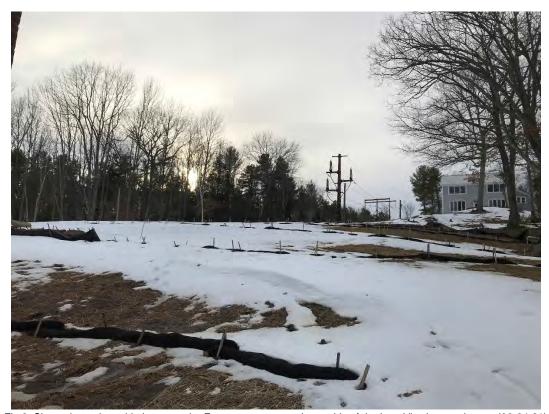
Fig 3: Slope above the cable house at the Eversource property/west side of the bay. Viewing southwest. (02-24-21)

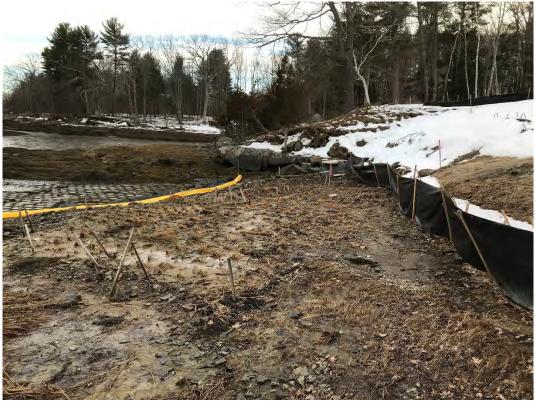
Fig 4: Toe of the slope and salt marsh restoration at the Eversource property/west side of the bay. Viewing south. (02-24-21)

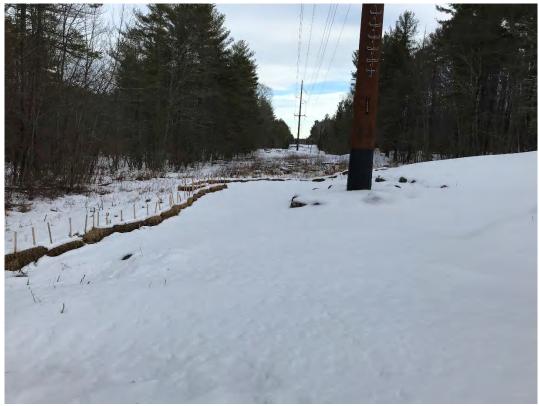
Fig 5: Str. 89 work area. Viewing southeast. (02-24-21)

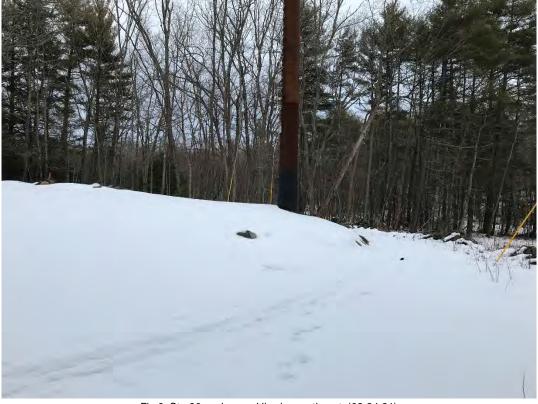
Fig 6: Str. 90 work area. Viewing northeast. (02-24-21)

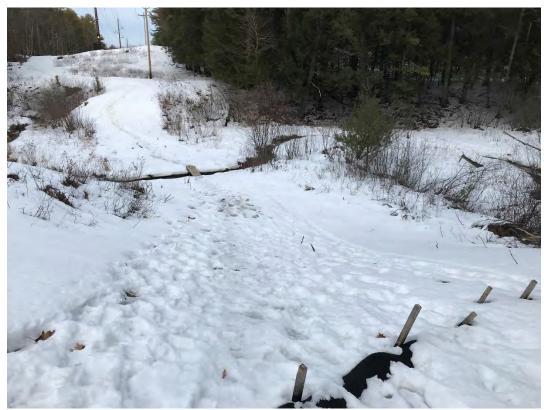
Fig 7: Stream DS46 between Strs. 51 and 52. Viewing northeast. (02-24-21)

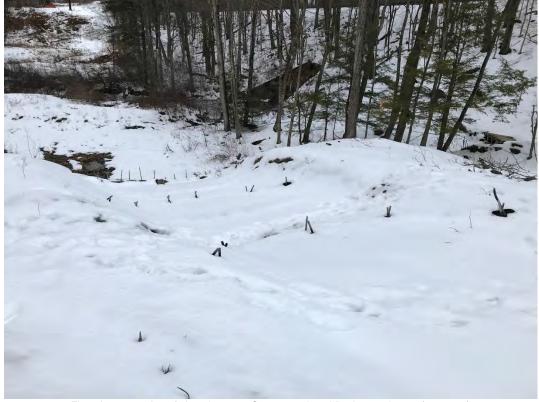
Fig 8: Lower portion of slope between Strs. 28 and 29. Viewing northeast. (02-24-21)

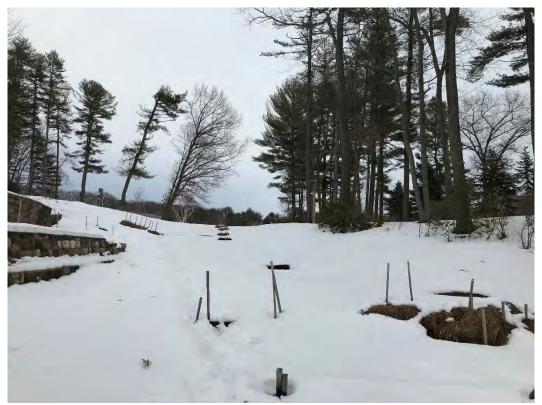
Fig 9: Slope above the manhole at Gundalow Landing/east side of the bay. Viewing east. (02-24-21)

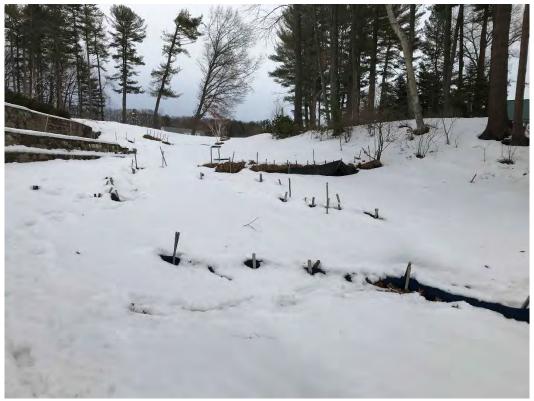
Fig 10: Slope below the manhole at Gundalow Landing/east side of the bay. Viewing east. (02-24-21)

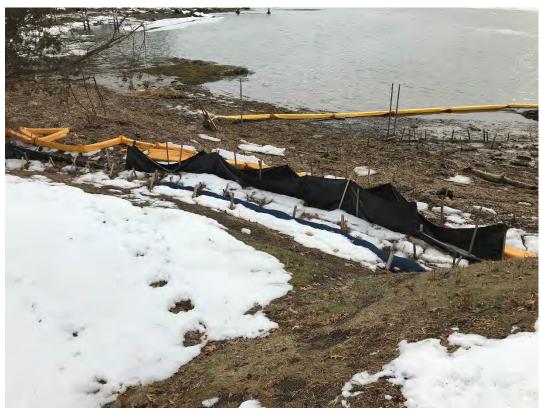
Fig 11: Toe of the slope at Gundalow Landing/east side of the bay. Viewing south. (02-24-21)

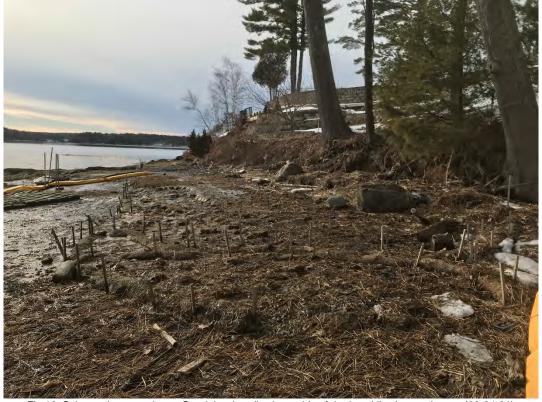
Fig 12: Salt marsh restoration at Gundalow Landing/east side of the bay. Viewing northwest. (02-24-21)
