DRAINAGE MONITORING REPORT

F107 - Seacoast Reliability Project

Newington, New Hampshire

04.0190967.00

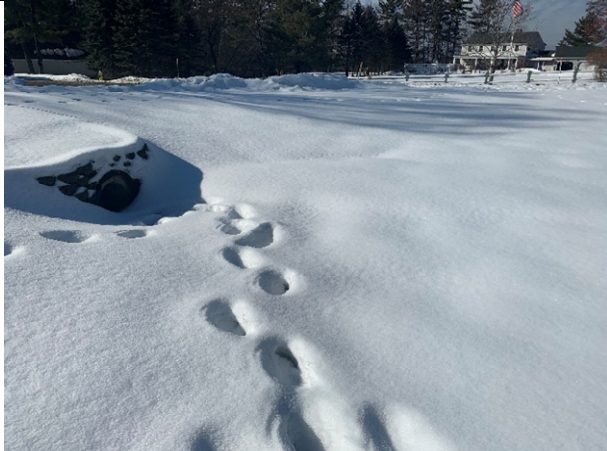
29 Gundalow - 1 (Drainage Area)

Observations/Notes: No water observed under snow cover.

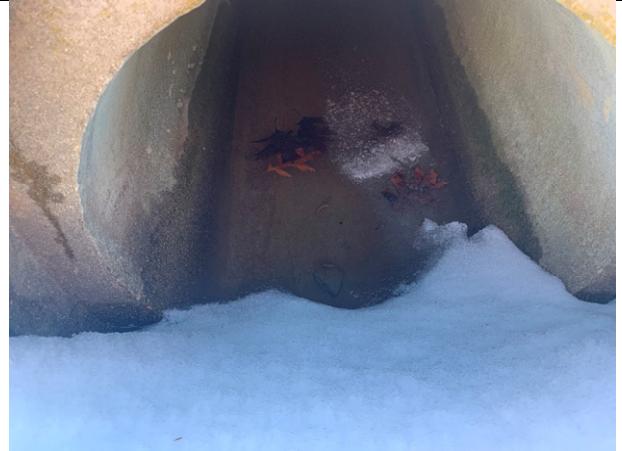
29 Gundalow - 2 (Culvert)

pH: 12.3

Observations/Notes: Approx. 7" of standing water within culvert inlet.

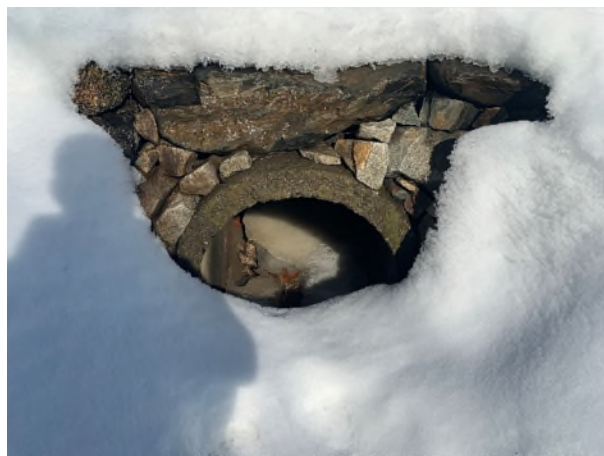
64 Gundalow - 1 (Drainage Course)

pH: 12.1

Observations/Notes: Flowing water under layer of snow and ice.

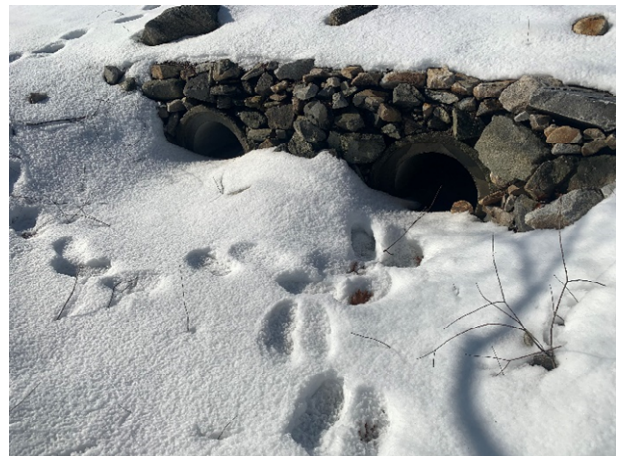
64 Gundalow - 2 (Drainage Course)

pH: 10.5

Observations/Notes: Flowing water under layer of snow.

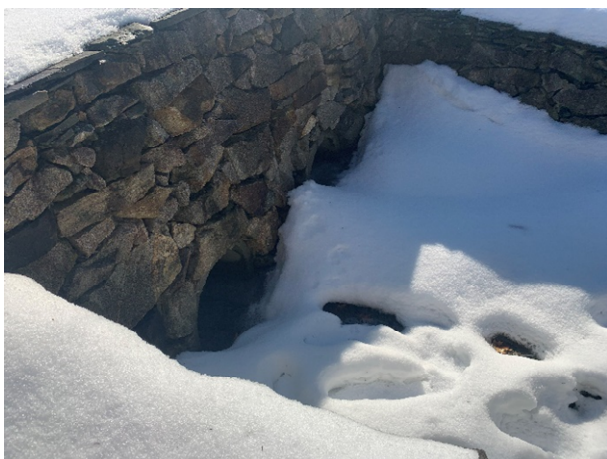
4 Brickyard Circle - 1 (Drainage Course)

pH: 9.5

Observations/Notes: Some solid ice and flowing water at culvert outlet.

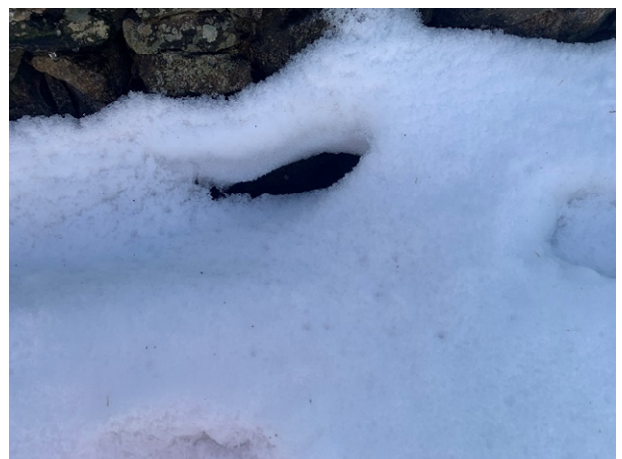
4 Brickyard Circle - 2 (Drainage Course)

pH: 8.0

Observations/Notes: Water flowing under snow and ice layer.

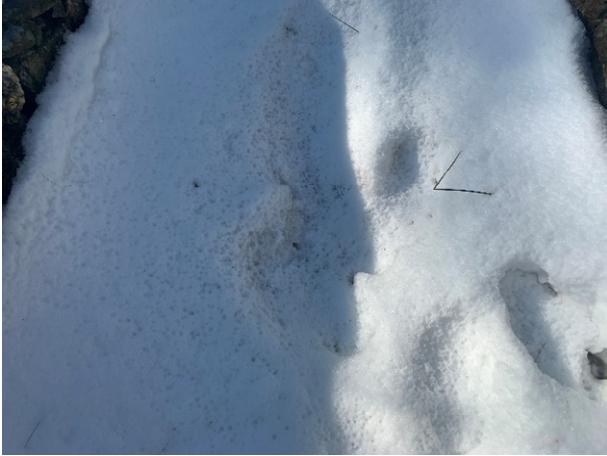
4 Brickyard Circle – 3 (Drainage Course)

pH: 7.6

Observations/Notes: Water flowing under snow and ice layer.
