DRAINAGE MONITORING REPORT

F107 - Seacoast Reliability Project

Newington, New Hampshire

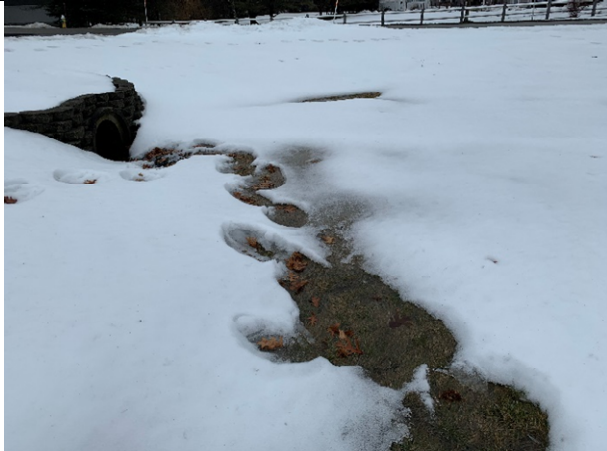
29 Gundalow - 1 (Drainage Area)

pH: **6.2**

Observations/Notes: Substantial overland flow from upgradient under ice and in areas of exposed ground, water approx. 1" deep.

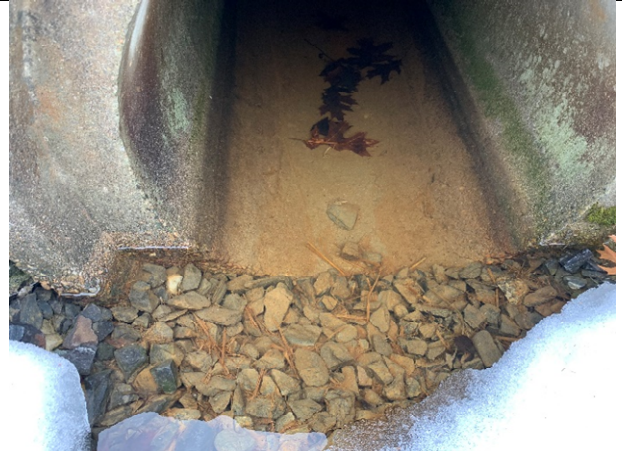
29 Gundalow - 2 (Culvert)

pH: **10.3**

Observations/Notes: Approx. 4" of flowing water within culvert inlet.

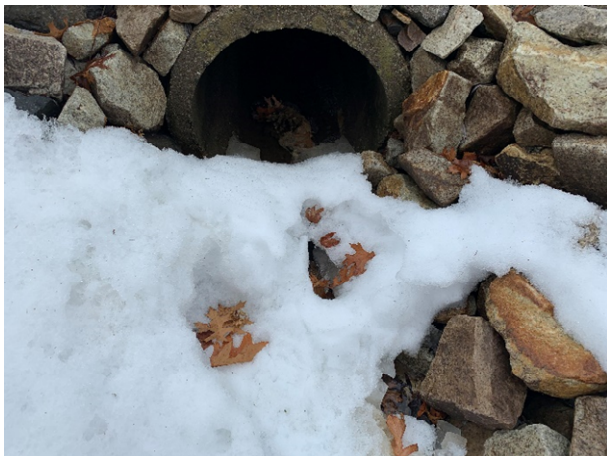
64 Gundalow - 1 (Drainage Course)

pH: **10.1**

Observations/Notes: Flowing water under layer of snow and ice.

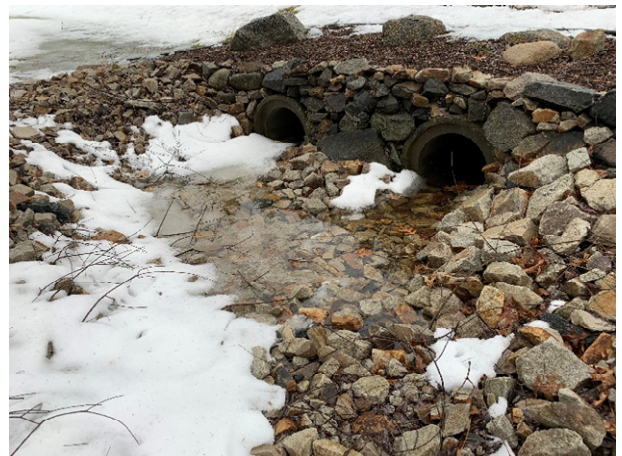
64 Gundalow - 2 (Drainage Course)

pH: **9.6**

Observations/Notes: Large area of water extending approx. 5' from culvert inlet, flow observed through culvert

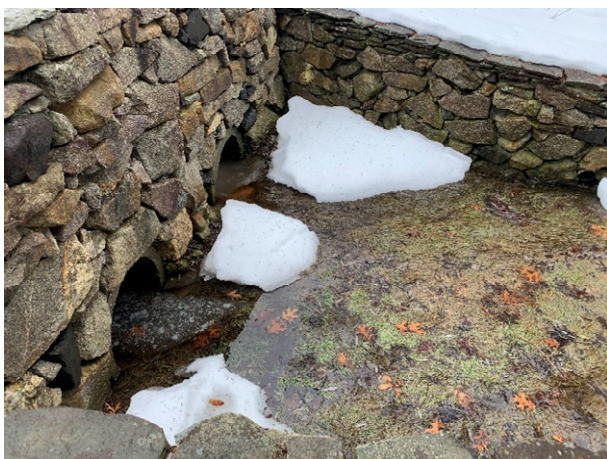
4 Brickyard Circle - 1 (Drainage Course)

pH: **8.5**

Observations/Notes: Maximum water depth approx. 8". Substantial flow down raceway observed.

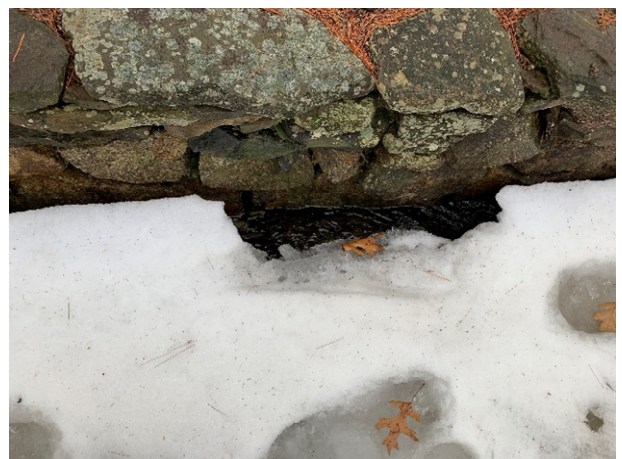
4 Brickyard Circle - 2 (Drainage Course)

pH: **7.6**

Observations/Notes: Water flowing under snow and ice layer.

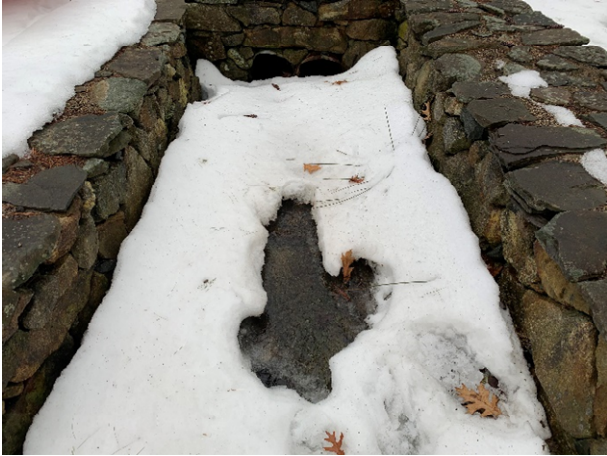
4 Brickyard Circle – 3 (Drainage Course)

pH: **7.3**

Observations/Notes: Water flowing under snow and ice layer and in exposed areas, maximum water depth approx. 3".
